Conditions Assessment Furnace Brook Parkway Substation

**1198 Furnace Brook Parkway
Quincy, MA**

DCR Project No. P25-3595-S2A

March 24, 2025

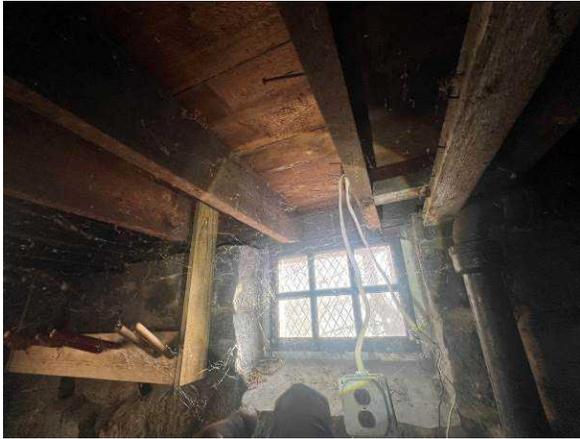
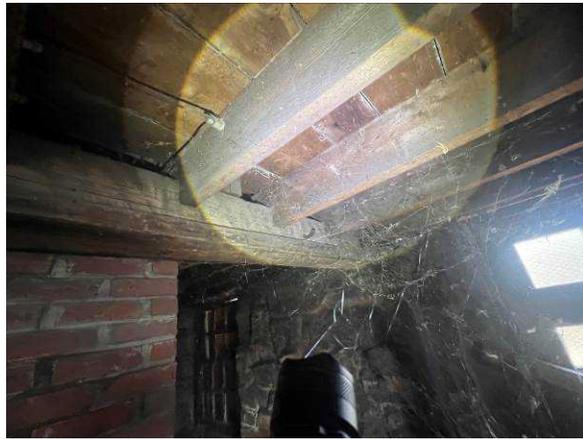
Existing First Floor Framing and Stone Foundation Walls

The existing structure is in good condition. The engineer did not observe any distress in any of the members. The engineer did not observe any signs of foundation settlement or undue vibrations due to footfall on the supported first floor. The engineer did not observe any signs of water infiltration through the roof or the exterior walls. The stair from the first floor to the basement is in state of disrepair and is structurally unsafe. The engineer observed some deterioration at the base of a wood column in the basement. The column may have to be replaced with a new wood column supported on a new thickened slab locally. The engineer observed some rusting at the base of the steel columns supporting the Entrance Canopy. Based on the observations, the majority of the structure is in fair condition and there are no major structural concerns at this time other than the basement column and the stair structure from the first floor to the basement.

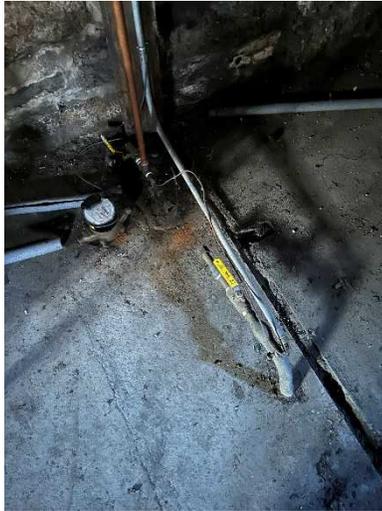
Water Service

The building's domestic water is supplied underground through a ¾-inch (¾") pipe which enters the basement through the slab. The domestic water supply was equipped with a meter which has been removed and sits on the floor next to the water service. The water service piping appears to be of unknown metal.

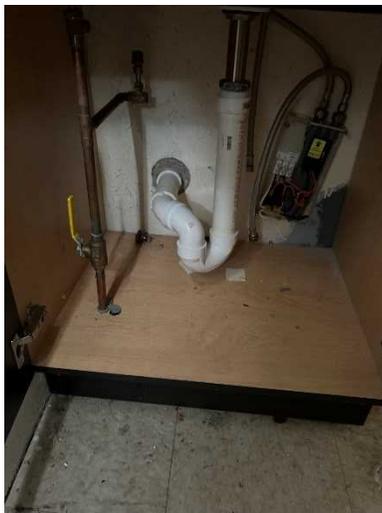
PVC Piping

What could be seen of the existing sanitary drain, waste and vent system appears to be a combination of PVC and hub and spigot cast iron with leaded and caulked joints. PVC is limited to the lavatory drain. Visible piping appeared to be in fair condition, with little evidence of active leaks.

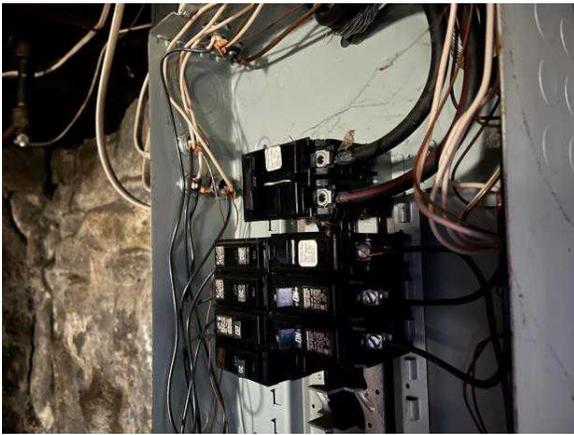
Westinghouse Load Center

While the Electrical System is in service, a rating of poor/failed is assigned due to the risk associated with corrosion and age and the absence of a protective panel cover. Support of the 35-yr old load

center is due for immediate replacement. Today's code requires AFCI and GFCI breakers as well as surge protection for the main service panel.

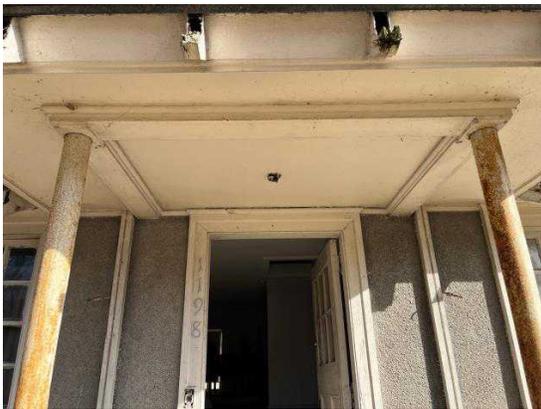
Lighting control is by wall mounted snap switches. The building's perimeter and porch lighting were missing. In general, the interior/exterior lighting system is barely functioning.

No Entryway Light

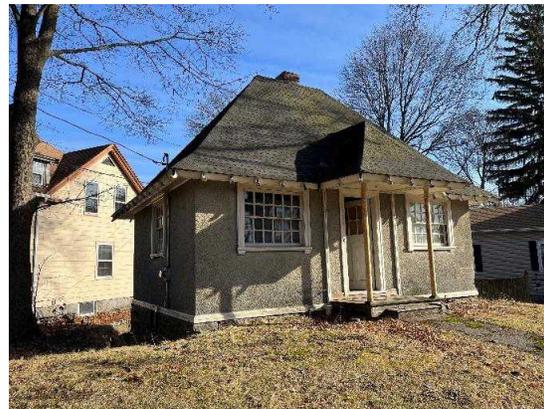
No Walkway Lighting

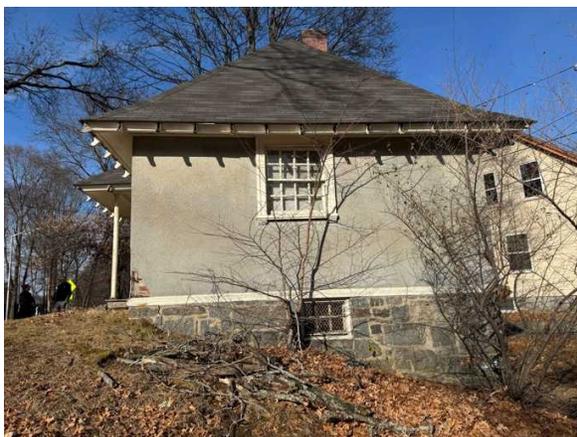
Overall, the stucco is in fair condition and in need of cleaning. In the south corner of the project at the foundation wall, the stucco has been damaged and come off, leaving the wood sheathing exposed. This corner needs to be repaired. There is also a crack in the stone foundation wall at this corner that should be evaluated and repaired.

East Side of Building where Stucco Needs to be Repaired and Shrubs Removed

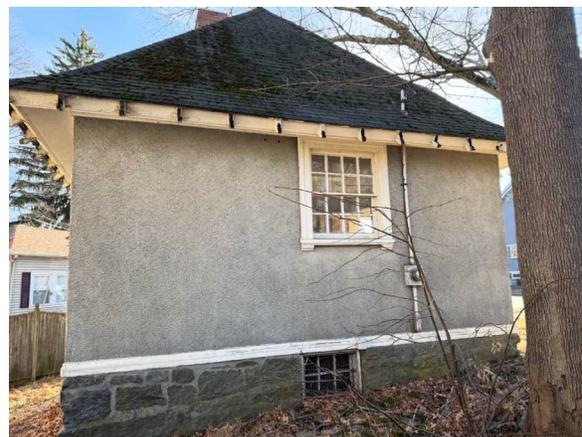
As observed from the ground, the asphalt shingle roofing appears to be fair condition, although there is some vegetative growth on the front portion of the roof. The exposed painted wood rafter tails are completely deteriorated and unusable. The soffit of the front entry canopy appears in fair condition. The steel columns supporting the porch roof are deteriorating and in poor condition as noted in the structural portion of the report. The front landing and stair are in fair condition, but do not meet code requirements for some of the proposed building uses.

West Side of Building including Deteriorated Rafter Tails to be Replaced

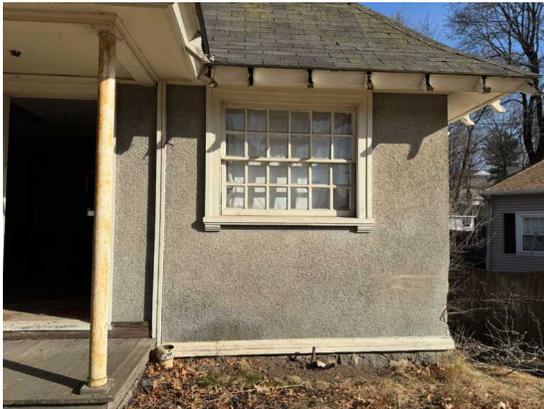
Partial view of Front of Building, Including Window, Column, and Rafter Tails to be Replaced

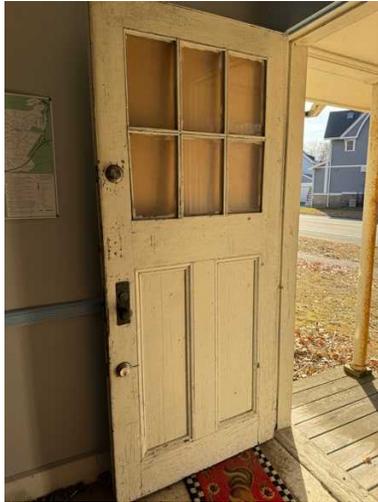
Existing Front Door

The threshold of the front door is a couple of inches above the exterior wood entry landing. The front door is a half-glazed painted wood door with two panels in the lower portion. The glazing is single pane with divided lites. There are no weatherstripping or sweeps on the door. The threshold is a flat wood threshold that is flush with the interior floor. Given the poor condition of the threshold and interior floor, it is difficult to determine if there has been any water intrusion. The door has two deadbolts (high and low) and a keyed doorknob. The paint is peeling and in unusable condition.

The door is in poor condition, although still serviceable currently by virtue of being intact, lockable, and fully openable. The door will either need to be replaced or restored. The approach needs to evaluate the historic significance of the property along with the energy code requirements for the for the building envelope as described in the Recommendations Section.

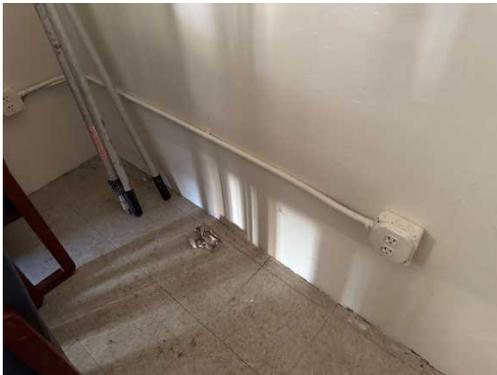
The first floor is resilient flooring over a wood plank subfloor. In the primary room, there is a painted wood wall base. In the secondary room and bathroom, there is no wall base. The flooring is in unusable condition.

First Floor Resilient Floor without Wall Base and Surface Mounted Electrical Conduit and Receptacle

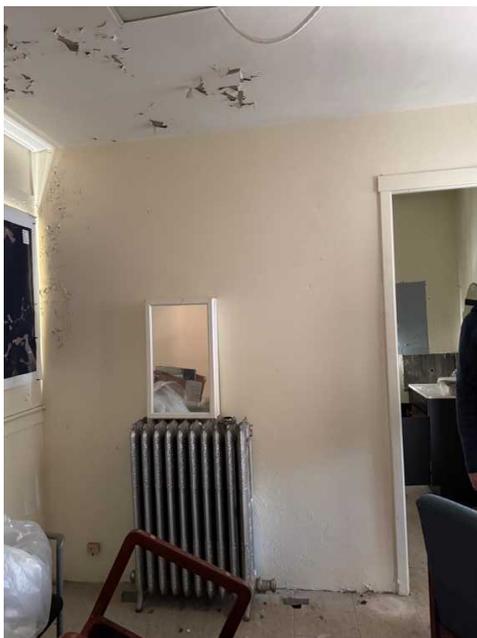
The first-floor walls and ceilings appear to be painted gypsum board and may also include plaster in some locations. There are several locations where the finish layer is peeling from the board and/or scaling, like what might be expected if there are moisture or condensation issues. This may be occurring because the building is no longer conditioned.

Wall and Ceiling Damage, Secondary Room

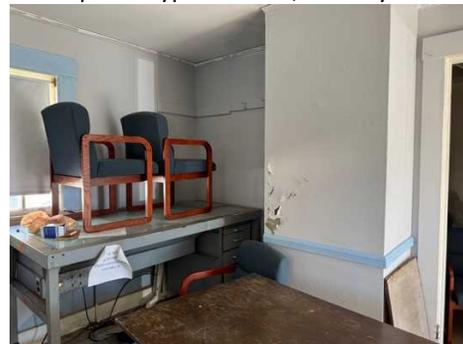
Wall Damage, Primary Room

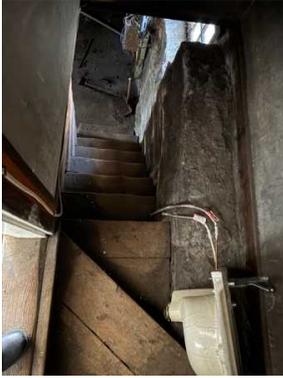
Stair looking down to
Basement

There is a wood stair down to the basement. It is narrower and steeper than code compliant, is lacking a handrail, and is in unusable/poor condition. One can currently walk down it, but it is an unsafe condition and will need to be fully replaced.

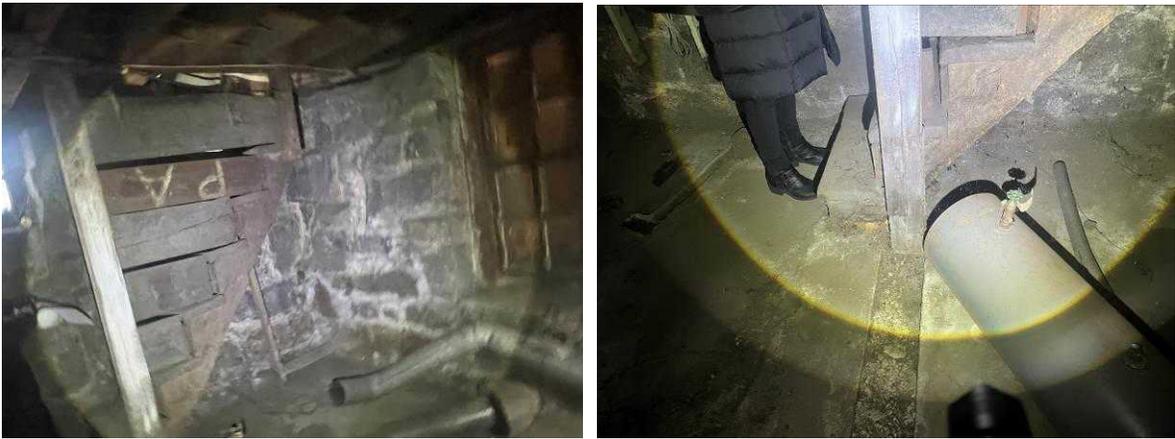
Existing Stair Framing

exterior walls. The stair from the first floor to the basement is in state of disrepair and is structurally unsafe. We observed some deterioration at the base of a wood column in the basement. The column may have to be replaced with a new wood column supported on a new thickened slab locally. We observed some rusting at the base of the steel columns supporting the Entrance Canopy. Based on our observations, majority of the structure is in fair condition and there are no major structural concerns at this time other than the basement column and the stair structure from the first floor to the basement.

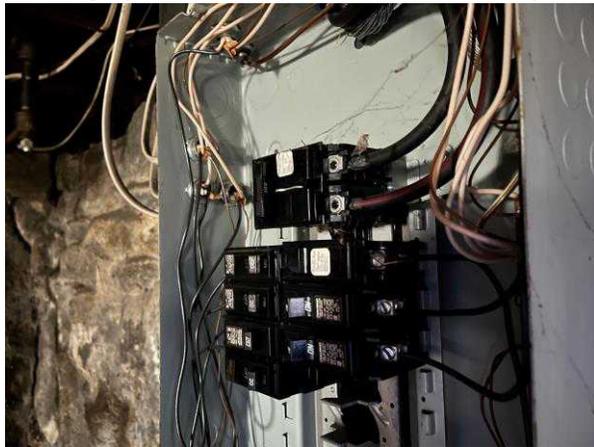
Westinghouse Load Center

While the Electrical System is in service, a rating of poor is assigned due to the risk associated with corrosion and age and the absence of a protective panel cover. Support of the 35-yr old load center is due for immediate replacement. Today's code requires AFCI and GFCI breakers as well as surge protection for the main service panel.

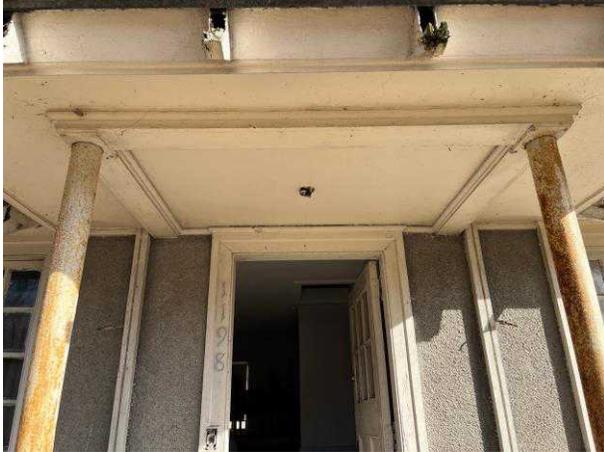
Lighting control is by wall mounted snap switches. The building's perimeter and porch lighting were missing. In general, the interior/exterior lighting system is barely functioning.

No Entryway Light

Rating: Failed – Recommend replacing all lighting to include dimming and use of Vacancy Sensors.

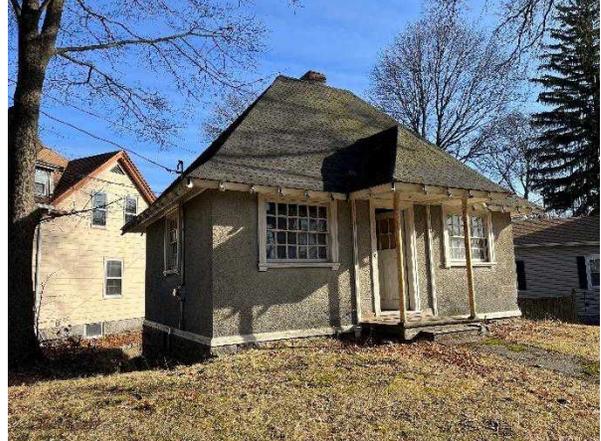
No Walkway Lighting
