ROAD SAFETY AUDIT

Arborway - West of South Street to West of Eliot Street

City of Boston

September 9, 2019

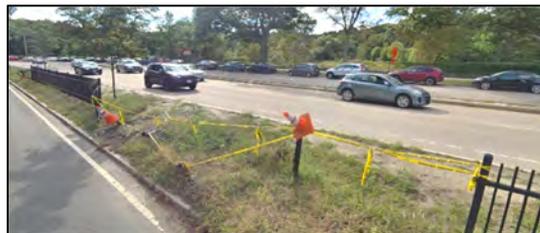
Four of the 27 crashes were reported as exceeding the authorized speed limit or driving too fast for conditions. All four crashes were single-vehicle crashes, all vehicles involved in these crashes were traveling northbound, and three crashed along the horizontal curve approaching the signalized pedestrian crossing approximately 400 feet south of the Arnold Arboretum driveway. Northbound vehicles may not have adequate sight distance to the midblock pedestrian crossing signal due to roadway geometry. This, combined with the high speeds vehicles travel along the roadway, may have led to the seven crashes involving the midblock pedestrian crossing. All seven crashes either involved pedestrians or vehicles stopping for pedestrians.

Vehicles crash into fence dividing the Arborway from the Upper Arborway road.

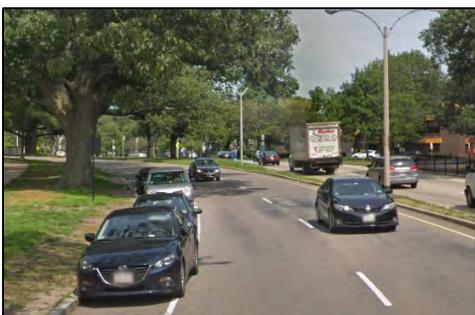
Vehicles are shown parked over the edge line of the shoulder, and doors extend into the lane when opened.

Audit members also discussed the unclear parking regulations along the shoulders along the Arborway. There is nowhere to patrol or pull over vehicles along the roadway except in the wide shoulder used as a parking lane. The shoulder provides signage implying the shoulder is a parking lane but the lane appears to be of inadequate width, also negatively affects the sight distance of vehicles traveling southbound toward the signalized pedestrian crossing. Three crashes, or 11%, involved a parked car or vehicle exiting the shoulder.

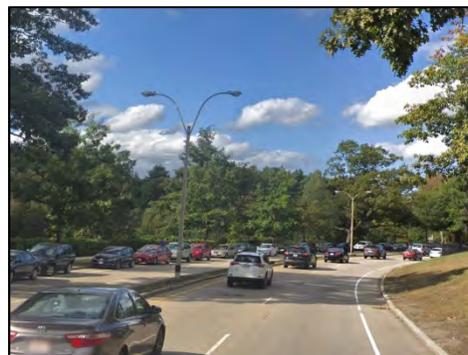
Approximately 1,000 feet west of South Street, the Arborway has an approximately 1,500 feet long horizontal curve. There is signage to warn drivers of the upcoming curve traveling on the Arborway northbound, but the signage is not present at the point where vehicles were noted to crash into the fence and median separating the Arborway from the Upper Arborway and the opposing Arborway direction, respectively. Four of the 27 crashes involved a vehicle crashing into the fence. In addition, there is no warning or object marker signage along the median with the fence facing the Arborway, which may impair visibility along the median, especially at night.

No signage is present along the Arborway curve northbound approaching the signalized crossing.

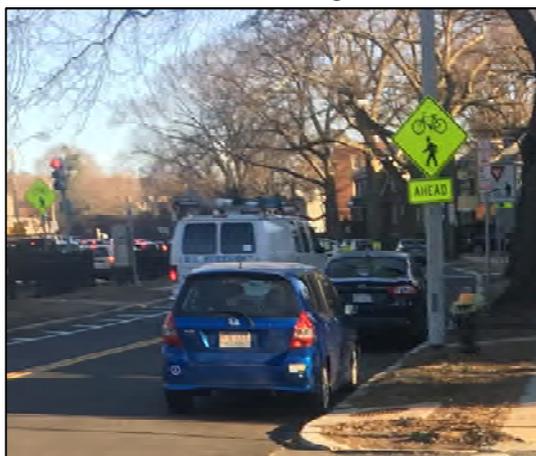
Advanced bicycle and pedestrian warning signage are provided warning about both pedestrians and cyclists crossing; however, no guidance is given to the cyclists directing them to use the road or sidewalk through the study area.

No clear bicycle accommodations are provided along the Arborway. The warning signage for motorists at the signalized crossing indicate the crossing is provided for both pedestrians and cyclists, but the sidewalks on either side are not signed as shared-use paths. There are also no bike lanes or shoulders cyclists can use due to parking along the Arborway and Upper Arborway. This section is part of a gap in bicycle accommodations between Jamaica Pond and the Casey Arborway.

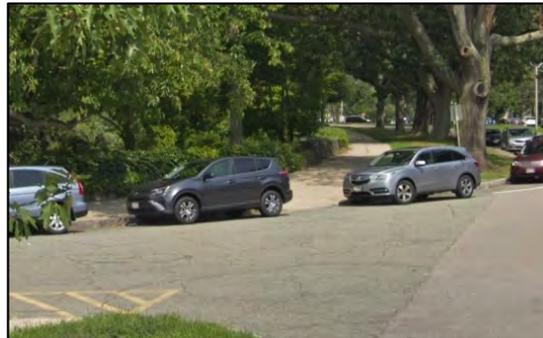
Cars park in front of the pedestrian ramp, which obstructs the path for pedestrians.

The west ramp and the refuge island ramps at the signalized midblock crosswalk across the Arborway do not appear to be ADA-compliant. Ramps are provided on both sides of the Arboretum driveway that also do not appear to be ADA-compliant; there is no painted crosswalk, and vehicles tend to park blocking the southern ramp.

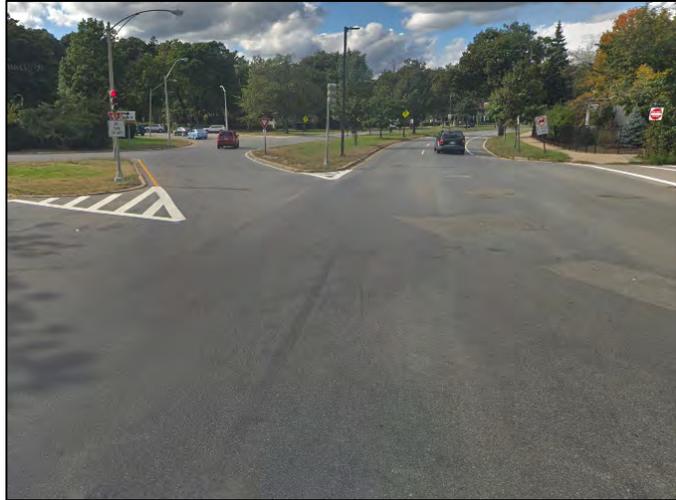
The signals are all post-mounted, which may affect motorists' sight distance of the signal indications. Although the signals are equipped with visors, a signal head facing Centre Street westbound on the Centre Street east/westbound splitter island is present and is visible as drivers approach the rotary from the Arborway northbound approach. Most of the signals are outside of the motorists' direct line of sight, which may lead to confusion. Two of the five crashes at the intersection were caused by vehicles making opposing movements believing they had the right of way, and one involved an emergency vehicle was hit trying to travel through the intersection, as there is no Opticom for emergency vehicles to travel through the intersection.

The signal facing the Centre Street eastbound approach is visible to the Arborway northbound traffic.

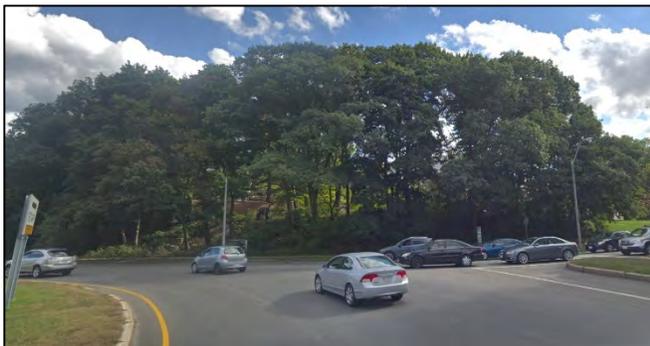
Murray Circle has a varied circulating width between approximately 30-60 feet. Without pavement markings, the circulating traffic lane usage varies from one to three or four lanes. There was queuing observed at the Centre Street eastbound approach during the RSA due to the circulating traffic using the rotary as one lane, even though the circulating width is approximately 40 feet near the approach. Although the circle did not appear to be congested, the entering traffic did not have an adequate gap due to the lack of lane usage signage and markings. There were 18 of the 44 crashes involving switching lanes sideswipes within the rotary or while entering or exiting the rotary.

Lane usage is not clear in Murray Circle causing many motorists to drive in the middle of one wide travel lane.

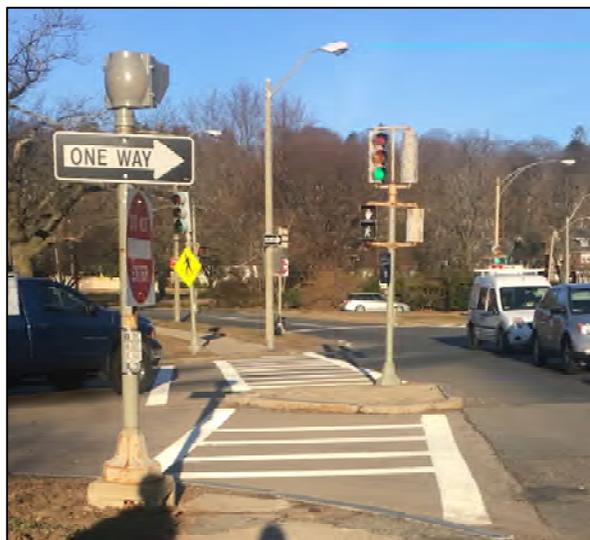
Through Murray Circle, many approaches are missing crossings or pedestrian ramps. There is no crossing along the eastern leg of the rotary. In addition, there is currently no crossing across the eastern segment of Centre Street until over 800 feet east of the rotary. Pedestrians have no safe way to cross Centre Street. MBTA routes 35 and 37/38 are present on this leg of Centre Street, creating demand to cross Centre Street. In addition, it was noted that at the Upper Arborway at Centre Street, a crosswalk was present across the Upper Arborway road; however, after the road was repaved, the crosswalk was not repainted. Around the rotary, the crossings force pedestrians to cross two lanes of traffic at a time with no RRFB or HAWK signal assisting in the crossing. Pedestrian crossing warning signs are provided for some but not all pedestrian crossings around the rotary. One crash of the 44 reported crashes was a rear-end involving a vehicle stopping for pedestrians while exiting the rotary northbound onto the Arborway. The existing pedestrian signals do not have APS pushbuttons, nor do they have a countdown. The crosswalks are also not all marked the same way; for instance, the Prince Street crosswalk does not have ladder markings.

The signalized crossing across Arborway at Centre Street does not have ramps or pedestrian head with countdowns.

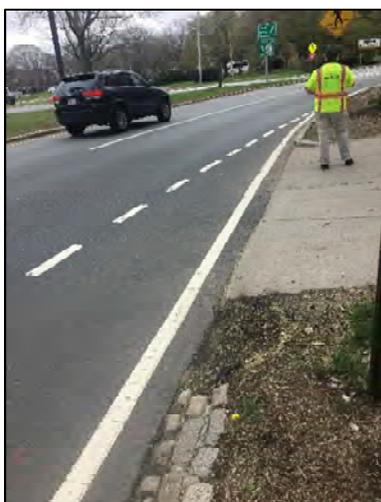
Bicycle lanes taper at the Carriage Road southbound approach to the rotary.

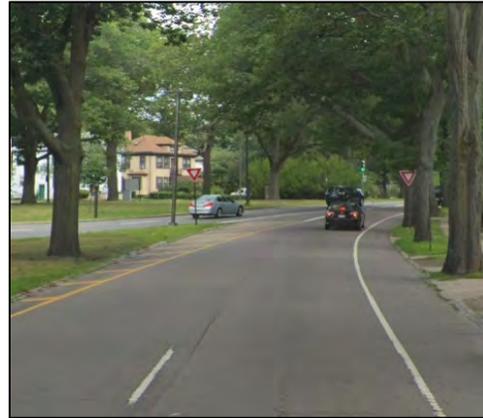
All five of the reported crashes occurred on the Carriage Roads. The northbound Carriage Road merges from two lanes to one lane approaching Kelley Circle. The lane markings end, but no signage indicates the need for motorists to merge. One of the five crashes involved

The Carriage Road merges from two lanes to one lane with no warning for motorists.

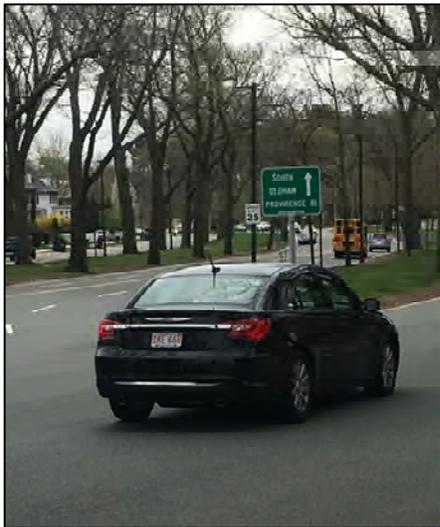
Although there were only five crashes reported along this corridor, issues were noted through the RSA site walk observations. Vehicles are guided from both the north and south into the Carriage Roads, meant for local access, as opposed to the main Arborway roads. The main Arborway roadways between Kelley

The geometry of the road direct motorists straight onto the Carriage Roads, as opposed to the main Arborway roadway.

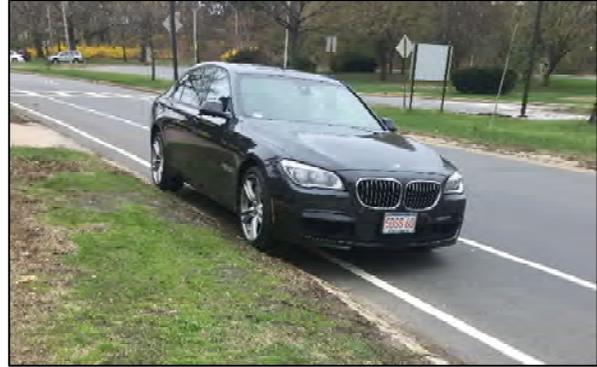
Along the Carriage Roads, an approximately five-foot shoulder is provided on the right. According to RSA members, the shoulder was originally marked as a bicycle lane, but due to the lack of connection at Kelley and Murray Circles, the markings were removed. This shoulder is now used at times for illegal parking. No bicycle accommodations are provided at either Kelley or Murray Circles; the shoulder ends with no warning signage, so cyclists using this shoulder are forced onto the roadway or sidewalk with no warning.

Vehicle is parked on the shoulder along the Carriage Road.

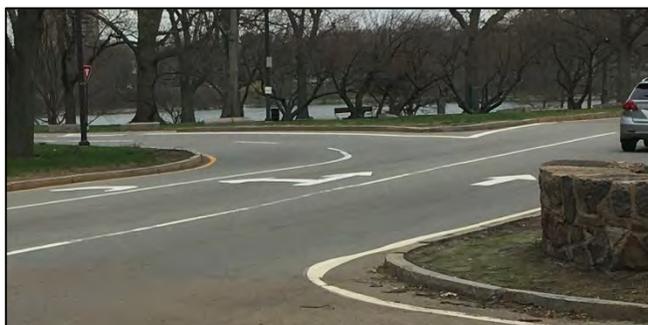
Francis Parkman Drive enters the rotary in a right-turn only lane towards the western leg of Pond Street. This requires motorists heading east toward the eastern leg of Pond Street to enter and cross three lanes of traffic to travel around Kelley Circle. During the RSA, finding gaps in circulating traffic to enter and cross lanes was noted to be an issue, especially during the afternoon peak. Two rear-end crashes occurred at the entrance to the rotary, possibly due to the first vehicle struggling to find a gap in the traffic. Vehicles tend to look left to find a gap in traffic and fail to look right towards the crossing, which may have led to one of the crashes with a cyclist in the crossing.

The pavement markings indicating lane use is provided after the motorist's decision point.

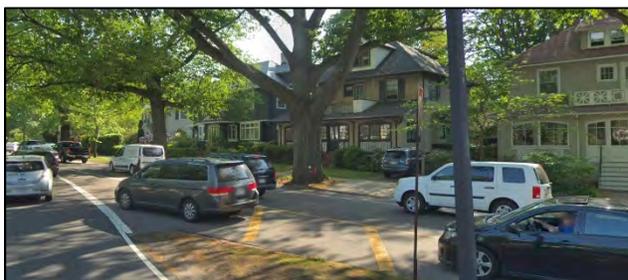
The Carriage Road merges from two to one lane, approximately 400 feet before the pedestrian signal at the rotary. Many motorists were witnessed changing lanes over the gore, which was the cause of one of the 31 reported crashes to avoid the exit only lane 300 feet north of the signalized crossing. In addition, approaching the exit onto Pond Street/Jamaicaway, pavement markings indicating lane use are placed near the split, leaving motorists without enough distance to safely switch lanes. This may have contributed to four of the 31 crashes. The traffic control at the pedestrian signal is unclear. In a typical rotary, traffic entering the rotary would yield to circulating traffic. However, the pedestrian signal gives the Arborway northbound traffic a green signal when the pedestrian signal is not activated. Although no crashes were reported involving a conflict with the U-turn and northbound traffic, the green signal for the Arborway approach and lack of yield control at the U-turn makes the vehicular right of way unclear.

Vehicles entering the rotary from the Carriage Road switch lanes onto the Arborway through the gore to avoid the Pond Street/Jamaicaway exit only lane.

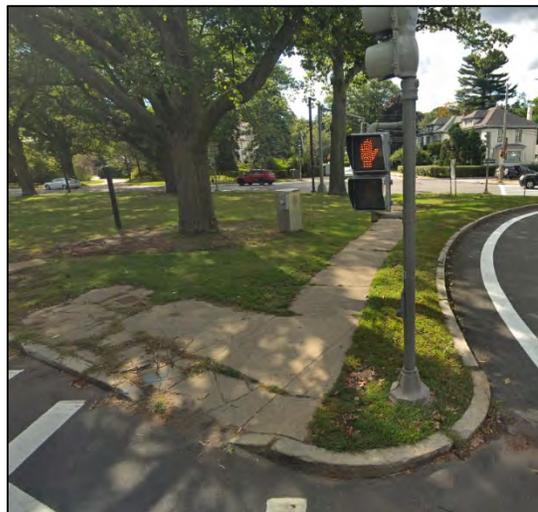
Most existing wheelchair ramps and pedestrian pushbuttons at the crossings do not appear to be ADA-compliant. The signals at the southern section of the rotary, at Pond Street and the northbound entrance to the rotary, do not have Accessible Pedestrian Signals (APS), nor do they have countdown signal heads.

The pedestrian signals at the Arborway northbound entrance to the rotary are outdated, and the wheelchair ramps are in poor condition.
