**Barnstable Probate & Family Court
Barnstable, MA**

HVAC SYSTEM EVALUATIONS COVID-19

Office of Court Management

July 15, 2022

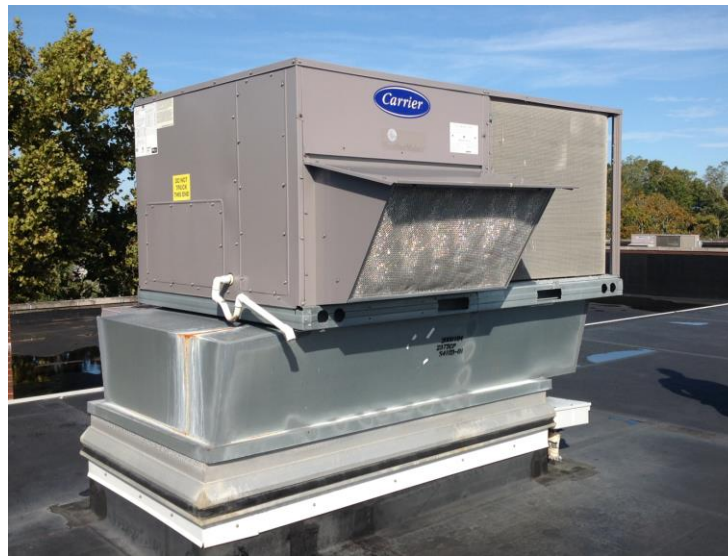
Photo 1 – Representative Rooftop Air Handler

The RTU's have DX cooling, supply fan, as well as return, outside, and relief air dampers. There is no heating within the RTU's. The conditions vary from poor to good condition, as some appear to have been replaced at different times. The RTU fans do not operate continuously, and cycle in response to cooling needs in the spaces served. In heating mode, RTU's 1-3 run continuously to serve the multiple zones with individual hot water heating coils in the ductwork. RTU's 4-6 are single zone systems and only provide cooling, cycling the fan in response to cooling demands. Heat is provided in these areas via hot water baseboard around the perimeter. The newer RTU's (1,3,5, and 6) include economizer controls and have 3 position outdoor air dampers. The oldest RTU's (2 and 4) have fixed outdoor air dampers.

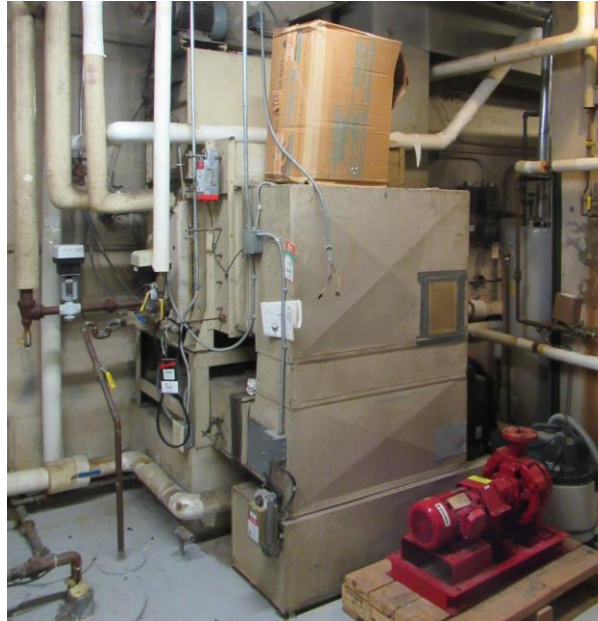
Photo 2 – Air handler AHU-1

AHU-1 is located in the basement boiler room and serves the land court offices in the basement. The unit has a hot water coil, chilled water coil, hot water reheat coil, supply fan, as well as return and outside air dampers. This unit is in poor condition. The hot water coil was dirty, and the unit did not appear to be providing any outdoor air at the time of the visit based on the position of the outdoor air damper.

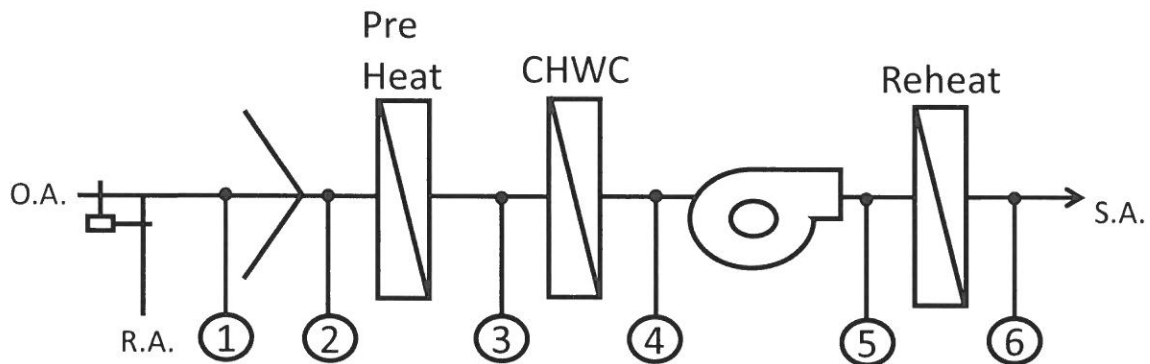
PROJECT: Barnstable Probate
SYSTEM/AREA: AHU-1 / Land Court

UNIT	1	2	3	4	5	6	7	8	NOTES
AHU-1	-0.28"	-0.38"	-0.46"	-0.53"	+0.73"	+0.07"

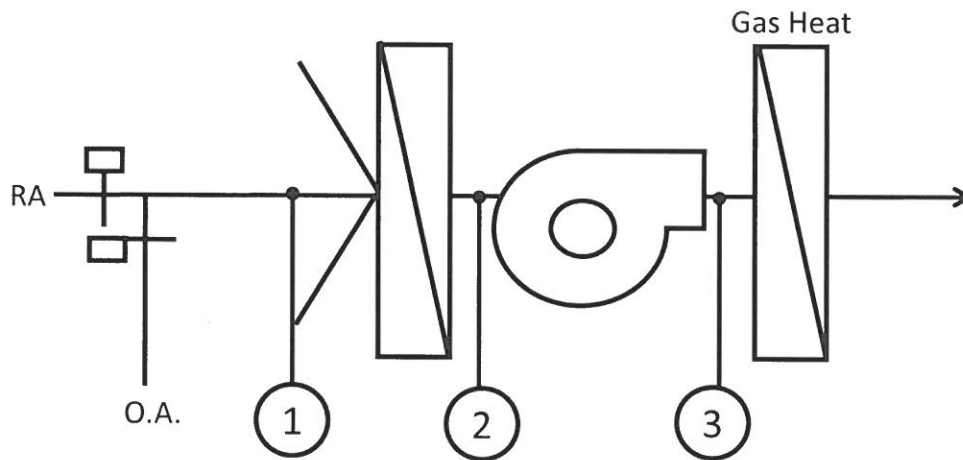
SYSTEM STATIC PRESSURE PROFILE**PROJECT:** Barnstable Probate**DATE:** May 16-20, 2022**SYSTEM/AREA:** RTU's 1-6**TECH:** BS, NC

UNIT	1	2	3	4	5	6	7	8	NOTES
RTU-1	-0.35"	-0.65"	+0.65"						
RTU-2	-0.55"	-0.89"	+1.18"						
RTU-3	-0.39"	-0.65"	+0.6"						
RTU-4	-0.37"	-0.57"	+0.24"						
RTU-5	-0.54"	-0.91"	+0.54"						
RTU-6	-0.52"	-1.04"	+0.27"
