**Town of Bernardston, MA
State Community Compact of
Drainage Structures**

Prepared for:
Town of Bernardston, MA
Selectboard

Prepared by:
Stantec Consulting Services, Inc.

October 11, 2017

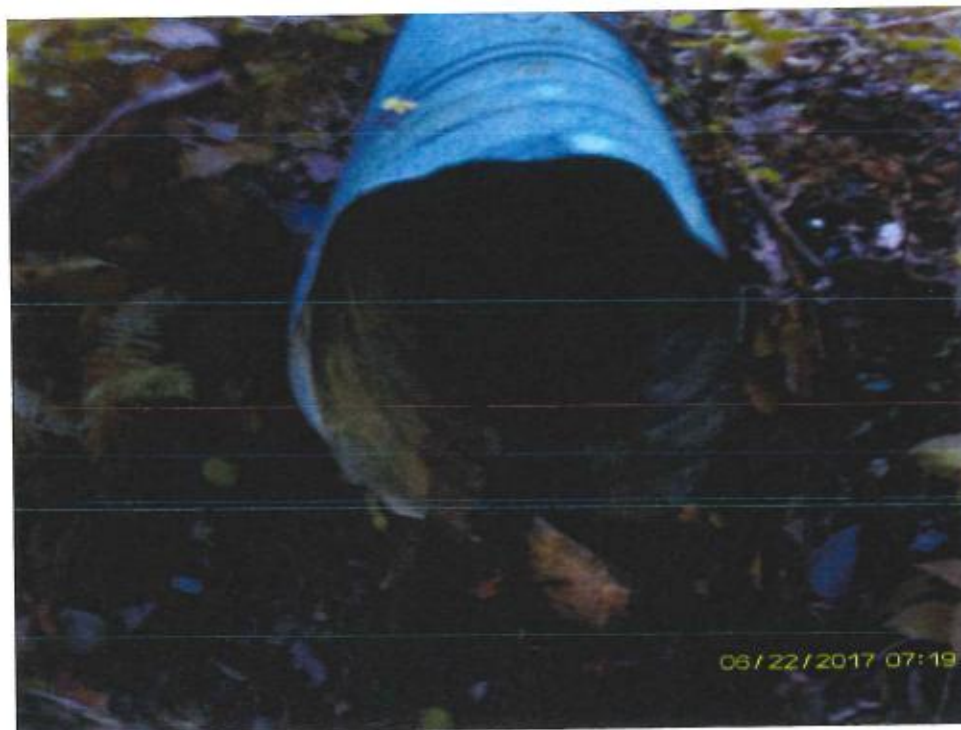
Metal culverts are susceptible to corrosion, especially in locations of salt application and where a section of the culvert is exposed to ambient conditions. In general, most of the culverts that were inspected had some level of material corrosion on the bottom and outlet of the pipe. Photo 1 shows an example of corrosion observed at the outlet of one of the culverts that was

Photo 1: Corroded Metal Culvert at Outlet

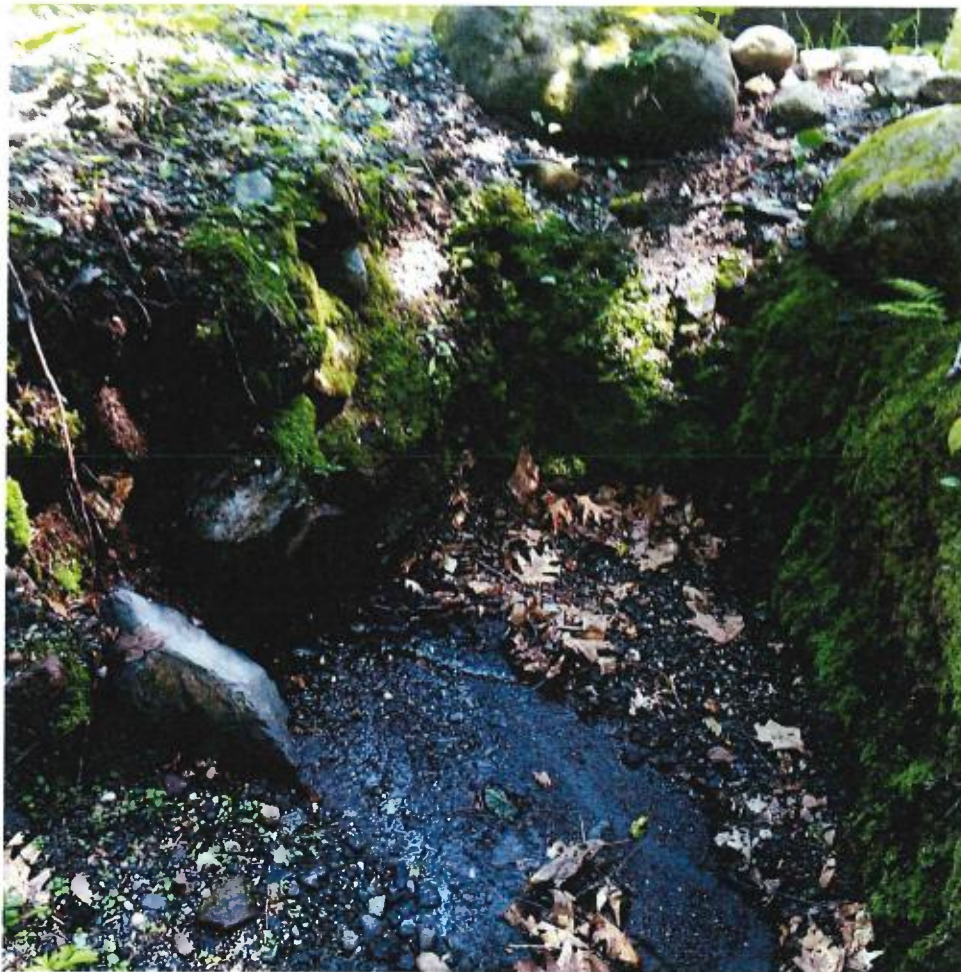
Inlet flooding, sedimentation and outlet scour conditions were observed at a number of culverts inspected, these conditions appear to be attributed to limited culvert capacities, either due to sediment/silt blocking the inlet or the diameter of the existing culvert is undersized to convey the tributary stormwater flows. Photo 2, shows a culvert with limited inlet capacity due to sedimentation build up at the inlet.

Photo 2: Culvert Inlet with Limited Capacity

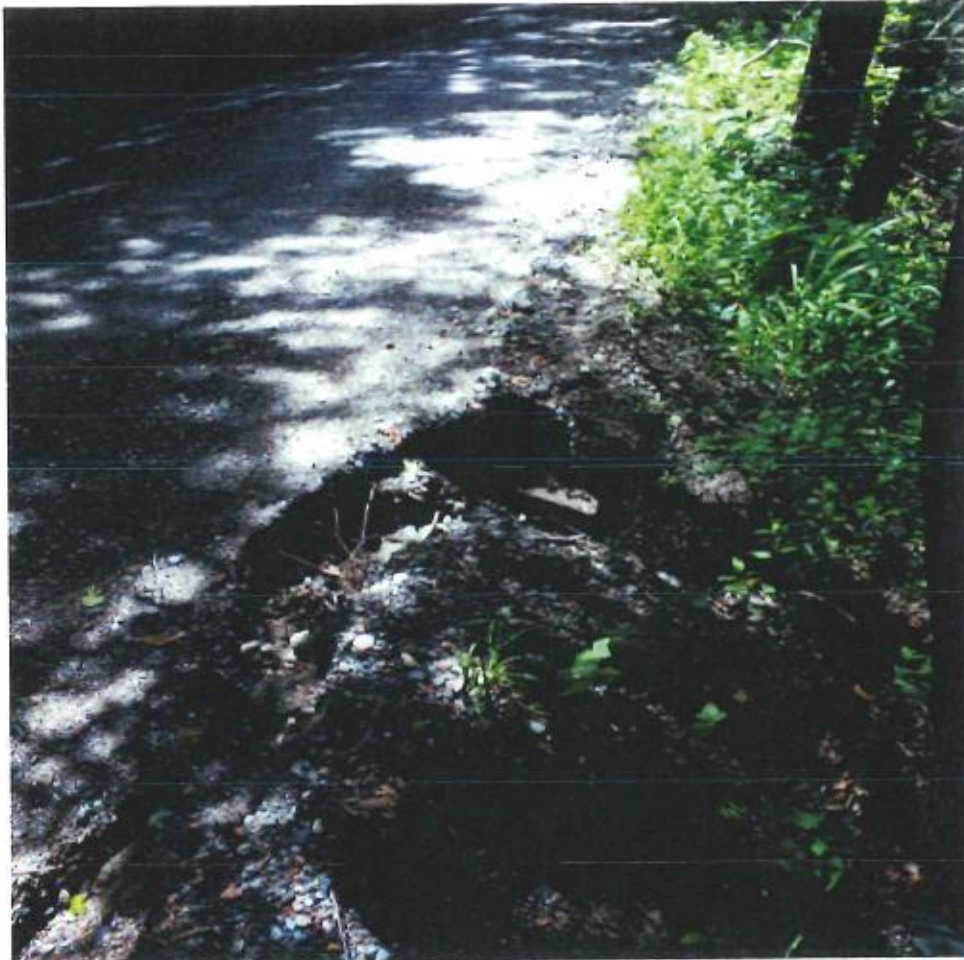
Roughly half of the inspected culvert locations are on gravel roads, where it is more common that sedimentation and erosion will accumulate in the ditch, limiting capacity of the existing culvert. At the cross culvert locations on Haigis Branch Road it was observed that the shoulder and side slopes on the outlet side of the existing culverts are eroding. This appears to be attributed to water backing up in the ditch due to the limited capacity of the cross culverts, overtopping the road and eroding the downhill side slopes. Photo 3 shows an example of this occurrence at Haigis Branch Road culvert#5.

Photo 3: Eroded Side Slope on Downhill side of Road at Haigis Branch Road

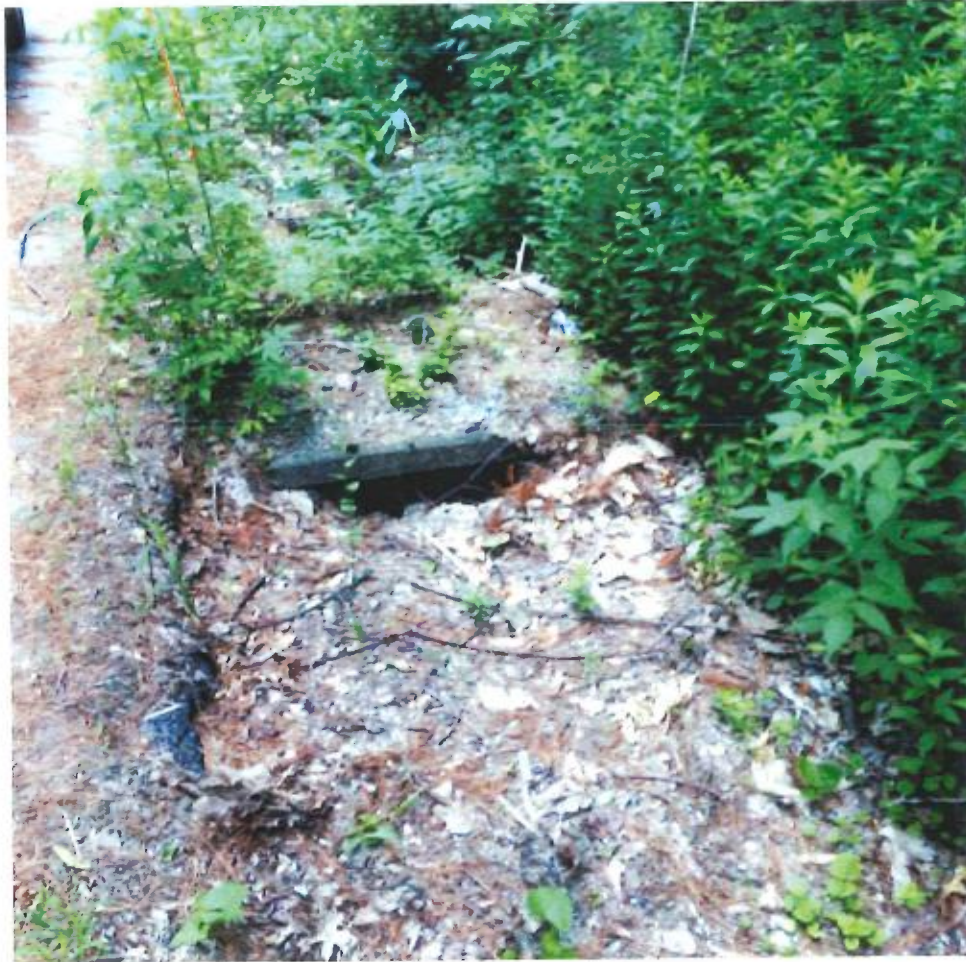
It appears that the drop inlets have been installed in lieu of catch basins or deeper ditches and headwalls due to the shallow depth to ledge, to provide an inlet for stormwater without requiring the depth of a catch basin. For all drop inlets inspected, sediment was observed either blocking the inlet or blocked inside culvert.

It should be noted that these structures should be considered deficient due to the lack of a sump for sediment collection to maintain the pipe and structure inlet clear of debris. Photo 4 provides an example of a custom drop inlet structure that was identified during inspections.

Photo 4: Drop Inlet
