**Town of Bernardston, MA
State Community Compact of
Drainage Structures**

Prepared for:
Town of Bernardston, MA
Selectboard

Prepared by:
Stantec Consulting Services, Inc.

October 11, 2017

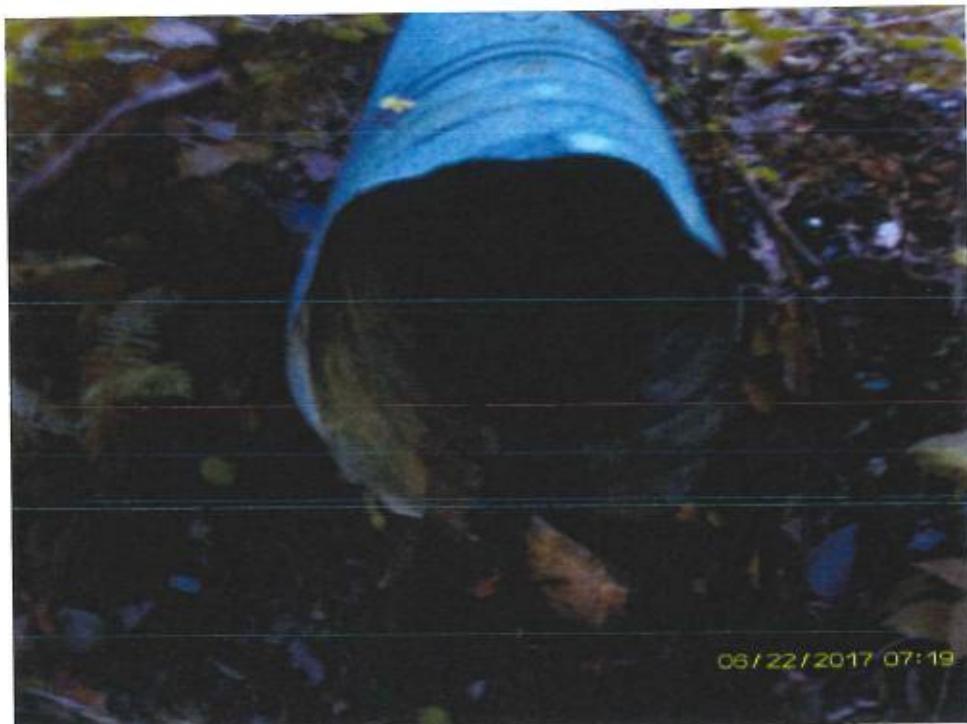
Metal culverts are susceptible to corrosion, especially in locations of salt application and where a section of the culvert is exposed to ambient conditions. In general, most of the culverts that were inspected had some level of material corrosion on the bottom and outlet of the pipe. Photo 1 shows an example of corrosion observed at the outlet of one of the culverts that was

Photo 1: Corroded Metal Culvert at Outlet

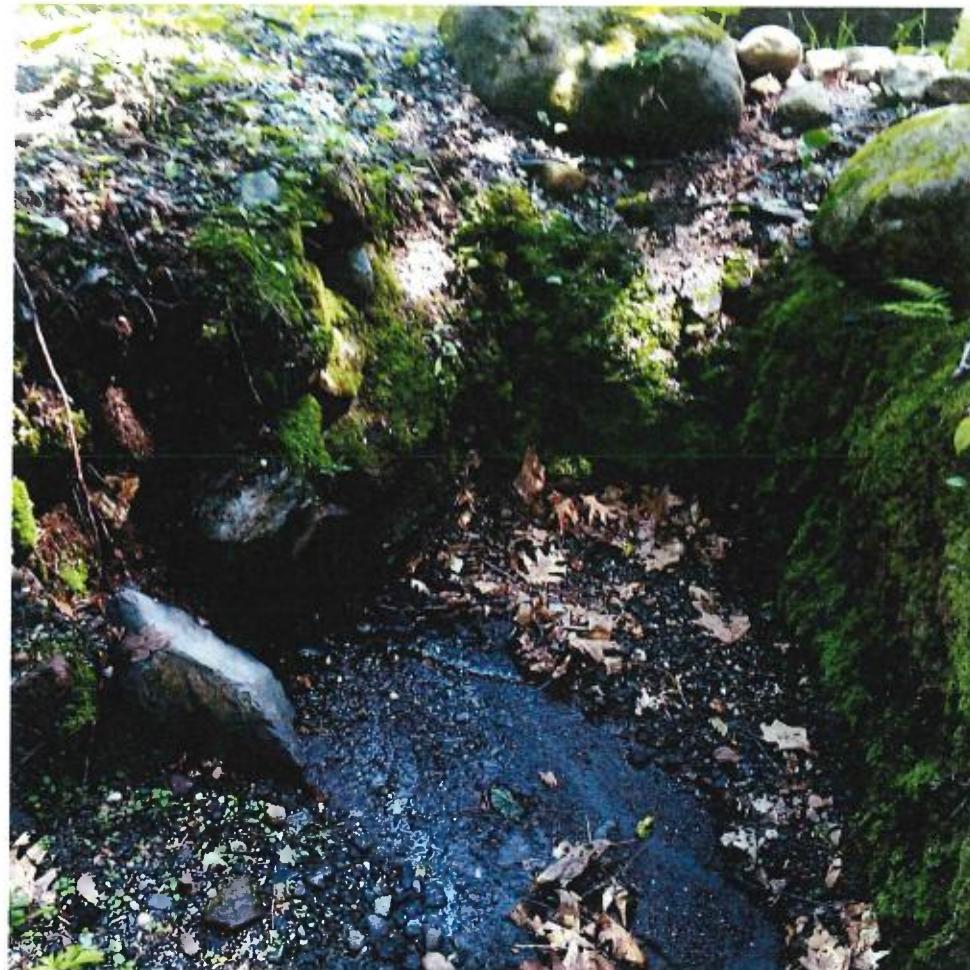
Inlet flooding, sedimentation and outlet scour conditions were observed at a number of culverts inspected, these conditions appear to be attributed to limited culvert capacities, either due to sediment/silt blocking the inlet or the diameter of the existing culvert is undersized to convey the tributary stormwater flows. Photo 2, shows a culvert with limited inlet capacity due to sedimentation build up at the inlet.

Photo 2: Culvert Inlet with Limited Capacity

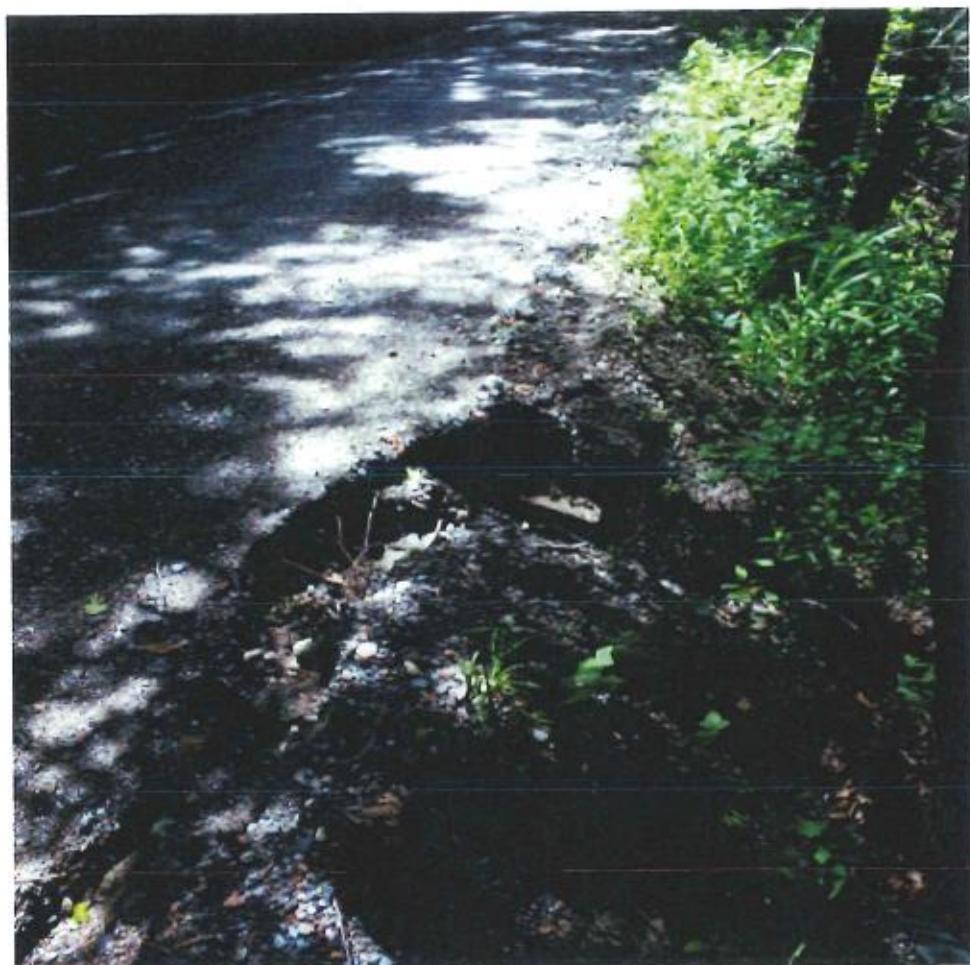
Roughly half of the inspected culvert locations are on gravel roads, where it is more common that sedimentation and erosion will accumulate in the ditch, limiting capacity of the existing culvert. At the cross culvert locations on Haigis Branch Road it was observed that the shoulder and side slopes on the outlet side of the existing culverts are eroding. This appears to be attributed to water backing up in the ditch due to the limited capacity of the cross culverts, overtopping the road and eroding the downhill side slopes. Photo 3 shows an example of this occurrence at Haigis Branch Road culvert#5.

Photo 3: Eroded Side Slope on Downhill side of Road at Haigis Branch Road

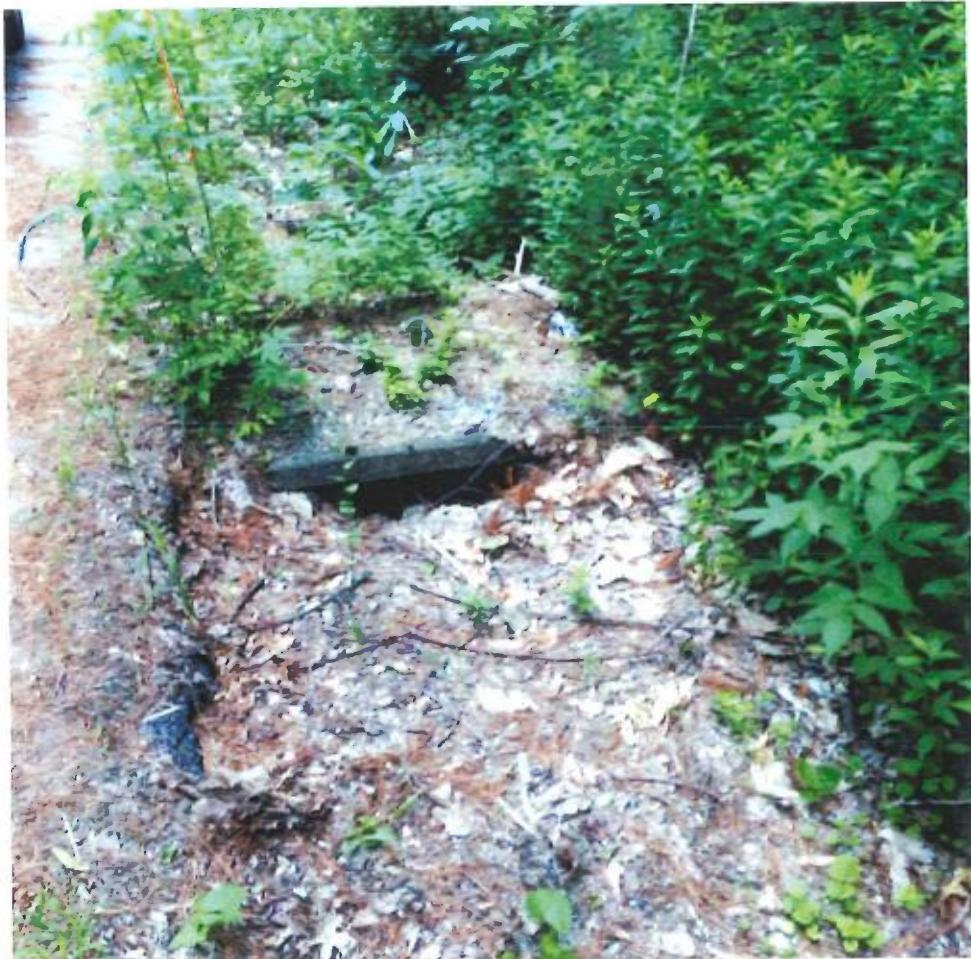
It should be noted that these structures should be considered deficient due to the lack of a sump for sediment collection to maintain the pipe and structure inlet clear of debris. Photo 4 provides an example of a custom drop inlet structure that was identified during inspections.

Photo 4: Drop Inlet

It is recommended that as culverts are replaced the existing drop inlets and headwalls also be replaced with pre-cast concrete drop structures and precast headwalls to provide additional life expectancy for those structures.

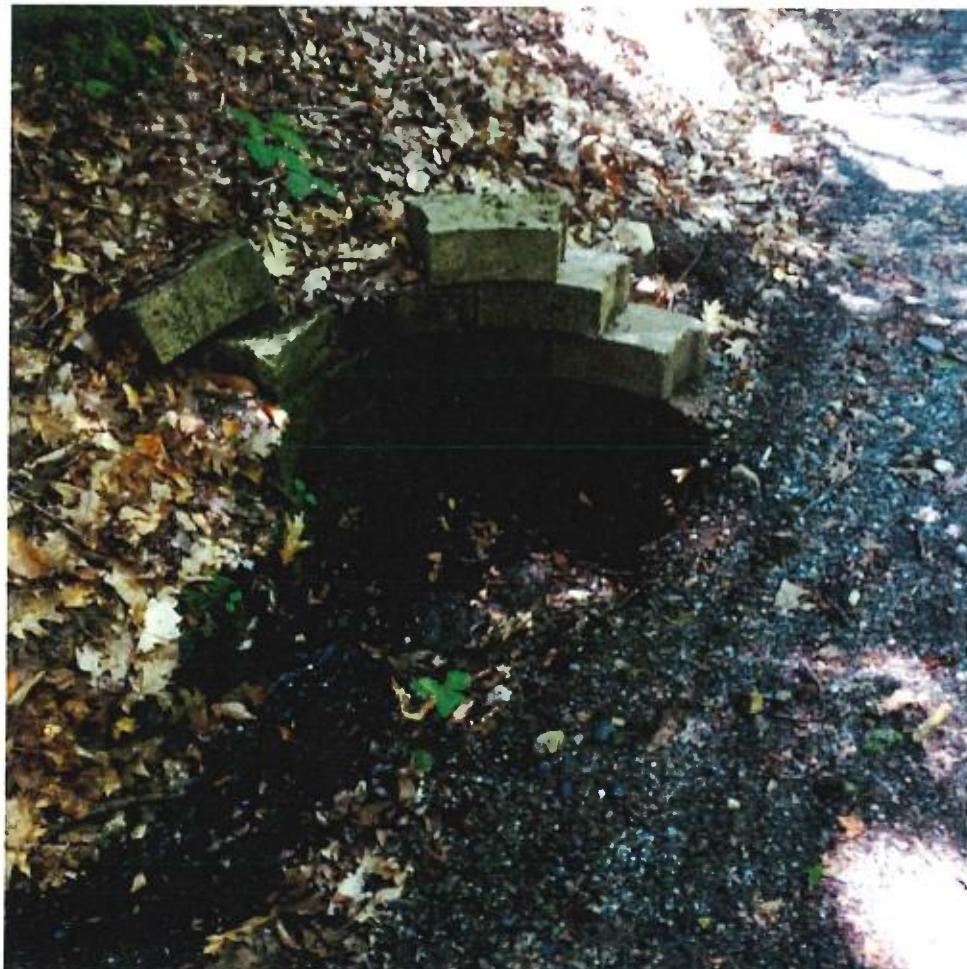
A majority of the drainage structures inspected did not have end treatments. Two types of headwalls were observed during inspection, a loose block retaining wall/headwall (see Photo 5) and a loose rubble rock headwall (see Photo 6). Although none of these constructed walls were observed as currently being in need of repair there is concern with the long-term stability during larger storm events of these structures and the possible need to repair/replace these structures as a result of flooding conditions.

Photo 5: Loose Block Headwall/Retaining Wall

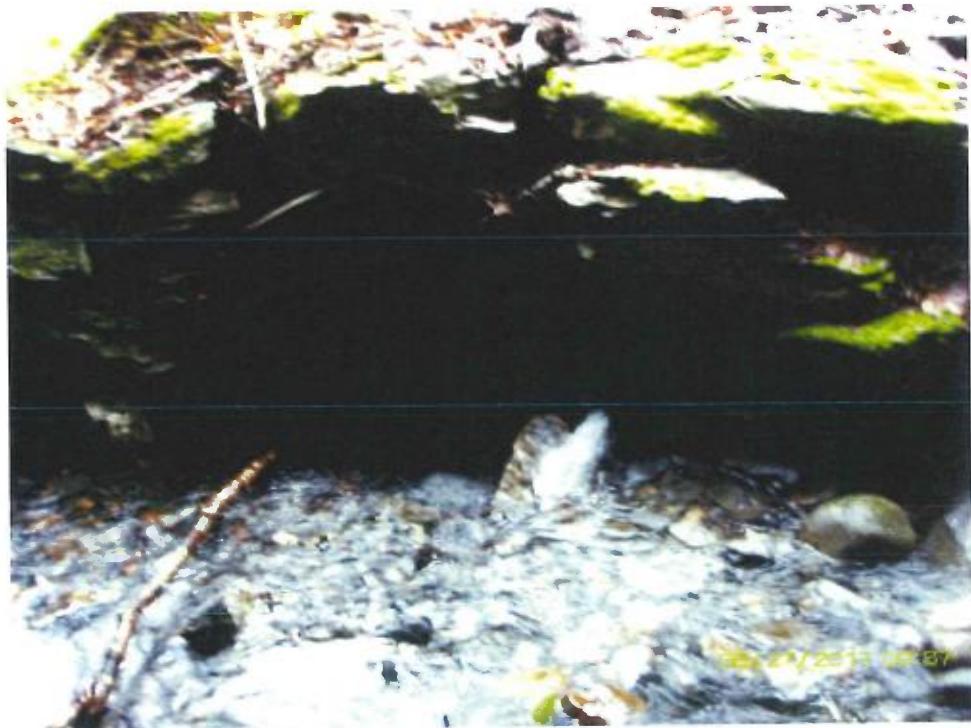
Photo 6: Loose Rubble Rock Headwall

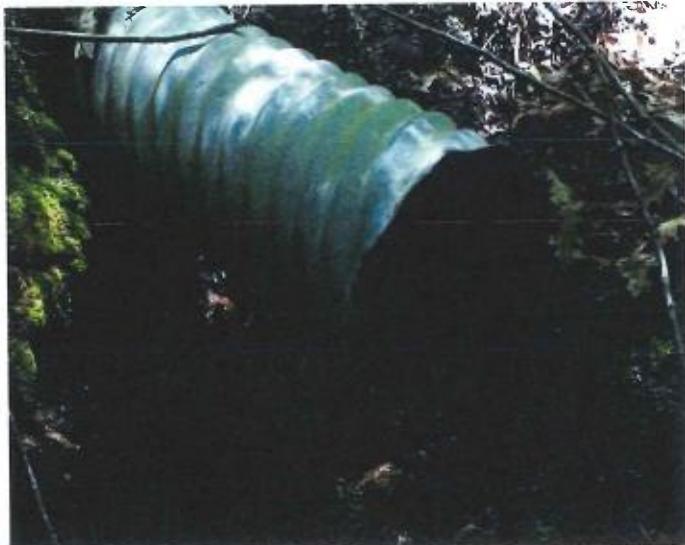
headwall. It was noted during our inspections that the outlet of the existing culverts protruding out of the roadway side slopes typically result in increased corrosion of the culverts and has misaligned the culvert overtime due frost action and the outlet not being secured by a solid headwall outlet or flared end section. The extended protrusion (See Photo 7) of the culverts will likely result in continued degradation of the culverts in poor and very poor condition.

Photo 7: Culvert Outlet Pipe Protrusion

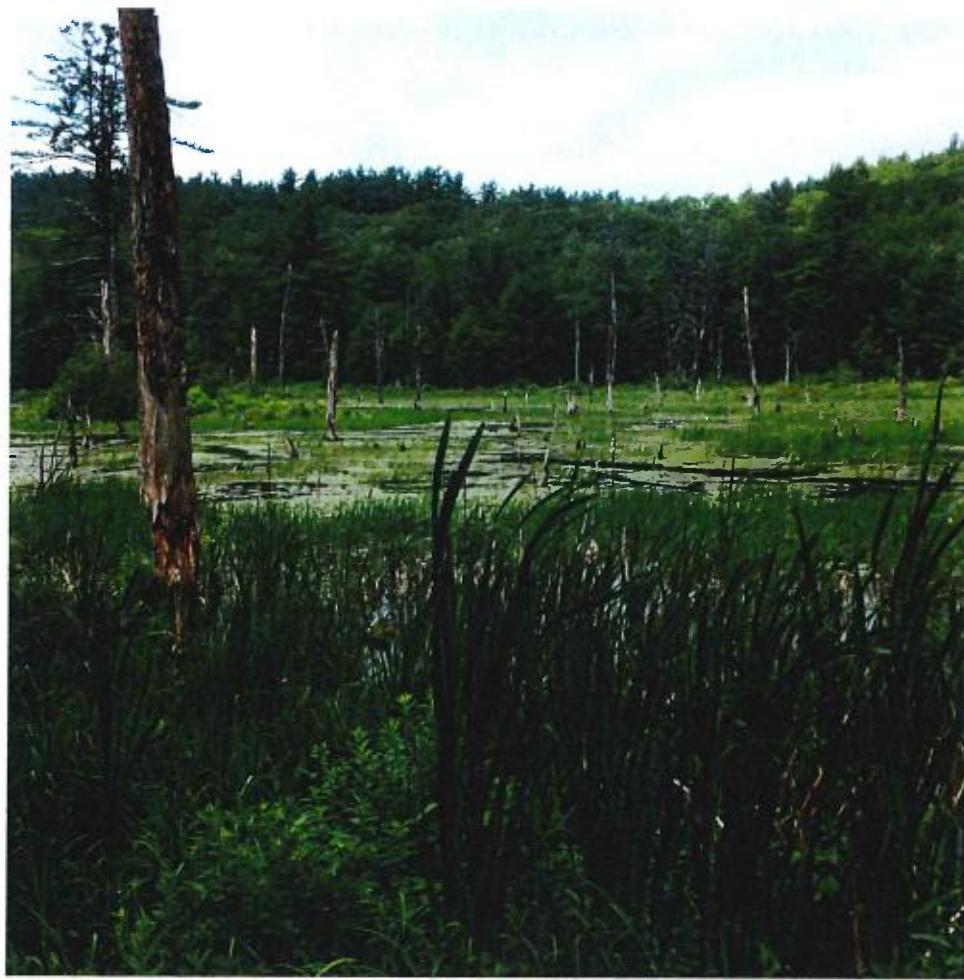
Photo 8: Huckle Hill Road Environmental Conservation Land
