## BOSTON HARBOR WATERSHED

# Boston Harbor Watersheds

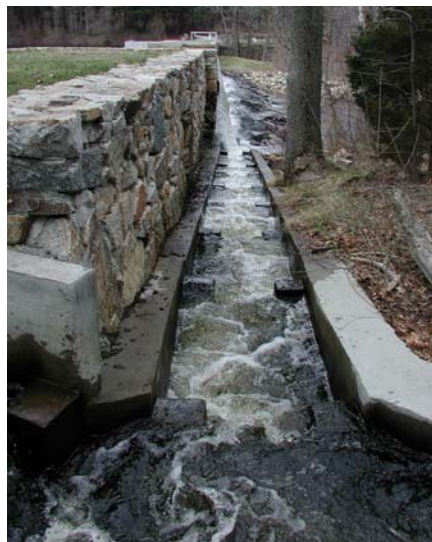
Design	Material	Length (ft)	Inside W (ft)	Outside W (ft)	# of Baffles	Baffle H (ft)	Notch W (ft)	Pool L (ft)	Condition/Function
Notched weir-pool	Concrete	73.5	3.0	4.6	12	3.0	1.5	6.5	Good Passable

Fishway at Foundry Pond Dam

Weir River forms a 6 acre impoundment as it flows to Boston Harbor. The 9 foot dam which creates the impoundment has recently been restored and the fishway that provides access was also modified at this time. Juvenile herring out-migration may be negatively impacted by the new rip-rap facing piled at the base of the dam. Efforts should be made to correct some of the detrimental impacts of the dam restoration. The area immediately downstream of the dam has historically supported a strong smelt population and white perch are known to spawn in the lower river.

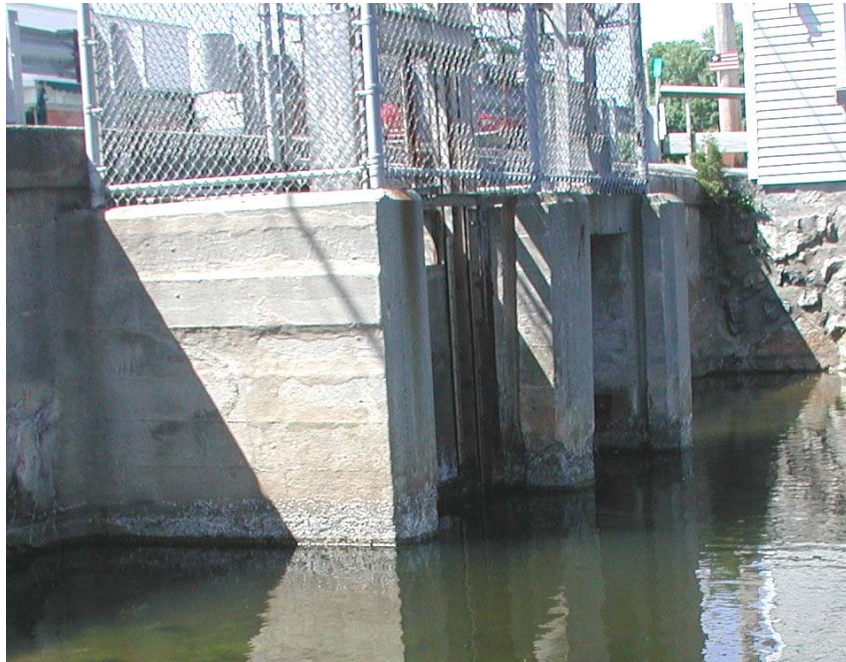
Tidegate at Straits Pond

This 95.8 acre salt pond is maintained at low salinities by a tide gate operated by the Town of Hull. River herring enter the pond when the tide gate is properly adjusted. Other than maintaining a flow regulation protocol which would insure maximum fish passage, little can be done to improve the productivity of this system.

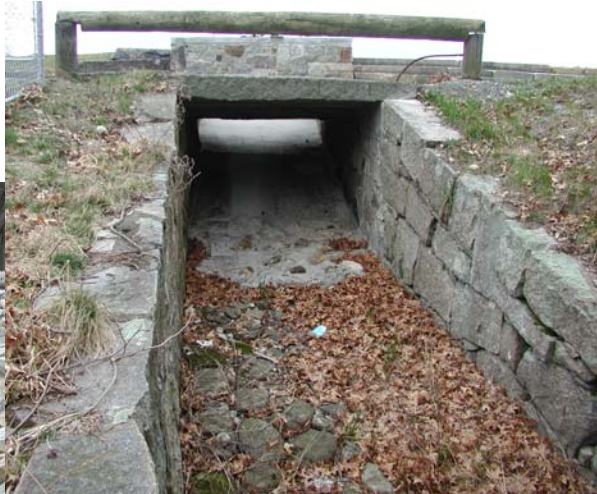
Spillway at Accord Pond

Accord Brook is a tributary to the Weir River and forms two impoundments along its course. The first, Triphammer Pond, is equipped with a weir-pool fishway which allows river herring to access its 17.4 acres of habitat when properly adjusted. The second impoundment, Accord Pond, is 95 acres in area but functions as a public water supply. No outflow was observed at the time of this survey and there is little potential for development here.

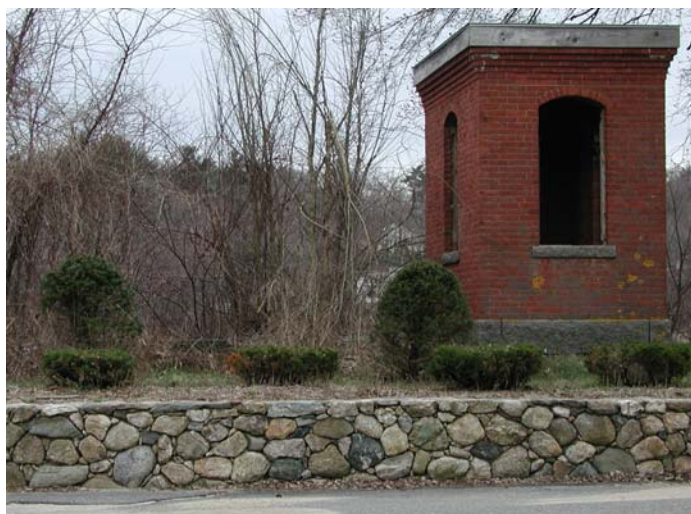
Fulling Millpond Dam

This stream is also a tributary to the Weir River and forms a 13.4 acre impoundment called Fulling Millpond before joining that stream. The spillway design creates a difficult fishway installation problem and the impoundment is used as a public water supply making this a very low priority for development.

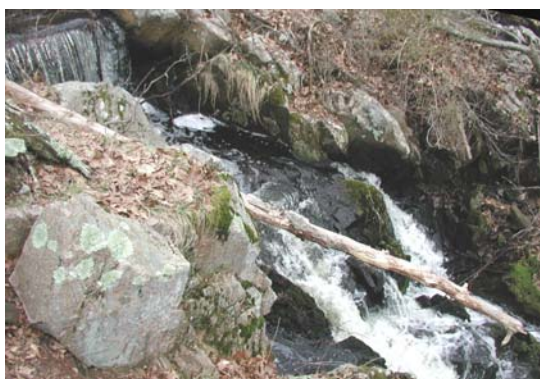
Elevation change downstream of Cushing Pond

This stream flows into the Weir River and two obstructions block fish passage before any significant habitat can be reached. The difficulty in providing access to the 18.8 acres available in Cushing Pond reduces potential for development.

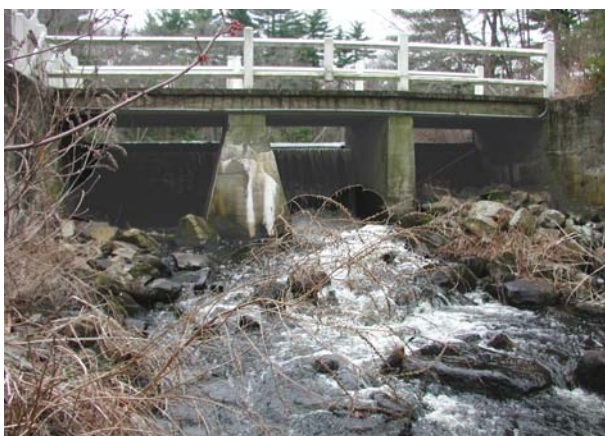
Cushing Pond Dam

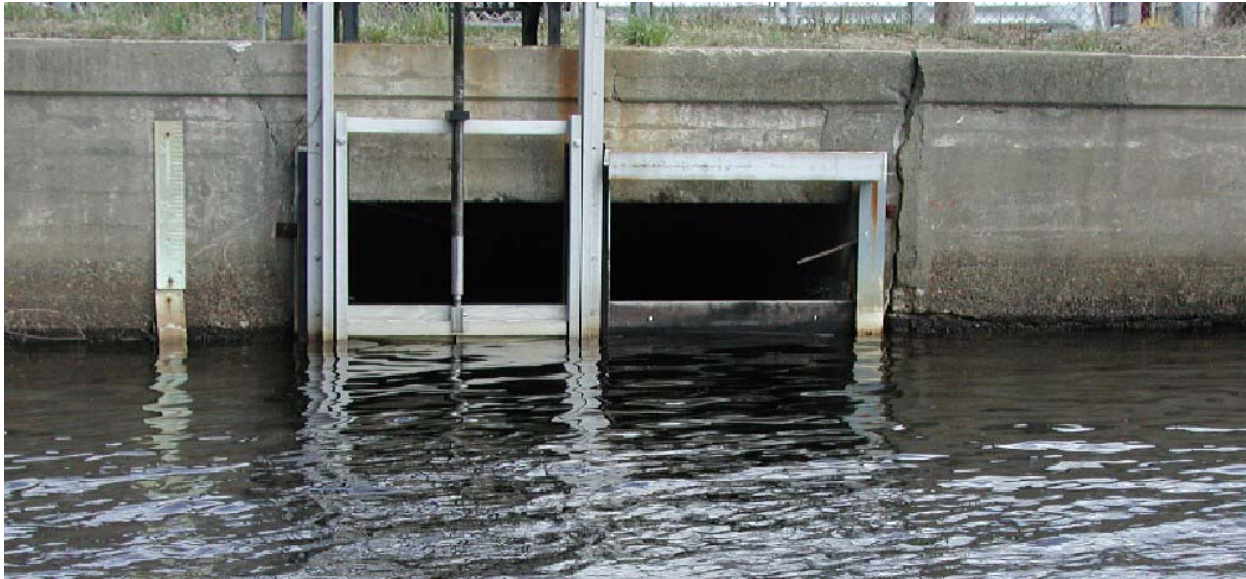
Control structure at Washington Street

Another factor which certainly affects productivity is the blocking of the portion of Whitmans Pond south of Washington Street to spawning river herring. This extension of the pond is used as a water supply and, in order to isolate it from the poorer quality water in the northern section, a sluice gate prevents any back flow. While river herring could conceivably enter this area in spring without risking contamination of the water supply, any young herring produced would have a difficult time exiting the upper system when the levels were drawn down. As a result, it was decided to confine spawning to the main pond and avoid losses of juveniles.

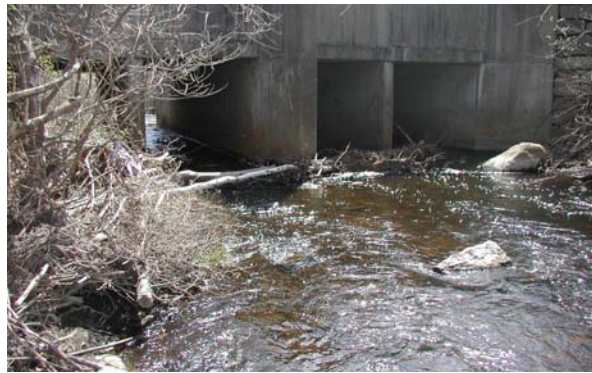
McCusker Road culvert

The first obstruction on Fore River is a road culvert at McCusker Street. The 1.5 foot drop at the culvert is passable by river herring during spring flows but effectively limits smelt movement. A 3 foot high natural falls a very short distance upstream of McCusker Street is also passable by river herring under ideal flows but would not allow smelt to pass. Altering the culvert to allow smelt passage could increase smelt spawning habitat by 300 square meters. Due to the numerous fishways needed to overcome a third obstruction (6 foot natural falls) and two upstream dams, plus possible seasonal low flow issues, the further development of the river herring resource would be a difficult and expensive project. This river, once above the influence of the tide, is known as the Monatiquot River.

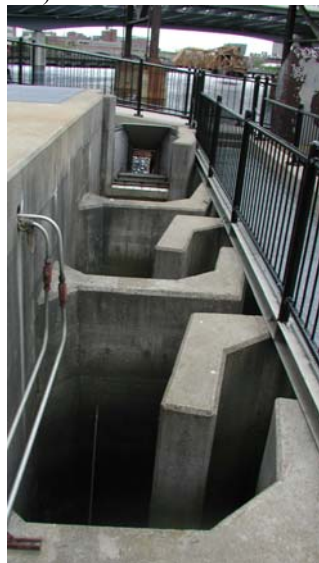
Design	Material	Length (ft)	Inside W (ft)	Outside W (ft)	# of Slots	Baffle H (ft)	Notch W (ft)	Pool L (ft)	Condition/ Function
Vertical slot	Concrete	170	Varied (.5-1.0)		29	N/A	-	Varied	Fair Not passable

Vertical slot fishway at Charles River Locks

The Charles River is a large system and offers an abundance of riverine habitat to anadromous fishes. Its potential, however, is drastically impacted by the numerous obstructions to passage in its lower reaches. The first of these, the Charles River Dam and Locks, operated by DCR, is near the mouth of the river and has an effect on any fish attempting to enter the system. Although equipped with a fishway in 1978, the facility has never operated effectively due to mechanical failures and insufficient attraction flow and, as a result, migrating fish must rely on opening of the locks for access to the river. A locking protocol has been developed to maximize usage by rainbow smelt, river herring and American shad during their spawning runs.

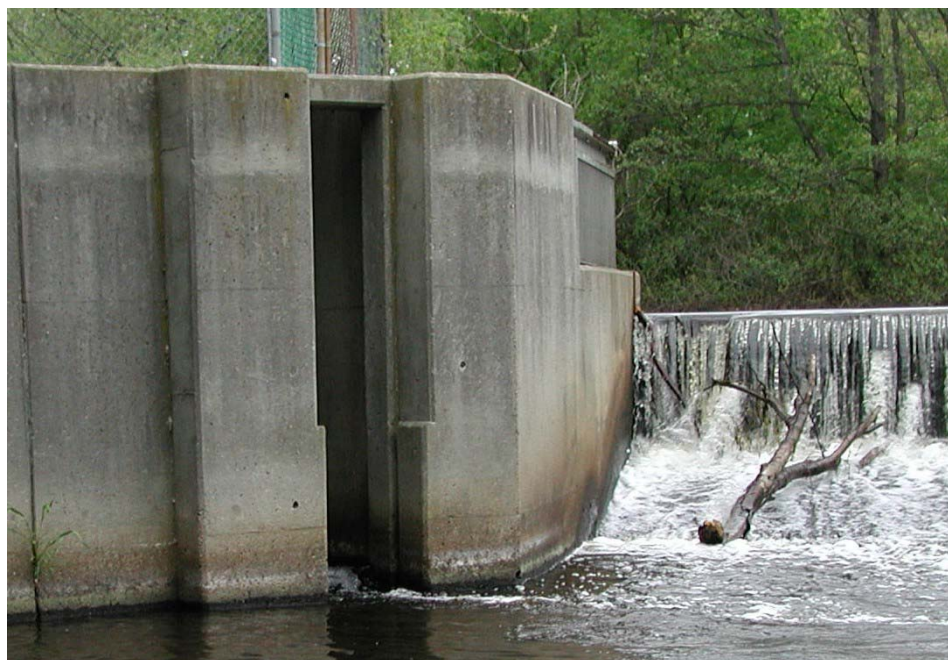
Fishway entrance at Watertown Dam

Approximately 8.5 miles above the first obstruction fish encounter the Watertown Dam. While the Denil fishway at this location functions well, the width of the spillway and river make it difficult for river herring and shad to locate the entrance and it is likely that a large percentage of these populations fail to ascend the river beyond this point. The smelt population spawns below this dam and is not affected by the fishway's shortcomings.

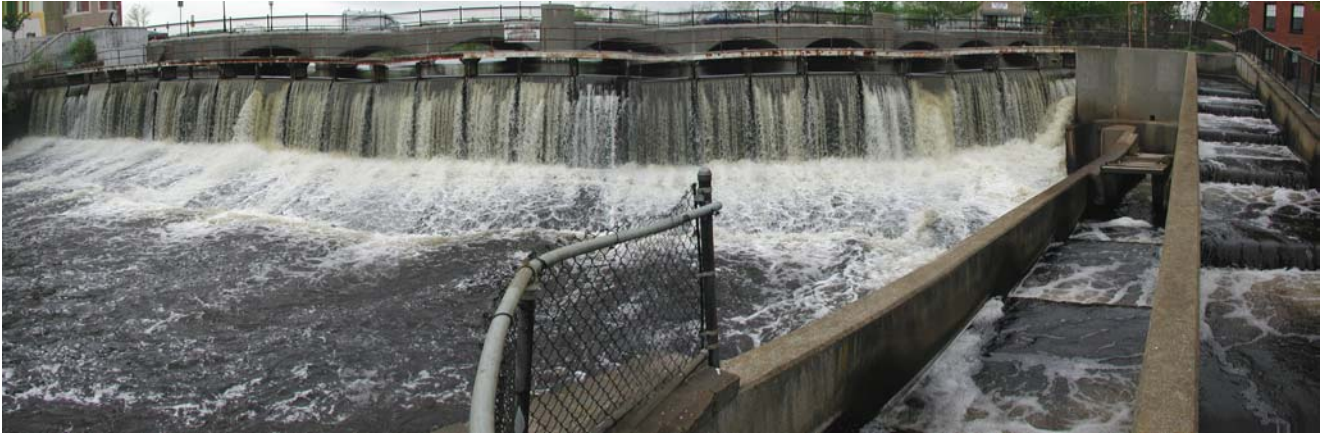
Moody Street Dam and Fishway

Design	Material	Length (ft)	Inside W (ft)	Outside W (ft)	# of Baffles	Baffle H (ft)	Notch W (ft)	Pool L (ft)	Condition/ Function
Denil & weir-pool	Concrete with wooden Denil baffles	216.0	6.0	8.7	23	7	6	10.0	Fair Inefficient passage

The fourth obstruction, the Moody Street Dam, is at river mile 12.2 and is equipped with a combination Denil and weir-pool fishway. The incorporation of these two designs into one fishway makes proper flow regulation critical to efficient passage. Other problems such as competing spillway flow, which makes entrance to the ladder difficult, and a deteriorated baffle have made this site a problem spot. In order to pass any significant numbers of fish, a conscientious program of flow regulation and maintenance must be applied to this structure.

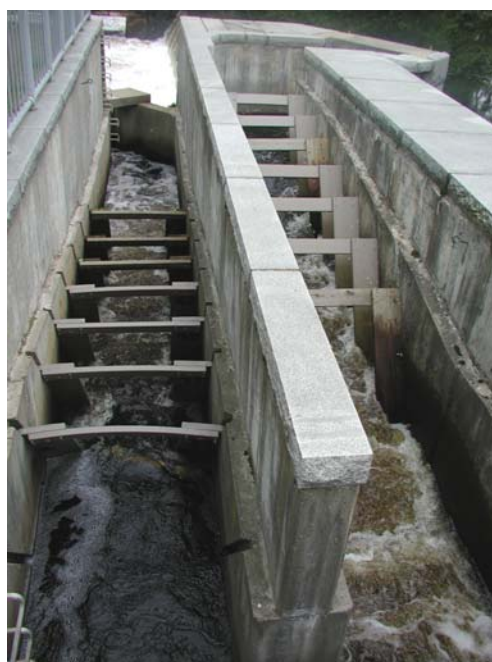
Fishway at Finlay Dam

The next two obstructions, the Finlay (Newton Lower Falls) and the Cordingly (Newton Upper Falls) Dams, are both equipped with Denil fishways. The wooden Denil baffles in the first ladder had badly deteriorated and have recently been replaced with an experimental design incorporating a recycled plastic material. The upper fishway is currently scheduled for a similar renovation. It should be noted that, to date, there is no documentation of anadromous species reaching the Newton Lower Falls. Two large dams, Metropolitan Circular Dam at river mile 20.0 and the Silk Mill Dam at river mile 20.2, have no fish passage facilities and eliminate any potential for further upstream migration.

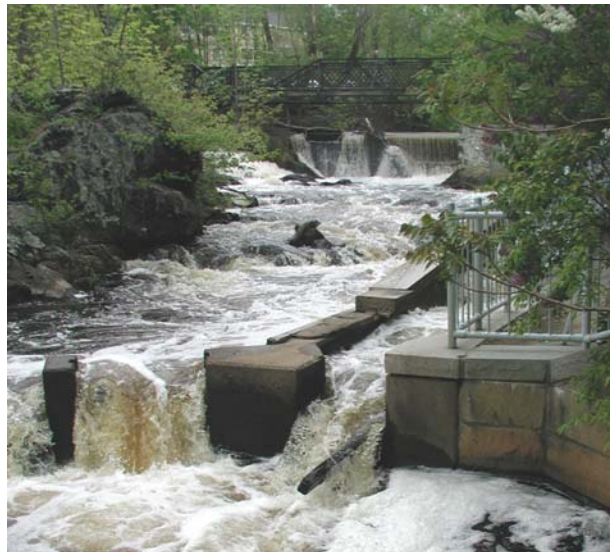
Design	Material	Length (ft)	Inside W (ft)	Outside W (ft)	# of Baffles	Baffle H (ft)	Notch W (ft)	Pool L (ft)	Condition/Function
Denil	Concrete with wooden baffles and a granite cap	166	4.6	7.5	40	7	-	-	Fair Not passable

Fishway at Cordingly Dam

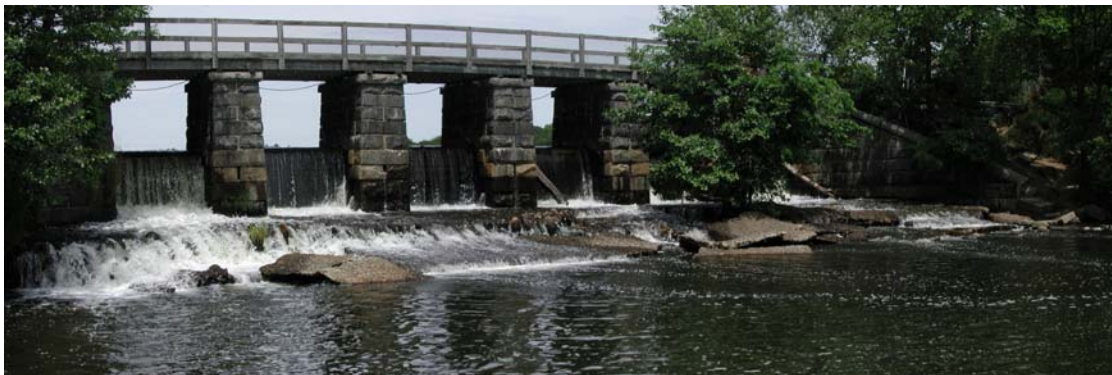
Mystic Lakes Dam

A 5.8 foot dam separates 85 acre Lower Mystic Lake from 165 acre upper Mystic Lake and prevents herring from reaching the larger habitat. Deterioration of the dam has caused DCR to initiate planning for repair or replacement of the structure. A fishway should be included in any future modifications. A locking protocol should also be instituted to insure ongoing passage at the Amelia Earhart Dam.
