**Re: Examination of As-Built Conditions for
Mordecai Lincoln Road Pond Dam Removal (a.k.a. Hunters Pond Dam)
Town of Scituate, Massachusetts**

Technical Memorandum: Mordecai Lincoln Road Pond Dam Removal - Examination of As-Built Conditions

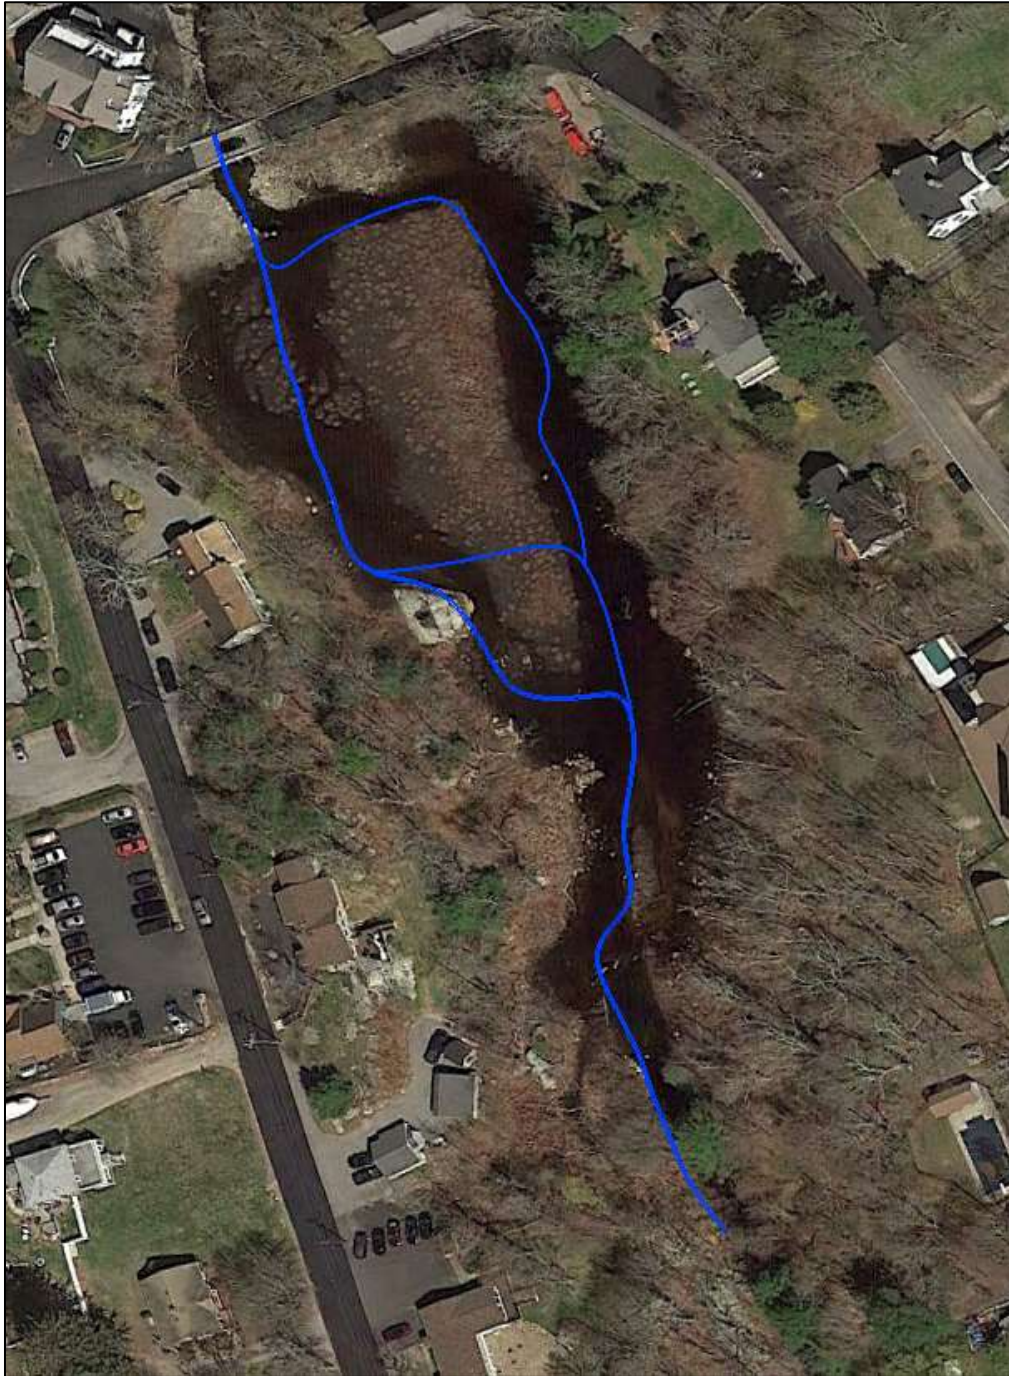
An as-built topographic survey was conducted of the area impacted by the dam removal in order to document post-dam removal conditions. The project was completed per the intentions of the 2017 final design plans. As shown in Figure A, the current flow path of Bound Brook has taken one of the three paths anticipated during the design phase. The design relied upon passive restoration (i.e. passive sediment transport and natural revegetation that allowed the natural channel processes to determine the final dimensions of the channel management) and as such, the only channel grading required by the design was through the footprint of the former dam/spillway just upstream of the Mordecai Lincoln Road Bridge. Rounded river stone was used to stabilize the brook in this section of channel. The Mordecai Lincoln Mill culvert was repaired, slip-lined, and partially blocked with an operable and maintainable plastic gate structure. All work was performed per the intentions of the design plans.

The as-built survey was conducted in May 2018 to both confirm that the work was completed per the plans and to document the progression of the passive restoration. Based on the as-built survey, the construction did indeed occur per the intentions of the plans. The section through the former dam/spillway, just upstream of the Mordecai Lincoln Road Bridge, shown as Detail 3 on sheet 4 of the Engineering Plan sheets, was depicted in the plans as an approximately 20-foot wide channel, with a depth of 1.5 to 2.0 feet and a channel invert of approximately 6.1-feet. The constructed channel, per the survey, was 22-feet wide, 1.6-feet deep, and has an invert elevation of 6.4-feet (NAVD88).

The as-built survey also documented changes throughout the passive recovery of Bound Brook. Bound Brook through the former impoundment has experienced both deposition and incision with a change of thalweg depth ranging from +1.0-feet (aggradation) to -1.5-feet (degradation). It is important to note that the existing conditions survey was conducted in April 2013 and November 2014. Some changes in the bathymetry of the former impoundment documented by the as-built survey may have occurred due to other forces before the dam was removed.

Figure A - Anticipated flow paths (blue) compared with post-removal conditions (aerial taken 4/22/2018). The primary flow-path is the eastern-most alignment.

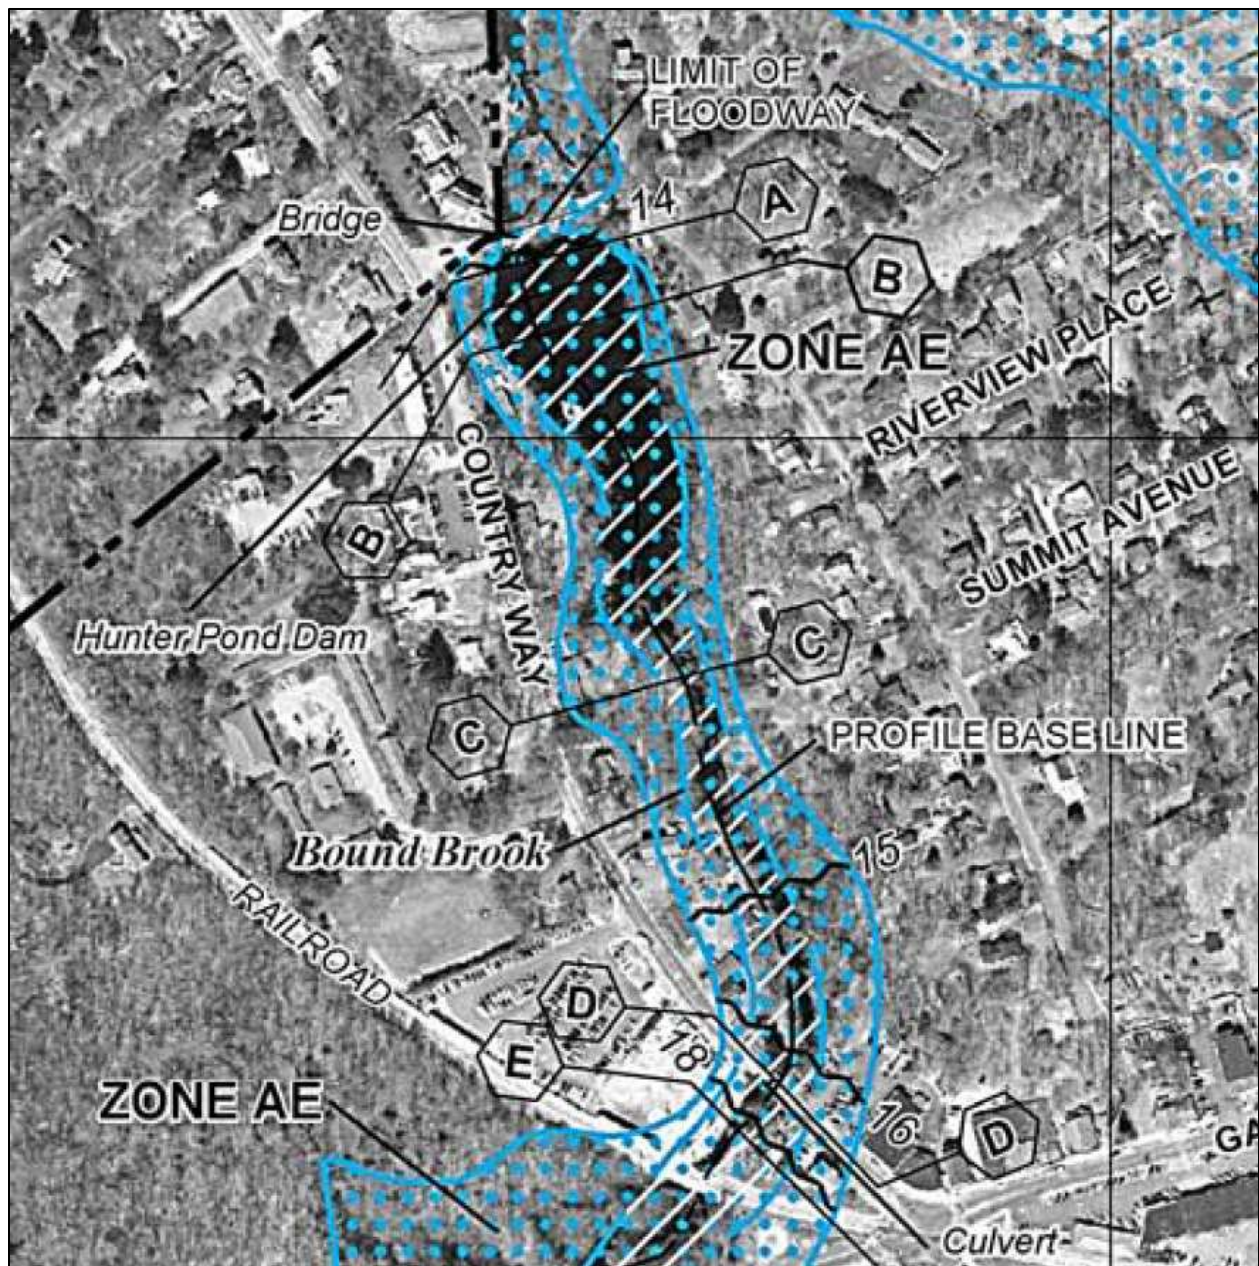
This as-built survey design included cross-sections that generally coincided with the FEMA FIS cross-section locations (shown in Figure B), allowing for an update of the pre-construction modeling.

Figure B - Flood Insurance Rate Map (FIRM) for Bound Brook (25023C0106K) - Map Revised November 4, 2016

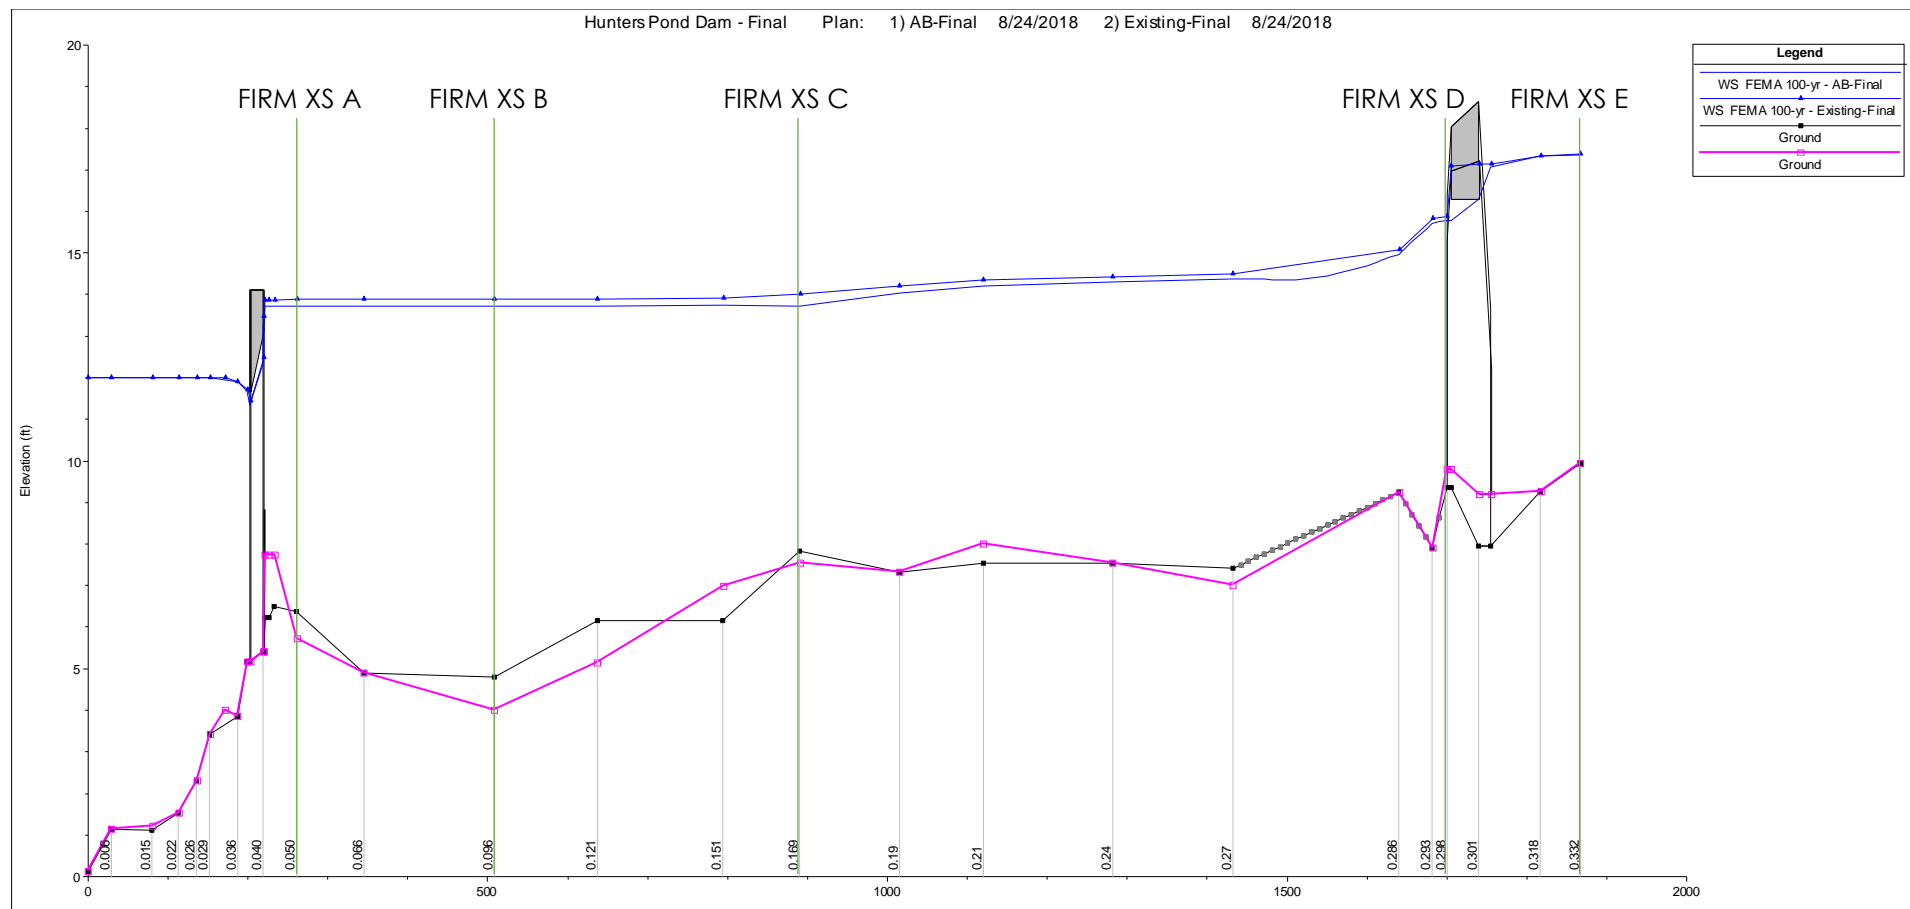
Table 1 and modeled profiles shown in Figure C. Although the channel bed varies from +1.0 to -1.5 feet, as shown in Figure C, the BFE is lower by a maximum of 0.28-feet and has no increases. Minimal change is observed upstream of Country Way Bridge (0.07-feet decrease) and negligible change downstream of Mordecai Lincoln Road (0.02-feet decrease). Decreases in water surface elevation within the former impoundment range between 0.10-feet and 0.28-feet with an average of 0.16-feet of decrease. These changes in water surface elevation are summarized in

Table 1. All decreases in depth are below the thresholds described in Special Conditions 4A, 4B, and 4C of the Town's Corps authorization.

Based on our analysis, the spillway of Mordecai Lincoln Road Pond Dam has not caused an increase in the BFE profile, has resulted in a maximum decrease of the BFE profile of less than 0.5 foot (actual decrease in BFE is only 0.2 foot), and does not require an alternation to the waterway's existing NFIP Regulated Floodway delineation. Our results therefore confirm that a NIFP flood insurance study change is not necessary, nor required, for this dam removal project and that no further coordination with FEMA should be needed for this completed river restoration project.
