*Massachusetts Coastal Infrastructure
Inventory and Assessment Project
Massachusetts Department of Conservation and Recreation
Office of Waterways*

Upper Cape Cod

Bourne
Sandwich
Mashpee

July 6, 2009

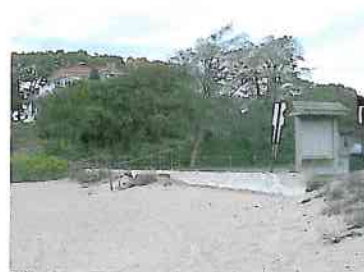
Precast concrete seawall is made up of 2 feet by 1 foot by 3 feet blocks stacked on top of each other. The visible height of the structure is only 2.5 feet. The concrete is slightly deteriorating throughout. There is a park behind the wall and a beach in front.

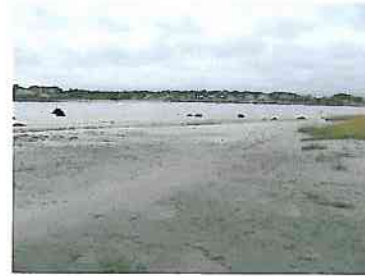
The beach, mainly made up of marsh, is in poor condition in most areas. It is at a 1 on 100 slope. Where the beach meets Massachusetts Maritime Academy, there is a fine sand that is more evenly graded.

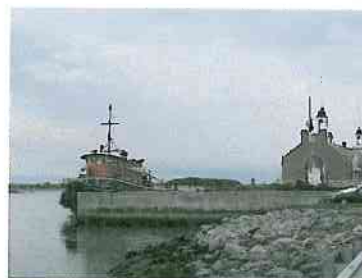
The concrete seawall surrounds that Massachusetts Maritime Academy. There is a building above the seawall. Large vessels dock along the seawall. There is no visible spalling.

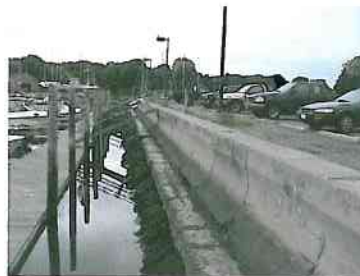
The precast concrete seawall with wave return face is 3.5 feet tall and 2 feet wide. There is scour at the toe of the wall. The wall sits on top of a cast in place concrete wall that has major deterioration. The riprap is dumped in front of the wall. There is a parking lot behind and 3 gangways coming off the wall to floats on the river.

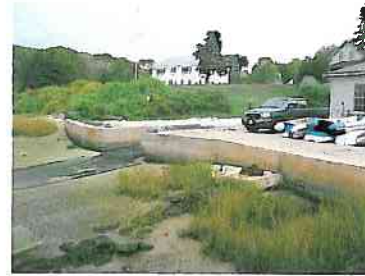
The concrete seawall surrounds the town boat ramp. There is cracking, spalling, scour at the toe, and exposed rebar. The concrete has begun to deteriorate at the ends of the wall. The wall is heaving outward. A boat yard and store are located behind the wall.

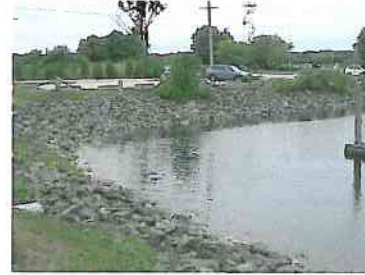
This structure is the stone revetment around the west side of the Sandwich Marina basin. The armor stone is weathered but in good condition. The crest and side slopes show good lines and are in good condition.

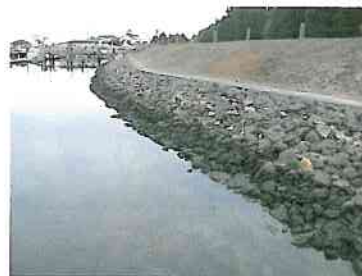
This structure is the stone revetment around east side of the Sandwich Marina basin. The armor stone is weathered but in good condition. The crest and side slopes show good lines and are in good condition.

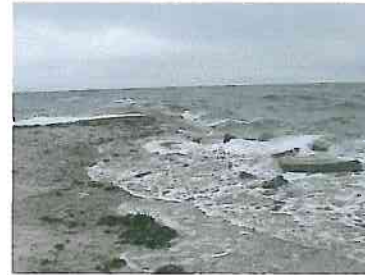
This structure is the stone jetties at the entrance to Old Sandwich Harbor. The inlet is no longer contained within the jetties and so the structures are non-functional. The west jetty is exposed at low tide and in poor condition. The east jetty is submerged at all tides.

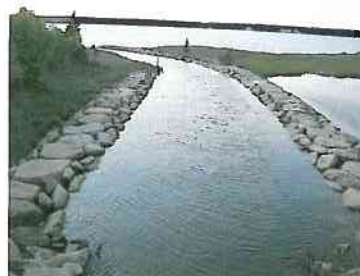
This structure is the jetties at the culvert into Hamblin Pond along Seconsett Island Road. The armor stone is weathered but solid. The side slopes and crest in good condition.

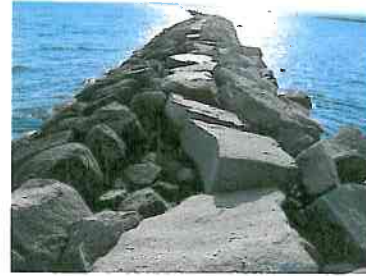
This structure is the East Jetty at Wauquoit Bay. There are multiple sections with damaged armor. These damaged areas show slumped sideslopes and loss of crest elevation. There is minimal interlocking between armor stones in the damaged sections.
