BUZZARDS BAY DRAINAGE

Buzzards Bay Drainage

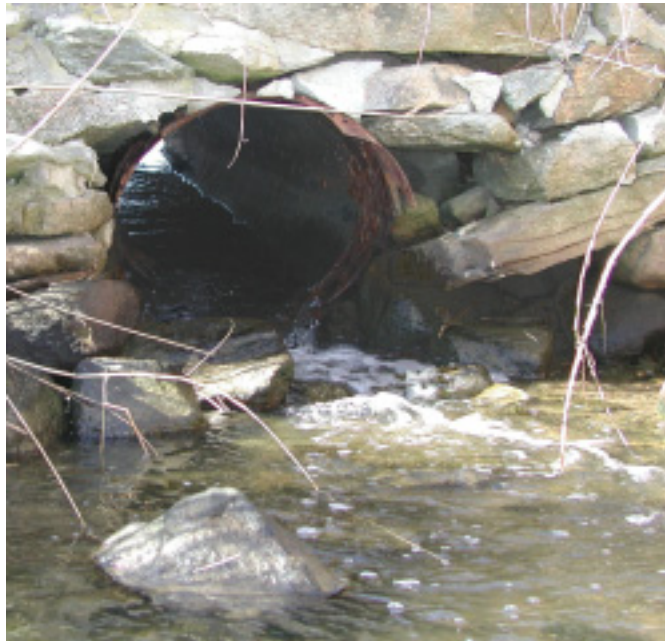
Cockeast Pond outlet/fishway

Design	Material	Length (ft)	Inside W (ft)	Outside W (ft)	# of Baffles	Baffle H (ft)	Notch W (ft)	Pool L (ft)	Condition/Function
Natural boulder vortex	Stone	5.0	8.0	8.0 (channel width)	1	1.0	1.0	5.0	Fair Passable

This 99 acre salt pond enters the Westport River at its mouth. Herring are able to access the pond through the short connecting stream and, although they appear to prefer higher tidal stages and the darkness of night, there is no real obstruction. Plans for modification of the road culvert have been discussed and care should be taken to insure continued fish passage and maintenance of salinity levels adequate to sustain this population. A small, traditional bait-fishery is carried on at this location.

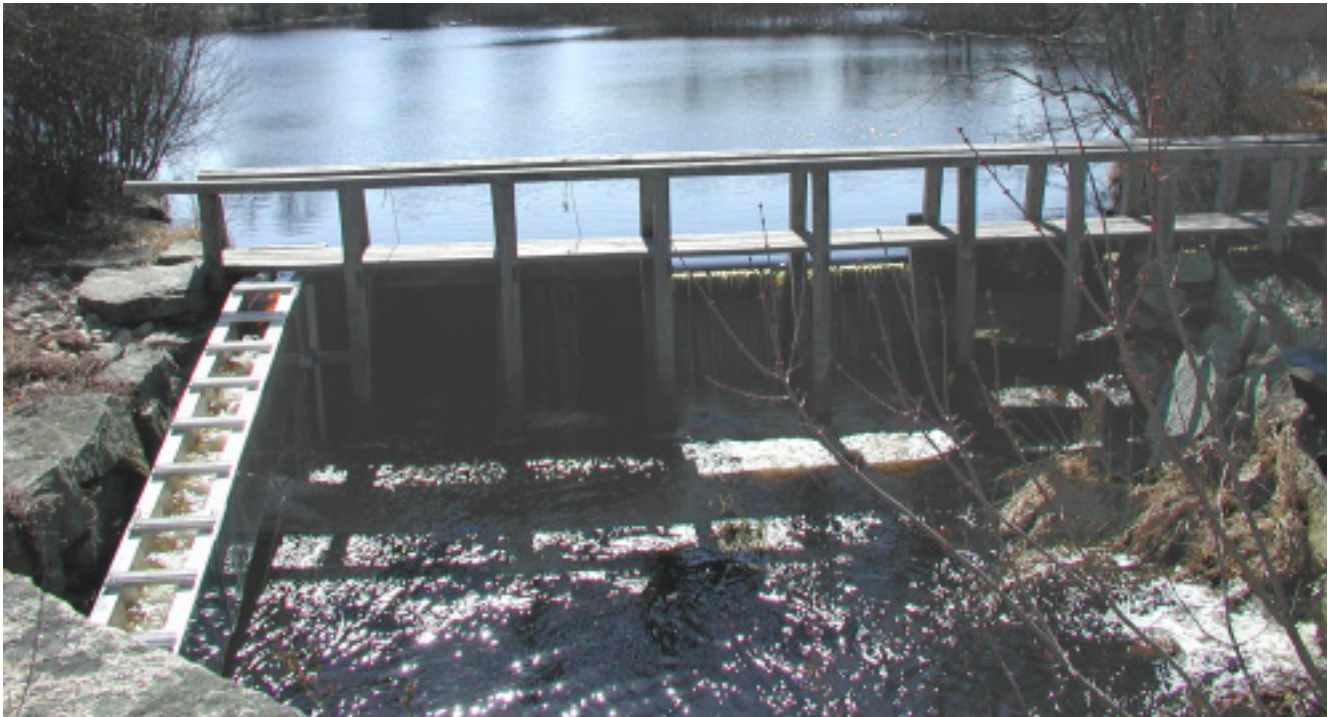
Gray's Mill Pond Dam and Ladder

Design	Material	Length (ft)	Inside W (ft)	Outside W (ft)	# of Baffles	Baffle H (ft)	Notch W (ft)	Pool L (ft)	Condition/Function
Alaskan Steeppass	Aluminum	24.0	1.5	-	-	-	-	-	Excellent Passable

Grays Mill Pond provides the only accessible river herring spawning area in this system. This 3 acre impoundment on the Massachusetts/Rhode Island line was equipped with a wooden Denil ladder, built by the Town of Westport and installed by DMF in 1995. This was washed away by high water in 2001 and replaced with an aluminum Denil fishway in 2002. A small run of river herring has existed here and this population can be expected to increase in size with improved access to the pond.

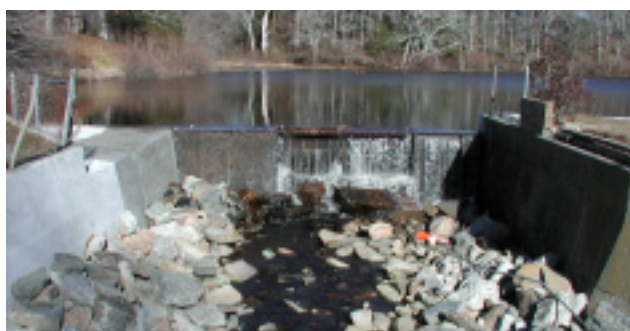
Russells Mills Pond Dam

Design	Material	Length (ft)	Inside W (ft)	Outside W (ft)	# of Baffles	Baffle H (ft)	Notch W (ft)	Pool L (ft)	Condition/Function
Denil	Concrete with fiberglass baffles	18.0	3.0	4.5	7	6.0	-	-	Good Inefficient passage
Weir-pool	Concrete	61.0	5.0	7.0	12	2.0	3	5.5	Good Passable

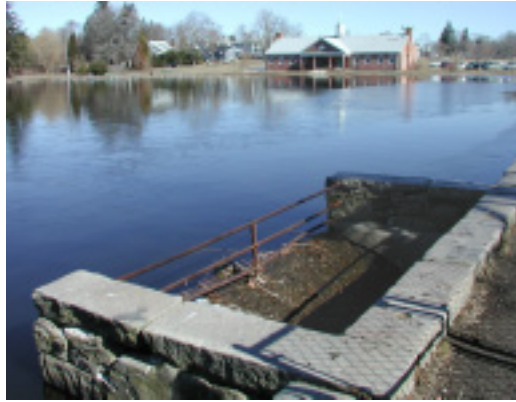
Buttonwood Park Zoo

This small stream flows through New Bedford's Buttonwood Park and is impounded there, forming an 11.6 acre pond. The spillway configuration makes fishway installation difficult which, combined with the relatively small impoundment size, makes this a low priority site.

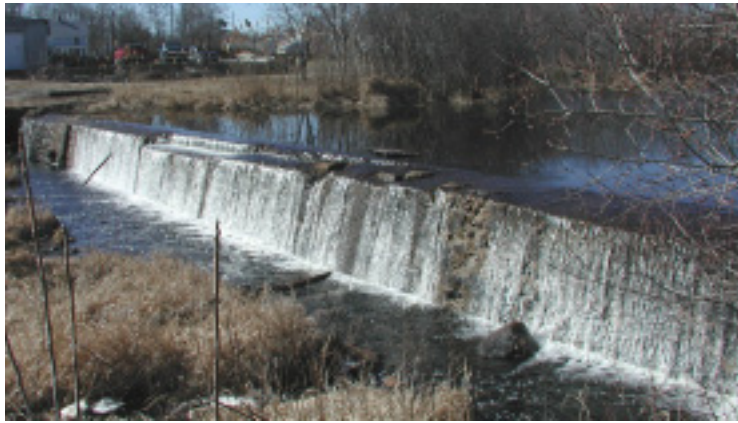
Acushnet Sawmill Dam

Design	Material	Length (ft)	Inside W (ft)	Outside W (ft)	# of Baffles	Baffle H (ft)	Notch W (ft)	Pool L (ft)	Condition/Function
Notched weir-pool	Concrete	33.0	3.0	4.2	6	1.8	0.8	Varied (2.0-3.0)	Fair Inefficient passage

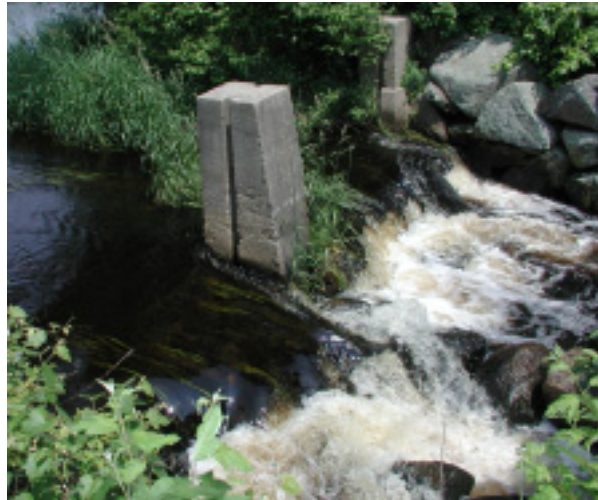
Hamlin Street Dam

The Hamlin Street dam, the second on the stream, is also the subject of a feasibility study for full or partial breaching. While herring have been able to pass this obstruction under suitable flow conditions it remains a limiting factor in the population's ability to reach its potential. Again, if removal is decided against, a fishway must be installed at this location.

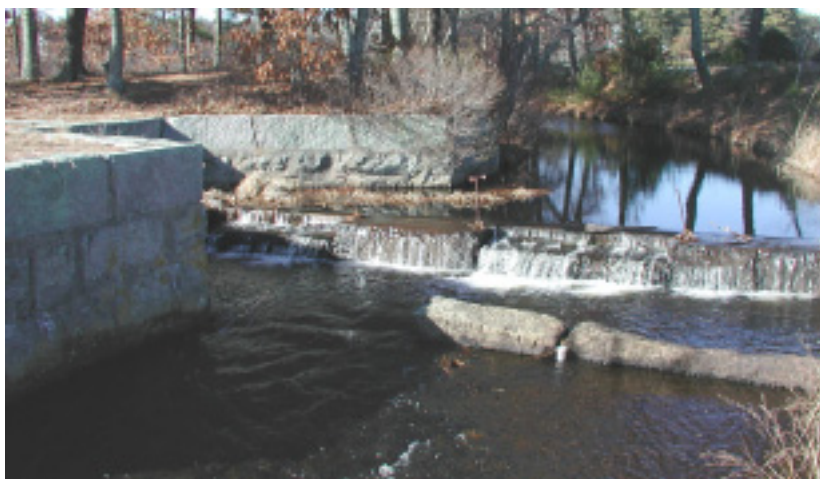
New Bedford Reservoir Dam

Design	Material	Length (ft)	Inside W (ft)	Outside W (ft)	# of Baffles	Baffle H (ft)	Notch W (ft)	Pool L (ft)	Condition/Function
Denil	Concrete with wooden baffles	264.0	3.0	5.0	26	5.0	-	-	Excellent Passable

An 11 foot dam at 220 acre New Bedford Reservoir is the third and last obstruction on the system. Although the spillway at this dam has passed fish under ideal flow conditions, this structure has severely limited the number of fish spawning in the Reservoir. A state-of-the-art Denil fishway, designed by DMF with assistance from the U.S. Fish and Wildlife Service and funded by the New Bedford Harbor Cleanup Fund, was constructed in 2002. In anticipation of the fishway installation, DMF initiated alewife stocking at the Reservoir in 1999 in order to accelerate the recovery of this population.

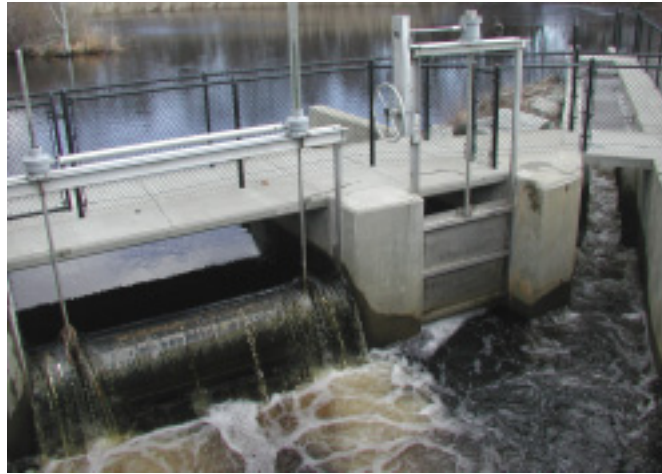
Dam at Route 6 Crossing

Design	Material	Length (ft)	Inside W (ft)	Outside W (ft)	# of Baffles	Baffle H (ft)	Notch W (ft)	Pool L (ft)	Condition/Function
Denil	Concrete with wooden baffles	58.0	3.0	5.0	16	8.6	-	-	Excellent Passable

The dam and fishway at the first impoundment on the Mattapoissett River at Route 6 were both replaced in 1996. The new fishway is a Denil design which provides optimal passage around this obstruction. Water levels in the impoundment are controlled by the Fairhaven Water Department and must continue to be regulated with fish passage in mind.

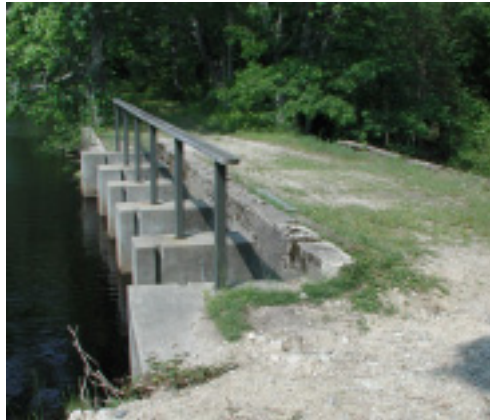
Hathaway Pond Dam

Design	Material	Length (ft)	Inside W (ft)	Outside W (ft)	# of Baffles	Baffle H (ft)	Notch W (ft)	Pool L (ft)	Condition/Function
Weir-pool	Concrete with wood baffles	85.0	2.0	4.8	8	Varied (2.6)	-	Varied (9.5-30.7)	Fair Inefficient passage

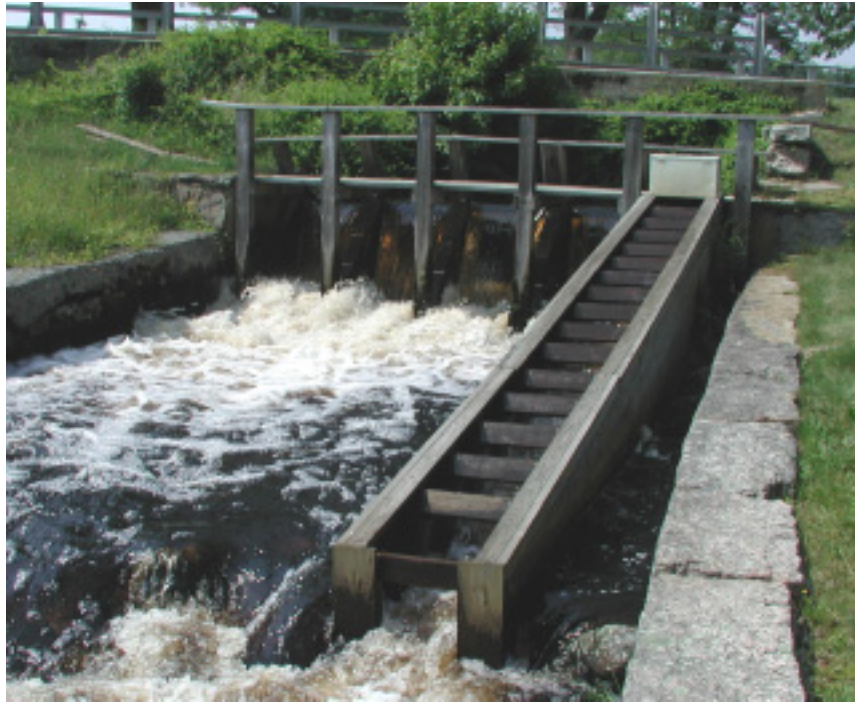
Leonards Pond Dam and Ladder

Design	Material	Length (ft)	Inside W (ft)	Outside W (ft)	# of Baffles	Baffle H (ft)	Notch W (ft)	Pool L (ft)	Condition/Function
Denil	Wood	30.0	2.2	2.5	16	3.0	-	-	Fair Inefficient passage

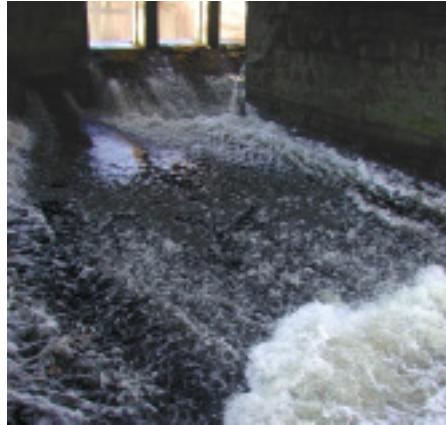
Horseshoe Pond Dam

The first obstruction to fish passage is just above the point of tidal influence. This 6 foot dam creates a 59 acre impoundment called Horseshoe Pond. An old millrace is capable of passing fish under ideal flow conditions although its entrance location is too far downstream of the dam. A Denil fishway has been designed for this location and, until funding for construction is secured, modifications to the millrace could provide improved passage into the pond.

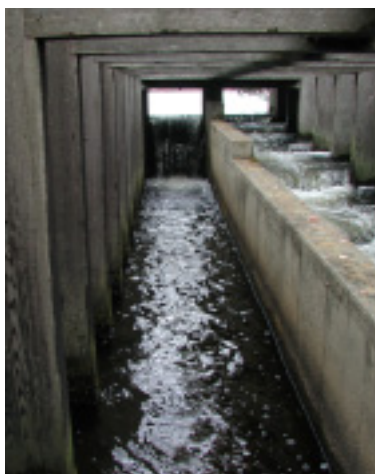
Tihonet Pond Dam

Design	Material	Length (ft)	Inside W (ft)	Outside W (ft)	# of Baffles	Baffle H (ft)	Notch W (ft)	Pool L (ft)	Condition/Function
Denil	Concrete with fiberglass and wooden baffles	86.0	2.0	3.8	37	8.0	-	-	Good Inefficient passage
Notched weir-pool	Concrete with wooden baffles	62.0	4.5	8.0	7	1.9	1.5	6.6	Good Inefficient passage

Tihonet Pond has two outlets, the eastern-most of which is equipped with a fishway. This combination weir-pool and Denil style ladder functions adequately with proper flow adjustment. The problem that occurs at this impoundment is the attraction flow from the west outlet which causes migrating herring to be diverted into a dead end channel. Careful adjustment of flows from the two outlets could increase the numbers of fish which reach the spawning area. Further development within this system is not justified due to numerous small obstructions and competing water usage by the cranberry growers.

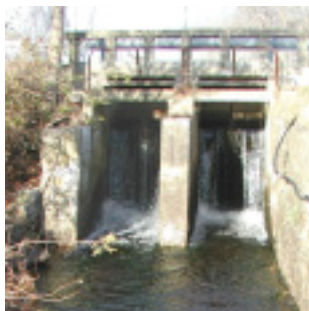
Mill Pond Dam

Design	Material	Length (ft)	Inside W (ft)	Outside W (ft)	# of Baffles	Baffle H (ft)	Notch W (ft)	Pool L (ft)	Condition/Function
Alaskan Steeppass	Aluminum	20.0	1.2	1.85	-	2.3	-	-	Excellent Passable
Notched weir-pool	Concrete and wood	117.0	6.0	Stream width	10	3.0	1.0	12	Poor Inefficient passage
Stream baffle	Stone	445.0	4.4	6.0	9	1	-	Varied (20-55)	Poor Inefficient passage

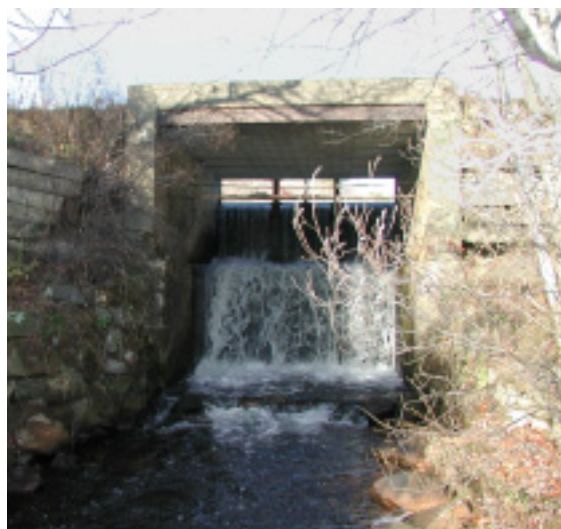
Besse Bog Reservoir Dam

Design	Material	Length (ft)	Inside W (ft)	Outside W (ft)	# of Baffles	Baffle H (ft)	Notch W (ft)	Pool L (ft)	Condition/Function
Denil	Concrete with wooden baffles	157.0	3.0	4.5	36	5.0	-	-	Excellent Passable

A deteriorated wooden ladder at Besse Bog Reservoir was replaced by DMF in 1994 with a concrete and wood Denil fishway. This ladder functions efficiently but requires careful adjustment of flow to provide sufficient attraction to the entrance.

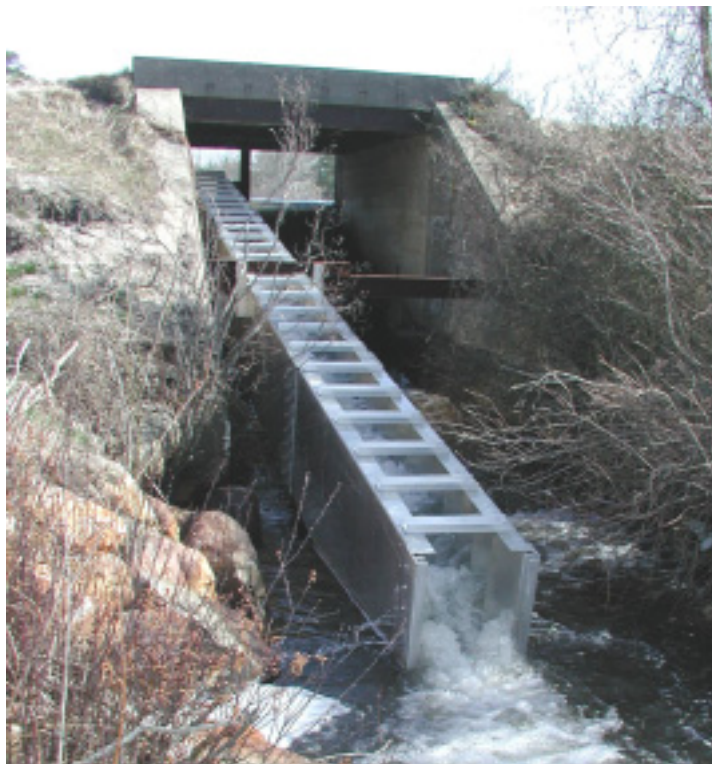
Kennard Bog Dam and Ladder

Design	Material	Length (ft)	Inside W (ft)	Outside W (ft)	# of Baffles	Baffle H (ft)	Notch W (ft)	Pool L (ft)	Condition/Function
Alaskan Steeppass	Aluminum	42.0	2.0	-	-	2.25	-	-	Excellent Passable

The final fishway, at Kennard Bog dam, was replaced in 2002 with an aluminum steeppass ladder. This work was also funded by a grant from NOAA, designed by DMF and USFWS. Installation was carried out by the property owner, A.D. Makepeace, Inc.

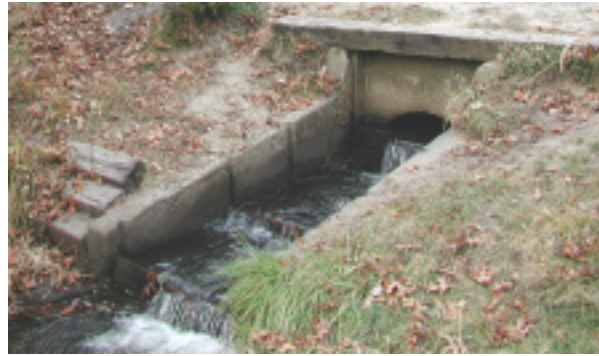
Dick's Pond Dam and Ladder

Design	Material	Length (ft)	Inside W (ft)	Outside W (ft)	# of Baffles	Baffle H (ft)	Notch W (ft)	Pool L (ft)	Condition/Function
Notched weir-pool	Concrete with wood baffles	23.0	Varied (3.5 and 20)	4.6	6	Varied (1.3 and 2.0)	Varied (0.6 and 1.0)	Varied (3.0 and 4.0)	Poor Inefficient

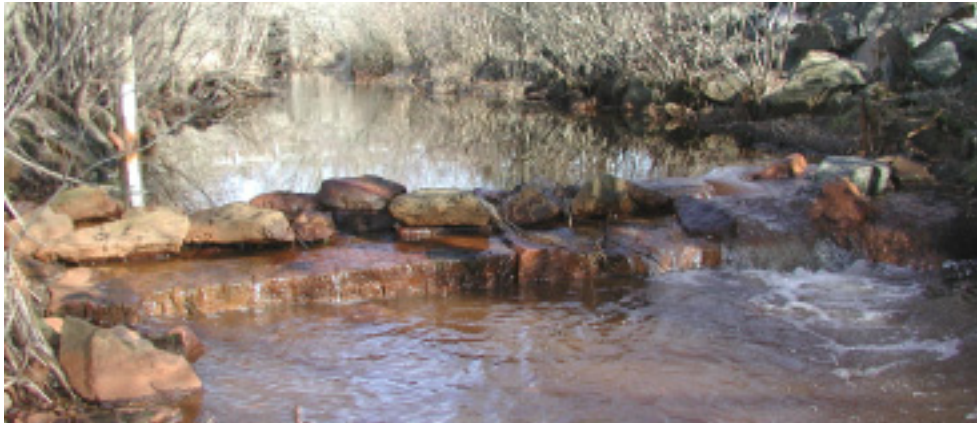
Stream Baffle downstream of Route 25

Design	Material	Length (ft)	Inside W (ft)	Outside W (ft)	# of Baffles	Baffle H (ft)	Notch W (ft)	Pool L (ft)	Condition/ Function
Stream baffle	Granite and stone	N/A	13.0	13.0	1	1.5	1.7	N/A	Fair Inefficient passage

The first obstruction on the stream is actually a stream baffle which backs water up into the Route 25 culverts. A notch in this baffle allows fish to pass under spring flow conditions. Baffles in the culverts themselves increase water depth for passage but are poorly maintained and create difficulties for migrating fish. The Town of Wareham and DMF are aware of the difficulties in passage here, and attempt to make adjustments as needed. A third ladder at the outlet of White Island Pond enables fish to access the headwater pond if properly adjusted. Sediment deposited at the ladder's exit at the time of this survey made it temporarily inoperable.

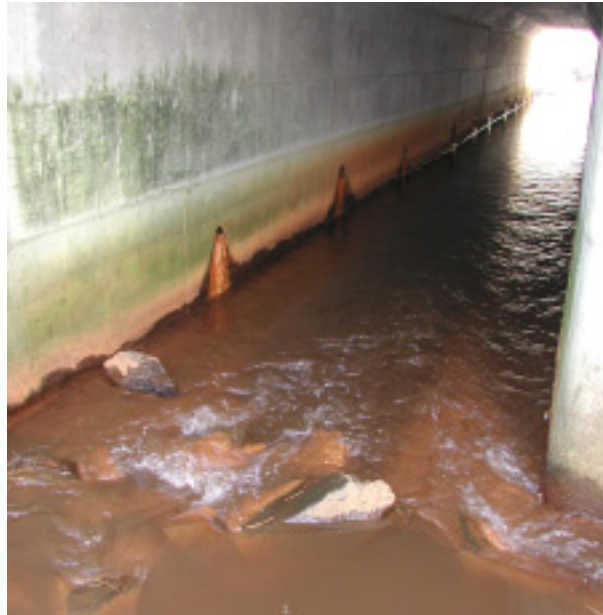
Southbound Route 25 Crossing

Design	Material	Length (ft)	Inside W (ft)	Outside W (ft)	# of Baffles	Baffle H (ft)	Notch W (ft)	Pool L (ft)	Condition/Function
Trench with baffle	Concrete trench, stone stream baffle	88.0	3.0	6.0	1	1.0	-	N/A	Poor Inefficient passage

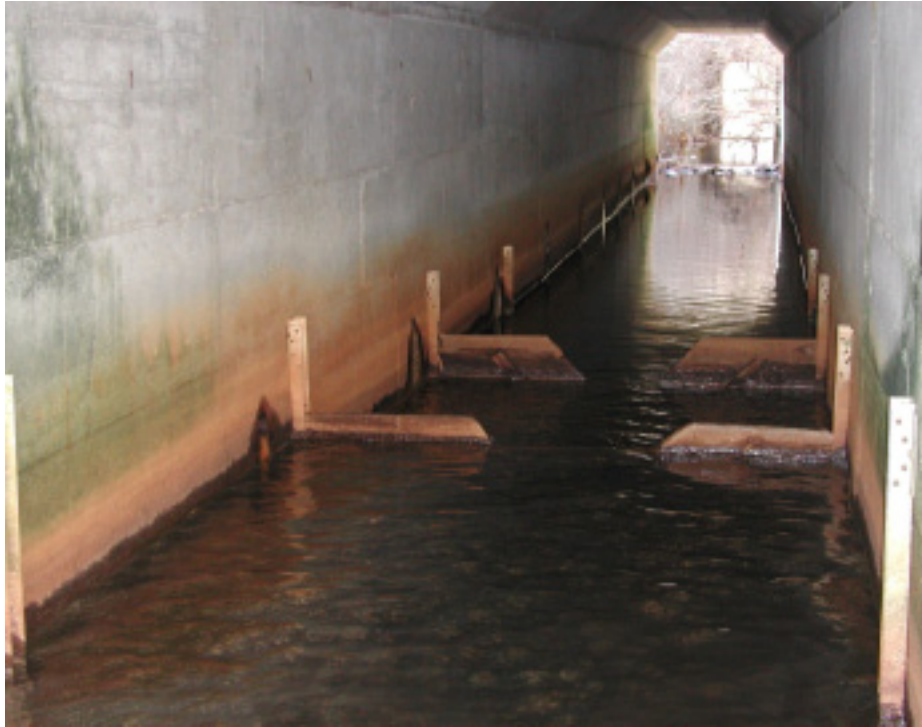
Northbound Route 25 Crossing

Design	Material	Length (ft)	Inside W (ft)	Outside W (ft)	# of Baffles	Baffle H (ft)	Notch W (ft)	Pool L (ft)	Condition/ Function
Notched weir-pool	Wooden boards, metal slots, stone stream baffle	88.0	6.0	Culvert wall	5	Varied (1.0-1.5)	1.8	Varied (8.0-56)	Fair Inefficient passage

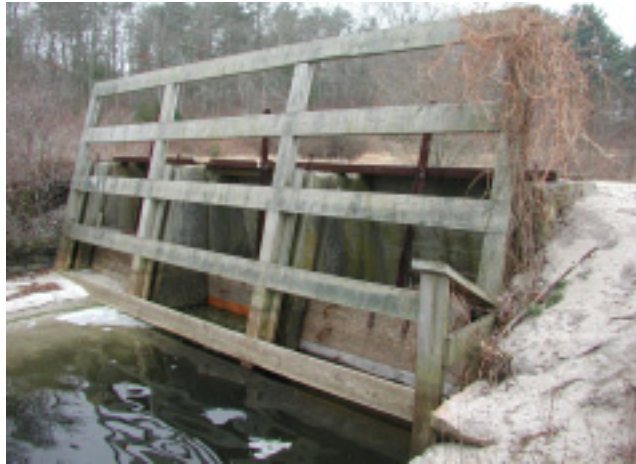
White Island Pond Dam

Design	Material	Length (ft)	Inside W (ft)	Outside W (ft)	# of Baffles	Baffle H (ft)	Notch W (ft)	Pool L (ft)	Condition/Function
Denil	Concrete with wooden baffles	103.0	2.0	3.5	28	Varied (4.3 and 7.0)	-	-	Excellent Inefficient passable
