**CAPE COD WATERSHEDS (Western)**

# Cape Cod Watersheds

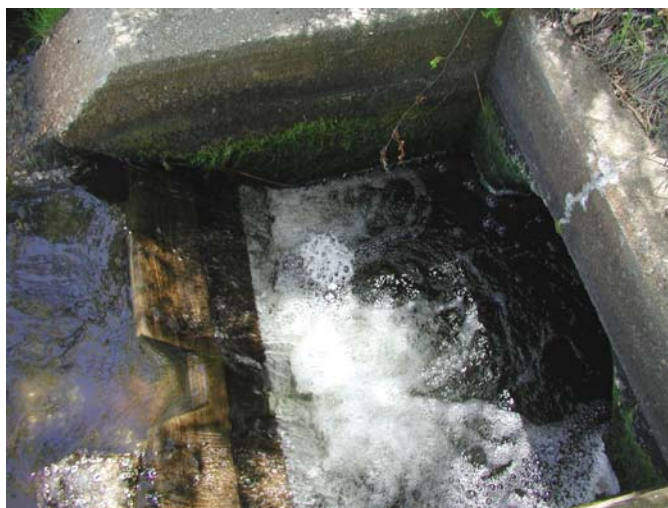
Dam Pond Culvert and fishway

Design	Material	Length (ft)	Inside W (ft)	Outside W (ft)	# of Baffles	Baffle H (ft)	Notch W (ft)	Pool L (ft)	Condition/ Function
Notched weir-pool	Concrete with wooden baffle	3.6	2.5	5.5	1	2.0	0.8	N/A	Fair Inefficient passage

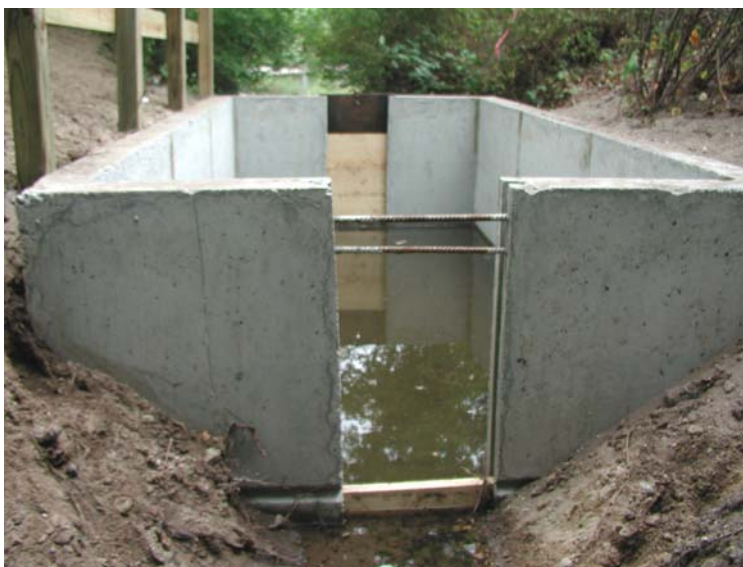
Connamessett Pond Outlet

<b>Design</b>	<b>Material</b>	<b>Length (ft)</b>	<b>Inside W (ft)</b>	<b>Outside W (ft)</b>	<b># of Baffles</b>	<b>Baffle H (ft)</b>	<b>Notch W (ft)</b>	<b>Pool L (ft)</b>	<b>Condition/Function</b>
Stream baffles	Concrete with wooden baffles	2660	Varied (3.1-9.0)	Varied (4.5-10.0)	5	Varied (1-3.3)	Varied (0, 1.6)	Varied	Excellent Passable

The final obstruction is actually caused by shoaling of the stream below the headwater pond. This and persistent low water levels in the pond itself have made juvenile and adult out-migration difficult in many years. To overcome this, a new outlet structure was installed in 2002 which deepened the outlet stream and is capable of functioning as a fishway.

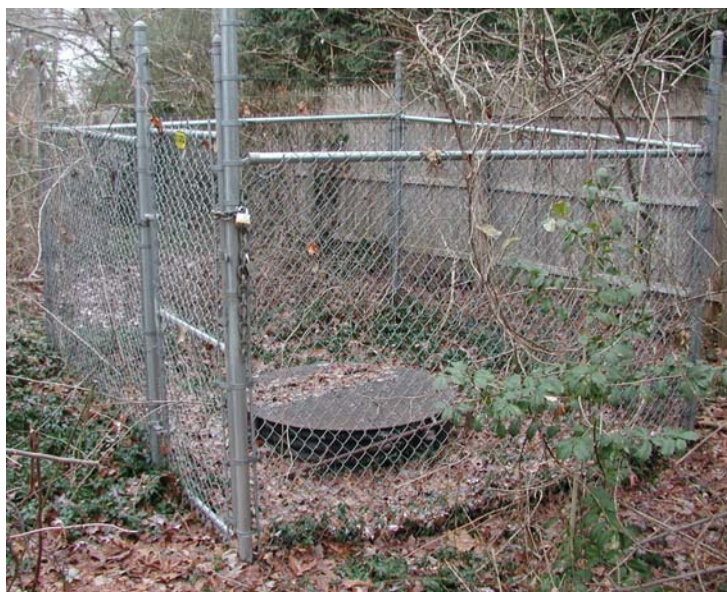
John's Pond Outlet Control Structure

This is one of two outlet streams from Johns Pond, a 317 acre natural water body. The first obstruction to fish passage is a small dam at Carriage Shop Road. A series of stream baffles once enabled fish to enter the pond but are now badly deteriorated. The second barrier is a control box below Johns Pond which regulates flow from a subsurface outlet in the pond.

The lack of adequate spawning area downstream of Johns Pond, the difficulties involved in providing access to the headwaters and the problems inherent in maintaining flow from two outlets make this stream a poor candidate for development. Resources should be directed toward improving passage conditions in the second outlet stream, the Quashnet River.

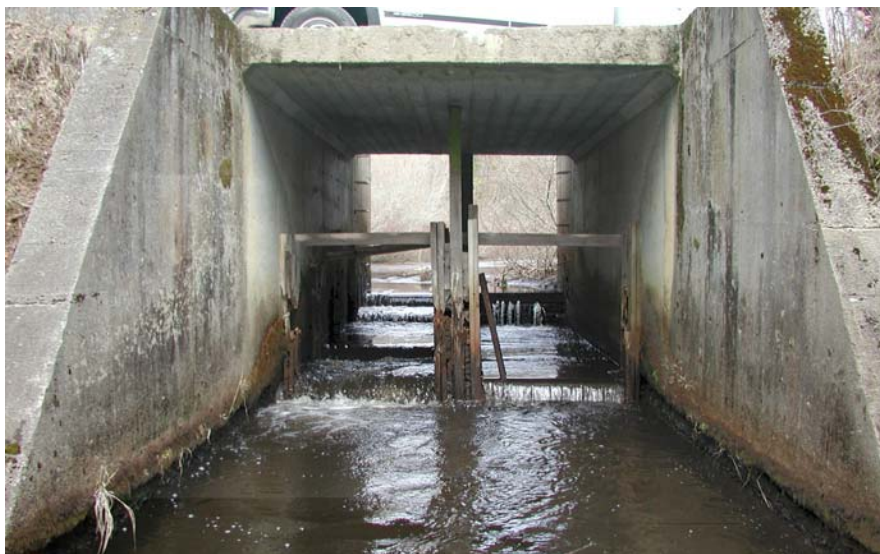
Second Unnamed Dam and Fish Ladder on U.S. Fish &amp; Wildlife Property

Design	Material	Length (ft)	Inside W (ft)	Outside W (ft)	# of Baffles	Baffle H (ft)	Notch W (ft)	Pool L (ft)	Condition/ Function
Weir-pool	Concrete with wooden baffles	24.5	4.5	4.7	4	0.9	-	6.0	Poor Inefficient passage

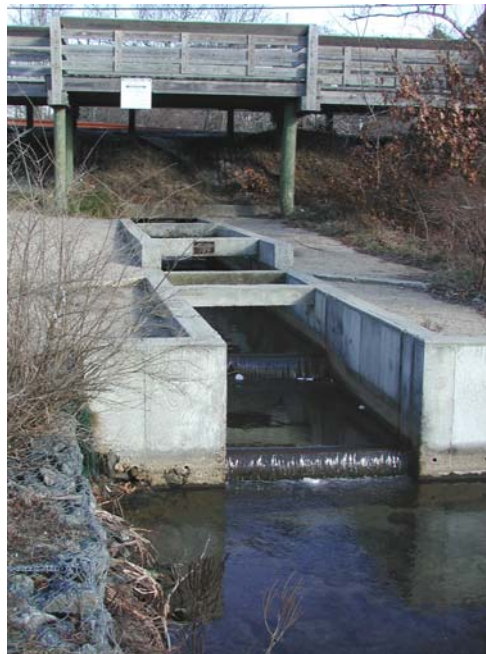
<b>Design</b>	<b>Material</b>	<b>Length (ft)</b>	<b>Inside W (ft)</b>	<b>Outside W (ft)</b>	<b># of Baffles</b>	<b>Baffle H (ft)</b>	<b>Notch W (ft)</b>	<b>Pool L (ft)</b>	<b>Condition/Function</b>
Weir-pool	Concrete with wooden baffles	219.0	Varied (3.0 and 5.0)	Varied (4.6 and 6.6)	10	Varied (1.1-2.1)	-	Varied (8.0-35.0)	Excellent Passable

Fishway at Route 130 Crossing

A small impoundment at Route 130 is made accessible by a concrete and wood weir-pool ladder. The lower section of the fishway was modified and the upper section completely replaced by DMF in 1997. This ladder now functions very well with proper flow adjustment. A short section of stream connects this impoundment to the outlet of Mashpee-Wakeby Pond. The control structure at the outlet is equipped with wooden baffles to allow fish to access the pond. Jetties have been installed at the outlet to reduce sand build up in the stream, a condition which has prevented juvenile out migration on a number of occasions.

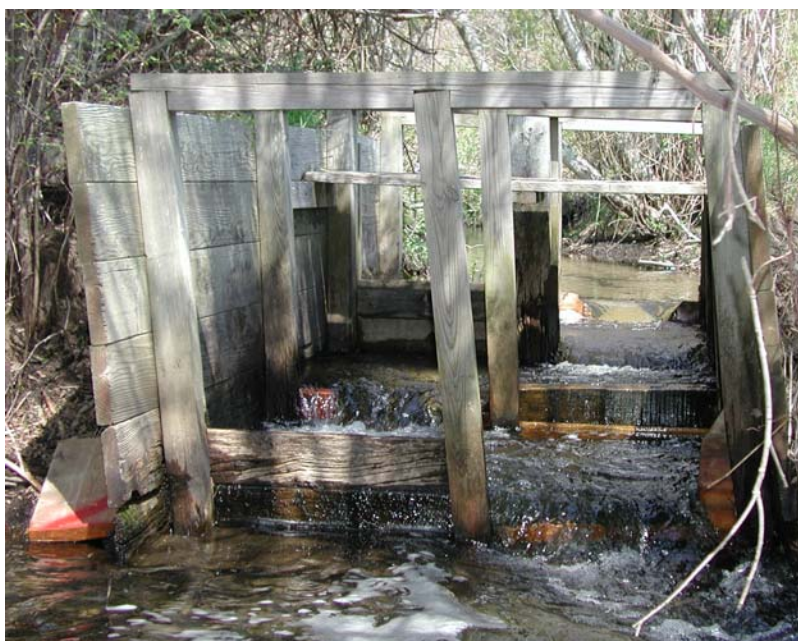
Dam and Ladder at Bog off Route 130

Design	Material	Length (ft)	Inside W (ft)	Outside W (ft)	# of Baffles	Baffle H (ft)	Notch W (ft)	Pool L (ft)	Condition/ Function
Notched weir-pool	Wood	13.9	4.9	5.1	4	Varied (0.2-0.9)	1.7	Varied (3.9 and 4.5)	Poor Inefficient passage

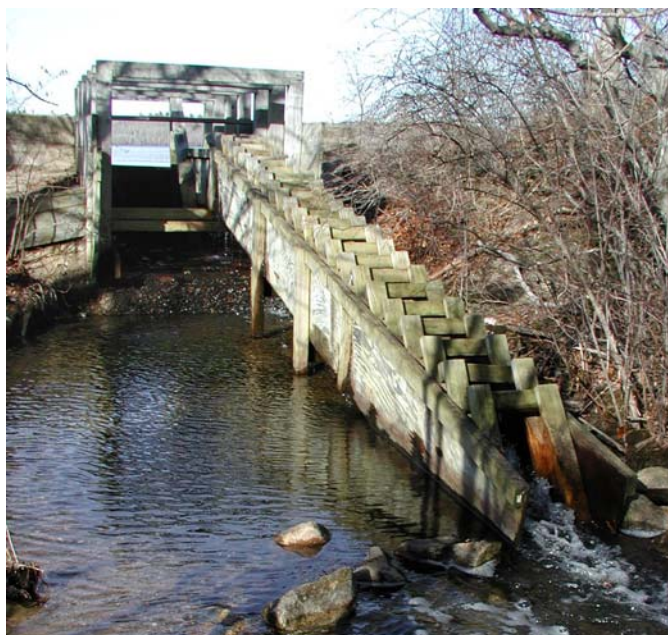
Santuit Pond Dam and Ladder

<b>Design</b>	<b>Material</b>	<b>Length (ft)</b>	<b>Inside W (ft)</b>	<b>Outside W (ft)</b>	<b># of Baffles</b>	<b>Baffle H (ft)</b>	<b>Notch W (ft)</b>	<b>Pool L (ft)</b>	<b>Condition/Function</b>
Denil	Wood	32.0	1.5	1.8	24	2.0	-	-	Good Passable

The final obstruction is the outlet dam at Santuit Pond. This site was fitted with a new wooden Denil fishway by DMF in 1997. The ladder functions adequately, however, the dam is leaking badly and, if replaced, should be equipped with a more permanent fish passage structure.

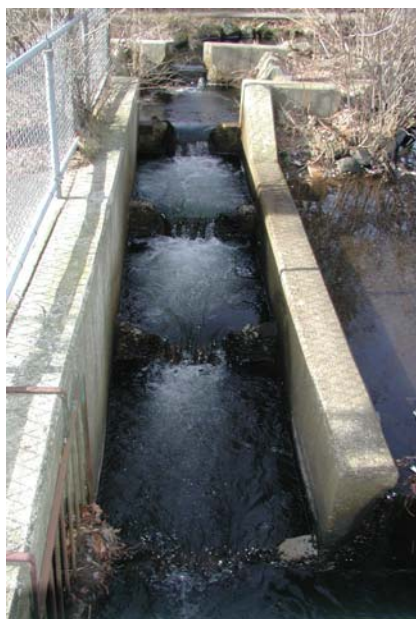
Design	Material	Length (ft)	Inside W (ft)	Outside W (ft)	# of Baffles	Baffle H (ft)	Notch W (ft)	Pool L (ft)	Condition/Function
Notched weir-pool	Concrete	53.0	4.0	6.0	6	Varied (1.8-2.3)	1.5	5.0	Poor Inefficient passage

Mill Pond Fishway

The first obstruction on the stream is an elevation change at Route 28. This is nicely surmounted with stone stream baffles. After passing this and moving through the Route 28 culvert, fish must ascend a concrete, notched weir-pool ladder which is in poor condition and not functioning well. A third barrier is a large concrete flume which, though passable, presents a difficult elevation change.

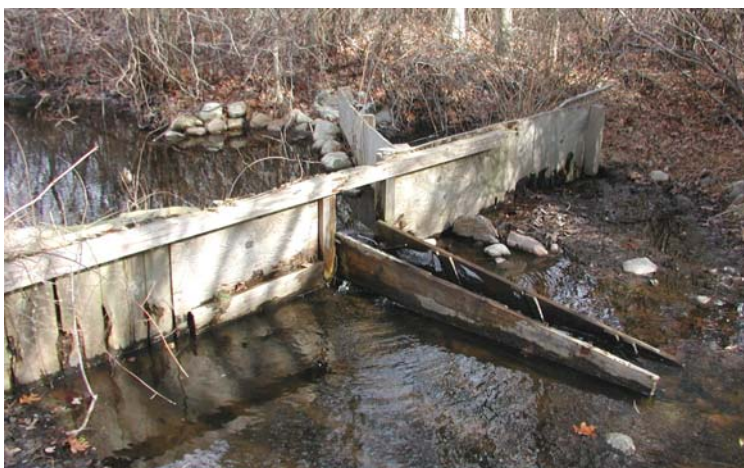
Lake Elizabeth Dam and Ladder

Design	Material	Length (ft)	Inside W (ft)	Outside W (ft)	# of Baffles	Baffle H (ft)	Notch W (ft)	Pool L (ft)	Condition/Function
Notched weir-pool	Wood	5.0	1.0	1.2	3	0.5	0.3	~1.5	Poor Inefficient passage

These two small ponds, totaling 9.6 acres drain into the Centerville River estuary via a small stream. River herring access the lower pond by means of a small, wooden notched weir-pool ladder. The upper pond is connected by a corrugated metal culvert that should be passable although the extent to which herring utilize it is unknown. The dam at Lake Elizabeth is deteriorating and, if replaced, a more efficient fishway should be incorporated into it.
