Appendix A: Assessment Summaries for BMPs

HW Site ID#: 1	
Type of BMP: Constructed wetland

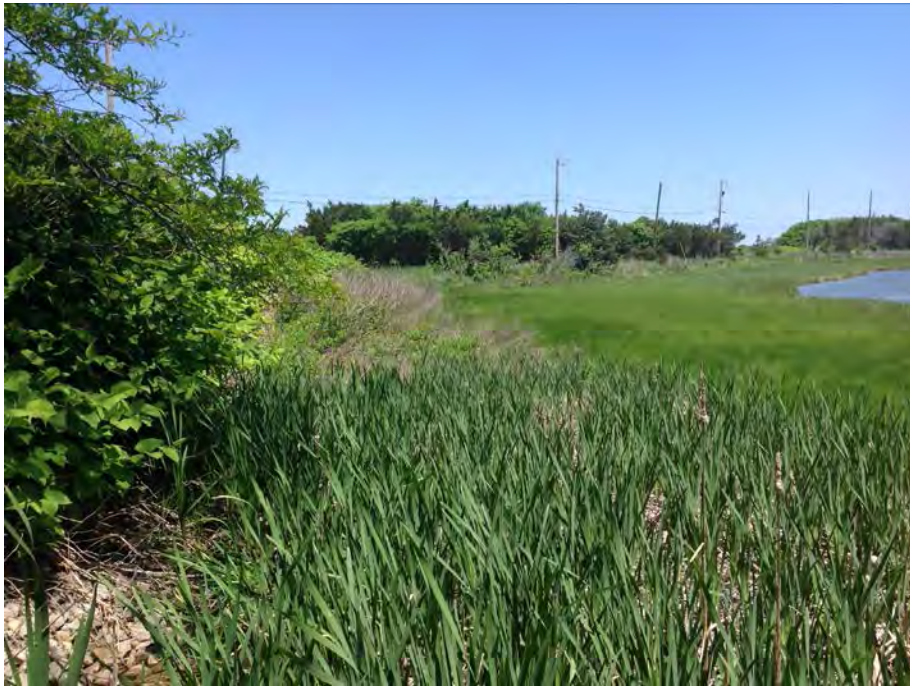
Swale is in the knotweed, upland marsh area is to the left and salt marsh grass to the right.

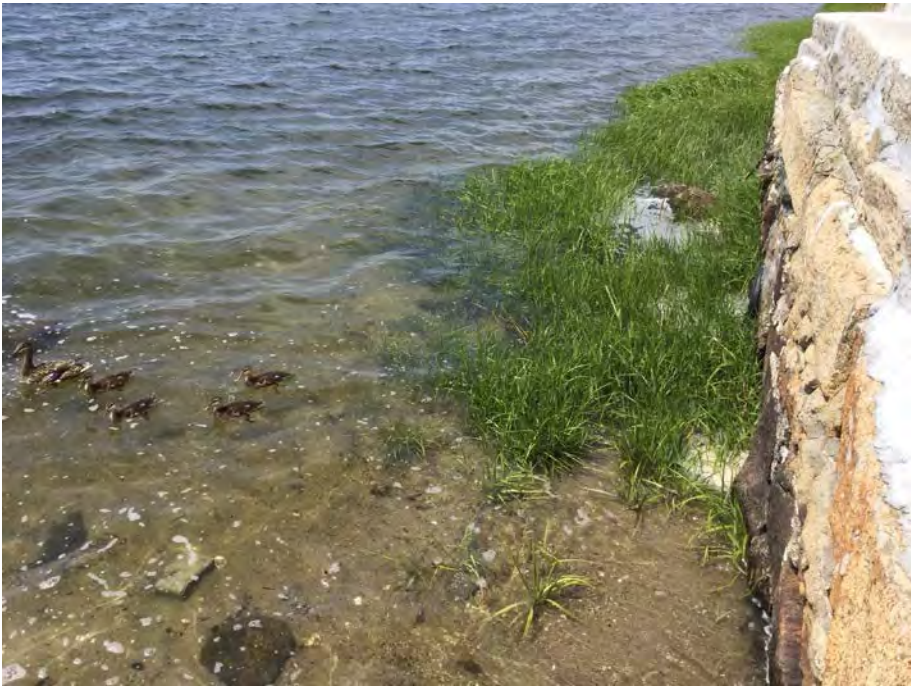
Needs maintenance.

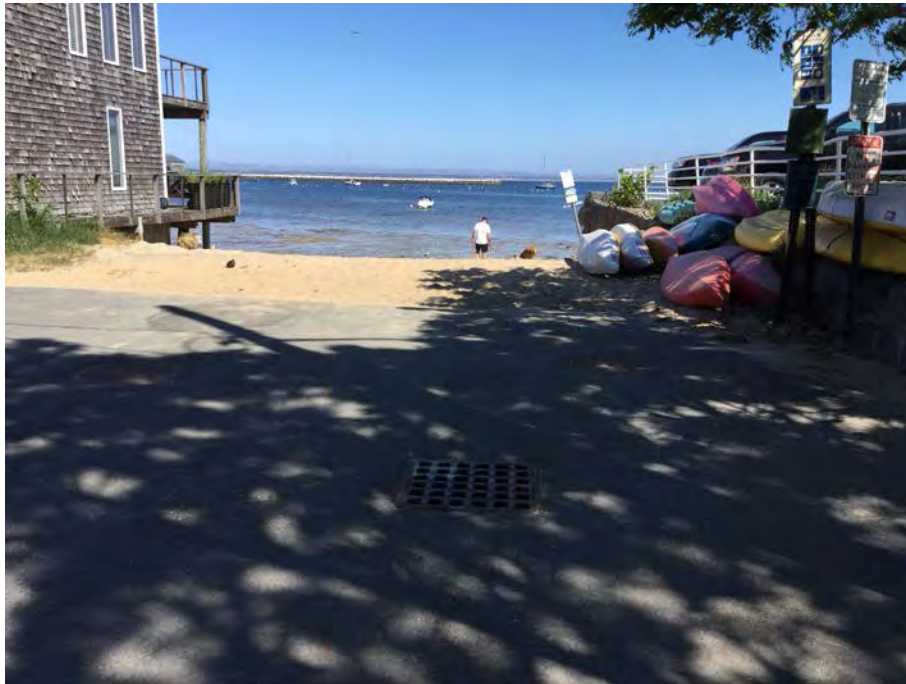
Inlet not built per design. Commercial Street is now porous asphalt. DMH is under trash can.

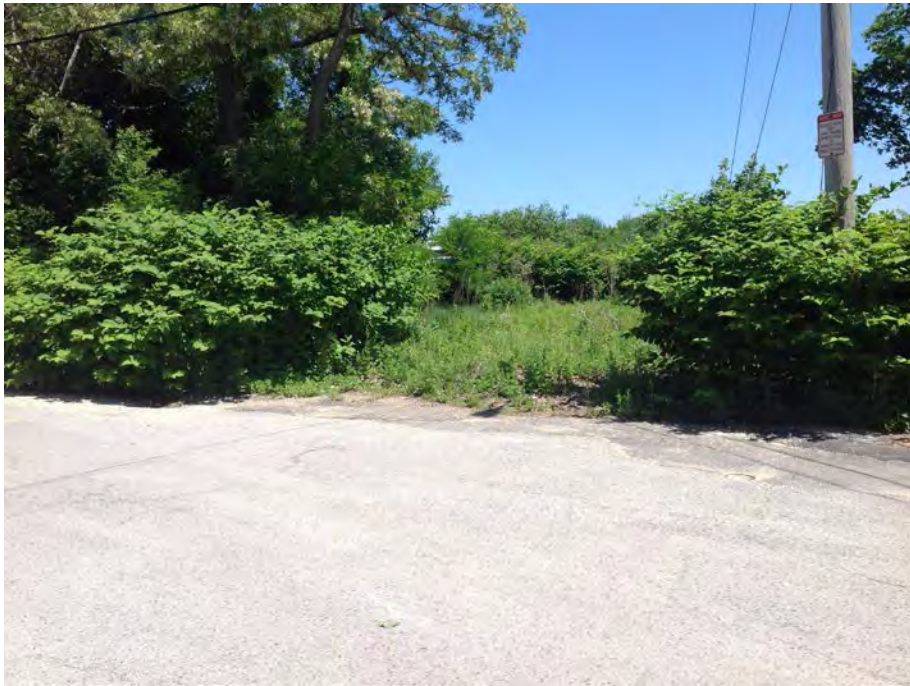
Surface of practice area.

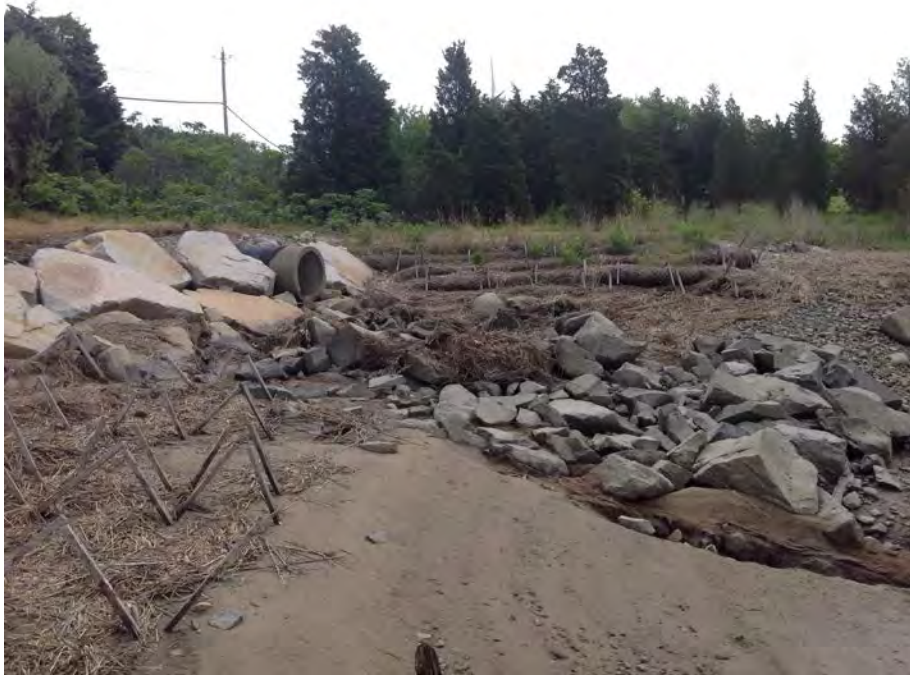
Erosion.

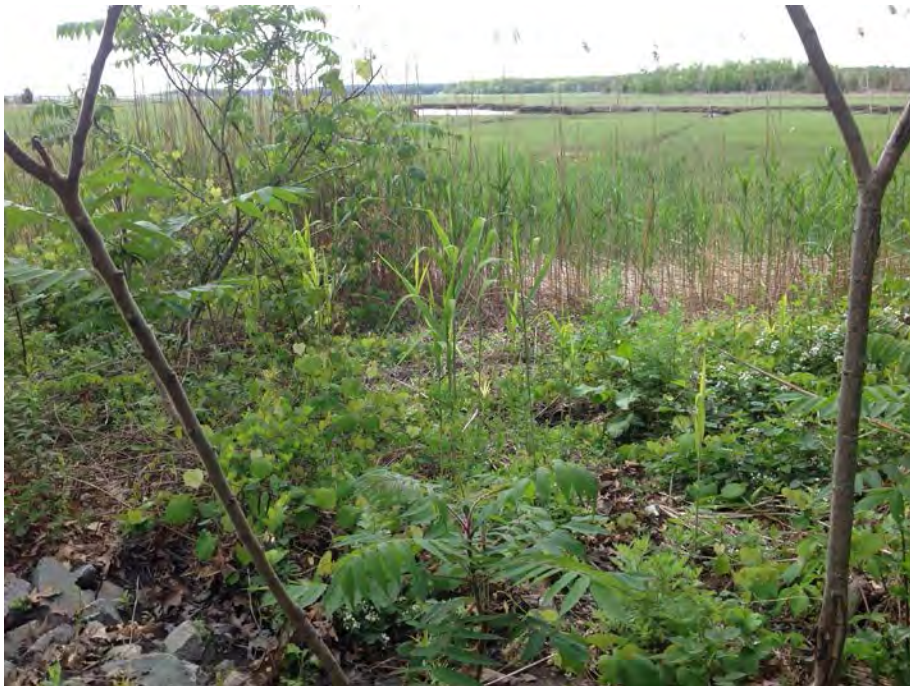
Forebay full of sediment.

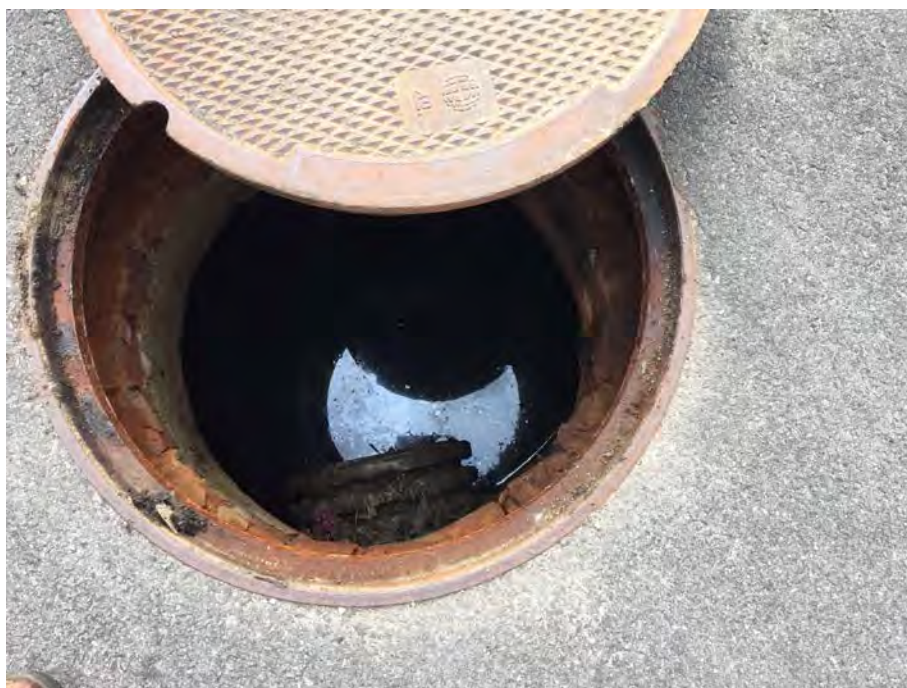
Hooded outlet pipe.

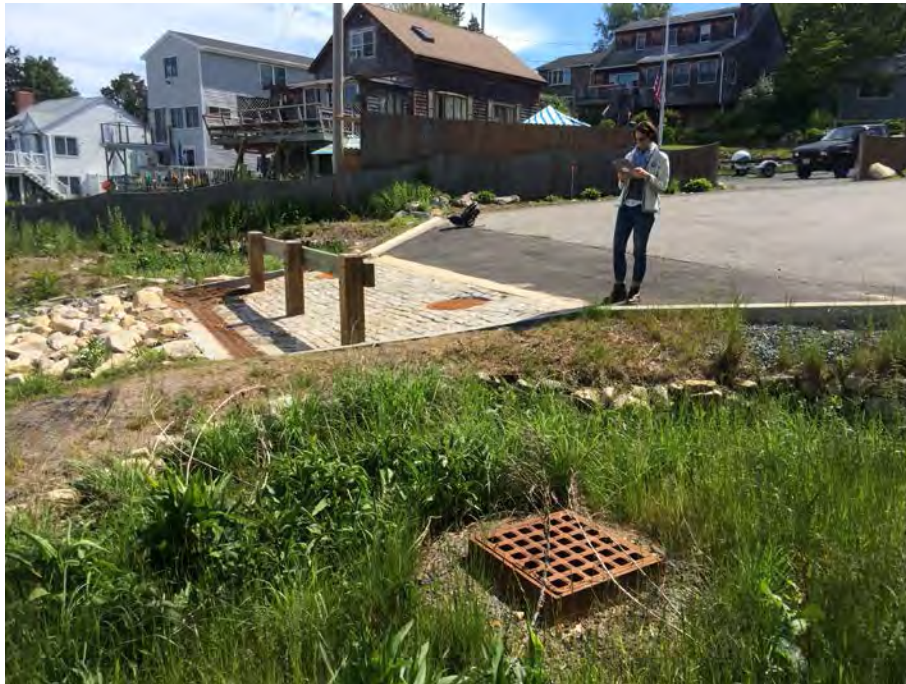
Rain garden immediately downgradient of Delano. Broken concrete curb.

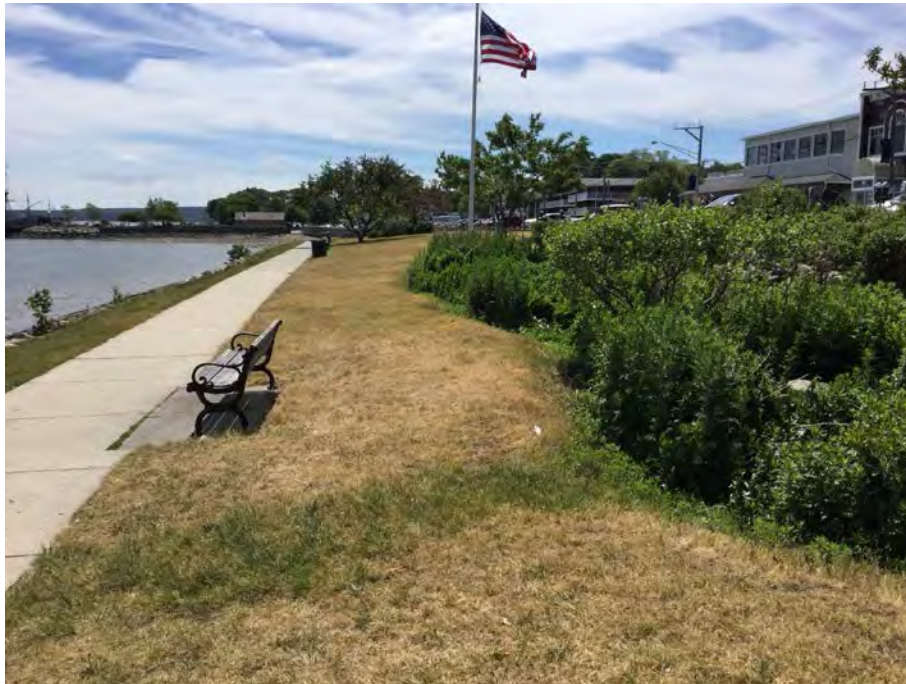
Green grass indicates overflow from bio. Erosion on other side of sidewalk where overland flow discharges to sea wall.

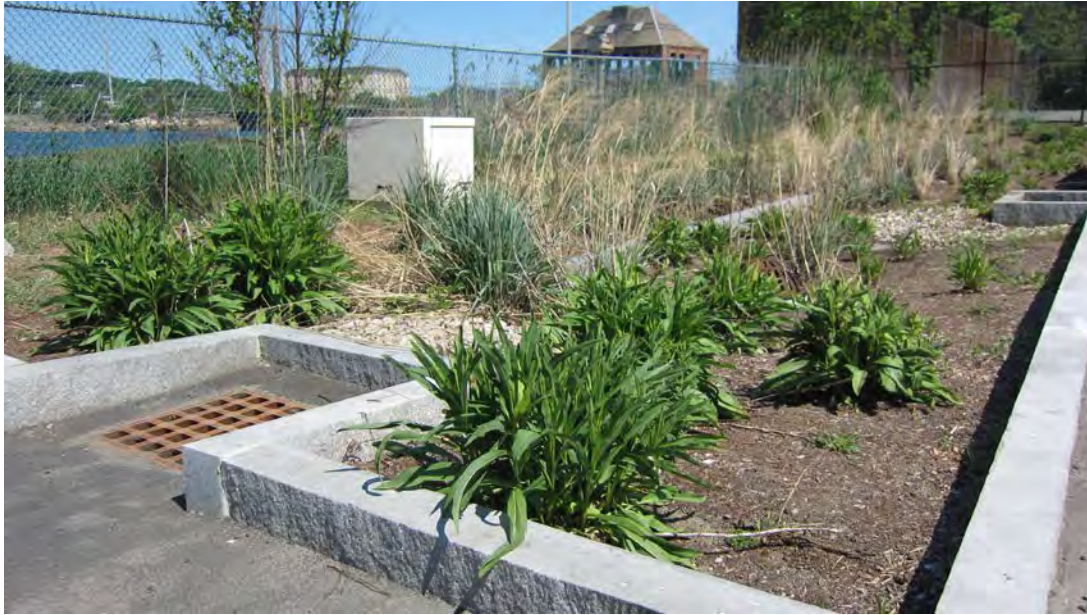
Maintenance underway.
