Appendix A: Assessment Summaries for BMPs

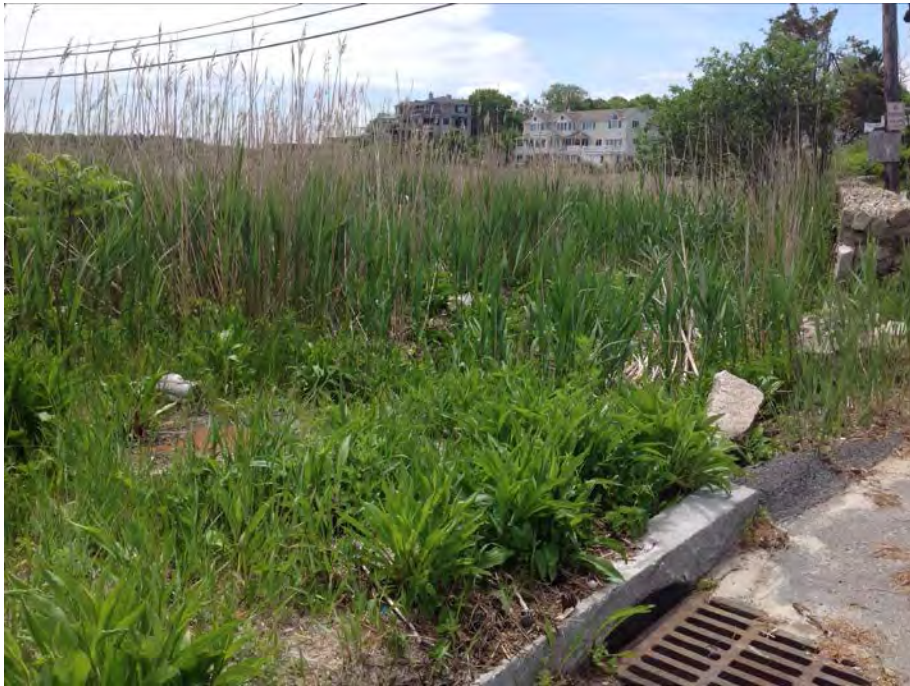
GENERAL INFORMATION	Site Visit
Elevation: 5.11 ft.	Weather: Rain Within Past 24 hours
BMP Plant Health: Salt Impacts. Lots of phragmites. Wall collapsed into forebay, possibly undercut by high water. Water in catch basin approx 2 feet below rim. Inlet from diversion manhole completely blocked. Appears that bmp is not functioning and all water is diverted to nearby wetland.	Arrival Time: 12:05 PM
	Nearest Tide: High, 1:28 PM
	Observers: None
Observed Constraints: None	Date Assessed: 6/4/2015
	Outfall Details
	Outfall Observed: No
	Outfall Notes: Did not find outfall structure, but clear indication of discharge.
Direction of Coastal Exposure: North	Outfall Photo:

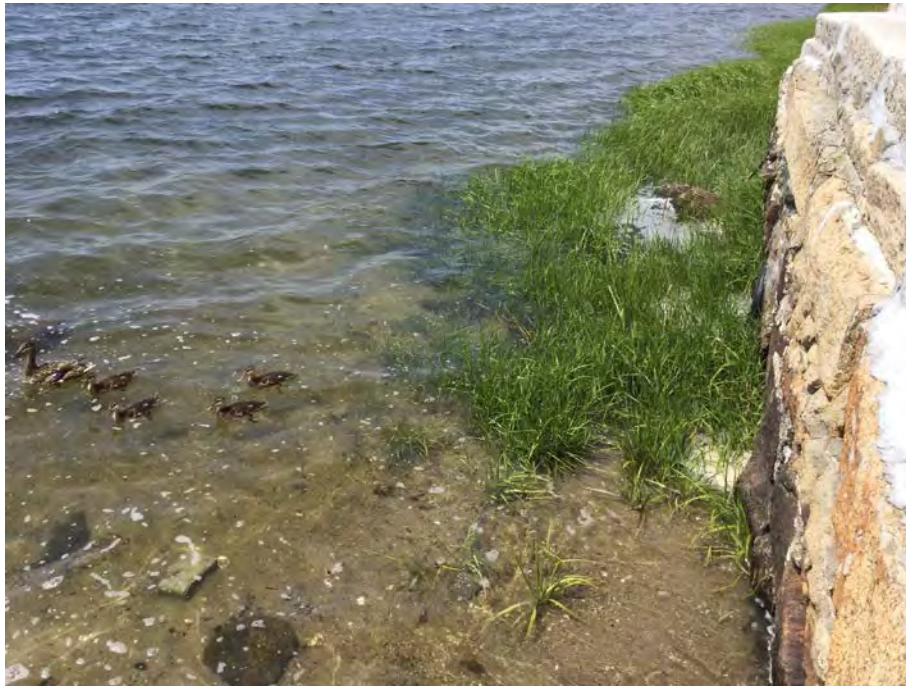
Needs maintenance.

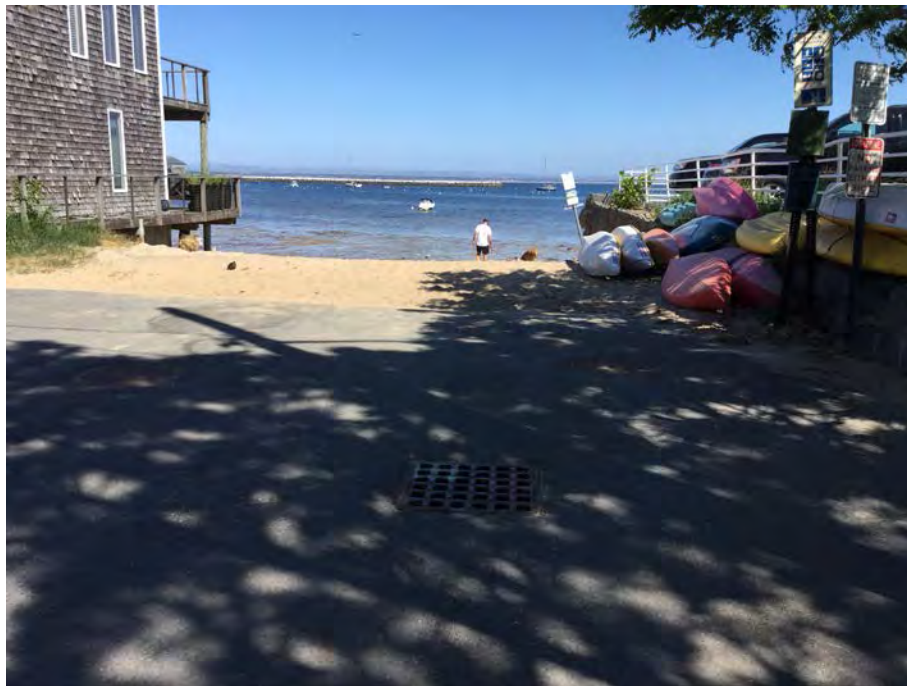
Looking towards water.

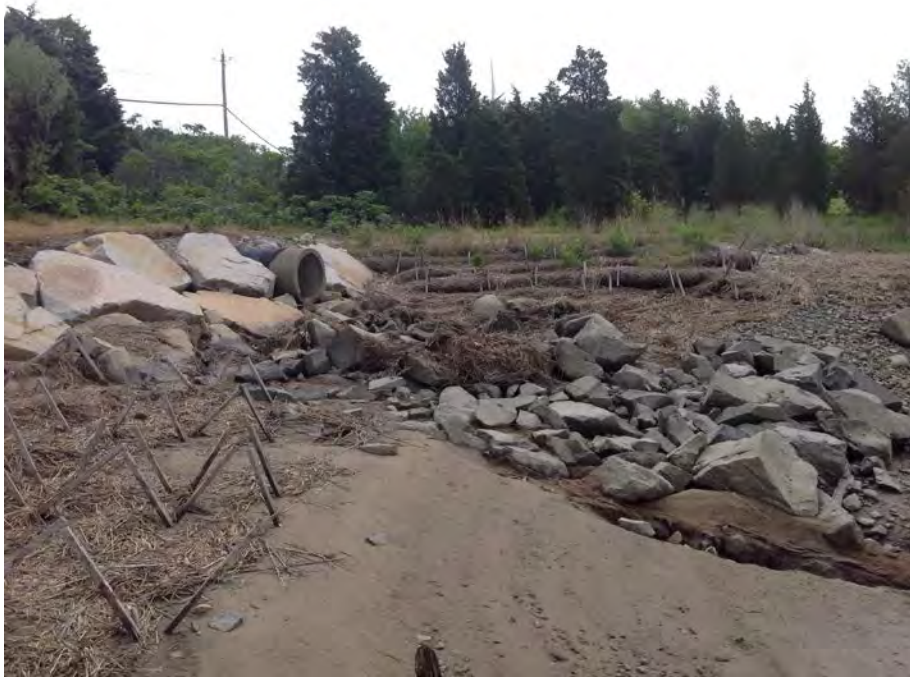
Erosion.

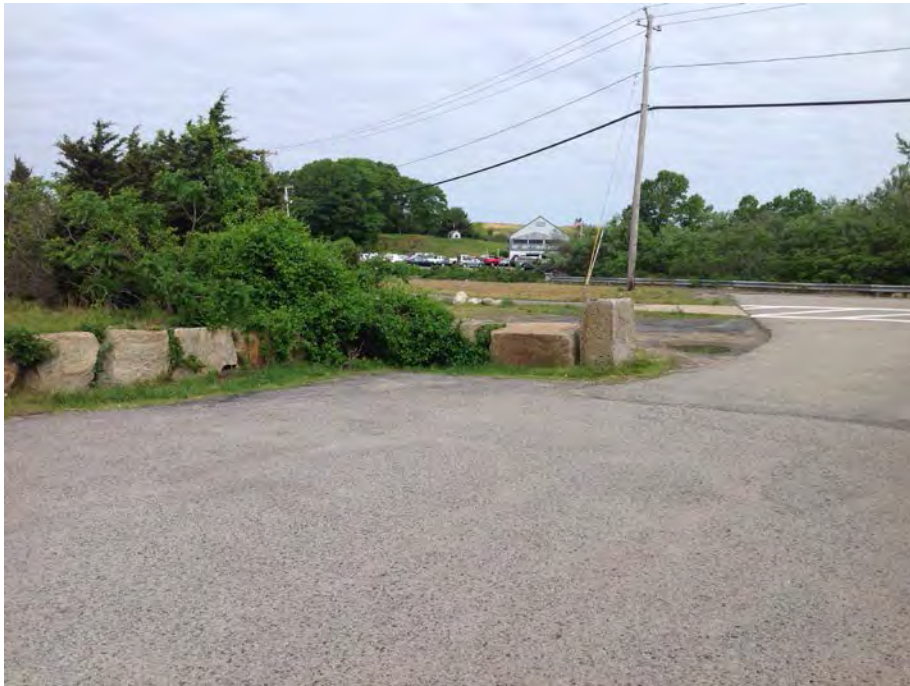
Looking toward marsh.

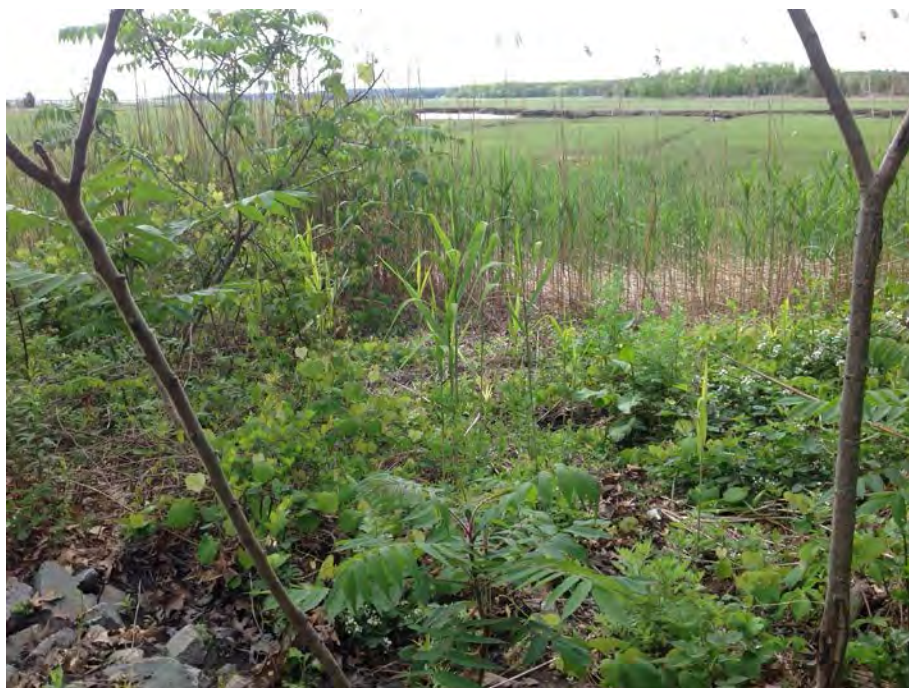
Grant Funding Source/ID Number: 319/06-06		
Year Built: 2009		
Reference Plans: Project Final Report - Herring River Coastal Low Impact Development Project, DEP Project #06-06/319		
Address: Adjacent to Driftway, east of Ladds Way development		
BMP Condition: Overgrown. Not maintained well. Still appears to be functioning. Forebay has significant sediment and debris. Overgrown outfall structure. Flared end of pipe has significant sediment. Needs cleaning,		
Climate Change Risks: Adjacent to marsh. Discharge is slightly above marsh, but no apparent high water issues. Water observed in base of overflow structure, at least 2 feet below grate.	Potential Retrofit:	
Notes: Structure appears to be functioning well but needs maintenance. Forebay full and spillway riprap embedded with sediment.

Forebay full of sediment.

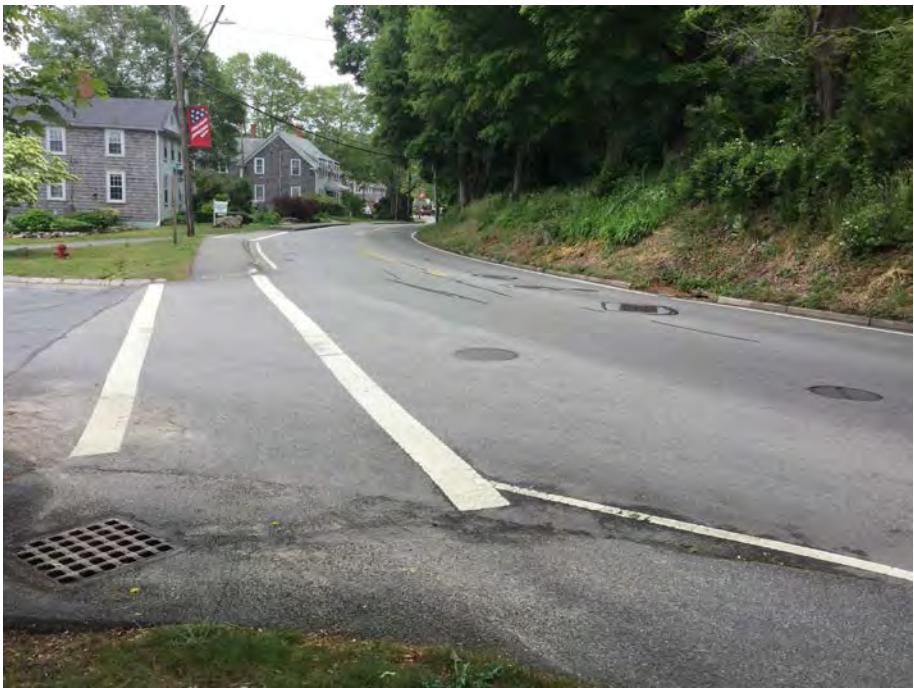
Looking south.

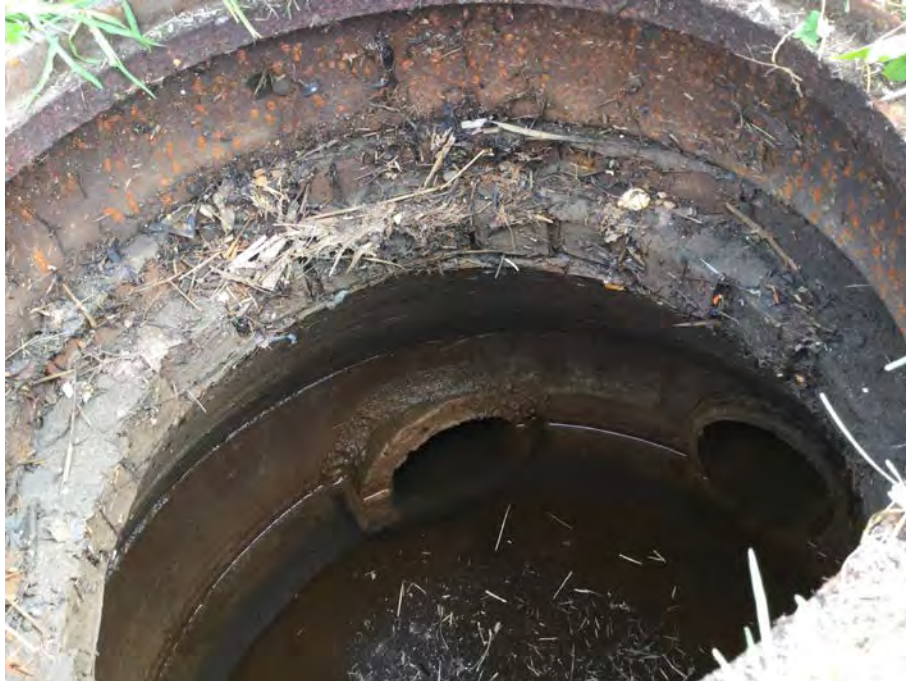
Manhole.

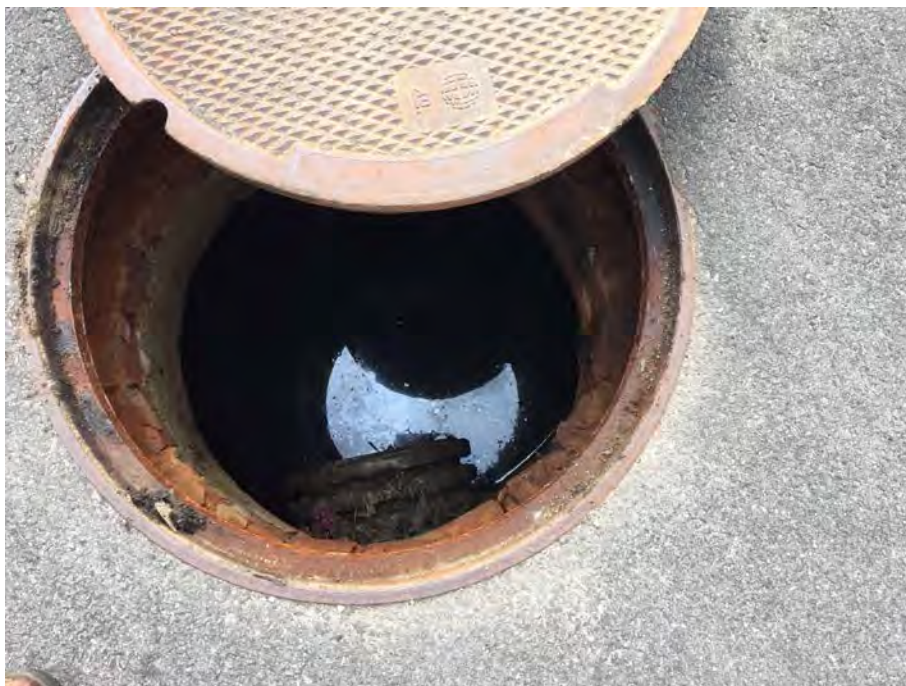
Hooded outlet pipe.

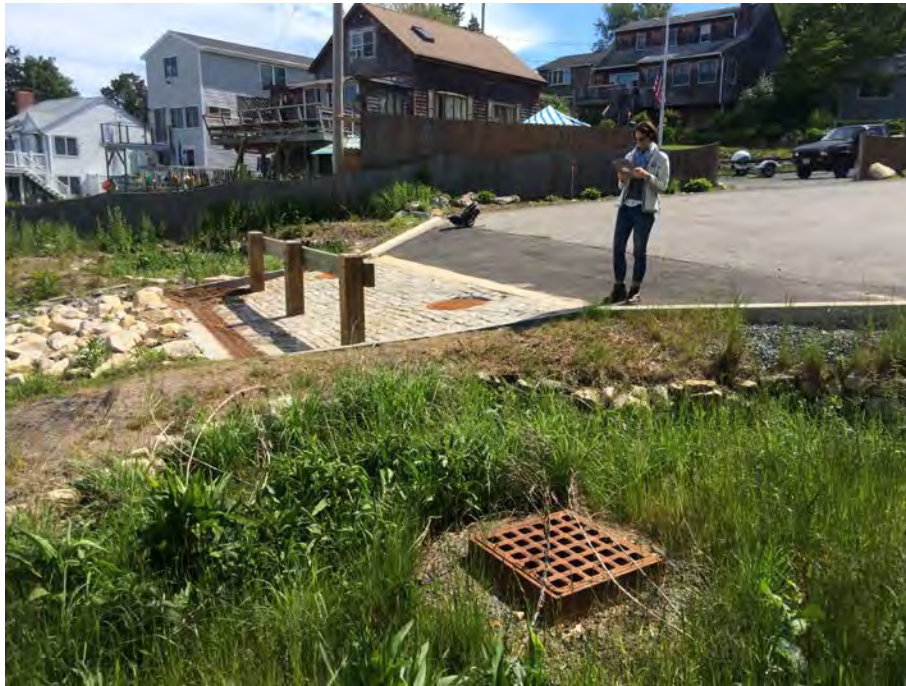
Rain garden immediately downgradient of Delano. Broken concrete curb.

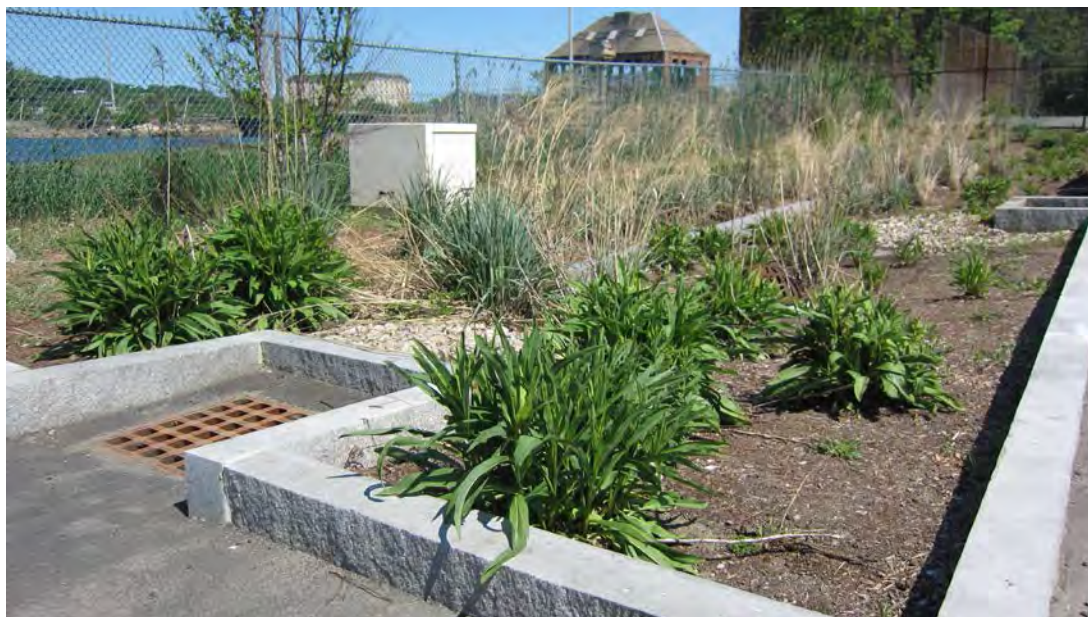
Maintenance underway.
