***South Shore Coastal Infrastructure Inventory  
and Assessment Demonstration Project  
Coastal Hazards Commission***

**Town of Cohasset**

**Prepared for:  
Office of Coastal Zone Management  
Boston, MA**

**Presented by:  
Bourne Consulting Engineering  
Franklin, Massachusetts**

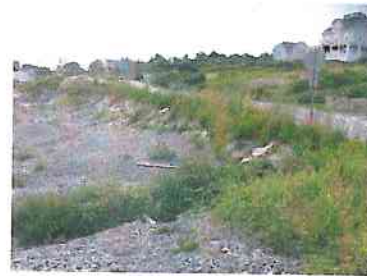
Placed rip rap slope (45 degree) with 1000 to 3000 lb stones. Slope is chined well and toed into cobble beach. Road directly inshore.

Structure observed to exhibit very minor problems, superficial in nature. Minor erosion to landform is present. Structure / landform adequate to provide protection from a major coastal storm with no damage. Actions taken to prevent / limit future deterioration and extend life of structure.

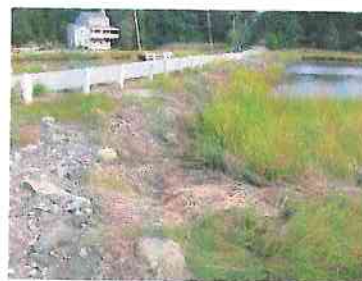
Dumped rip rap slope along edge of road. 100 to 500 lb stones primarily. Earth slope is eroding as well as edge of pavement. Sections of slope have no stone. Wetlands outshore. Culvert near center of structure.

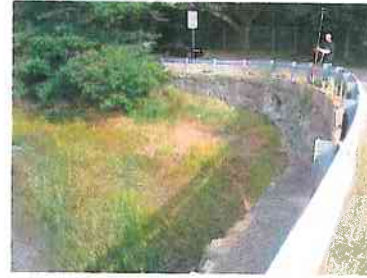
Bridge abutment. Stone block bridge abutments and seawall mortared with concrete. Placed rip rap along corners of abutment (1000 to 2000 lb stone). Stone missing (1 foot by 1 foot void) at north west abutment about 4 feet above mean high water.

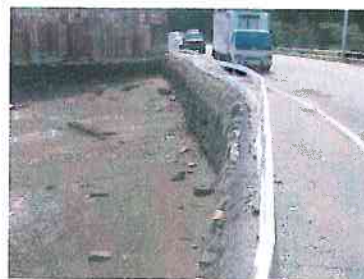
Stone block seawall mortared with concrete and road located directly inshore. Multiple patches of road and evidence of fill loss. Revetment placed in one location (most likely to repair collapse).

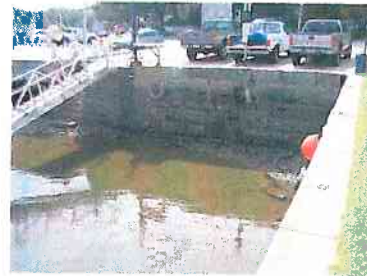
Stone block seawall (mortared) forming filled wharf and public landing. Some voids at outshore corners, but little to no movement of stones.

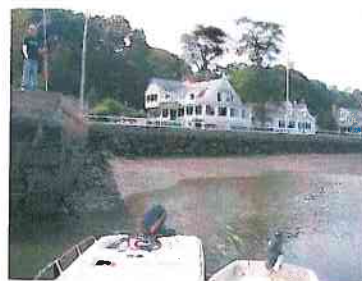
Stone block seawall with multiple concrete patches. Concrete poured on top to reduce fill loss. Multiple patching of pavement inshore of seawall. Some undermining at base of wall.

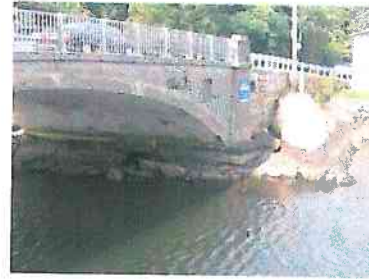
Concrete bridge for Border Street and stone block wing walls (mortared). Some scour and undercutting of south east wing wall (4 feet long by 1 foot high by 2 feet deep). Spalling of concrete cap on wing walls (guardrail attached to cap).

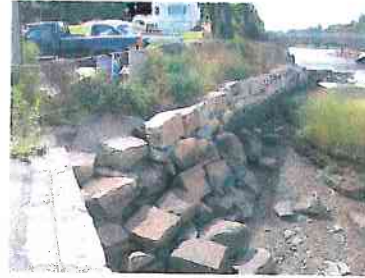
Stone block seawall (dryset) on rock ledge. Stone size 500 to 2000 lb stones are loose and jumbled. Many voids in wall from the way it was constructed.

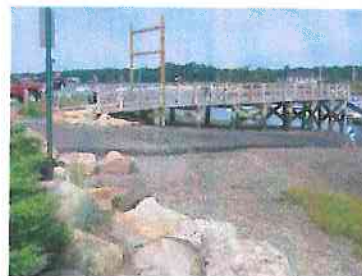
Bituminous concrete pavement boat ramp. East edge of ramp is deteriorated with loss of pavement.
