Bridge Assessment and Ranking

Town of Colrain

July 2018

BSC GROUP

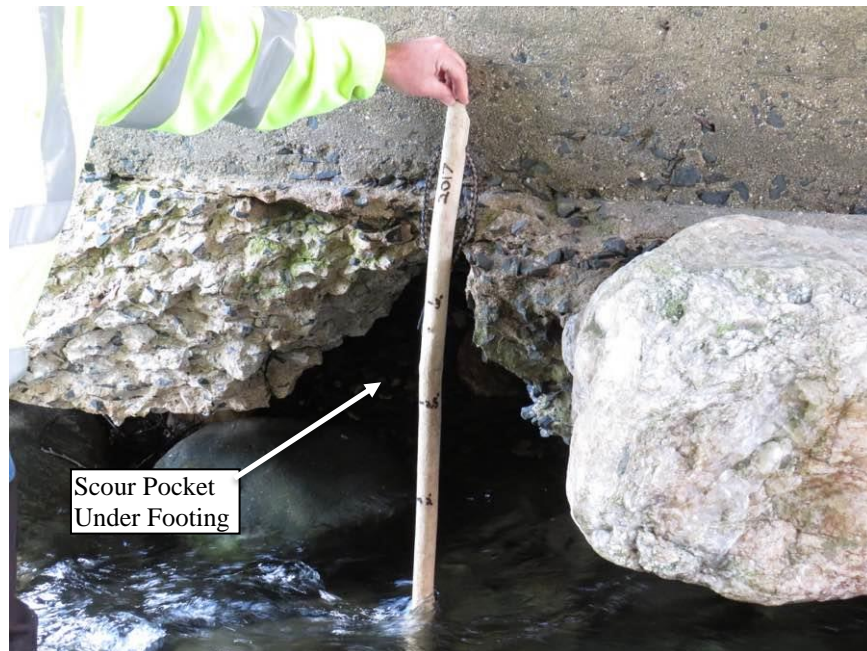
The reason for the serious condition rating of a 3 is due to the severe scour along the abutments [see Figure 1.2-1.5]. The structure is being inspected annually due to the low condition rating. A further advancement of the scour could potentially result in a bridge closure. Both abutments have scour along the entire footing with depths up to 3 feet and widths up to 6 feet.

Figure 1.3 Scour Pocket at West Abutment

- Remove spalled and deteriorated concrete by removing loose areas until sound concrete is found.
- Replace rebar that is showing signs of section loss.
- Apply an epoxy bounding compound to the areas of concrete excavation and place new concrete in the areas that have been removed.
- Repair the existing footings by filling the voids with concrete.
- Excavate existing streambed material and construct scour protection in conformance with the MassDOT LRFD Bridge Manual.

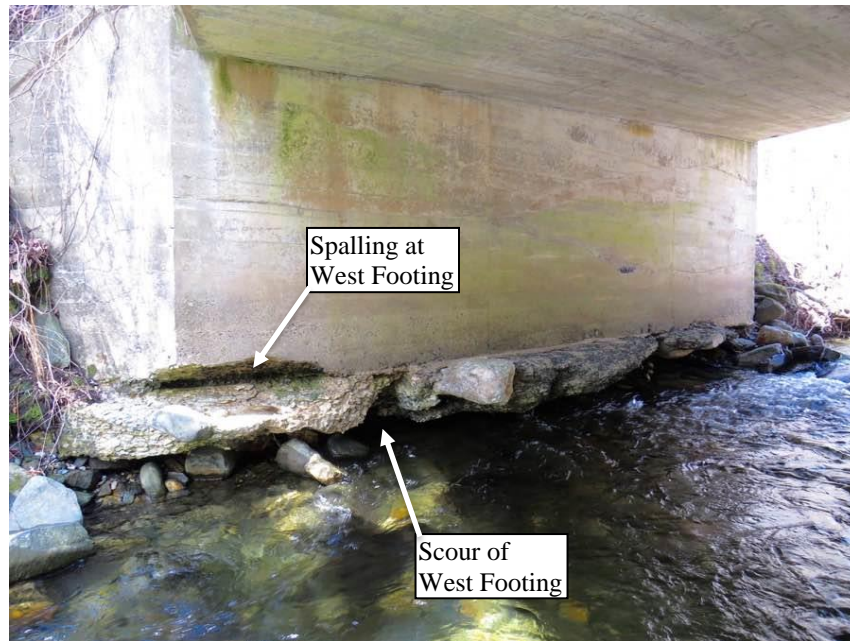
Figure 1.4 Scour Along the West Abutment

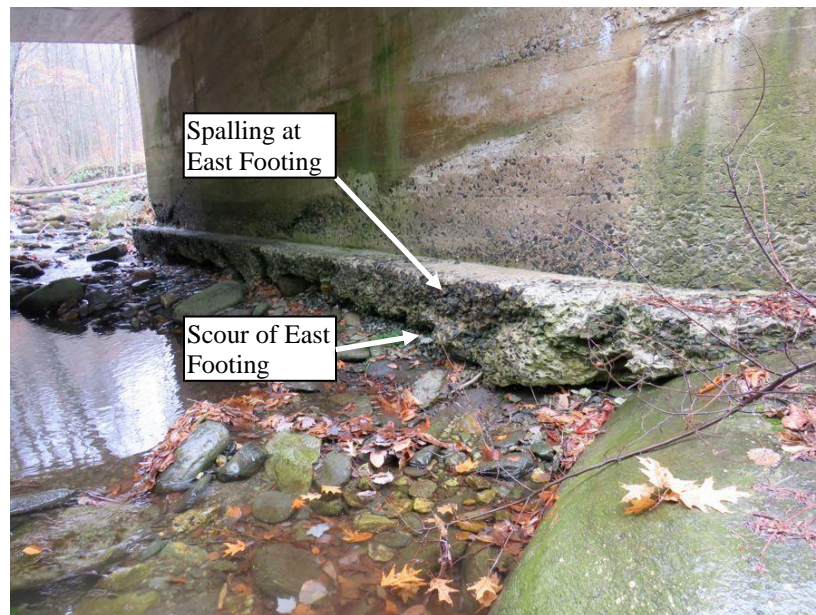
Figure 1.5 Scour and Spalling Along the East Footing

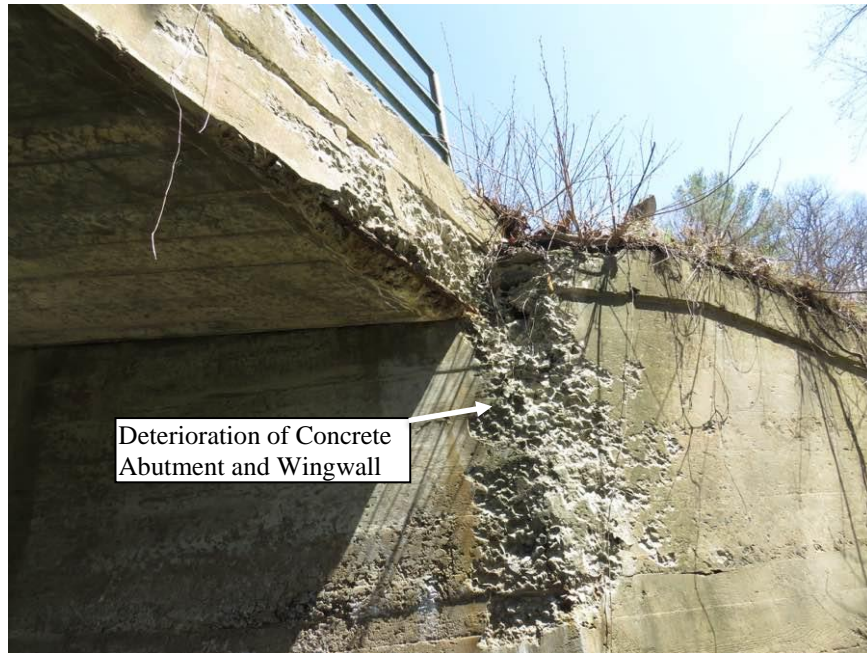
In addition to the scour of the abutments, the concrete shows various areas of scaling, honeycombing, and spalling [see Figure 1.6]. A significant area of concrete deterioration is at the south end near the footing, measuring approximately 4'x15" and up to 15" deep. In some of these areas rebar has been exposed with rusting and minor section loss.

Deterioration of Concrete
Abutment and Wingwall

Figure 1.6 Typical Concrete Deterioration

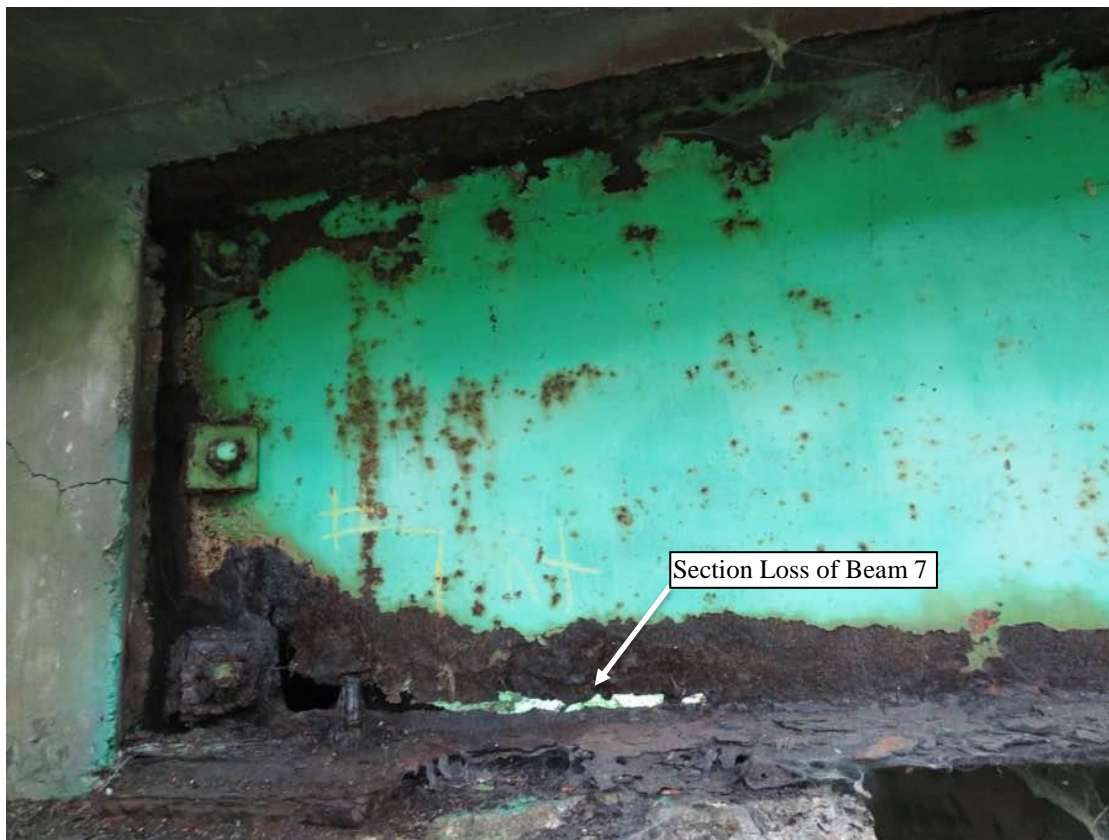
The most current inspection report scores the superstructure with a condition rating of 4 and substructure 5. Deterioration and section loss to beam 7 [see Figures 2.3 and 2.4] has resulted in the installation of temporary concrete barriers to the south side of the roadway restricting travel to 14'-9" [see Figure 2.1]. The travel restriction only allows for alternating traffic.

Figure 2.3 Beam 7 Section Loss

Option A would consist of repairing existing beam 1 and 7. This would be either done with a bolted or welded repair as shown in Figure 2.10 and Figure 2.11. In order to determine which repair type would be most suitable would require analysis and design.

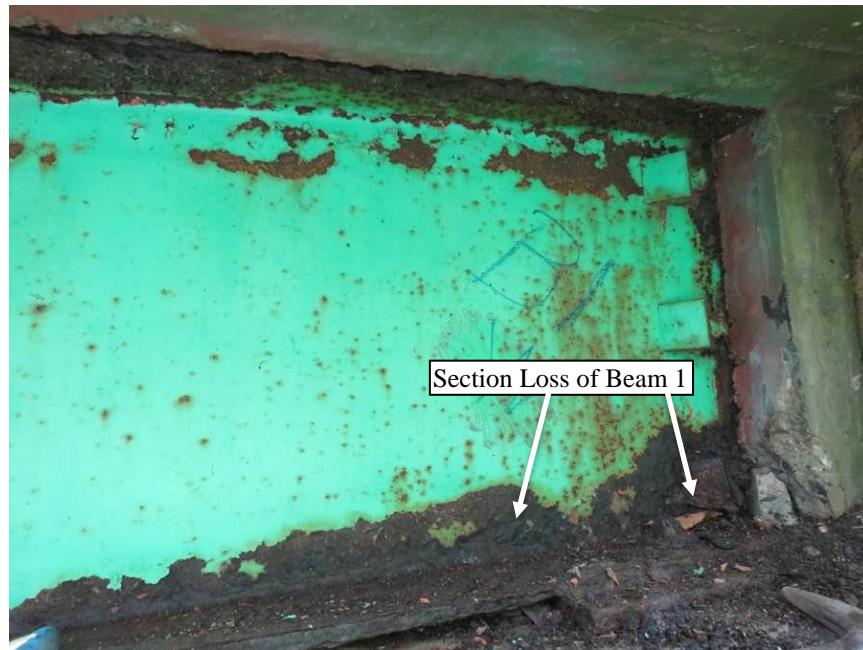
Similarly, beam 1 also has section loss to its web and bottom flange at both ends of the beam [see Figures 2.5 and 2.6]. Unfortunately, this will lead to further travel restrictions or a bridge closure. The section loss is typically caused by road salt mixed with snow that gets plowed over the side of the bridge or salt laden water that infiltrates through cracks. Salt acts as a catalyst to accelerate the corrosion/rusting process of the steel members and steel reinforcement.

Figure 2.5 Beam 1 Section Loss

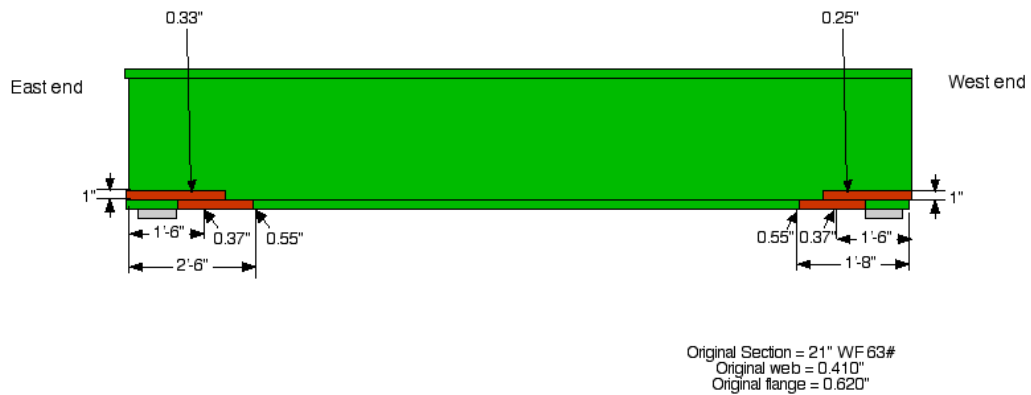
Figure 2.6 Sketch of Beam 1 Sketch of Section Loss

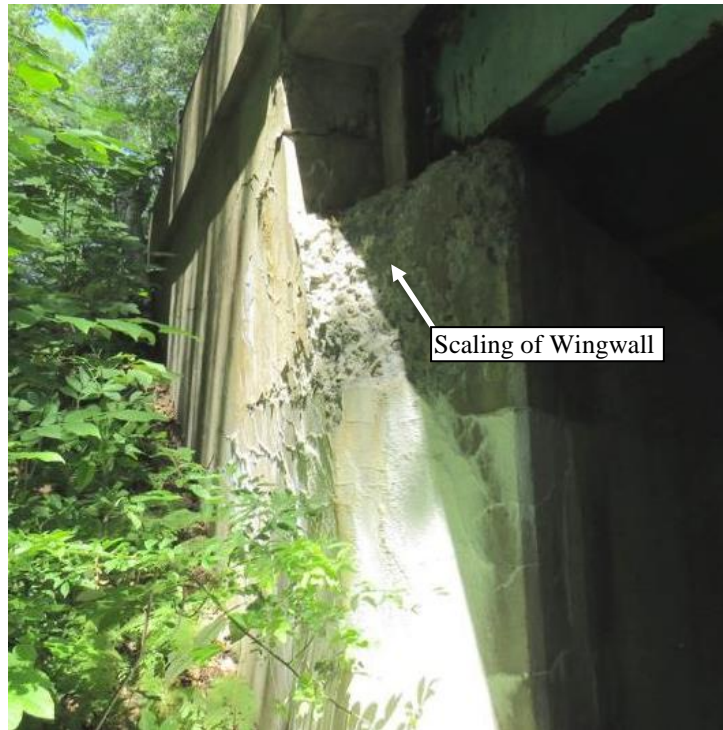
The substructure also has structural deficiencies. The southeast and southwest wingwalls have moderate to heavy concrete deterioration and spalling [see Figures 2.7 and 2.8]. The east and west abutments have cracking in the breastwall [see Figure 2.9].

Figure 2.7 Scaling at Southwest Wingwall

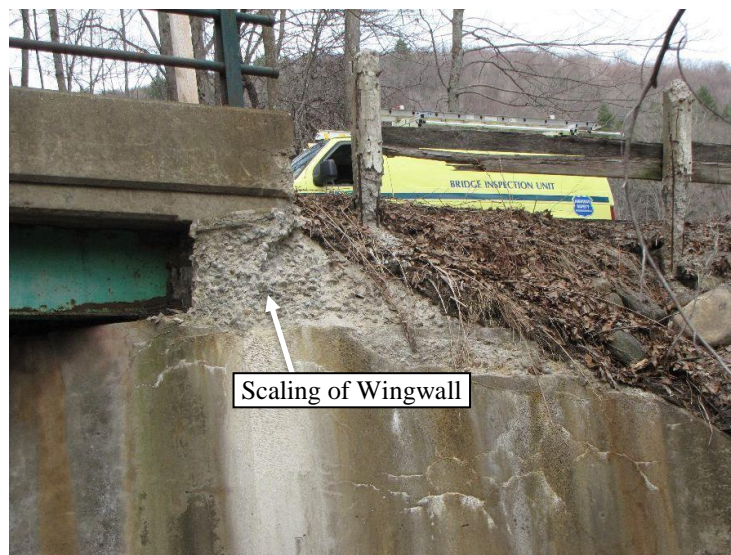
Figure 2.8 Scaling at the Southeast Wingwall

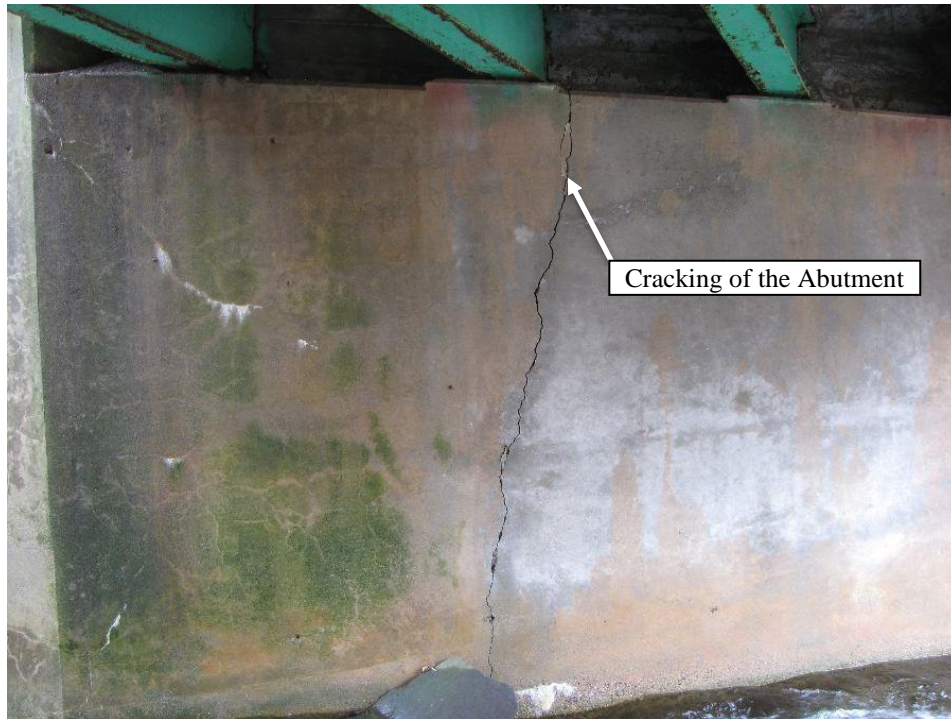
Figure 2.9 Cracking at Abutment

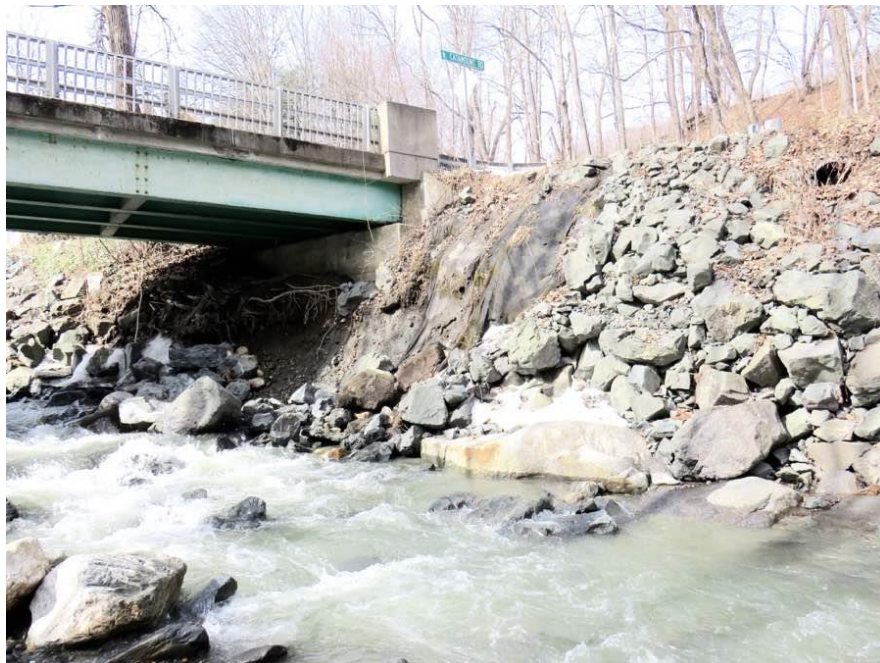
The superstructure and substructure are in good shape. The most current inspection report rates both at 7. However, one of the concerns with this bridge is the significant erosion [see Figures 3.2 and 3.4]. The inspection report from March 2018 gives the channel and channel protection a condition rating of 4.

Figure 3.2 Elevation and Erosion

It is recommended to repair and replace the embankment as soon as possible. Repair should consist of riprap, crushed stone, and geotextile fabric. Riprap should contain stone that conforms to M2.02.0 as described in the materials section of the MassDOT standard specifications. MassDOT standards should be followed as shown in Figure 3.7. A minimum height of 3'-0" riprap is recommended. During riprap installation it is important that the existing abutment not be undermined or disturbed.

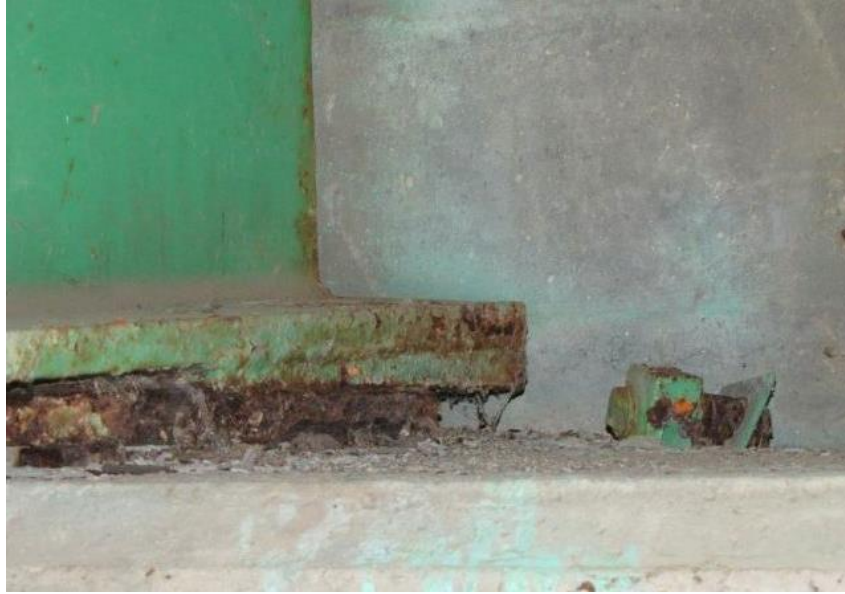
The north abutment is out of plumb by approximately 1 inch per every 2 feet of height. The north abutment has three out of eight anchor bolts sheared off [see Figure 3.3] and all of the sole plates have shifted towards the backwall up to 1½" ± on the north side. On the south abutment, four out of eight anchor bolts have sheared off and one is loose. Sole plates on the south abutment have shifted up to 4" ±. The 2002 report also list anchor bolts being sheared off with the problem growing over the years.

Figure 3.3 Typical Sheared Anchor Bolt

Based on reviewing the existing substructure drawings, it appears that the leaning of the abutments could be a combination of minimalistic design and the removal of material in front of the abutment. Testing and analysis would help determine the cause of the movement. Unfortunately, there are no easy repairs to effectively straighten the abutments. However, it is likely that the addition of riprap would help to reduce the progress of future abutment movement.

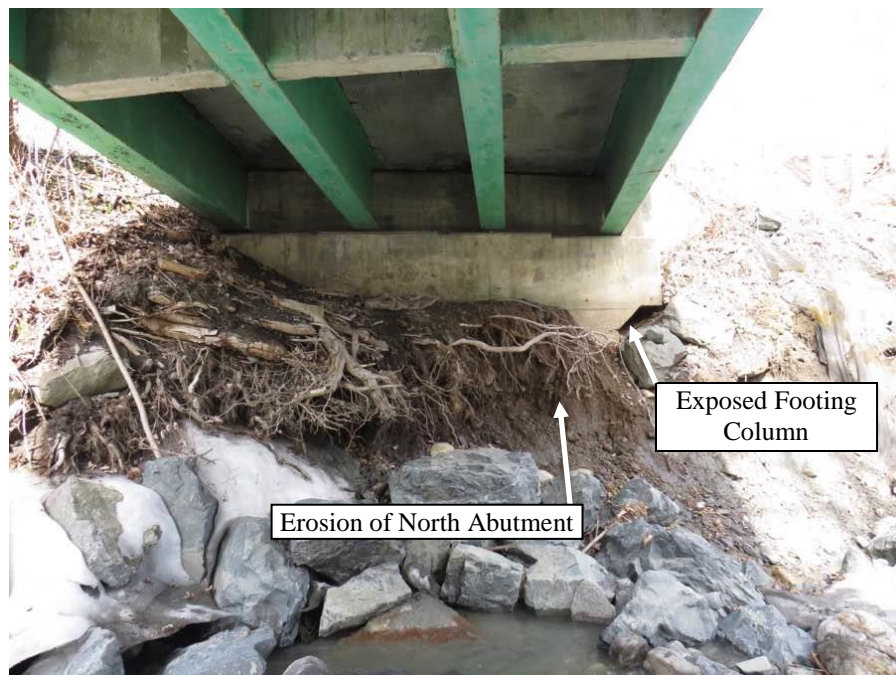
Figure 3.4 Erosion and Exposed Footing Column at The North Abutment

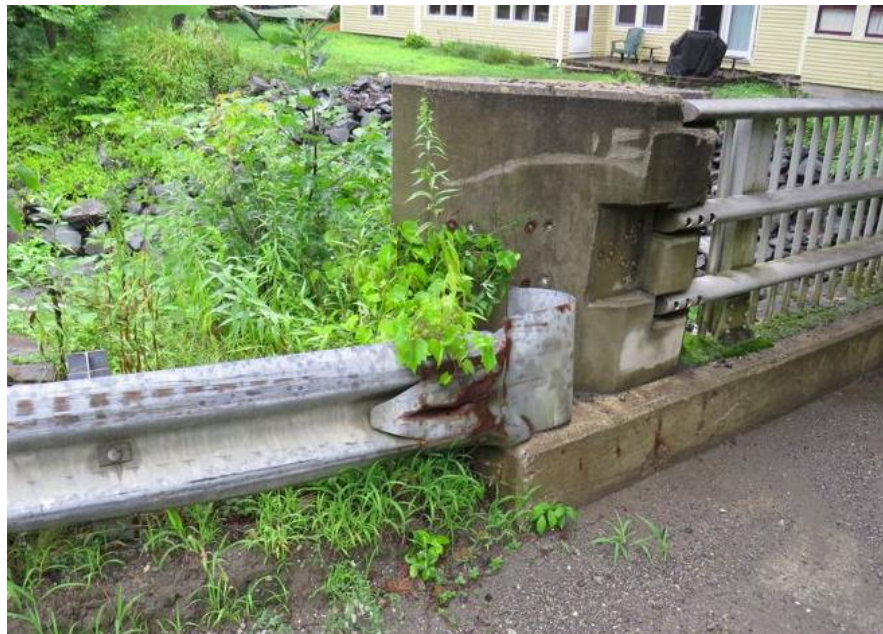
The concrete guardrail transitions are designed to be connected to bridge rail and guardrail at each approach. The approach guardrail has steel terminal ends and cannot be connected properly to the transitions [see Figure 3.6]. This is a safety concern because the transitions and guardrail are designed to act together.

Figure 3.6 Typical Guardrail at Transition

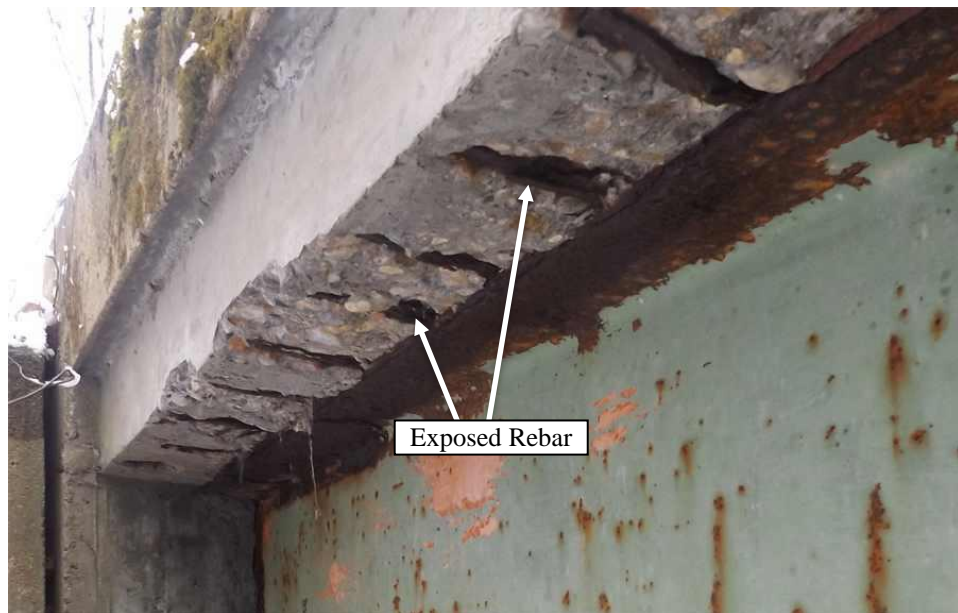
To the south, the channel has debris and trash. The deck shows spalling and scaling approximately 2 inches in depth [see Figures 4.2-4.4]. The spalling is possibly caused by poor concrete quality and/or minimal rebar cover. Typically, reinforcement has a minimum cover of 2 inches to completely encapsulate the rebar within the concrete.

Figure 4.3 Spalling and Exposed Rebar at Overhang

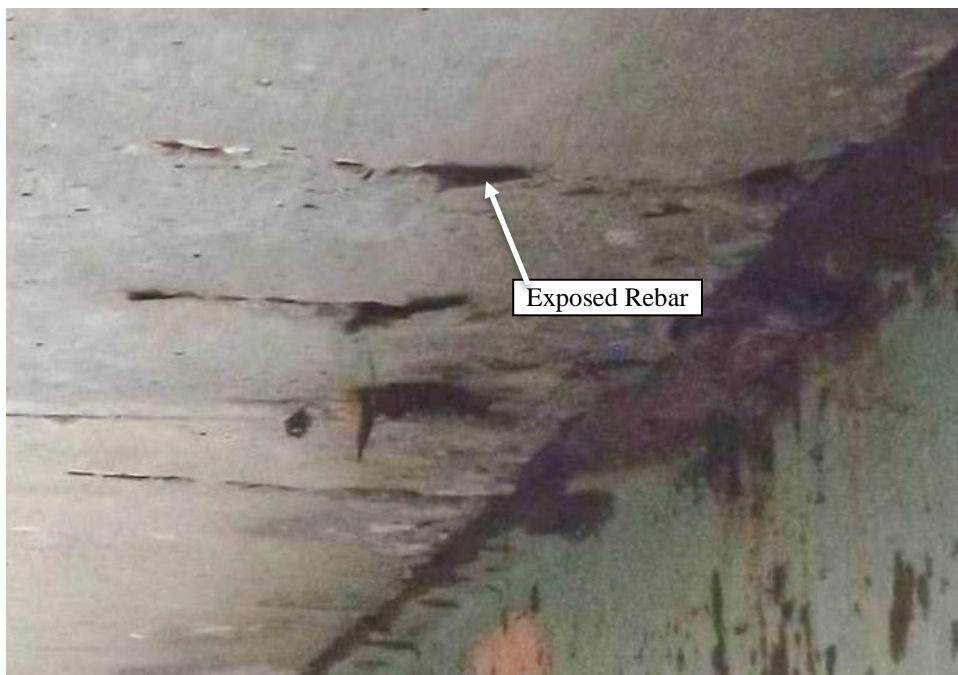
Figure 4.4 Concrete Deck Spalling with Exposed Rebar

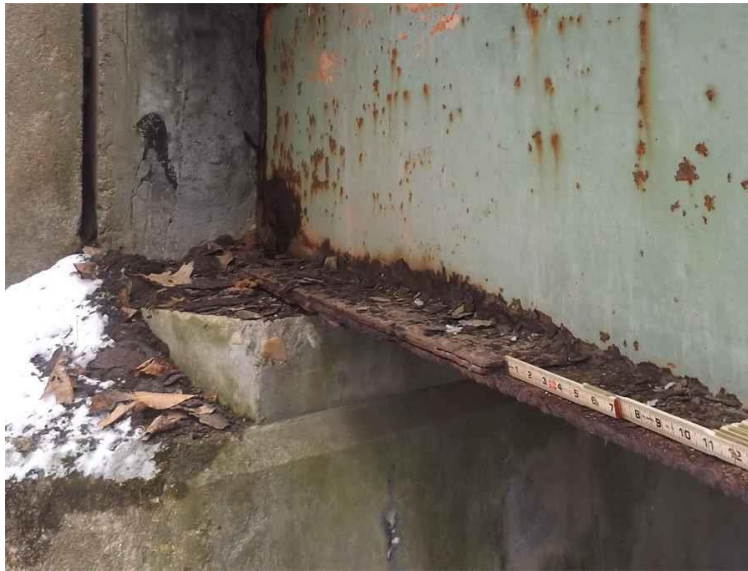
The superstructure has areas of complete paint failure to the fascia beams. At both facias and interior beam ends there is steel deterioration in the areas of paint failure [see Figure 4.5].

Figure 4.5 Typical Paint Failure and Steel Deterioration

It is recommended to have all the steel beams painted with a MassDOT approved primer and finished coat. Due to the age of the bridge the existing paint very likely contains lead. The rust removal, containment, disposal and painting should be performed by a MassDOT prequalified bridge painting company. At a minimum the ends of the beams should be prepared and painted for approximately 4'-0".

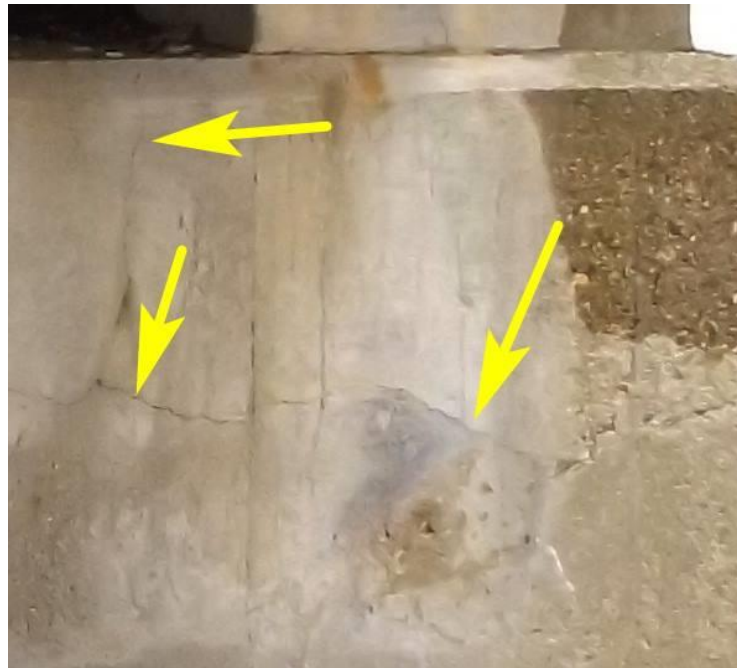
The concrete abutments have some cracking [see Figure 4.6]. There is a scour pocket at the southeast corner approximately 5 feet in diameter [see Figure 4.7]. However, currently the scour has not undermined the abutment's footing.

Figure 4.6 Cracking at the East Abutment

Cracking at the concrete abutments and deck should be monitored annually to ensure the problem is not getting worse, however, no immediate attention is needed.

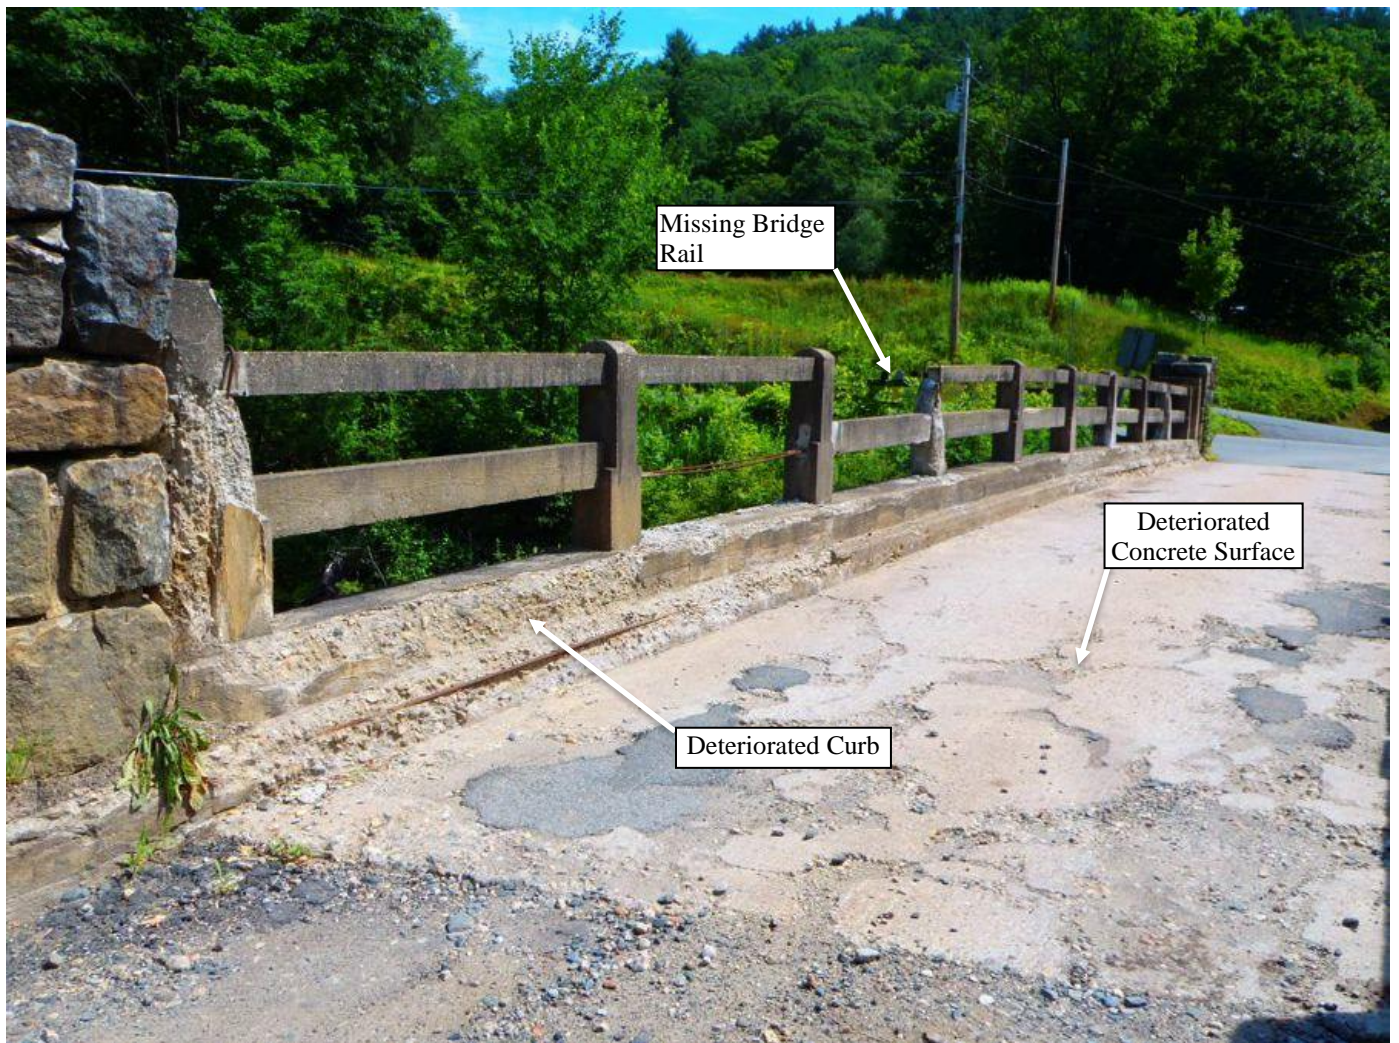
Structurally this bridge is in fair to satisfactory condition with rankings of 5's and 6's in the most recent MassDOT inspection report. However, the curbs and railings have extreme deterioration with section loss up to 100% [see Figure 5.4]. There are missing sections of rail that provide little protection for vehicles or pedestrians from falling off the bridge [see Figure 5.5].

Figure 5.4 Deteriorated Railings and Curbs

It is recommended that the bridge railings are repaired and/or replaced as soon as possible. Concrete deterioration is often caused from roadway salt and freeze thaw conditions during winter and early spring months. Fortunately, the concrete deck deterioration has had limited visible effects on the overall arch structure.

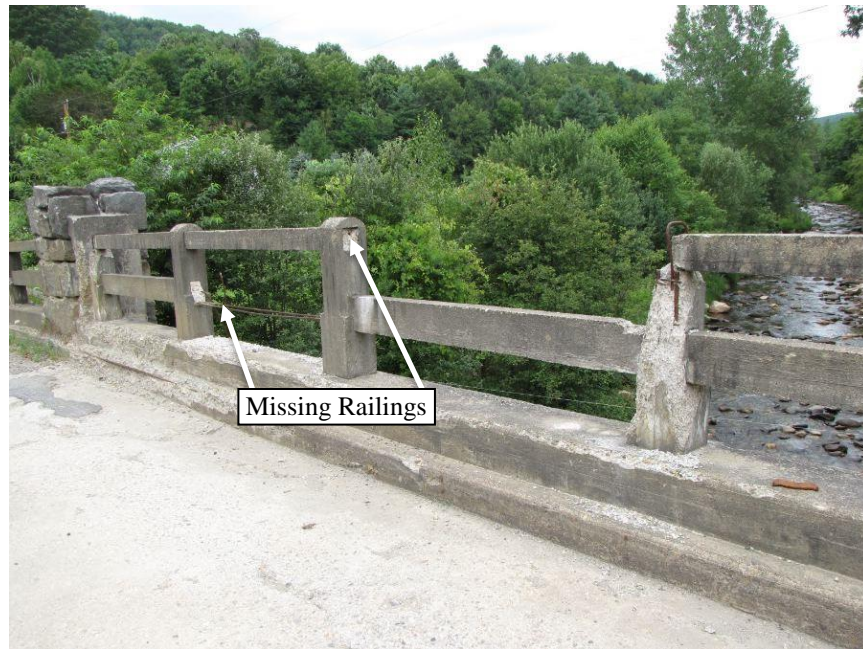
Figure 5.5 Missing Railings with Exposed Rebar

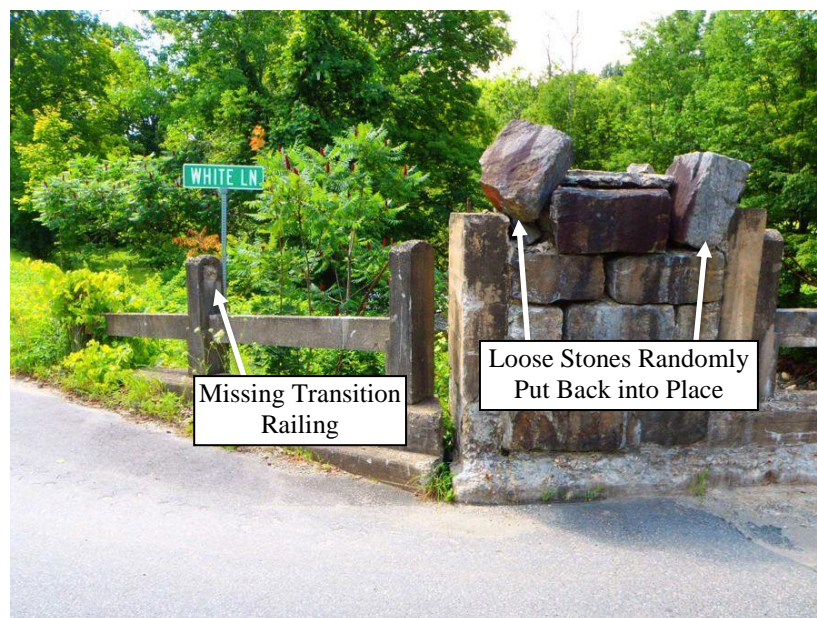
The exposed concrete bridge deck also has various areas of concrete deterioration up to 3 inches deep. The stone southeast transition has stones that have fallen and been randomly reset.

Figure 5.6 Railing Transition with Loose Stones

Option A: Replace/repair the substandard curbs, bridge rail and stone transitions in-kind.

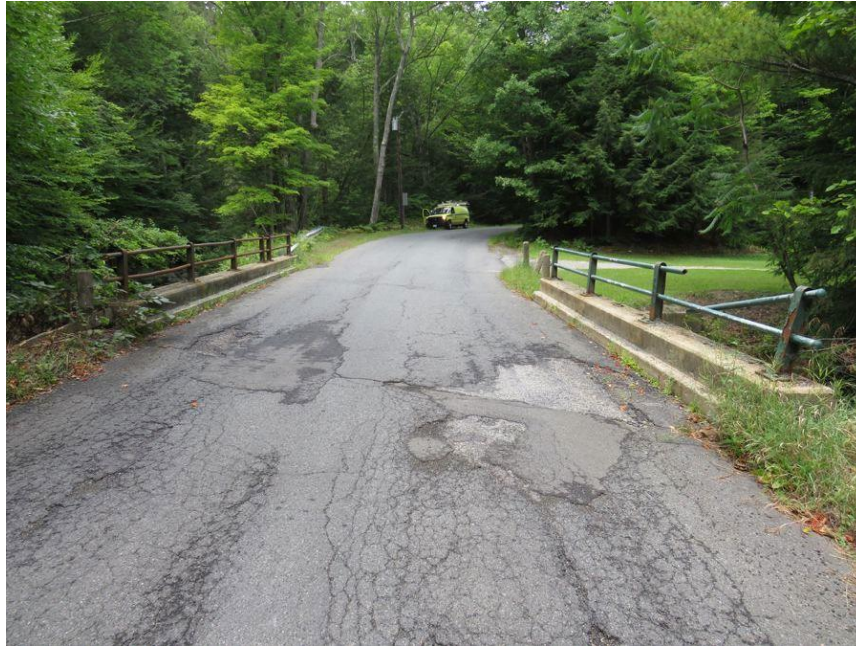
There is a damaged/detached bridge railing at the northeast corner [see Figure 6.5] which is a hazard. Guardrail at the east approach is missing or has been removed [see Figure 6.1].

The east approach pavement has heavy cracking and settlement [see figure 6.1].

Figure 6.1 Roadway and Approach

- Repair the gabion wall at the upstream end to sit plumb and prevent bank erosion.
- Repair the bridge rail. Typically, there is a sleeve that aligns the two pipes together from the inside. Rethread or reweld the rail in kind.
- Replace the missing guardrail at the east approach.

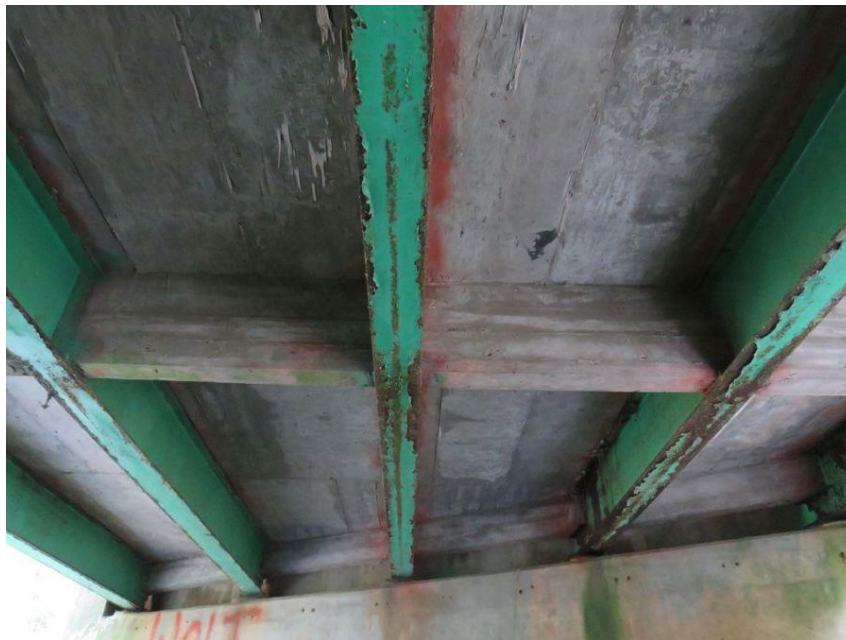
Complete paint failure at the beam ends and bearing devices are exposing bare steel to structural members [see Figure 6.2]. Beam ends are starting to rust with the heaviest occurring at the beam ends.

Figure 6.2 Typical Underside

Preservation - As preventative maintenance it would be recommended to clean the bridge seat and beam ends. The cleaning should be done annually, typically in the spring. The section loss is typically caused by road salt mixed with snow that gets plowed over the side of the bridge or salt laden water that infiltrates through cracks. Salt acts as a catalyst to accelerate the corrosion/rusting process. Cleaning this area will prolong the life of the bridge's superstructure and substructure.

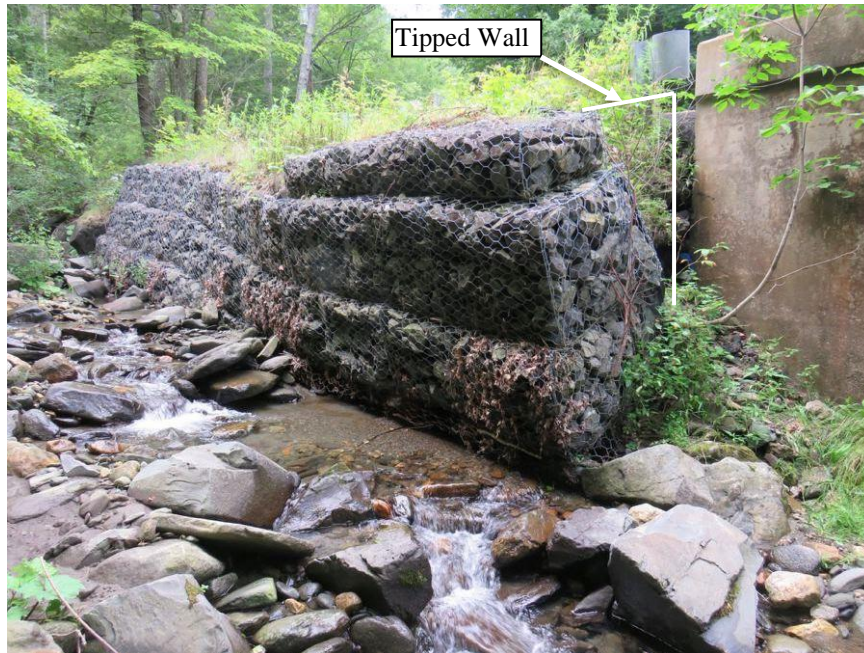
Figure 6.3 Southwest Gabion Wall Tipping and Falling

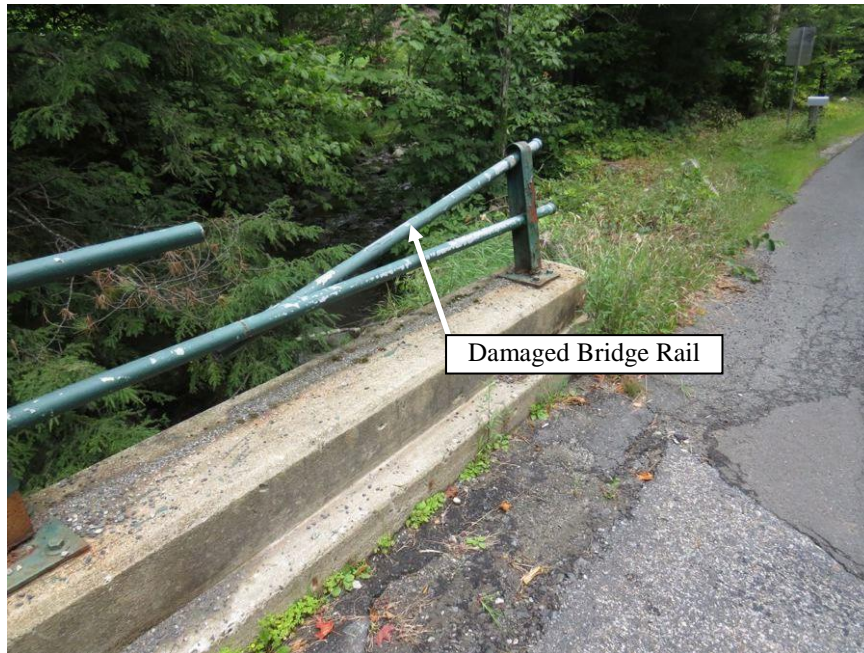
Figure 6.5 Damaged Bridge Rail

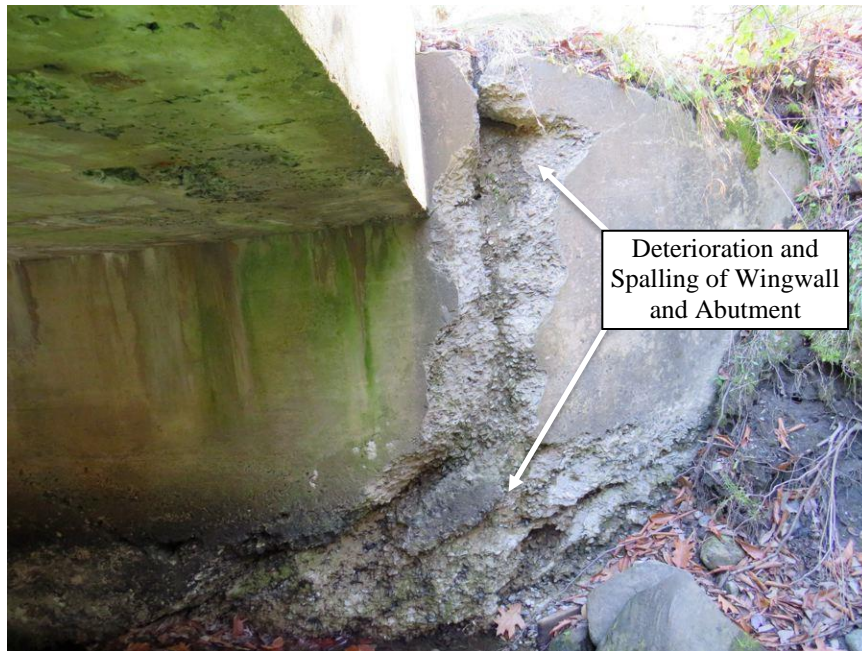
Figure 7.3 Deterioration and Spalling at the Southeast Wingwall and Abutment

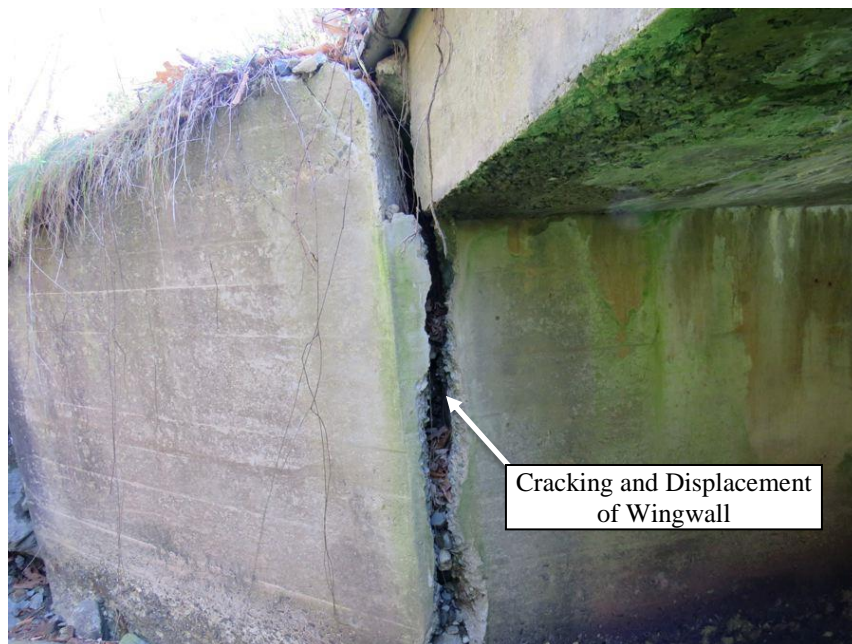
Figure 7.4 Cracking and Displacement at the Northeast Wingwall

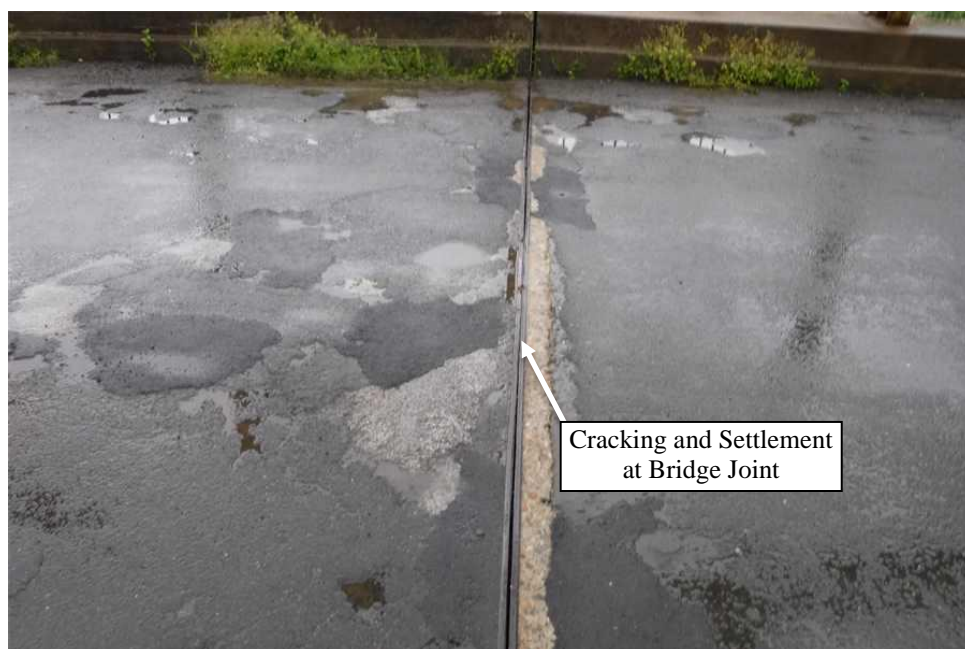
Figure 8.3 Cracking and Settlement at Bridge Joint

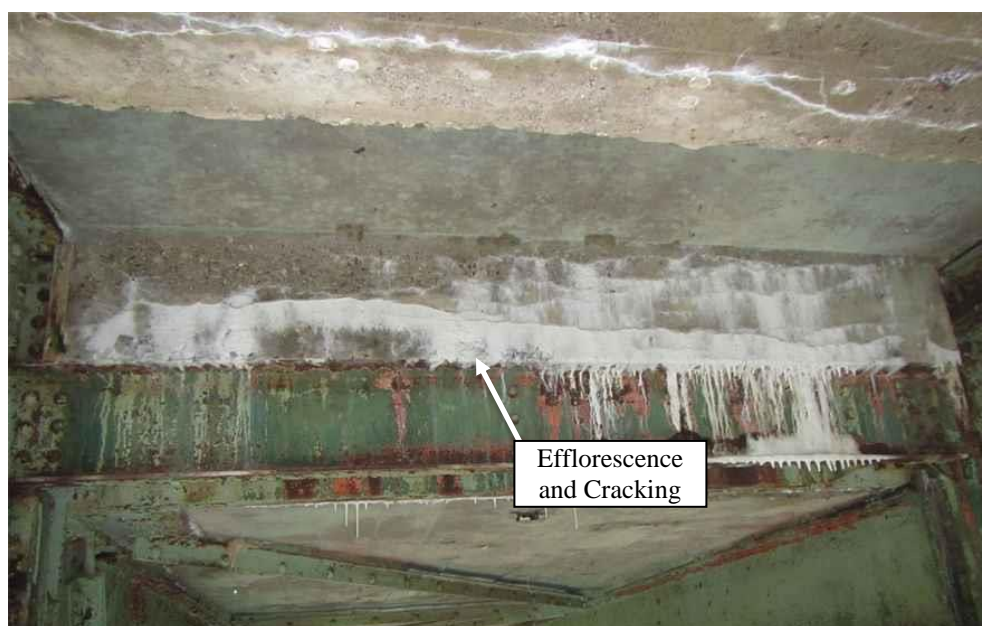
Figure 8.4 Efflorescence and Cracking Under Sidewalk

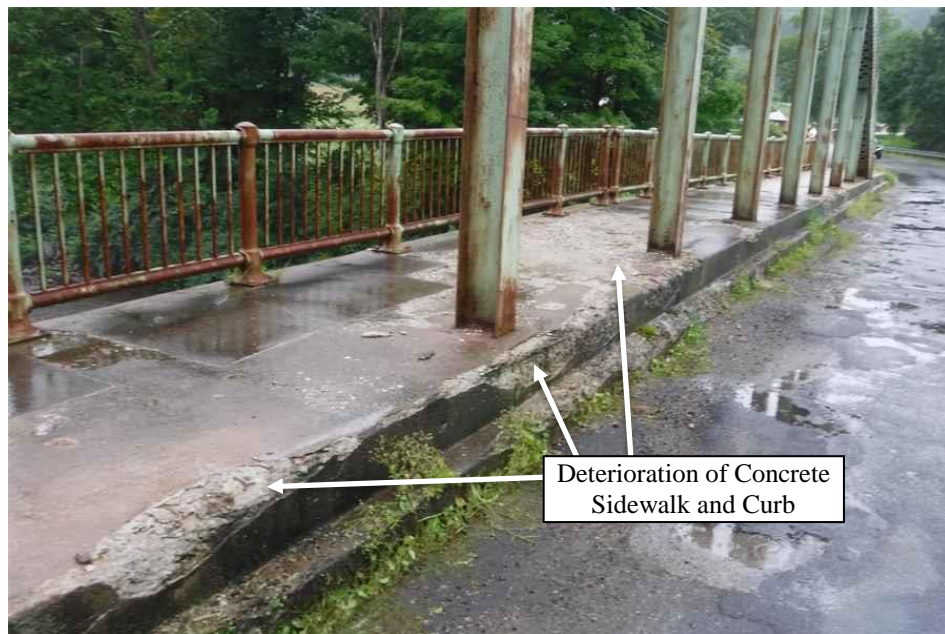
Figure 8.5 Deterioration to Concrete at Sidewalk and Curb

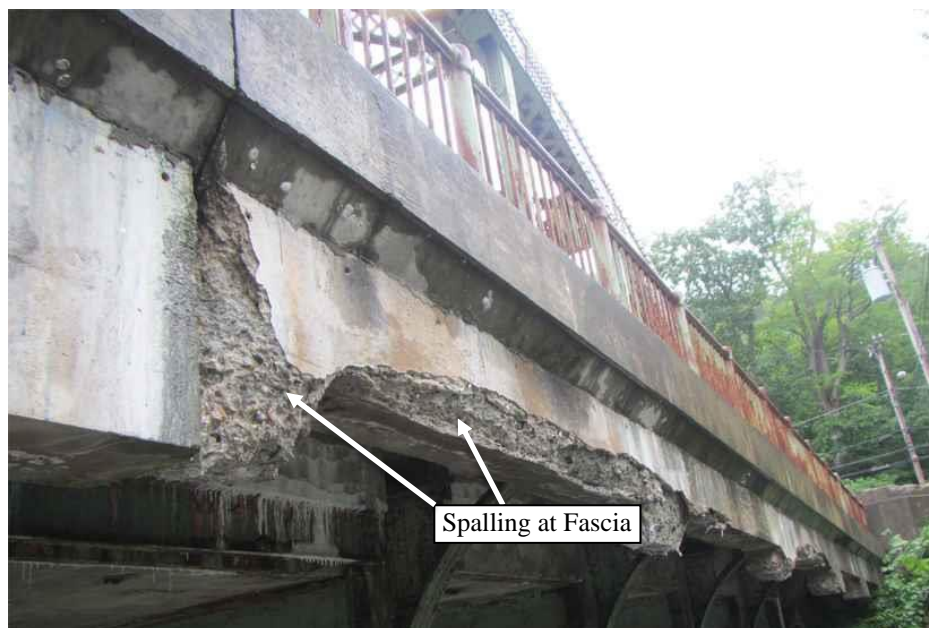
Figure 8.6 Typical Spalling at Fascia

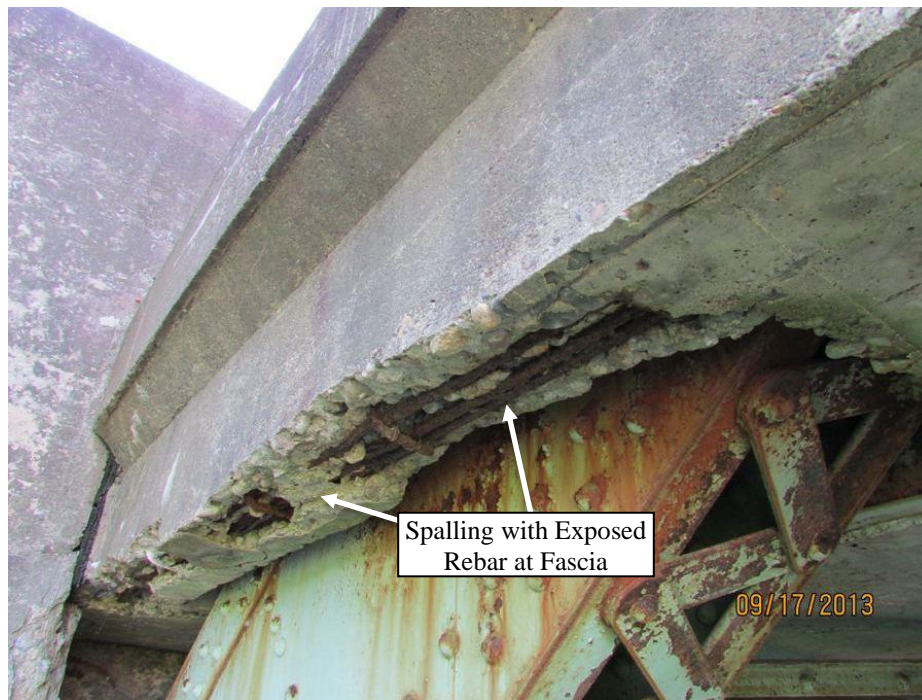
Figure 8.7 Spalling with Exposed Rebar at Fascia

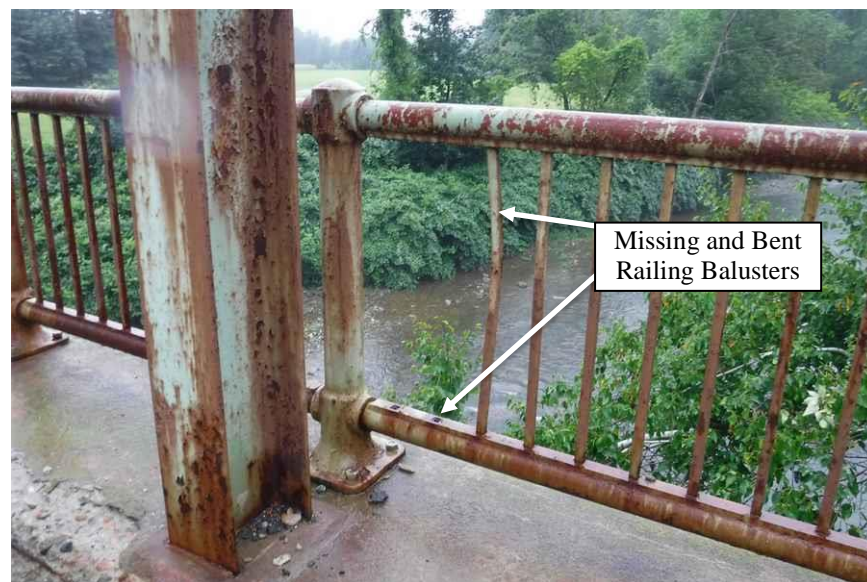
Figure 8.8 Missing and Bent Railing Balusters

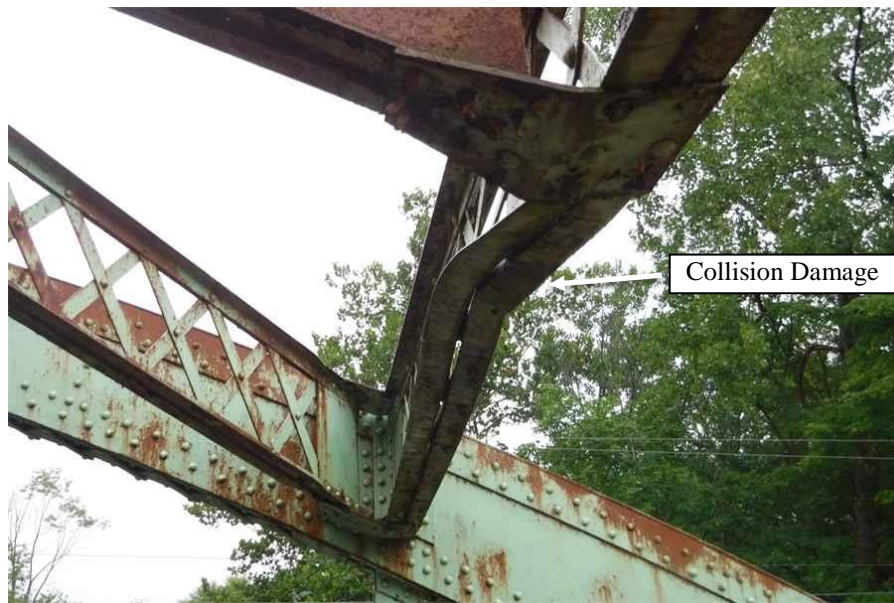
Figure 8.9 Collision Damage to West Portal
