Bridge Assessment and Ranking

Town of Colrain

July 2018

BSC GROUP

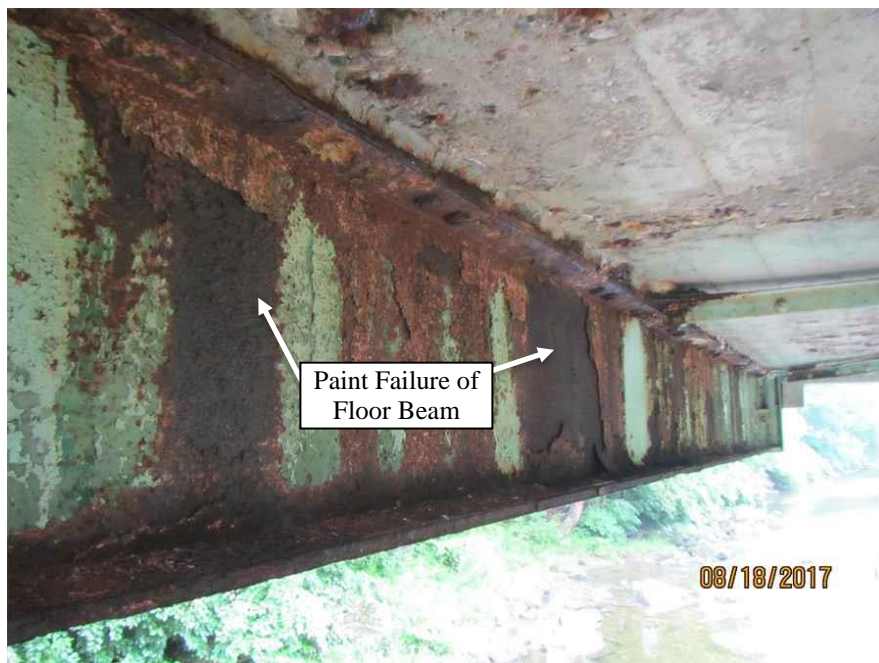
Figure 8.10 Typical Paint Failure to Floor Beam

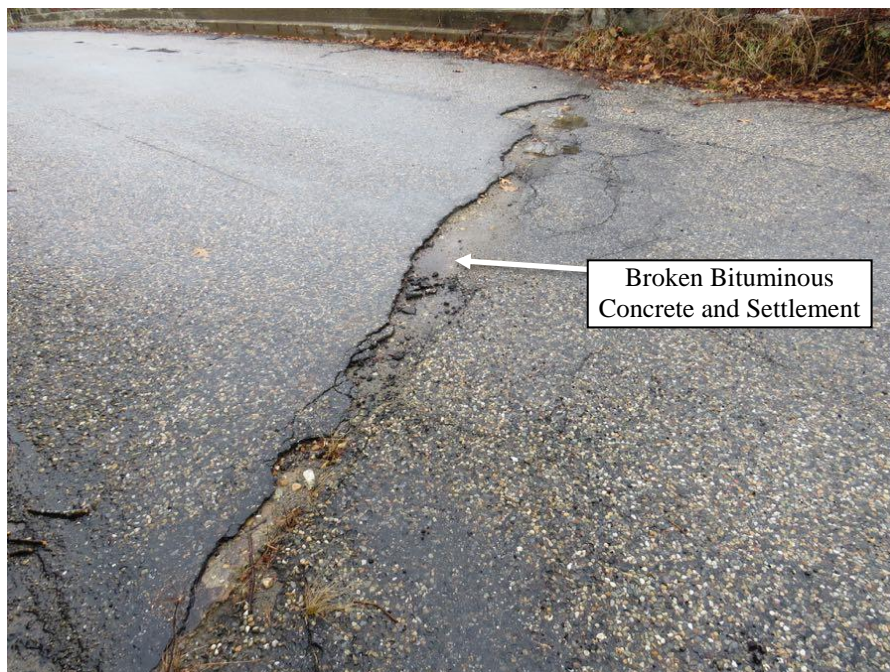
The roadway wearing surface has large cracks and potholes exposing the concrete deck [see Figure 9.4].

Figure 9.4 Broken Bituminous Concrete and Settlement at Bridge Deck

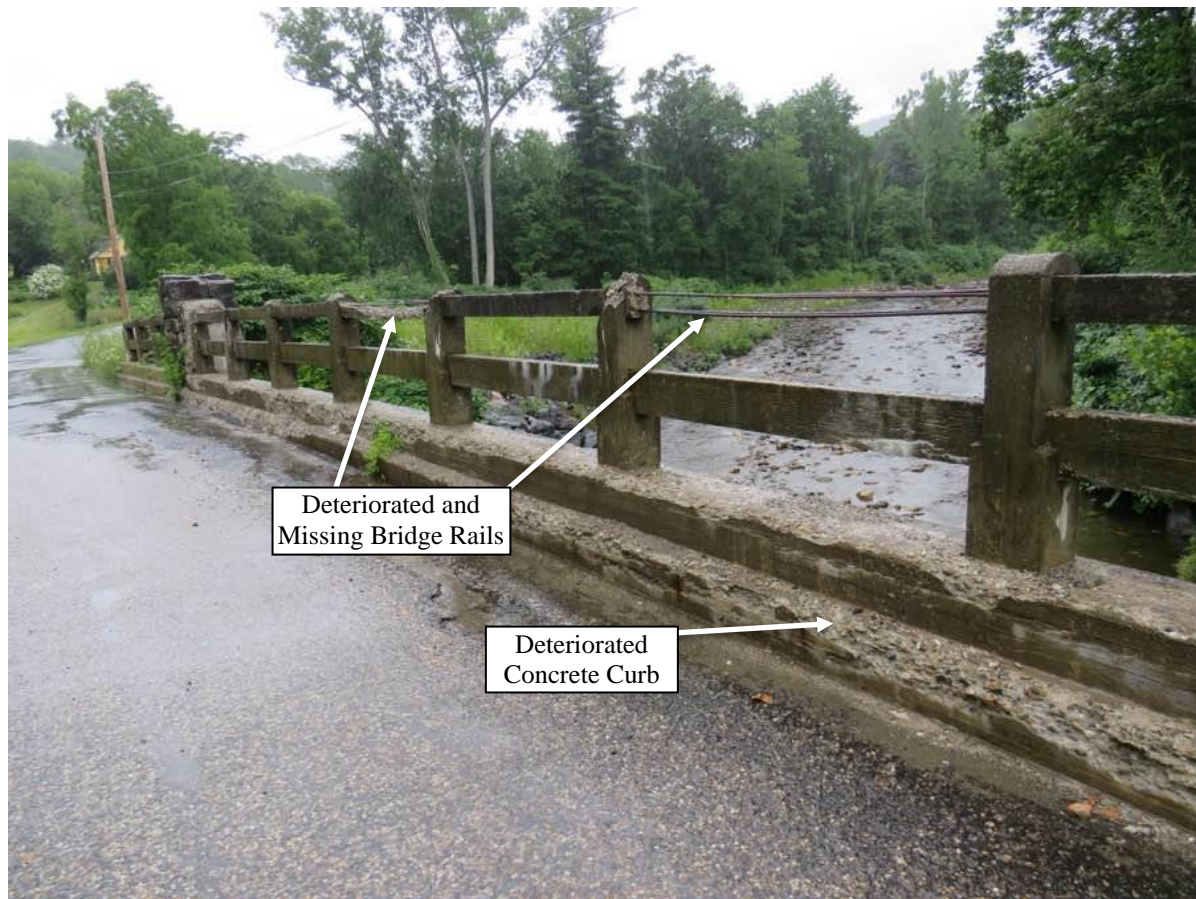
Figure 9.5 Typical Concrete Deterioration to Bridge Rail and Curb up to 100%

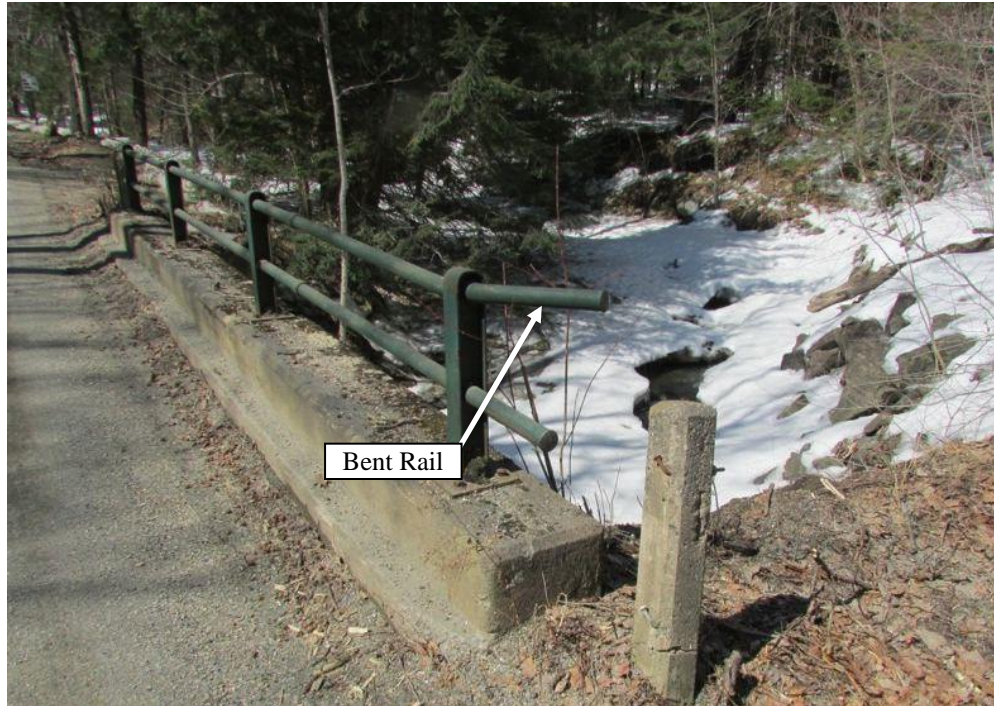
Figure 10.3 Bent Rail at Northeast Approach

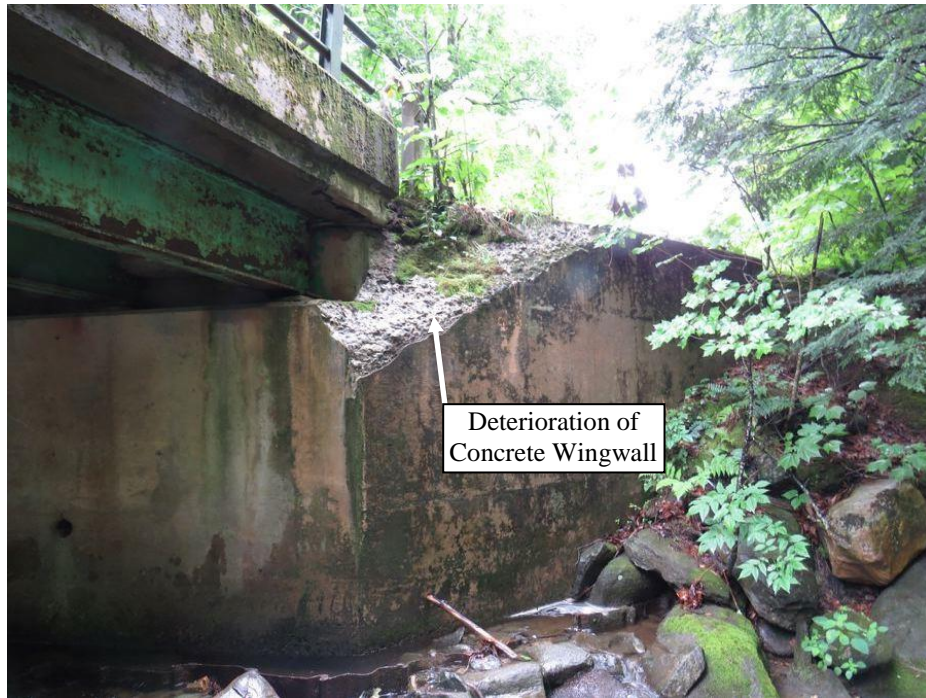
The abutments and wingwalls have areas of concrete spalling and deterioration [see Figure 10.4]. The largest area of spalling is at the south wingwalls up to 8'x4'x16" deep. The abutments also have random areas of cracking and scaling.

Figure 10.4 **Typical Concrete Deterioration to South Wingwall**
