REPORT#: 19MA049

REPORT DATE: November 10, 2021

Commercial Property Owner Fatally Injured When Forklift Tire Ruptures– Massachusetts

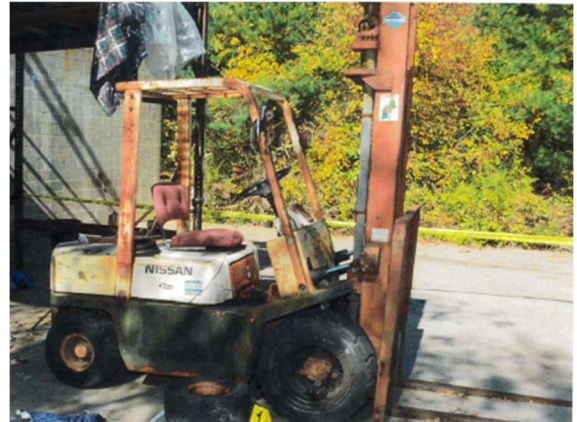
The equipment being worked on by the victim at the time of the incident was a diesel-powered forklift (Figure 1). The maximum lifting capacity of the unit was 5,000 lbs. The purchase history of the equipment was not known. The victim's brother and partner reported they had no maintenance issues with the forklift. They did report that the tires had deteriorated. As the victim was using the forklift to move items around the property, the tires became flat. The two larger tires were repaired at the site and the rear wheel was removed so the tire could be repaired off-site.

Figure 1 – Diesel forklift (photograph taken by first responders)

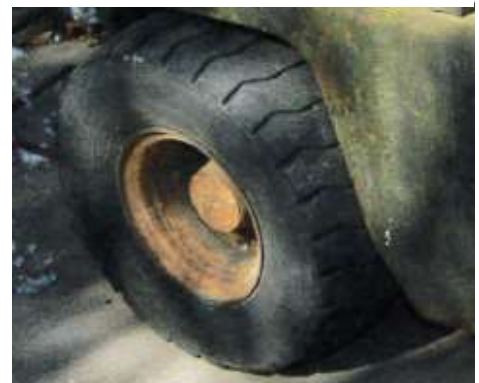
Figure 2 – Right side rear wheel, in place on forklift (photograph taken by first responders)

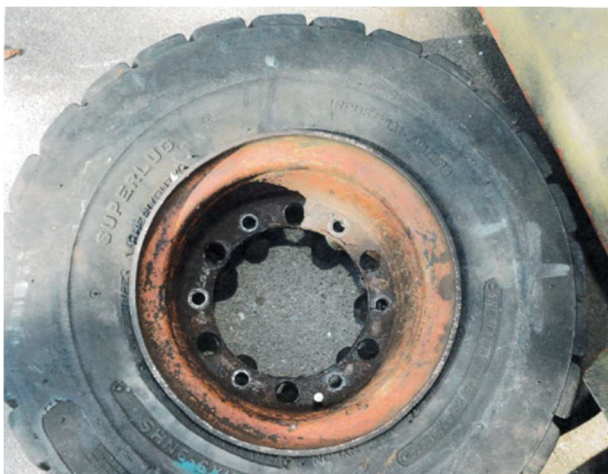
The rear forklift tire involved in the incident was a heavy-duty tire designed for industrial and mining equipment.¹ This tire was a tube-style tire with a diameter of 21 inches and width of 9 inches. It had a recommended air inflation of 110 psi and a weight rating of 4,645 pounds when used as a non-steering wheel as in the configuration on this front-wheel steering forklift.

Figure 3 – Left side rear tire, as found on the ground after the incident (photograph taken by first responders)

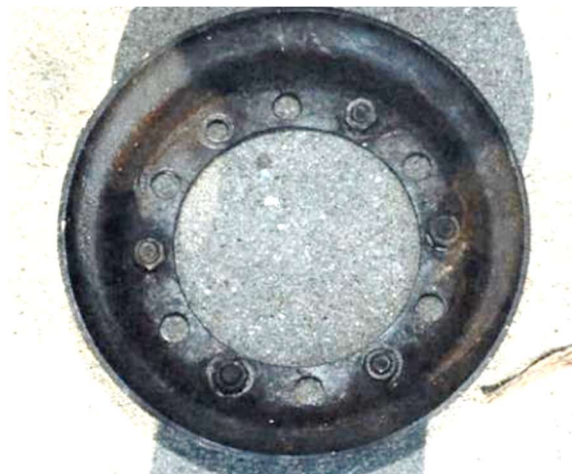
The steel wheel on this tire was a multi-piece wheel with two halves. Large truck and heavy-duty equipment wheels can contain multiple components, including multiple rim plates and rings or hoops that bolt together or are held in place by the pressure of the inflated tire.² In this case, the rim included two halves that were held together by bolts. This type of two-piece rim is commonly used on larger construction and mining vehicles, including forklifts, tractors, and other heavy equipment. Figure 3 shows what is the outer rim component when the wheel is mounted on the forklift. Figure 4 shows the inner rim component. Six bolts spanned the rim and would have been in place on the wheel when it was assembled.

Figure 4 – Inner half of split wheel (photograph taken by first responders)

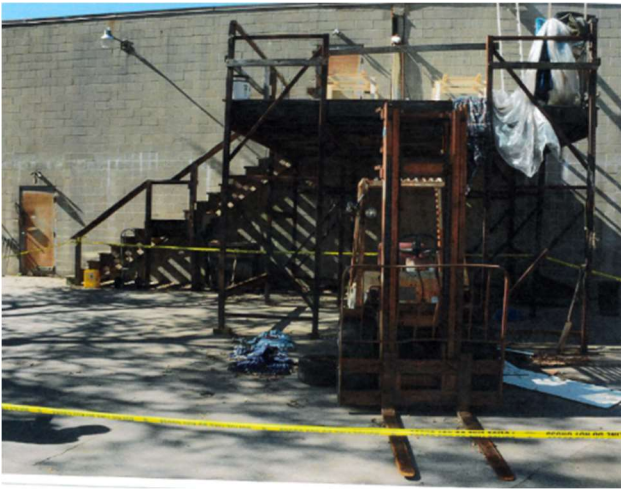
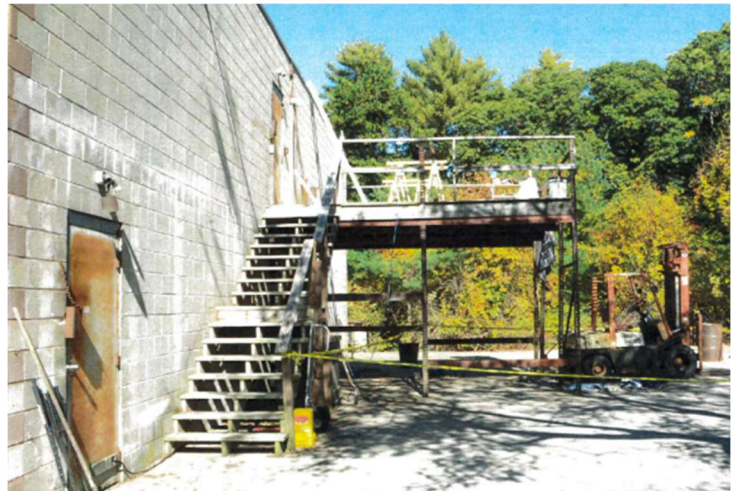
The location of the incident was a commercial property with one building. The concrete block building had two floors and was approximately 4,500 square feet. The incident occurred at the rear of the premises near a metal stairway and deck attached to the second level of the building (Figures 5 and 6). This is where the forklift had been parked. The outdoor space where the forklift was located was concrete and mostly flat. The concrete slab was roughly 3,200 square feet.

Figures 5 and 6 – Rear of commercial property where forklift was located (photographs taken by first responders)

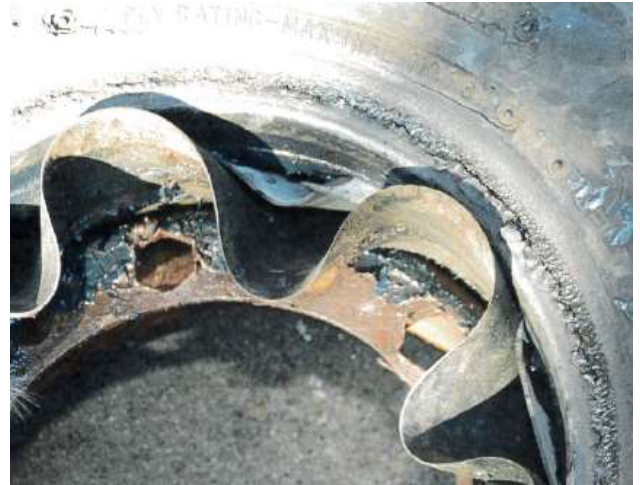
On the day of the incident, the victim started his day around 5:00 a.m. According to a source, the victim indicated he was going to be working again with the forklift wheel. The former tenant was planning to meet the victim at the premises at around 9:00 a.m. to help with this task. While no one witnessed the incident, evidence suggests the victim was using the lug wrench to work on the forklift wheel and the wheel was laying on the ground. It is believed he was disassembling the rim parts and had removed at least one nut, compromising the strength of the rim. Shortly after 6:30 a.m., a neighbor who lived a quarter of a mile away heard a loud boom. Due to the high pressure of the inflated tube and tire, and the force exerted by the victim on the wheel, the tube ruptured and there was a release of air pressure. Evidence suggests this caused the two rim halves to separate with such force that any remaining bolts tore through the rim, as visible in Figure 7. The smaller inner rim was found fully separated after the incident. The scalloped shape of the rim suggests it was also deformed by the air pressure.

Figure 7 – Outer half of split wheel; torn holes suggest bolts were torn through the rim plate (photograph taken by first responders)

Part of the rim may have been propelled downward into the ground as evidenced by an impression in the concrete slab. The victim was struck by the blast and fell backwards. The victim sustained multiple fatal injuries, including head trauma and spinal trauma from the fall to the ground. He also sustained a puncture wound and blunt trauma to the chest, a fracture to one eye socket, and trauma to his hands: this is believed to be from the air release and the four-way lug wrench striking him in the chest. At approximately 8:30 a.m. the tenant arrived at the property and found the victim unconscious next to the forklift. A 911 call was placed for emergency services. EMS arrived at the scene and transported the victim to a local hospital where he was pronounced dead.

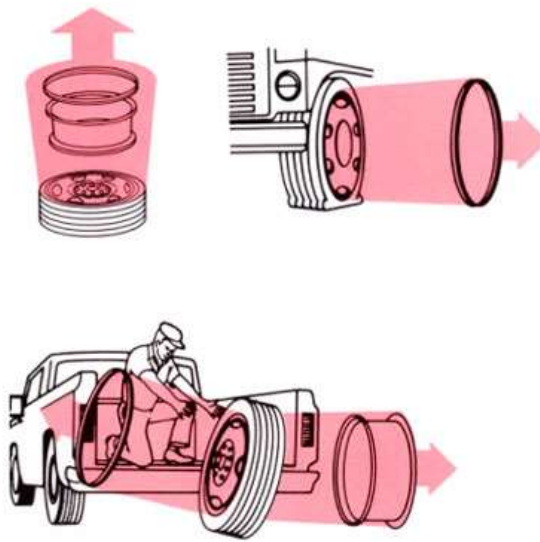
Discussion: Tires are a source of hazardous potential energy because of the pressurized air they contain. If this pressurized air is released during a tire or wheel component failure, the force of the air released is enough to seriously injure or kill those in its trajectory (Figure 8). Furthermore, multi-piece rim tires present an elevated risk-level due to their structure. Split-rim tires contain multiple pieces which are held together by a locking ring or by hardware that holds the pieces together. Failure of any of the pieces can cause separation of the pieces and an explosion of pressurized air, resulting in serious injuries and death. For this reason, several OSHA guidelines have been created to prevent injury and create a safe environment for the servicing of multi-piece rims.²

Figure 8 – Trajectory of multi-piece rim parts in different scenarios (images from 1910.177)

The victim was working in the blast trajectory of the tire as it lay on the ground. For this reason, it is essential and required that; 1) trained professionals examine multi-piece and single piece wheels prior to assembly in accordance with OSHA standard 1910.177(e)(2) and that employers 2) establish safe operating procedures for multi-piece rim wheels including completely deflating a rim wheel before removal from the axle if any obvious or suspected damage is identified in accordance with OSHA standard 1910.177(f).²

Recommendation #1: Ensure workers create a controlled safe work environment prior to servicing a rim wheel.

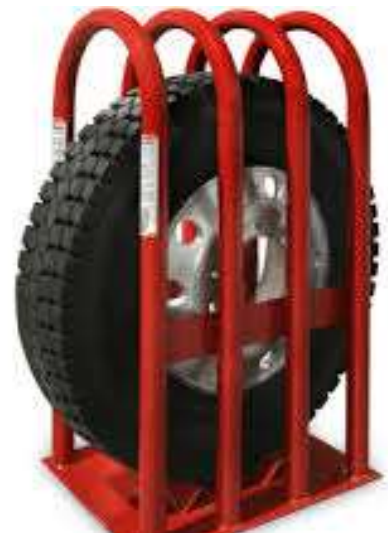
Figure 9 – Safety cage for use while inflating and deflating tires (image of example shown is from BendPak)

Additionally, measures should be taken to ensure employees have the proper equipment to service tires, including restraining devices or barriers (Figure 9). Restraining devices are utilized during inflation to prevent injury from components of multi-piece wheels in the event of an explosive separation.² Specifically, barriers or restraining devices must have the capacity to withstand 150 percent of the specified maximum tire pressure.² A safety cage/tire inflation cage is one method of containing wheel components in the event of an explosive separation.
