**TECHNICAL REPORT**

**MOA MITIGATION SERVICES – ARCHAEOLOGICAL MONITORING  
COTLEY RIVER RESTORATION / BARSTOW'S POND DAM REMOVAL**

**Taunton, Massachusetts**

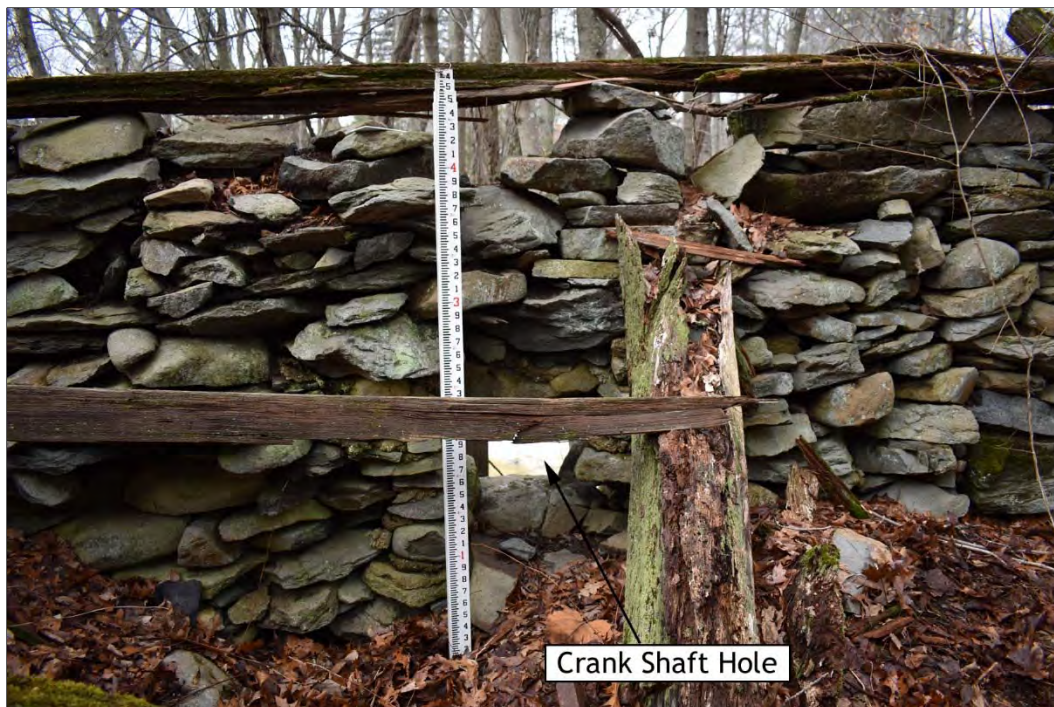
**Figure 9. Detail of square hole in foundation wall between two wheel pits, view northwest.**

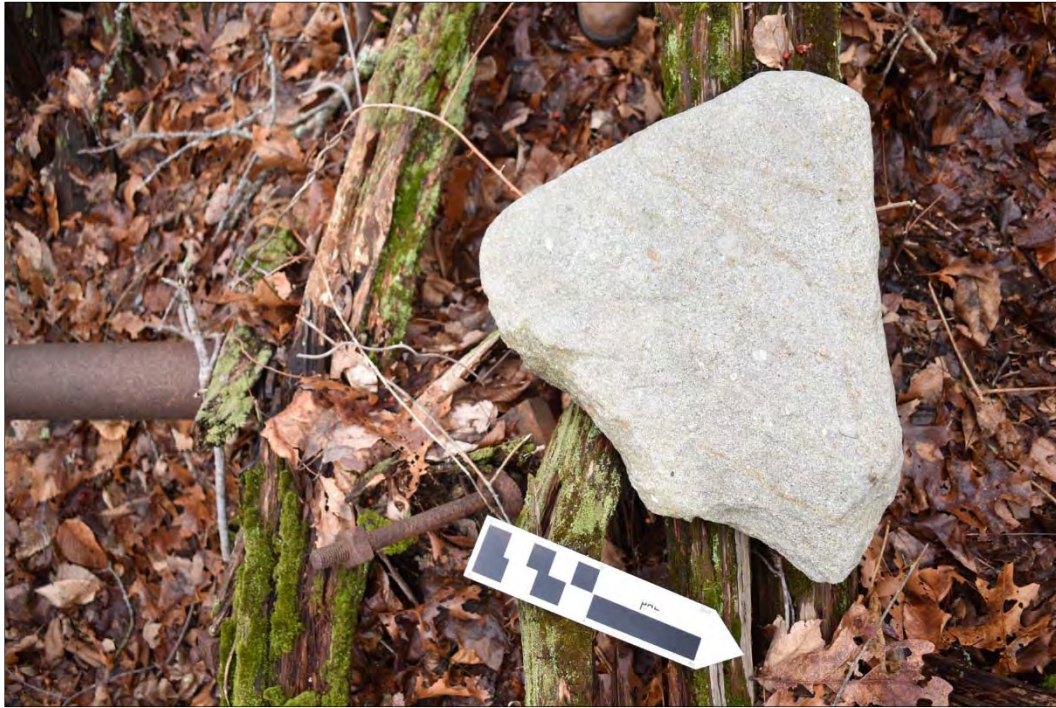
A possible granite millstone fragment was noted in the cellar hole of the mill building near the interior wooden waterwheel. The millstone fragment is approximately 12-x-16 in (30-x-40 cm) and approximately 3 in (7 cm) thick, with faint radiating furrows (grooves) incised on what would have been the dressed face of the stone (Figure 10). The side edges are very worn, which may indicate later reuse for some purpose other than as a millstone in the sawmill.

**Figure 10. Possible granite millstone fragment identified near eastern wheel pit in the mill foundation.**

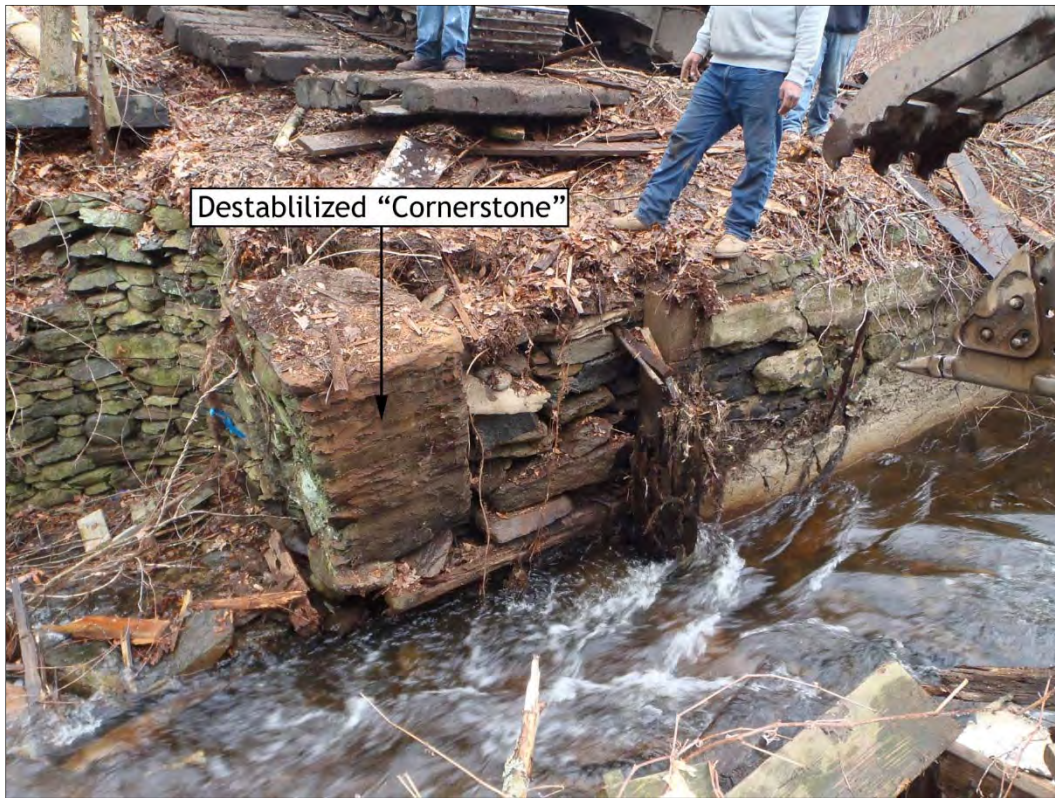
Machine excavation of the dam began with the removal of the modern wood deck and boards from the east channel (spillway) to facilitate drawdown of the impoundment (Figure 30). Removal of the wood deck, underlying support structures, and the wooden boards lining both sides of the spillway destabilized the mortared stones forming the right angle corner of the mill foundation remains closest to the east channel and southwest corner of the western wheel pit (Figures 31 and 32). The 5.2-ft (1.6-m) tall section of destabilized wall is composed of 8–10 courses of mortared narrow fieldstones topped with flat dry-laid fieldstones that formed a roughly 2.5-ft (0.8-m) square corner (Figure 33). The “cornerstone” section abuts the dry-laid fieldstone wall to the west and dry-laid fieldstone wall to the south that was underneath the wood plank deck across the spillway. The stonework rests on a horizontal wood timber set at the water line of the east channel. A rotting vertical wood post is present at the south side of the dry-laid stones where they abut a poured concrete section of mill foundation wall.

**Figure 31. Destabilized corner stones of mill foundation at spillway in east channel, view southeast.**

Because of the unforeseen wall destabilization, PAL instructed the construction contractor to stop work in this area and informed the Project partners of the possible need for additional protection measures. Following an on-site meeting with the contractor and PAL, the Project partners agreed that additional protection measures were needed to protect the mill foundation wall. As the lead federal agency, NOAA/NMFS notified the MHC and other MOA consulting parties of the proposed additional measures (see Appendix A): realigning the timber mats and access road extension across the east channel (spillway) slightly south away from the loose masonry to avoid further disturbance (Figure 34); shifting the proposed channel reconstruction work in this location approximately 5 ft (1.5 m) to the west; and placing native stone

material against the east side of the channel to within approximately 1 ft (30.5 cm) of the top of the stone wall (Figure 35). This approach was deemed appropriate given that the realigned east channel would no longer be the primary channel and would not receive normal river flows. NOAA did not receive a response from the MHC, and the additional protection measures for the mill foundation were carried out by the contractor.

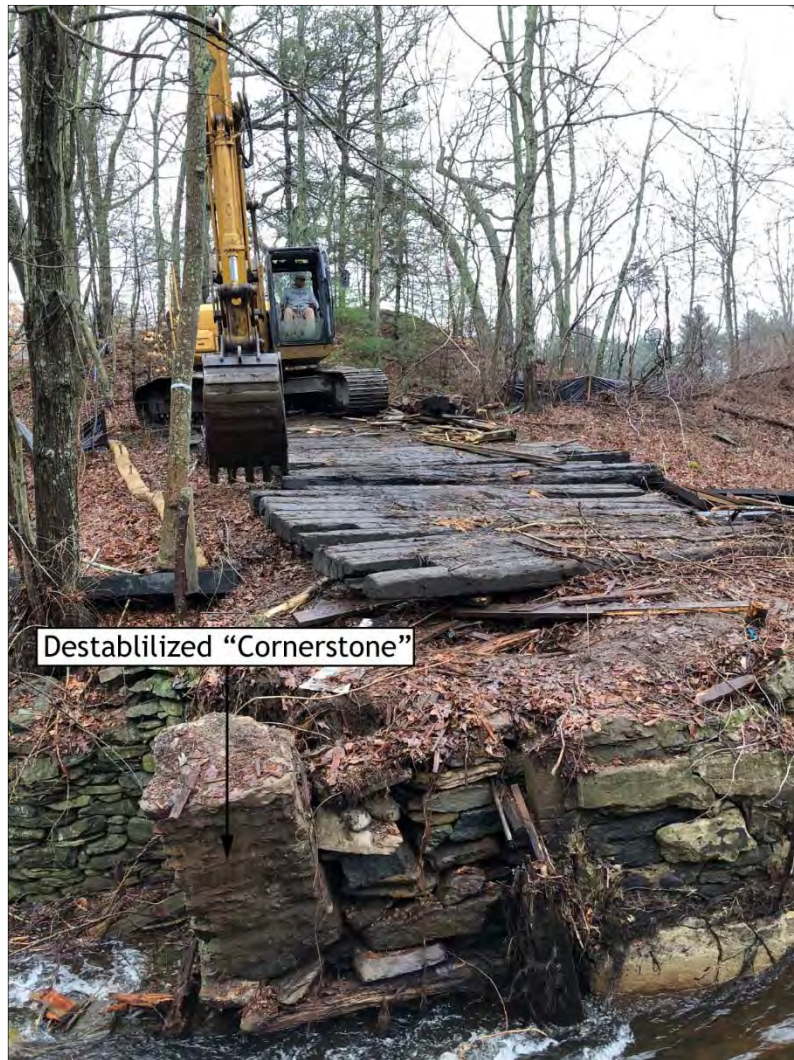
**Figure 32. Destabilized corner stones of mill foundation in relation to timber matting and dam removal access road extension to east channel, view west.**

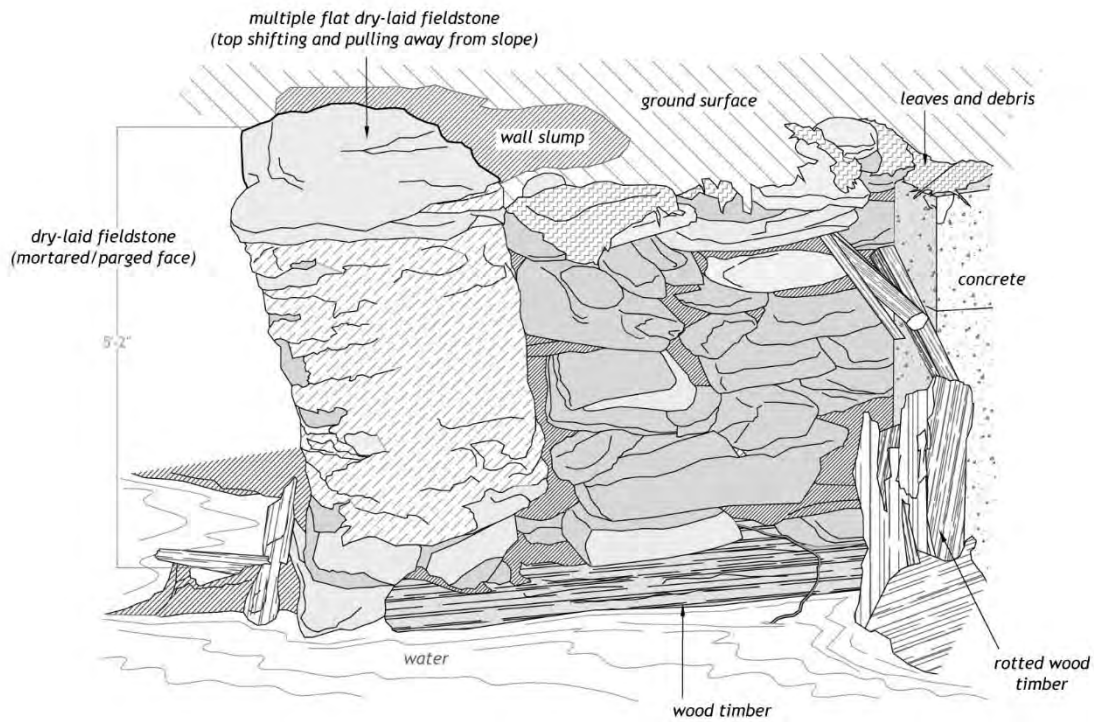
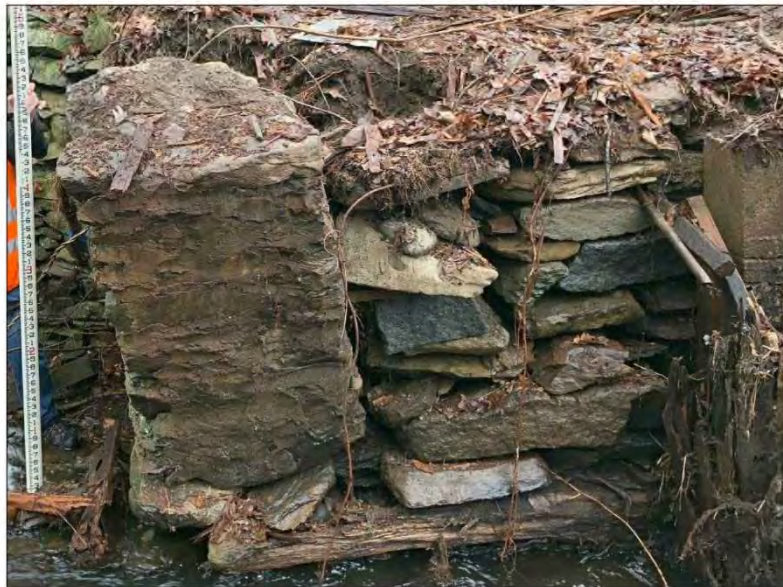
**BARSTOW'S POND MILL SITE (TAU-HA-67)**  
**PROFILE - EAST SIDE OF EAST CHANNEL SPILLWAY**

**Figure 33. Profile drawing and detailed photograph of destabilized mill foundation “cornerstone” wall section.**

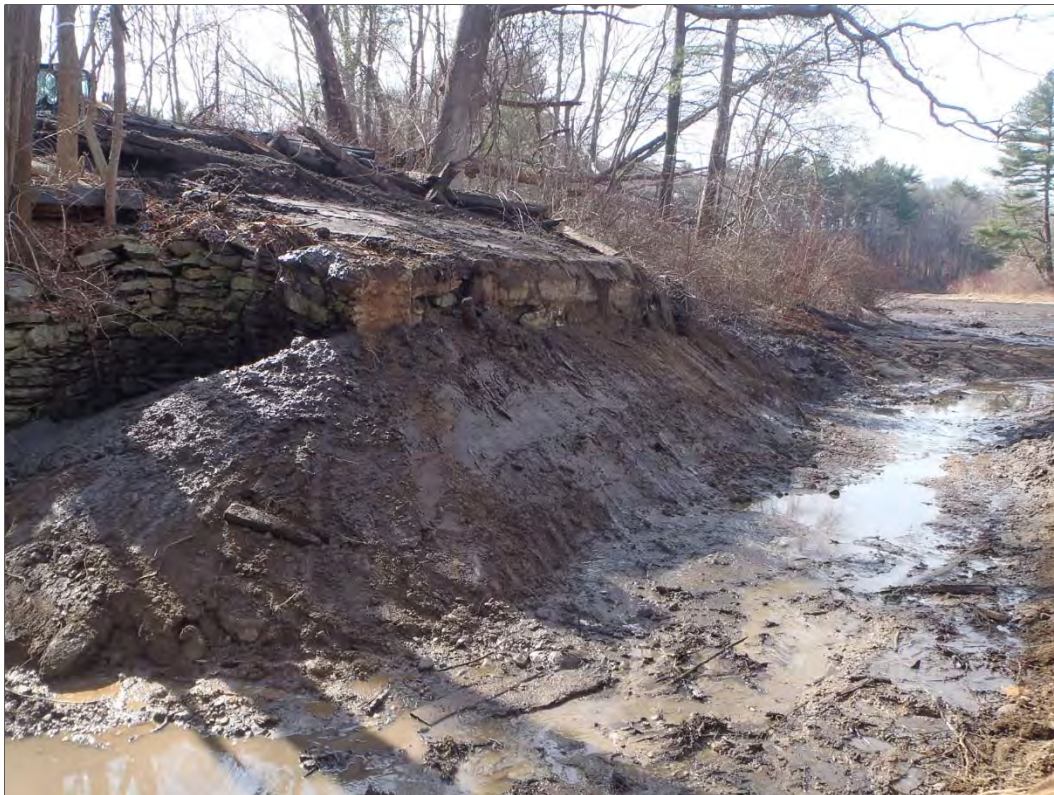
**Figure 35. Finished sloped grade of east side of realigned eastern channel along mill foundation fieldstone wall, view southwest.**

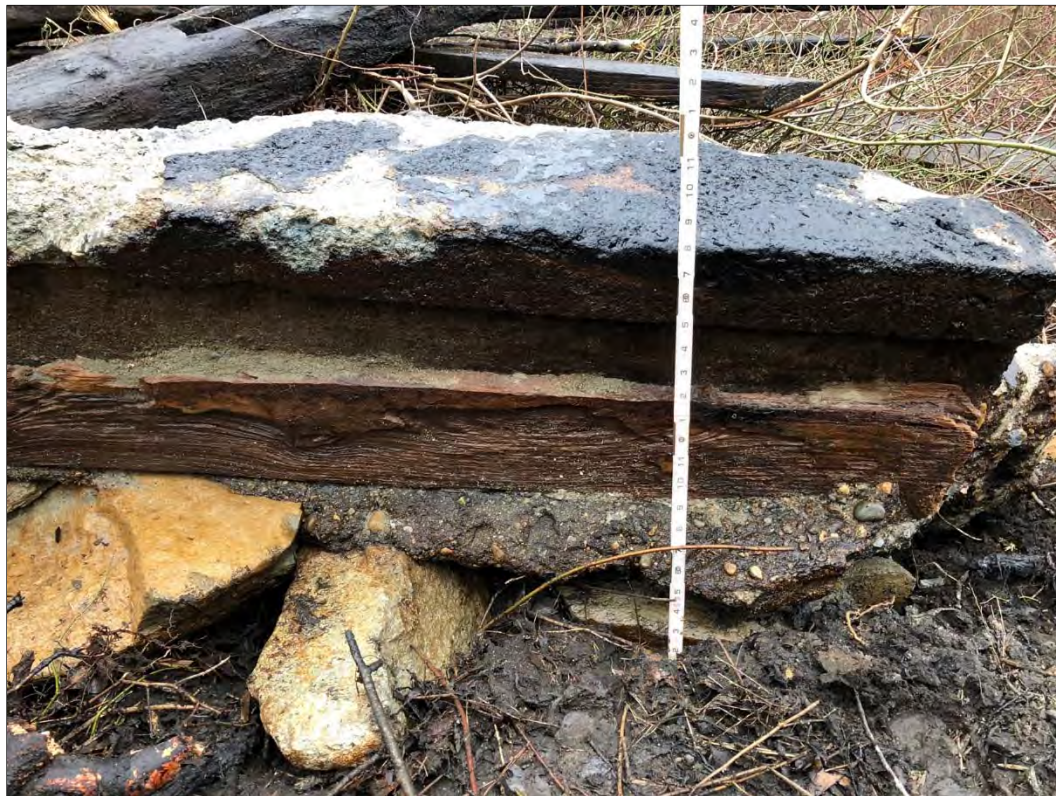
**Figure 37. Concrete slab with embedded timber removed from across river bottom in east channel (spillway).**

During the dam removal process, the contractor's machine excavations in the east spillway channel and adjacent berm section removed loose timbers and wood boards measuring 4–8 ft (1.2–2.4 m) in length. The timbers and boards were not attached or anchored to the spillway sidewalls, and were most likely remnants of flashboards and/or earlier spillway and sluiceway gate components. One larger structural element of note removed from the river bed in the channel was an approximate 4-ft (1.2-m) long section of formed concrete and conglomerate cement embedded with a wood timber. The formed concrete on the top side was approximately 8-in (20-cm) thick and the conglomerate cement on the bottom side was approximately 5-in (13-cm) thick and contained embedded fieldstones that were face down in the river channel sediments. The wood timber in the center was about 7-in (18-cm) thick and there were no nails or other hardware indicating that it was fastened to other wood or concrete parts. The entire composite element appears to have been lain horizontally across the width of the channel close to the top of the sediments. It likely functioned as the base of former sluiceway gate(s) originally made of timber(s) and then improved with the formed concrete on top.

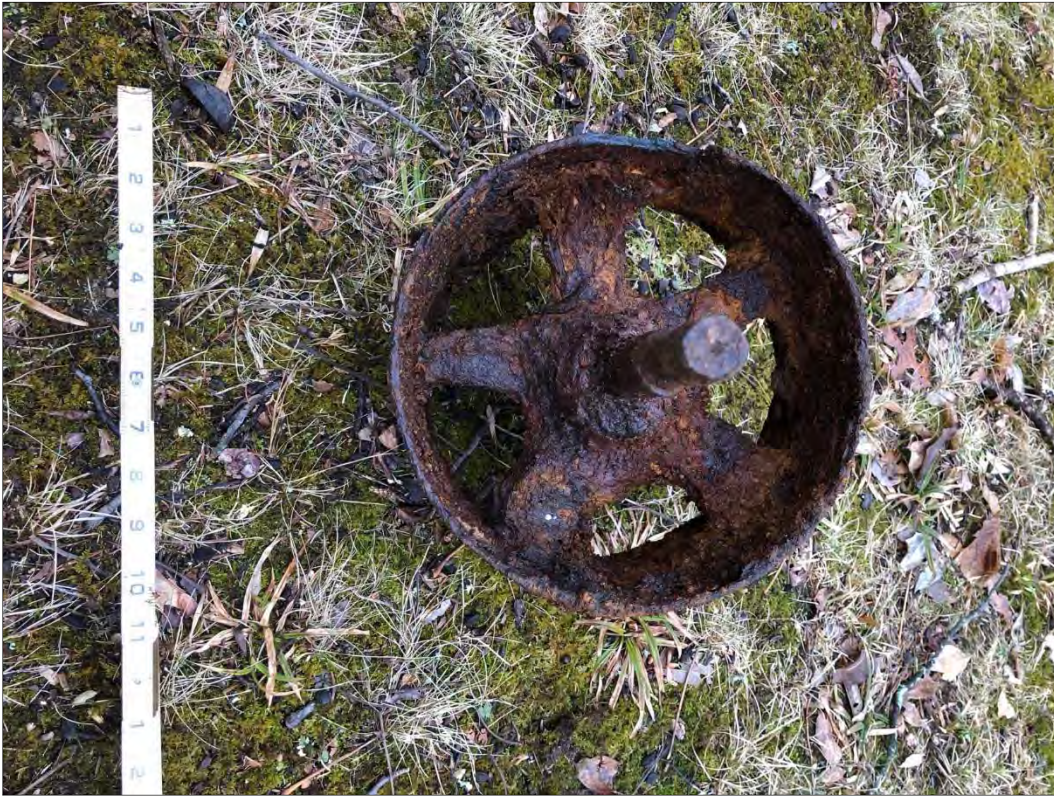
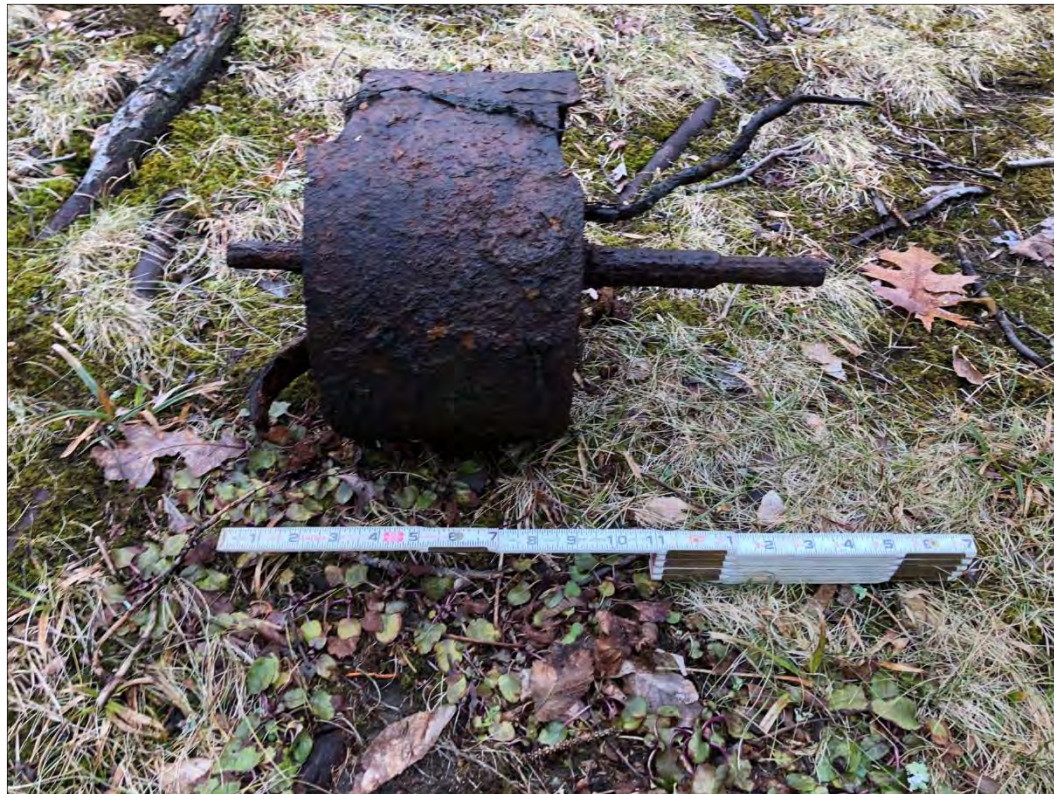
**Figure 38. Iron pulley with line shaft found in western wheel pit of mill foundation: a) interior assembly view; and b) exterior lengthwise view with shaft at both ends.**

The excavation of sediment in the spillway channel also uncovered an iron pulley just below the top of the river bed sediments at the southwest side of the western wheel pit. The pulley is about 10 in (25 cm) in diameter and 7 in (18 cm) wide and is fixed on the iron line shaft still present at both ends. The pulley would have been driven by belt from the power source (water wheels) to turn the saws that operated in the mill. The only cultural materials noted in the upper earthen berm fill soils were a few scattered bricks stamped "S & H", which stands for Stiles and Hart, a brick manufacturer located in Bridgewater, Massachusetts established in 1886.

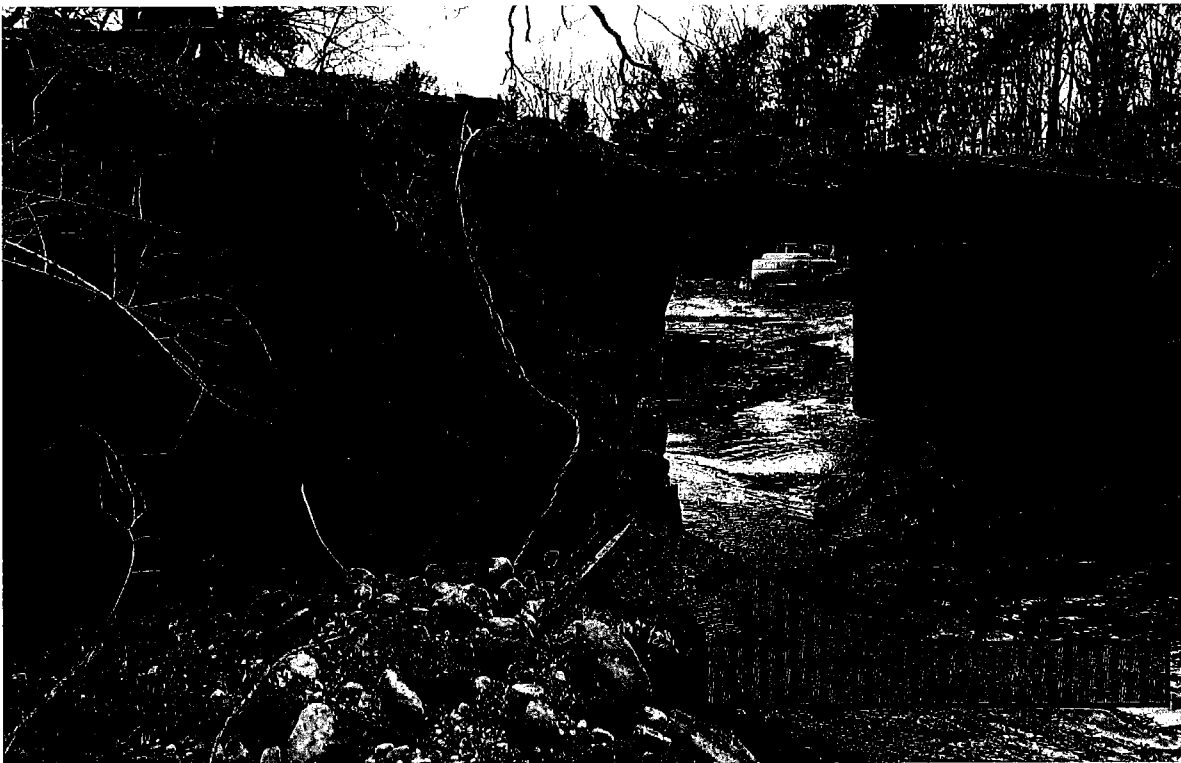
View of the destabilized retaining wall corner; view from the north.

Our approach is detailed and depicted in the attached plan sheets with captions. The treatment is not intended to repair or realign the wall stones or provide a structural support for the wall, but to protect the structure from further disturbance. This treatment will be installed by the contractor during the first week in March, as the contractor is advancing the final work at the site and completing activities in this portion of the project area.

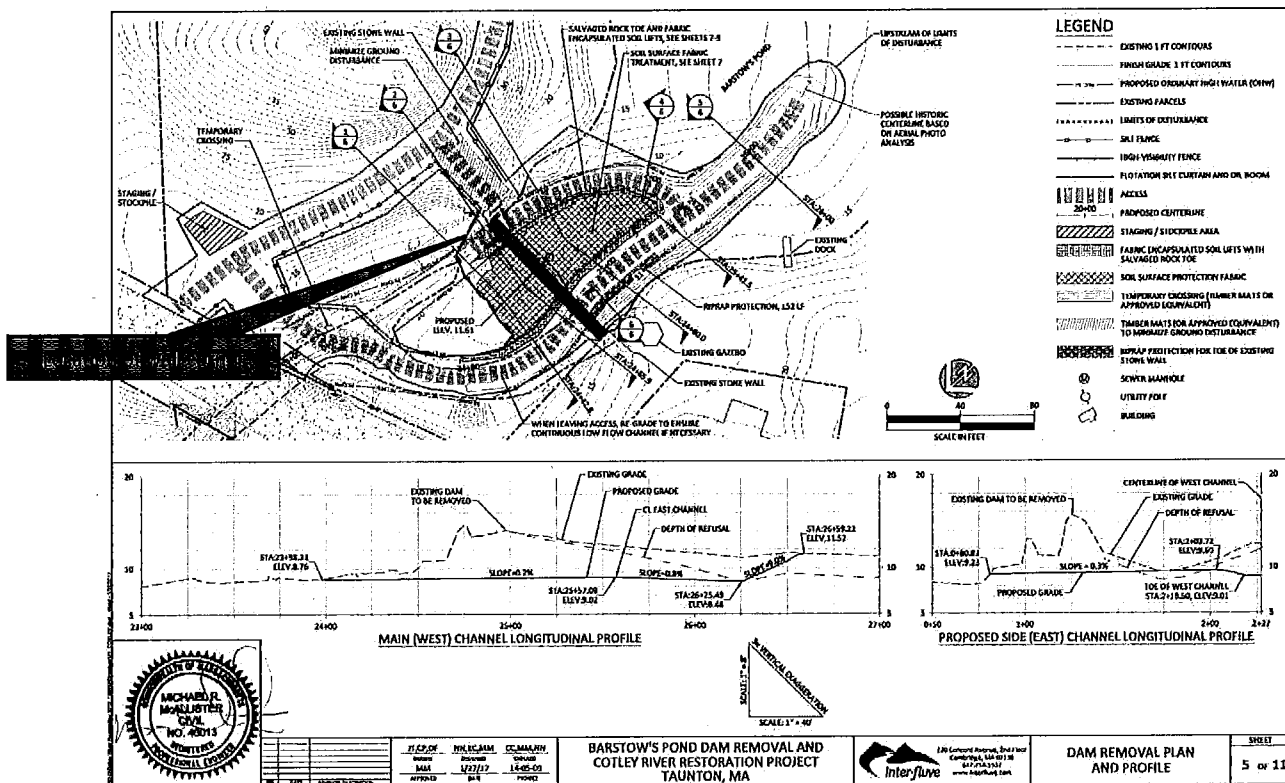
Plans sheet showing location of the destabilized retaining wall corner.
