TECHNICAL MEMORANDUM

From: Keith Kantak; Mike McAllister, PE; Nick Nelson; Sarah Widing, PE

Date: August 31, 2018

Re: Cotley River Restoration Project, Post-Construction Monitoring, Taunton, MA

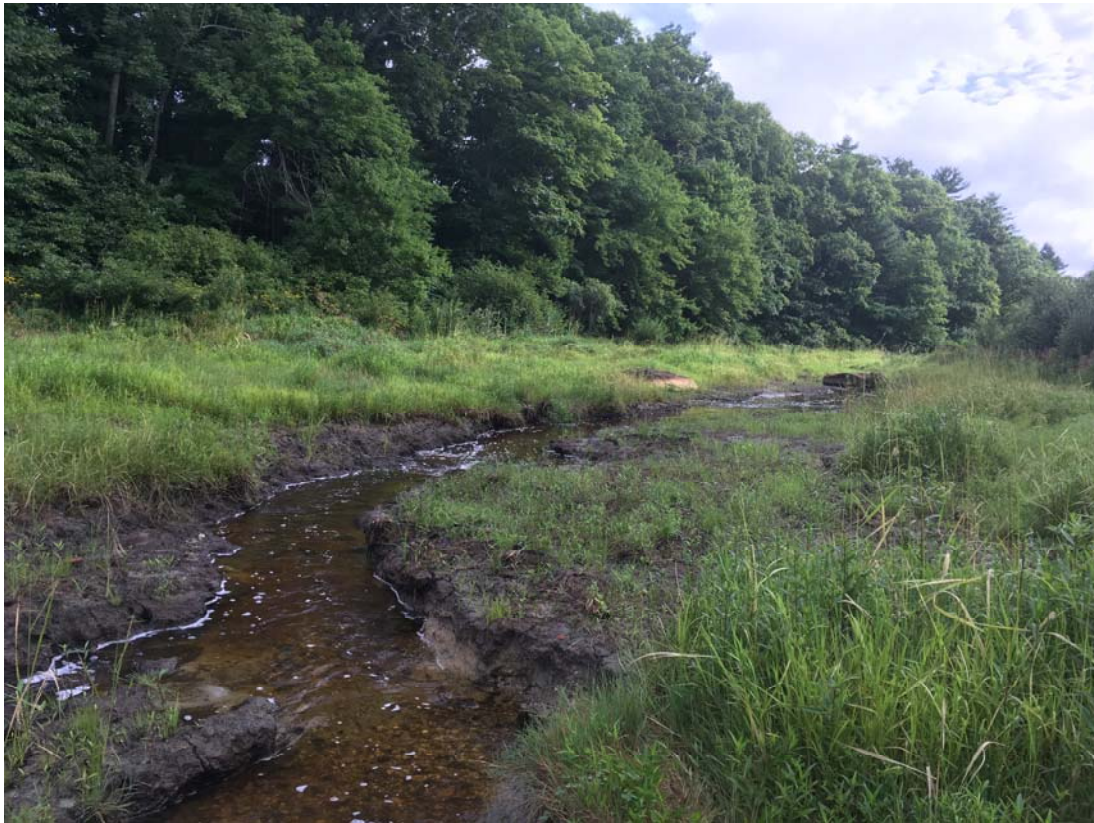
- We observed that the channel has assumed a sinuous, single thread though nearly the entire reach, with one exception—we observed a short, braided section above Cross-section 9 (Figure 2, Attachment 1).

- We observed a head-cut (a locally steepened, eroding section of channel) propagating upstream through the former impoundment. At the time of this field effort, the knickpoint of the head-cut was located approximately 100 feet upstream of Cross-section 9.

- We observed that the channel form upstream of the head-cut is poorly defined. The bed and the banks currently consist of poorly-consolidated, fine-grained sediment. The fine-grained sediment is very mobile; therefore, in areas where this substrate predominates, we expect that the channel will experience rapid evolution in the coming months.

Figure 2 The channel at cross-section 9, looking upstream.

Subsequent monitoring excursions may be used to track the upstream migration of the head-cut and to track the transition of the channel bed substrate from fine-grained material to coarser grained material.
