**Crossing Assessment for the Sandy Neck Barrier Beach System Area  
of Critical Environmental Concern (ACEC)**

**Suggested Citation:** Duffey, S.M. and A.L. Pappal. 2019. Crossing Assessment for the Sandy Neck Barrier Beach System Area of Critical Environmental Concern (ACEC). Massachusetts Office of Coastal Zone Management, Boston, MA.

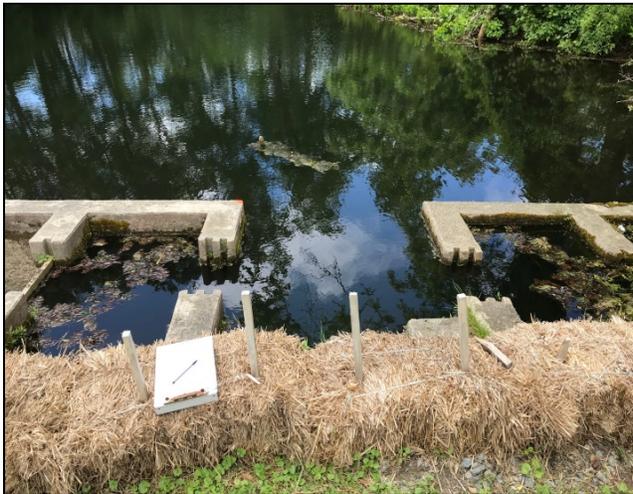
Scorton Creek. The crossing appears to be in OK condition. Visible utilities include overhead electrical wires and an underground natural gas line. Crossings S7 (pg. 12), S19 (pg. 14), S5 (pg. 16), and S8 (pg. 19) are located downstream. The downstream crossings could be contributing to the restriction at this site by impairing flow and drainage, and therefore should be considered with any restoration efforts at S4. The downstream area is on the property of the Nye Family of America Homestead and Museum, and the upstream area is divided among multiple private landowners. The vegetation on both sides is very different, with primarily lawn present on the downstream side and aquatic vegetation consistent with a freshwater pond on the upstream side. This system was once an active alewife run, and the Town of Sandwich has expressed interest in restoring it to allow anadromous fish passage. None of the visual indicators of a tidal restriction are evident at this site, as data collected at the time of this report suggest that this is a freshwater crossing. Since this site is a known former fish run, it may be appropriate to investigate further the feasibility of restoration for that use.

**Figure 3: Concrete dam/spillway structures controlling water levels on the upstream side of site S4.**

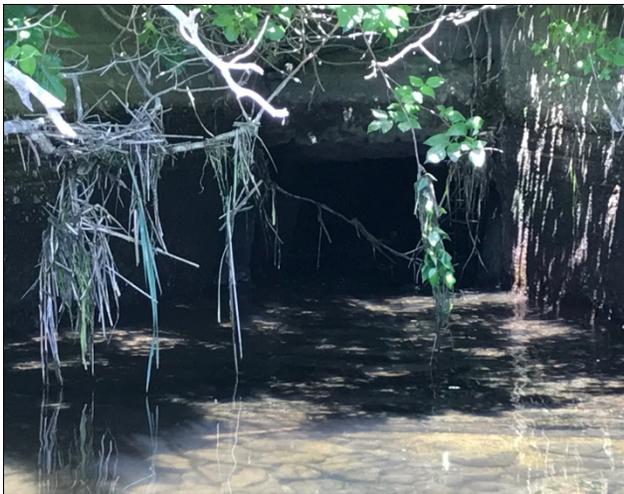
Mill Creek flows beneath the Massachusetts Coastal Railroad through a concrete bottomless culvert at this site. The crossing appears to be in poor condition. No visible utilities are present at the site. Crossing S4 (pg. 10) is located upstream and crossings S19 (pg. 14), S5 (pg. 16), and S8 (pg. 19) are located downstream. The downstream crossings could be contributing to the restriction at this site by impairing flow and drainage, and therefore should be considered with any restoration efforts at

**Figure 6:** The upstream box culvert structure at site S7.

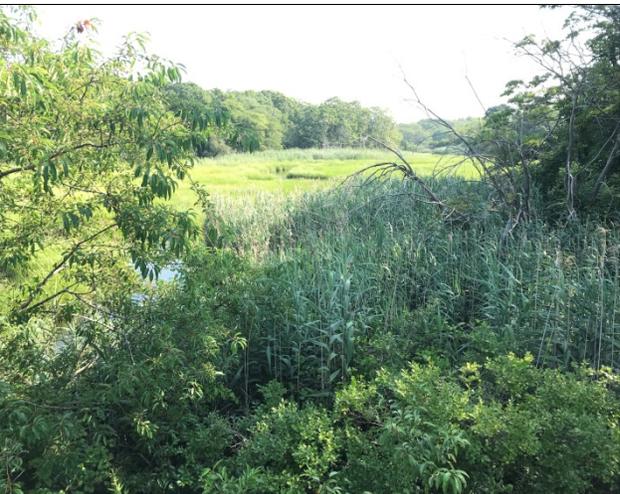
**Figure 7:** The area immediately downstream of site S7. Notice the invasive common reed (*Phragmites australis*) in the foreground.

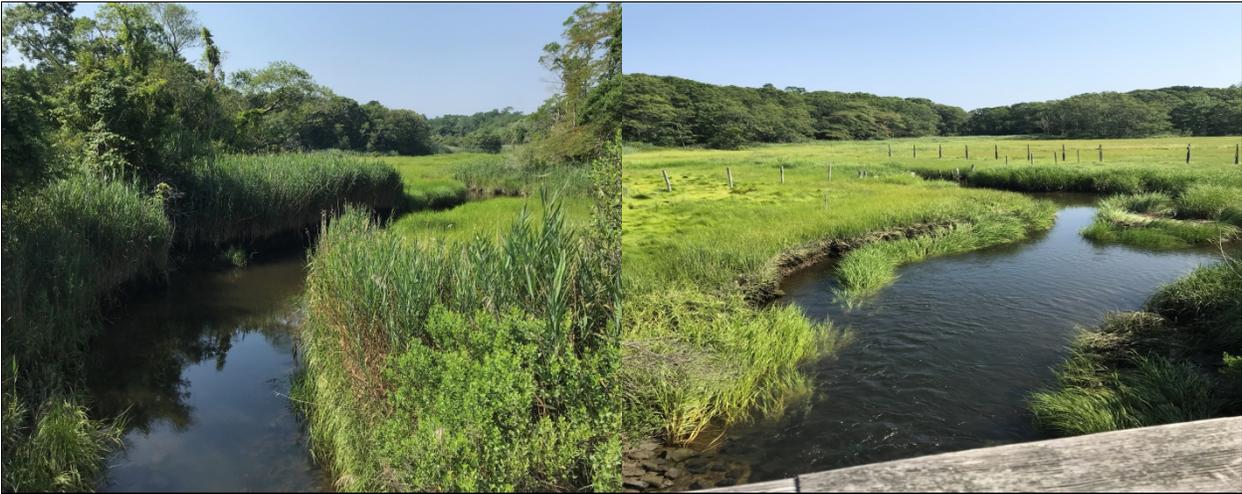
**Figure 9:** The wetland area immediately upstream of site S19. Notice the invasive common reed (*Phragmites australis*) stands along the creek bank.

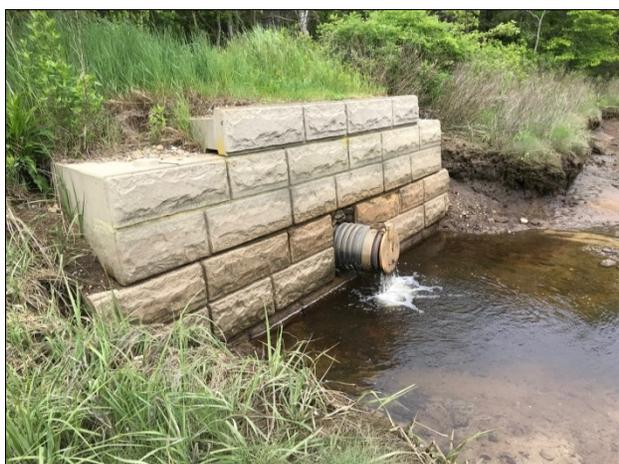
condition. No visible utilities are present at the site. Crossing S8 (pg. 19) is located downstream and could be contributing to the restriction at this site by impairing flow and drainage, and therefore should be considered with any restoration efforts at S5. The property is currently owned by DFG and leased to the Thornton Burgess Society. The vegetation on the downstream and upstream sides is very different, with the downstream area consisting of *Spartina* spp., while the upstream area is dominated by the invasive common reed (*Phragmites australis*). It is unclear whether this channel or the area leading up to the tide gate serve as an anadromous fish run. A clear tidal restriction is present at this site; observations indicate the flap gate structure significantly restricts saltwater flow upstream of the crossing at all stages of the tide. Visual indicators of a restriction include the dominance of *P. australis* in the upstream affected area, ponded water and a scouring basin at the downstream tide gate, and slumping of the marsh surrounding the downstream structure.

Figure 12: The flap gate on the downstream side of site S5 presents a tidal restriction, shown here at low tide.

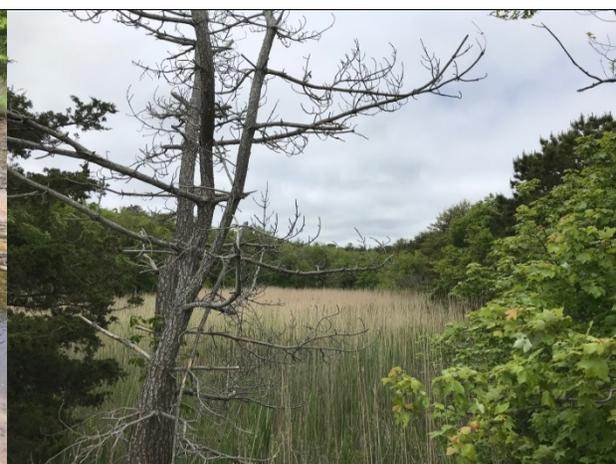
Figure 13: The area immediately upstream of site S5 consists of a dense stand of the invasive common reed (*Phragmites australis*).

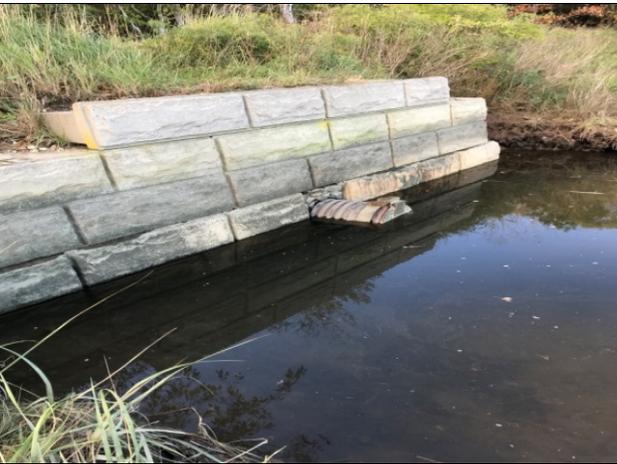
**Figure 15: The downstream flap gate at site S5 shown at high tide.**

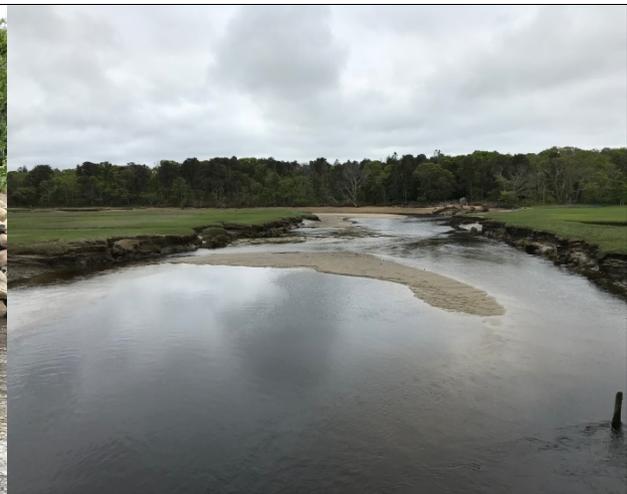
by the Massachusetts Department of Fish and Game (DFG), and the downstream area is privately owned. In 2001, the Cape Cod Atlas of Tidally Restricted Salt Marshes noted visual indicators of a restriction including scouring and erosion on both the upstream and downstream sides, as well as significant marsh slumping and vegetation die-back seaward of the crossing (Justus et al. 2001). In the current assessment, the vegetation between the upstream and downstream areas was observed to be very similar, with *Spartina* spp. the dominant species. Significant marsh slumping, bank erosion, and vegetation die-back on the creek banks was noted on both sides of the crossing along with large scouring basins. These indicators are likely a result of high velocity water flow through the crossing caused by both tides and storm events. The Town of Sandwich has expressed interest in restoring the once active anadromous fish run up Scorton Creek and through Mill Creek to Nye Pond, which passes through this crossing as well as S4, S7, and S19. Based on observations from the current assessment, this crossing does not appear to inhibit aquatic organism passage.

**Figure 18: View from site S8 of the salt marsh habitat upstream of the crossing. Notice the marsh slumping and erosion present on either side of the creek.**

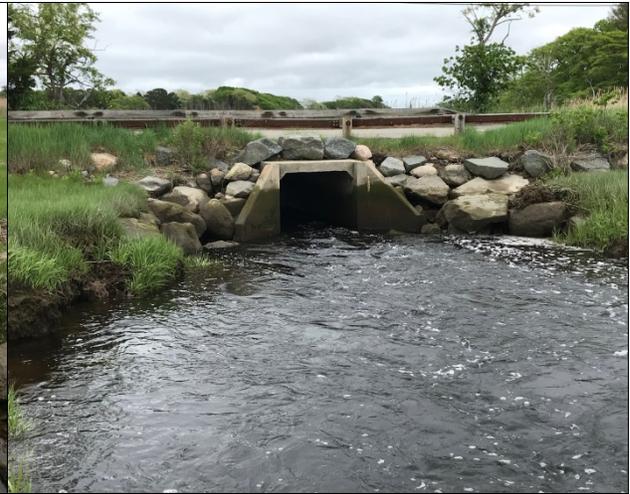
**Figure 21:** The downstream box culvert with wingwalls at site S10. Stone has been placed around both the upstream and downstream structures to help armor the crossing and minimize erosion.

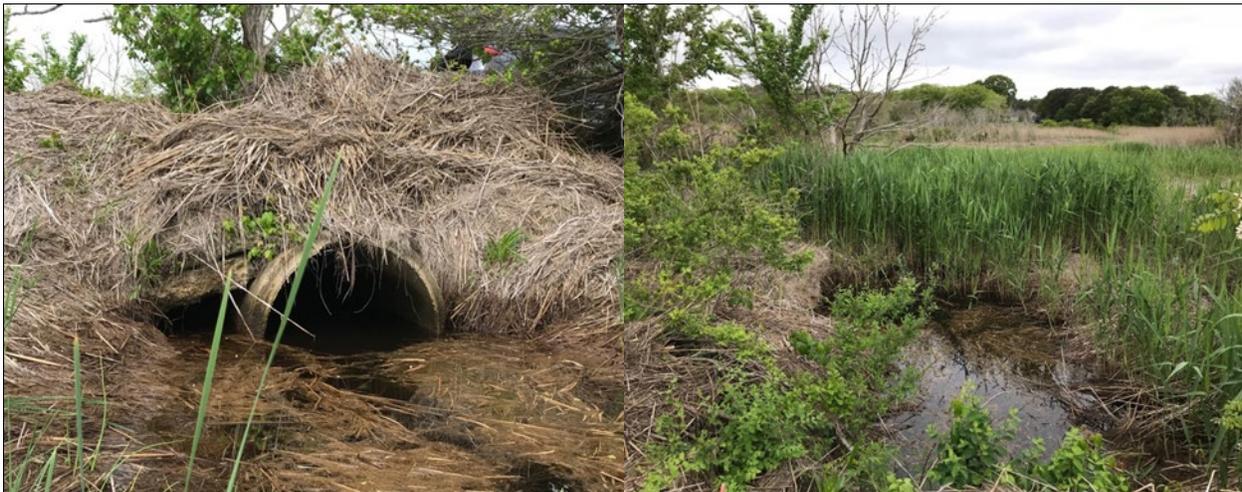
split among multiple private landowners. Upstream of this crossing the waterway joins the portion of Scorton Creek that drains into Cape Cod Bay. Consequently, it is here that the upstream area of this crossing merges with the upstream area of S10 (pg. 21). In the Cape Cod Atlas of Tidally Restricted Salt Marshes, the pipe is identified as being in good condition and unclogged in 2001. Fringing invasive common reed (*Phragmites australis*) was also documented on the upstream side (Justus et al. 2001). In the current assessment, however, the structure was observed to be at least partially clogged, as evidenced by very little active water flow through the structure. The vegetation upstream is moderately different from downstream; both sides are indicative of a brackish to freshwater wetland, but *P. australis* is much more prevalent on the upstream side. Visual indicators of a restriction include ponded water, scouring basins, vegetation die-back on both sides, and bank erosion on the upstream side. The higher prevalence of *P. australis* on the upstream side may also be evidence of a restriction at the site, as it prefers less saline waters. Based on observations from the current assessment, the structure may need to be unclogged to allow better flow through the culvert.

**Figure 26: The downstream culvert is covered in wrack, indicative of how the structure was impacted by the blizzard in January 2018 and northeasters in March 2018 at site B1.**

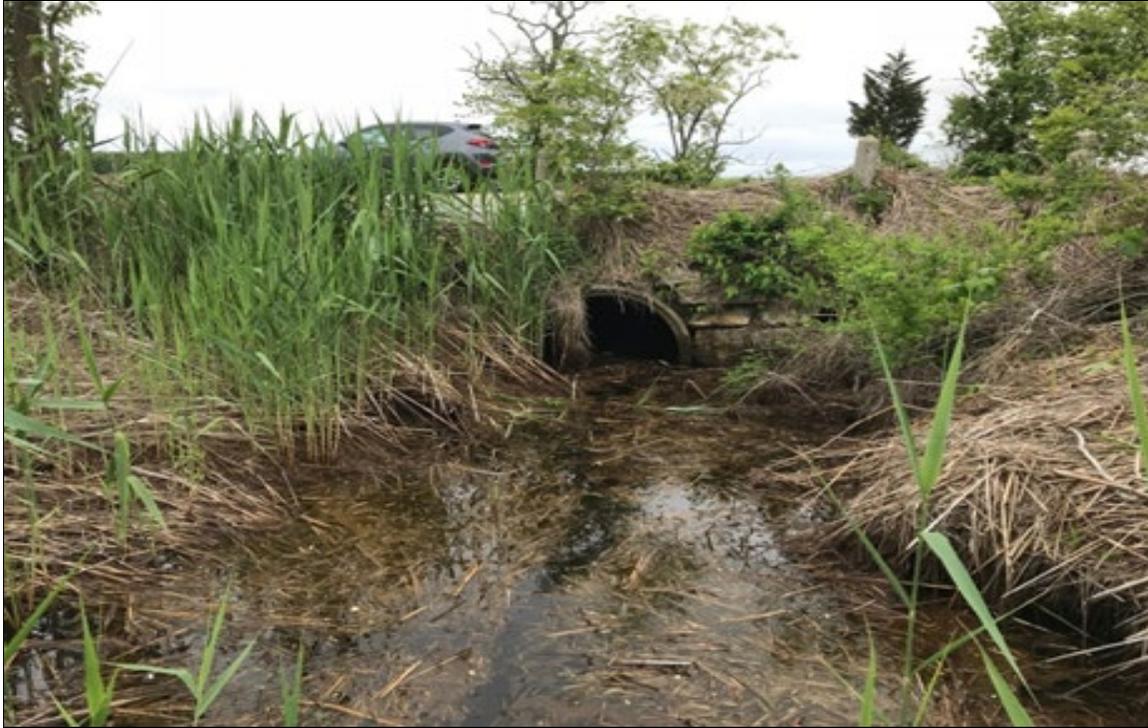
Figure 28: The culvert on the upstream side of site B1 is also covered with wrack, likely a result of high tides and storm surge from the blizzard in January 2018 and two northeasters in March 2018.

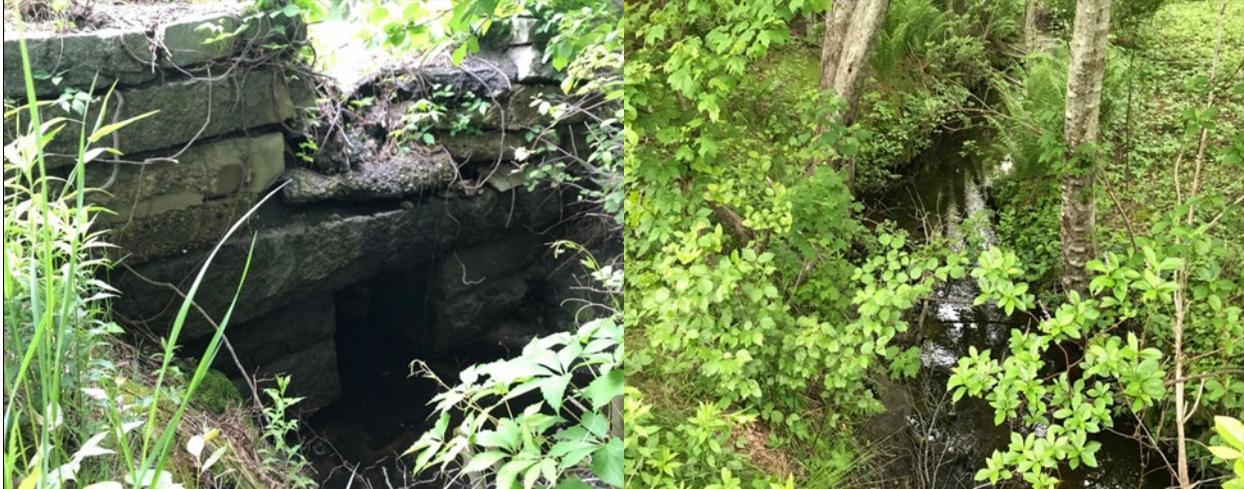
Smith Creek flows under Route 6A through a round concrete culvert on the upstream side to a stone box culvert with a synthetic bottom on the downstream side. The crossing structure appears to be in OK condition, though erosion of the substrate and structure above the crossing (likely from stormwater flow from the road) was observed. Overhead electrical wires are visible at the site. There are no known crossings upstream or downstream of this structure. Both the areas upstream and downstream of the crossing are privately owned. The vegetation upstream and downstream of the

**Figure 31:** The downstream box culvert at site B2 does not have a stone bottom, but does contain an artificial bottom that is not connected to the structure. Notice the erosion occurring directly above the culvert opening from road runoff.

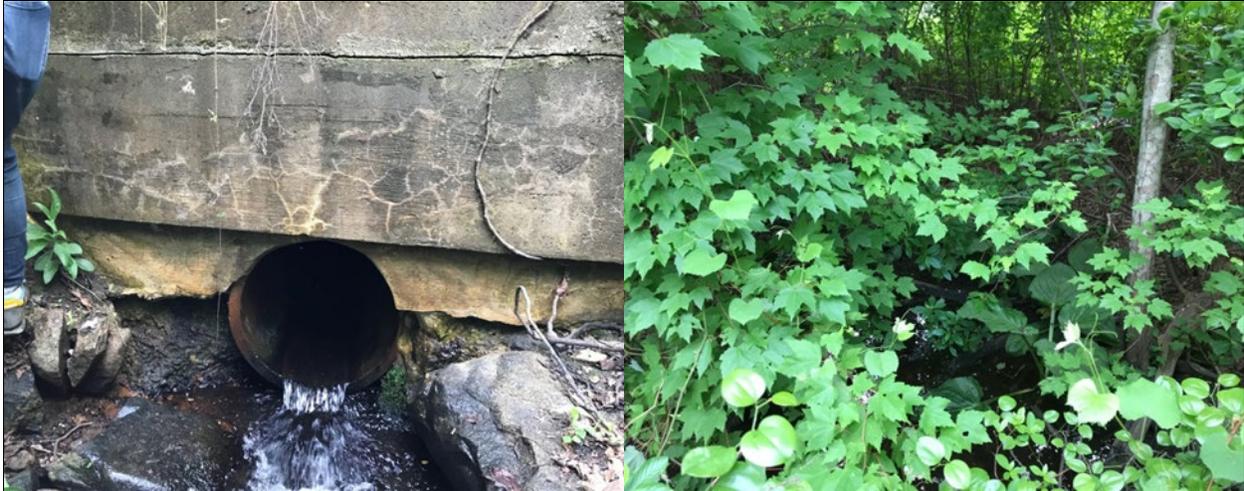
species. Visual indicators of a restriction include a clogged upstream structure and ponded water on the upstream side of the crossing. Site observations indicate the site is not currently influenced by tidal flow. The downstream structure is slightly perched during typical low flow conditions, which may impede the movement of aquatic organisms.

**Figure 34:** The downstream structure of site B3 is a small metal culvert that is slightly perched during typical low flow conditions.

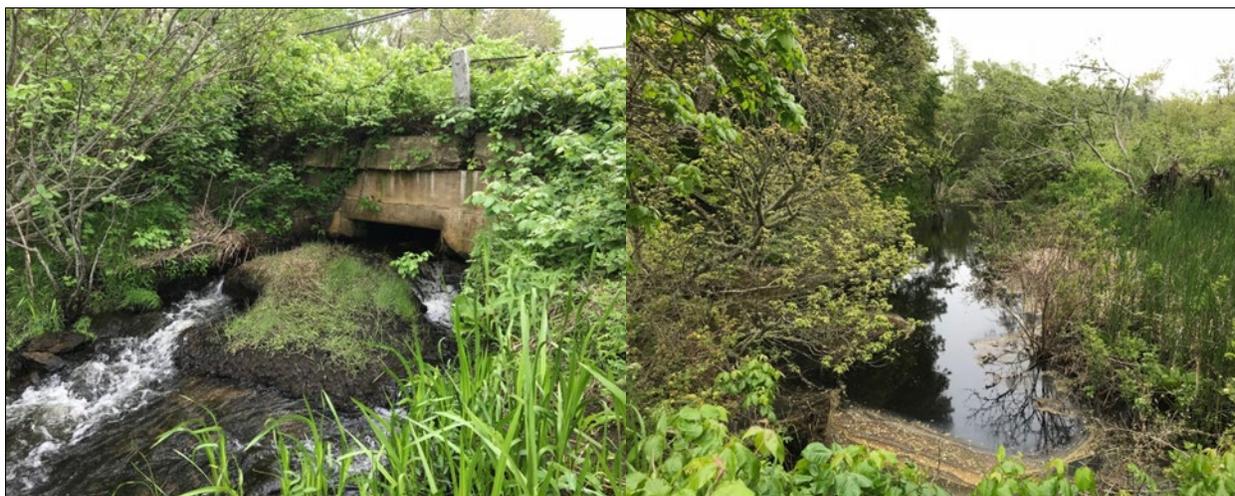
**Figure 37: A large mass of peat is partially blocking flow on the downstream side of site B7, most likely rafted up during the blizzard in January 2018 or the northeasters in March 2018.**

In 2019, the Town of Barnstable stocked Mill Pond with river herring in an effort to restore the anadromous fish run in Boat Cove Creek between Barnstable Harbor and the Pond. The large mass of peat on the downstream side (which may cause both a physical barrier and contribute to higher water flow velocities moving out of the structure) and clogging of the upstream side of the crossing by high amounts of debris may be impeding the movement of anadromous fish at this site. The

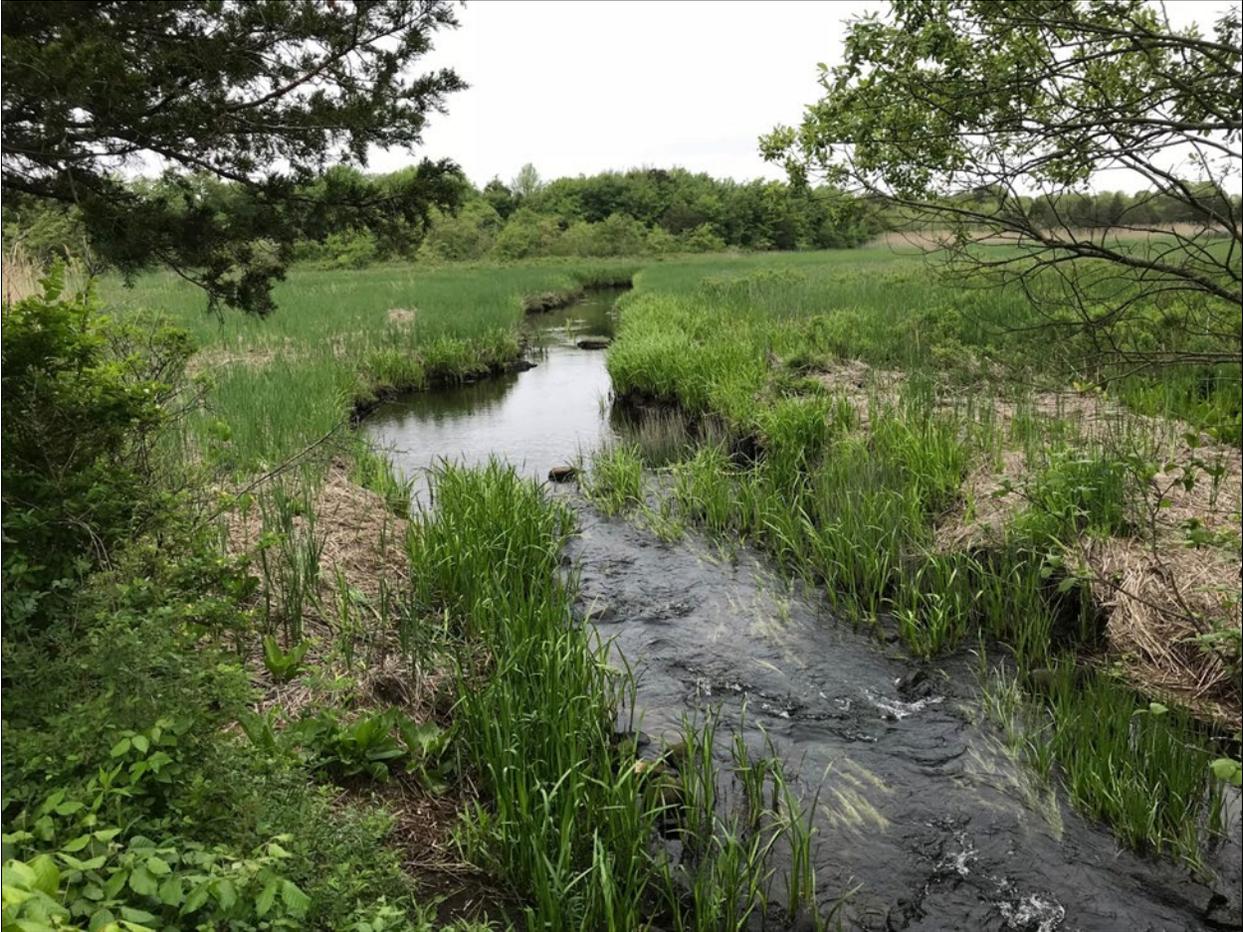
Although observations from this assessment indicate this site is not tidally influenced on a daily basis, this structure is clearly impacted at the very least by storm events. High accumulations of wrack were observed in the downstream area, and a large mass of peat was rafted right up to (and partially blocking) the downstream structure opening (Figure 37). This material was likely deposited during the major storms in the winter of 2018, including a blizzard in January that resulted in the highest high tide ever recorded (15.16 feet) at the National Oceanic and Atmospheric Administration (NOAA) tide gauge station in Boston (NOAA 2018), as well as several northeasters in March 2018 that also significantly impacted this site and Massachusetts coast-wide.

**Figure 39: View from the roadway showing the high accumulation of wrack on the downstream side of site B7.**

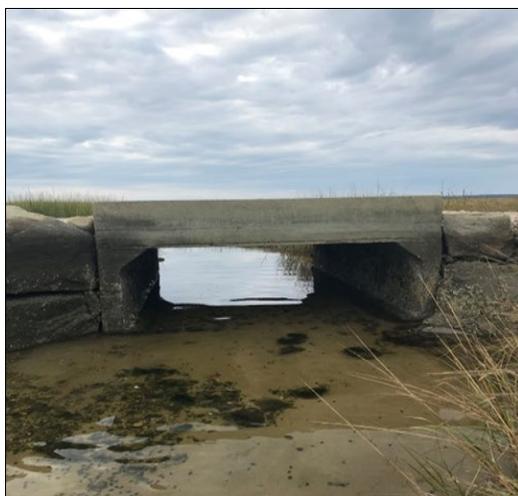
**Figure 41:** The upstream side of site B23. The structure is in good condition and rock retaining walls have been put in place around the opening to limit erosion and washout of the trail.

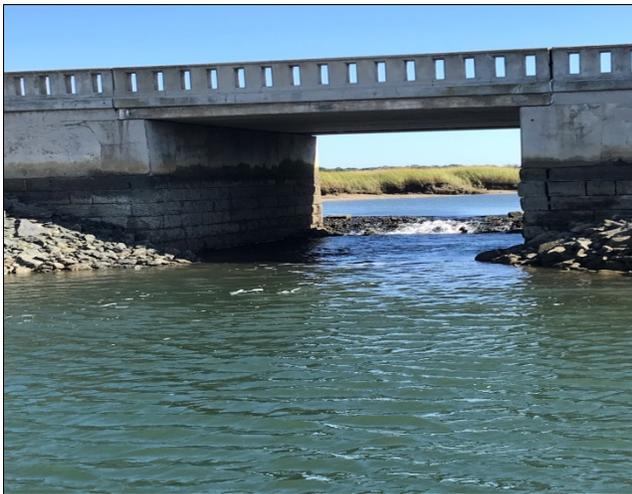
Marina, Inc. In the Cape Cod Atlas of Tidally Restricted Salt Marshes, a rise in elevation from the downstream to upstream side is noted. The remnants of an old mill dam on one of the many channels flowing through the upstream salt marsh were also observed (Justus et al. 2001). These characteristics were also observed in the current assessment, as well as rip rap on the upstream side of the crossing. The vegetation on the upstream side is very different from the downstream, as the upstream side is a salt marsh dominated by *Spartina* spp. while the downstream side is a public marina with no vegetation. Visual indicators of a restriction include marsh slumping, bank erosion, and ponded water on the upstream side of the crossing. There is no invasive common reed (*Phragmites australis*) at the bridge, but there are significant stands further upstream into Maraspin Creek. The perch created by the rip rap located in the creek may impede the movement of aquatic organisms at low tide. The elevation change, old mill dam, and rip rap should all be taken into account if this site is considered for restoration.

**Figure 45: View of the bridge from the downstream marina. Notice the perch created by the rip rap located on the upstream side of site B25.**

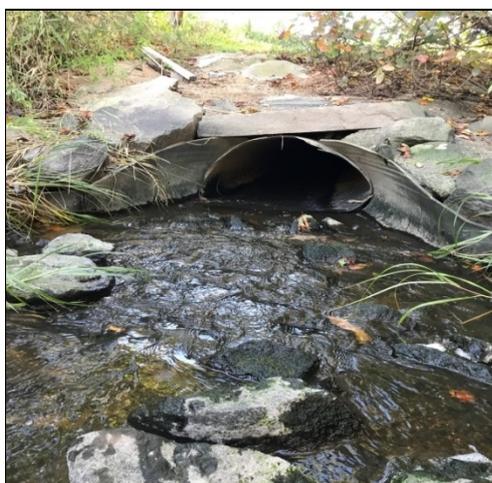
At this location, Maraspin Creek flows under Commerce Road through a corrugated metal pipe. The pipe appears to be in poor condition and is partially collapsed on both the upstream and downstream sides of the culvert. Visible utilities at the site include overhead electrical wires and underground water/sewer pipes. Crossing B25 (pg. 39) is located downstream and could be contributing to the restriction at this site by impairing flow and drainage, and therefore should be considered with any restoration efforts at B26. There is a mix of ownership on both the upstream

**Figure 48:** The metal culvert is partially collapsed on both sides of site B26. Shown here is the upstream side of the pipe, which is more profoundly collapsed than the downstream side.

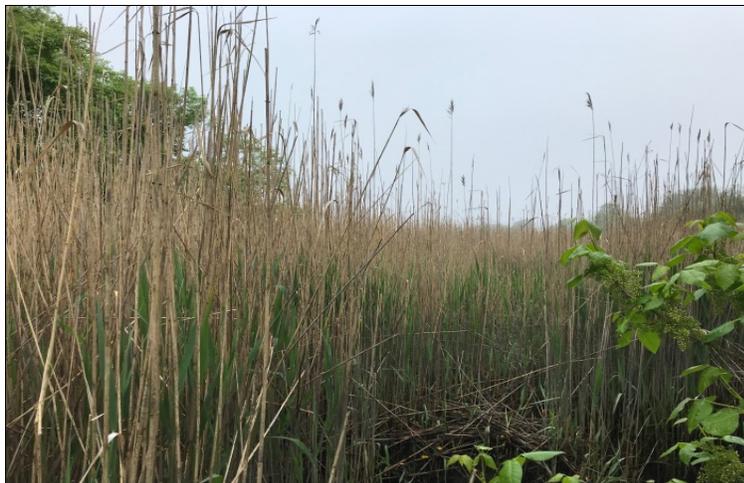
**Figure 50: A dense stand of the invasive common reed (*Phragmites australis*) dominates the immediate downstream area at site B26.**

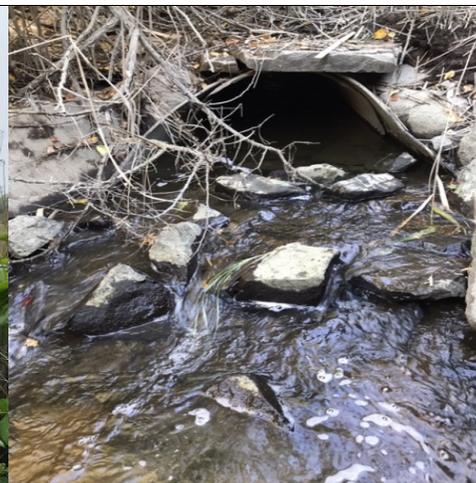
**Figure 51: The downstream creek has an area of rip rap that is creating a cascade from the culvert and resulting in increased water flow velocity at site B26.**

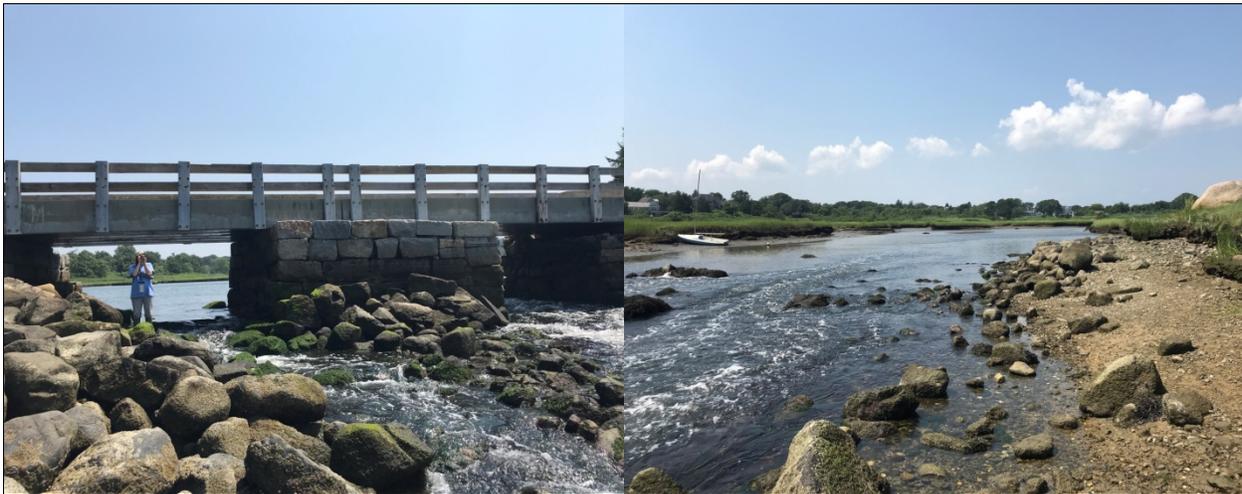
**Figure 54:** A stone support splits the bridge opening into two passageways for water flow and the bridge is heavily armored with large rocks on both sides at site Y1.

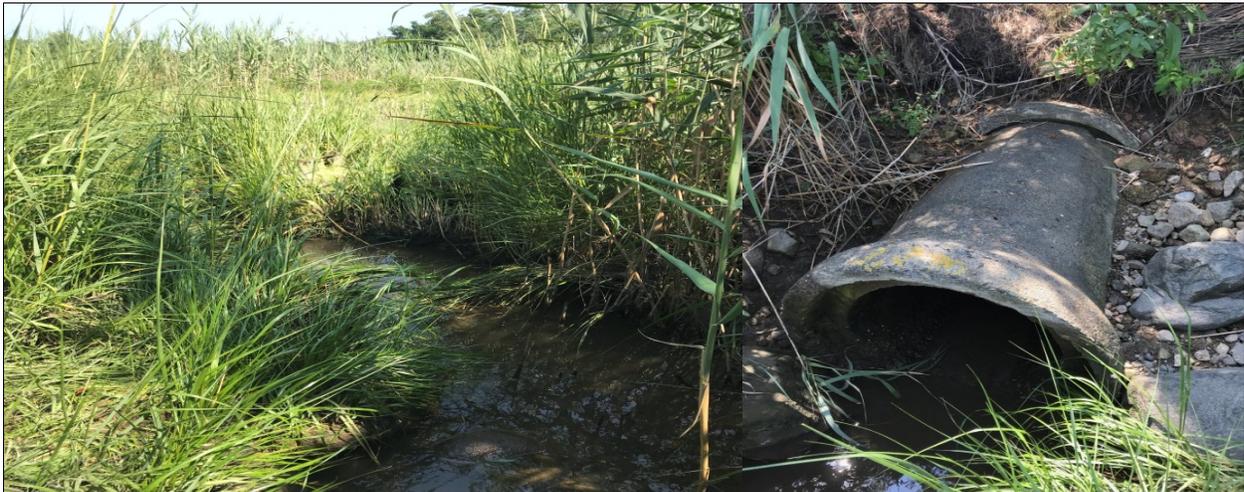
Figure 57: The invasive common reed (*Phragmites australis*) is abundant on the upstream side of site Y2 with minor abundance on the downstream side.

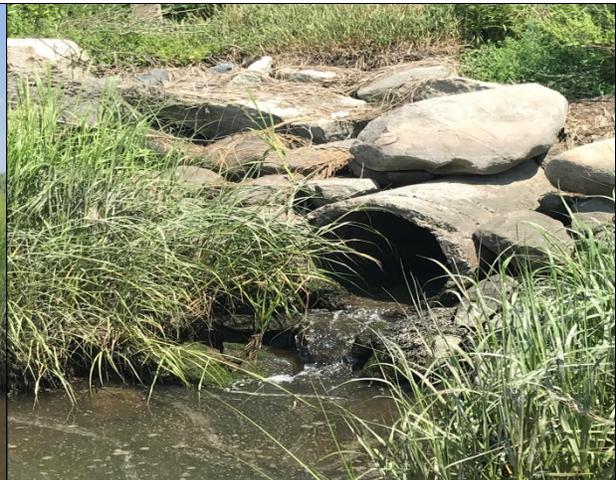
**Figure 60: The downstream structure is armored with stone and is perched above the creek at low tide at site Y2.**

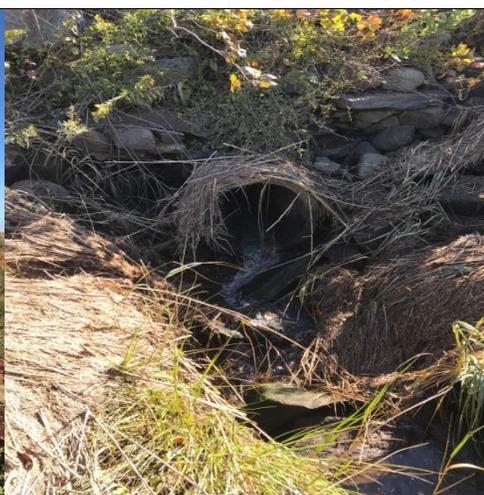
**Figure 64:** The downstream culvert was covered in wrack and is perched above a cascade caused by rip rap placed directly beneath the structure and continuing for some distance downstream at site Y3.

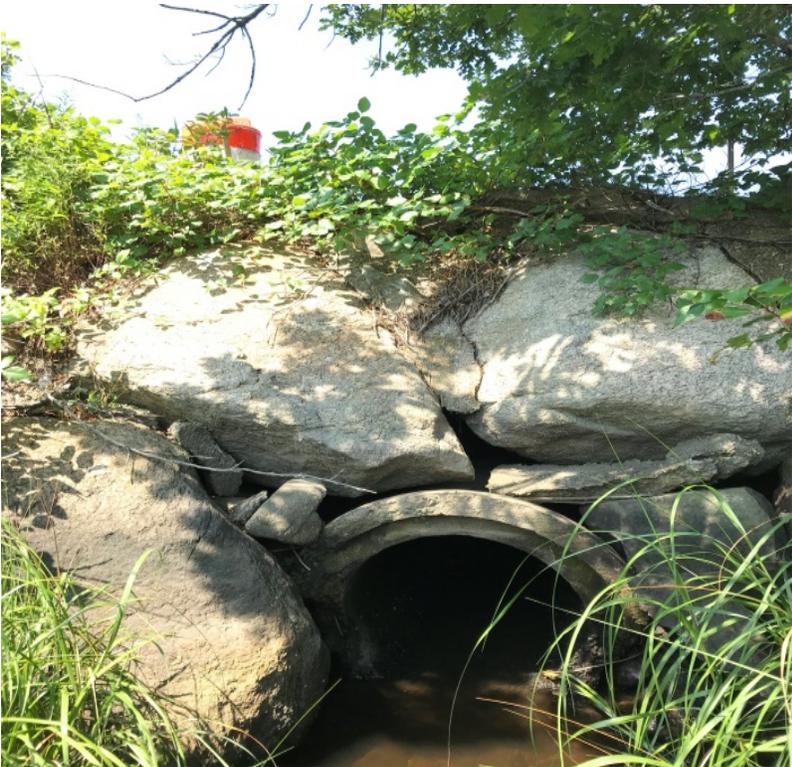
Figure 66: The upstream culvert has stone placed around the opening, and is beginning to deteriorate, especially the lower half of the structure at site Y3.

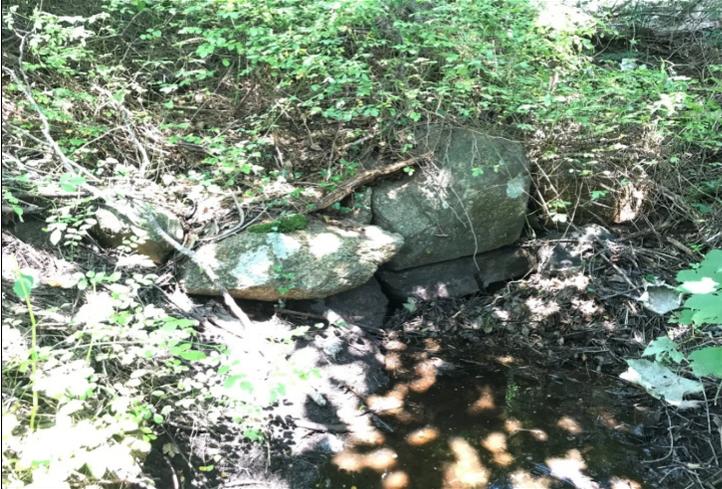
**Figure 69:** Field observers were unable to identify what kind of structure was covered by the stone at site Y4, shown here on the upstream side. Due to the small opening beneath the stone, debris has accumulated at the crossing.

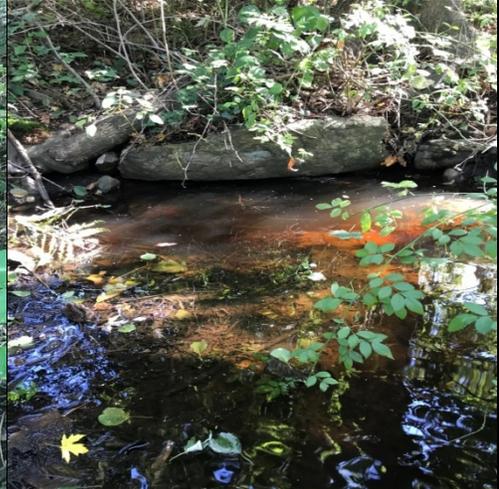
**Figure 70:** Much like the upstream structure, there is stone covering the downstream opening at site Y4. At the time that the crossing was assessed, very minimal water flow was observed through the structure.
