*Massachusetts Coastal Infrastructure
Inventory and Assessment Project
Coastal Hazards Commission*

South Coastal

Swansea
Somerset
Westport
Dartmouth

July 6, 2009

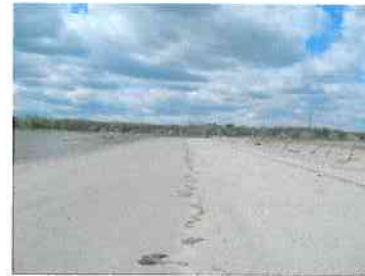
Sandy beach with some areas of 1 foot diameter cobbles, that shows signs of recent beach nourishment. Behind is a parking lot and houses. There is no sign of erosion or storm damage.

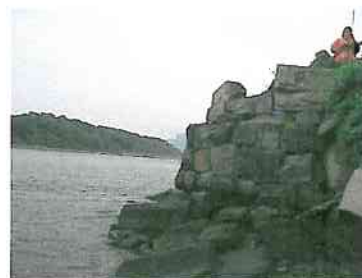
The stone block seawall has stones that are approximately 4 feet by 2 feet by 2 feet in size. The wall has failed and fallen on top of itself at one side. The stones have fallen off throughout. There is no sign of scour. There is a small gravel beach in front and adjacent to the structure.

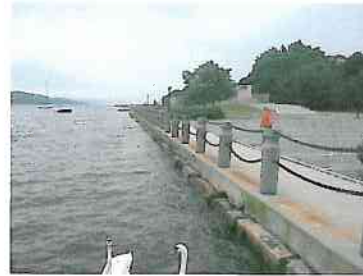
The stone blocks are approximately 3 feet by 1 foot in size with a concrete walkway above and parking lot behind it. There is a boat ramp located at one end of the structure. There is some stone settling, and a few stones are missing. There are areas of erosion and undermine.

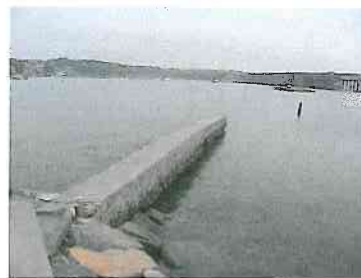
The breakwater is in place to protect the boat ramp. The structure is 2 feet wide, constructed of cobbles and mortar. There is some section loss and scour at the base of the structure. There are also cracks in the mortar.
