LINDEMANN MENTAL HEALTH CENTER

Programming & Renovation Feasibility Study
October 2023

Division of Capital Asset Management and Maintenance (DCAMM)
Department of Mental Health (DMH)

Prepared by **ICON Architecture**

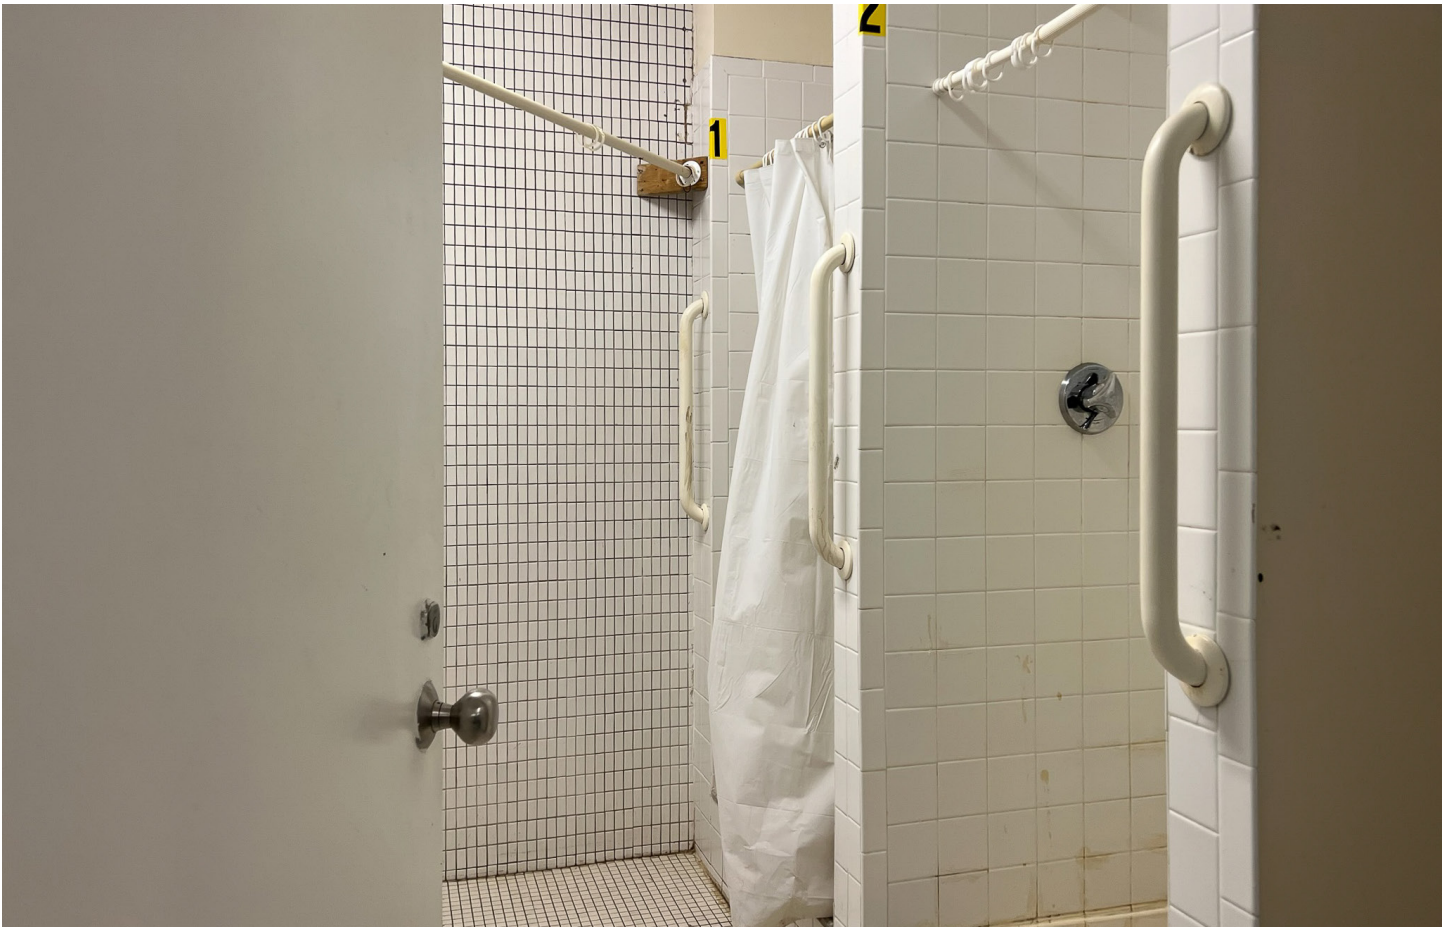
Figure 1.7. Existing Co-Ed Shelter Shared Shower Room in Lindemann Building

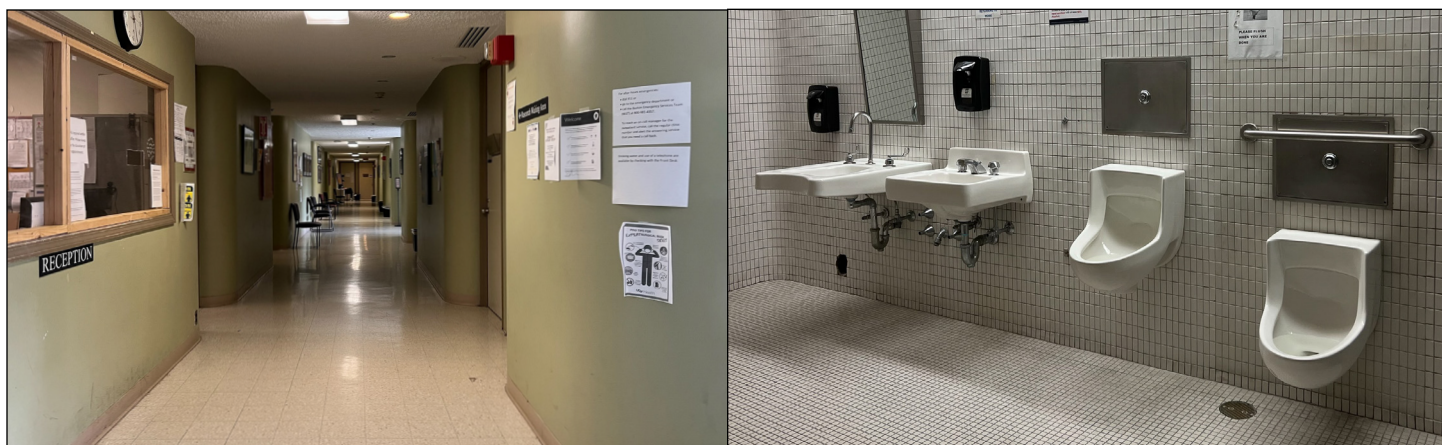
Figure 4.16 Existing Lindemann Building Spaces on Plaza Level (From Left to Right): Offices Hallway, Restrooms

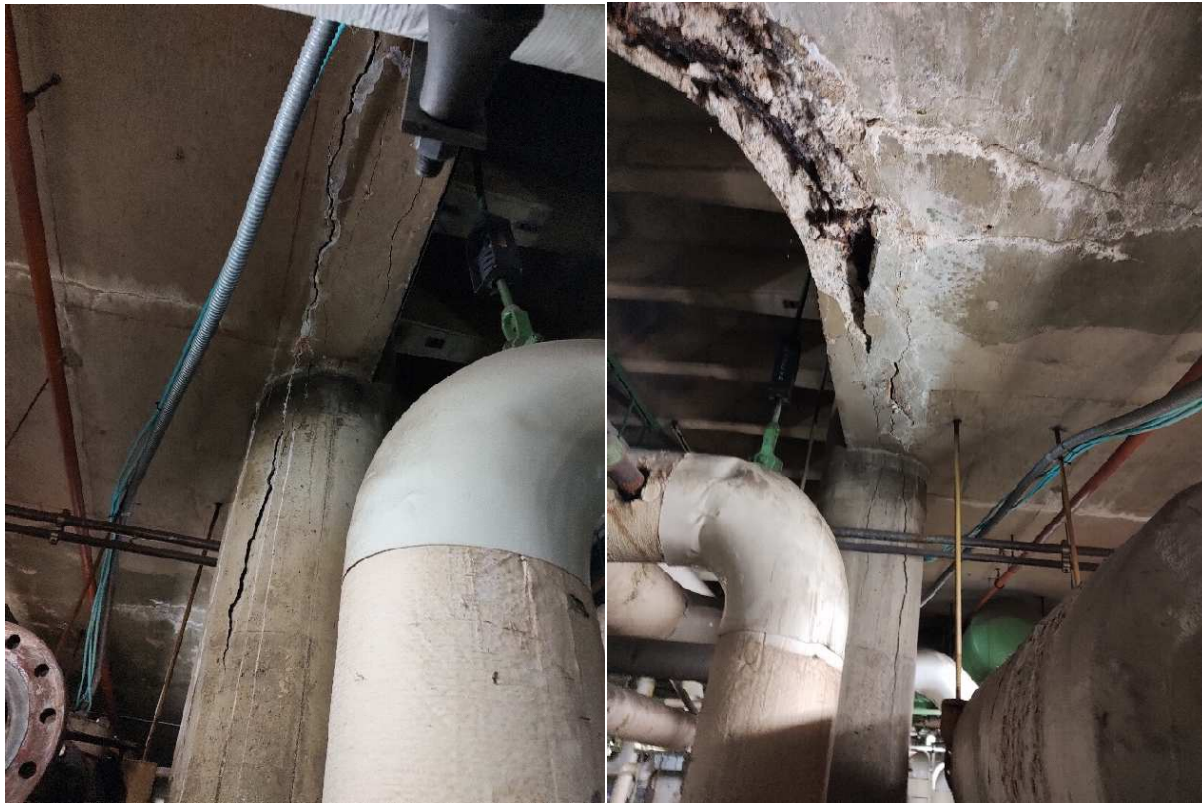
- 1) On the mezzanine level ramp, the existing concrete beam and column between B and E north of gridline 60 appeared to be in very poor condition. Much of the reinforcing steel had lost section, and much of the concrete cover had spalled off. There is also a longitudinal crack that propagates through the beam as well as column. Some of the cracks are nearly 3/4" wide. We recommend the owner to retain an engineer to evaluate, shore, and repair this condition as necessary. This work should be done as soon as possible.

Figure 1A&B – Cracking and spalling of the concrete column and beam on the mezzanine floor ramp.

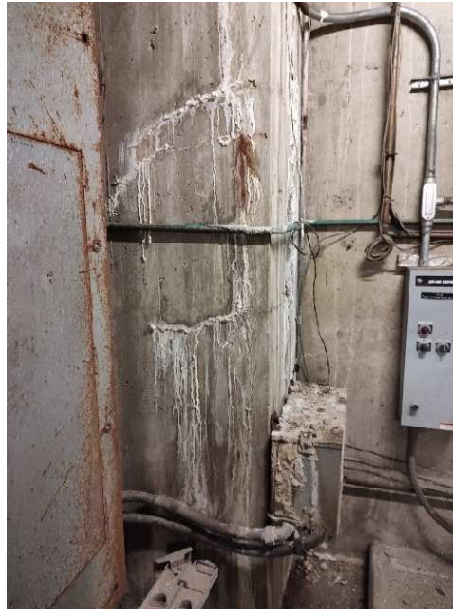
- 2) Water infiltration is observed on the ground floor walls and columns in mechanical room 2. We recommend addressing the source of water infiltration to prevent further corrosion and concrete damage.

Figure 2 – Water infiltration through the cracks of the concrete column.

3. Mechanical Room 2 has water infiltration and deterioration resulting in significant cracks in the structural beams and columns. The team recommends immediate evaluation of this area for shoring and/or repair of this condition as necessary.
4. The team understands that there is a proposal to replace the electrical FPE switchgear. Additionally, the team recommends that the Motor Control Centers and all the core electrical panels also be replaced.”
5. Fan coil units should be replaced.
6. A comprehensive design for building wayfinding is recommended to improve orientation and access.

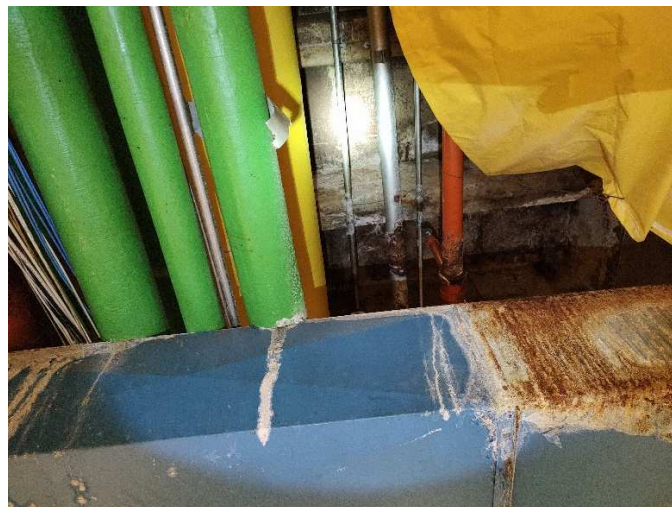
- 3) Water infiltration is observed from underside of the plaza and mezzanine level slabs. The water infiltration has corroded some of the ribbed joists. These joists will require structural repair. Structural repair will likely entail chipping out the bottom of the rib, splicing on new rebar, and patching the concrete.

Figure 3 – Bottom of the concrete rib is cracked, and rebar is experiencing section loss.

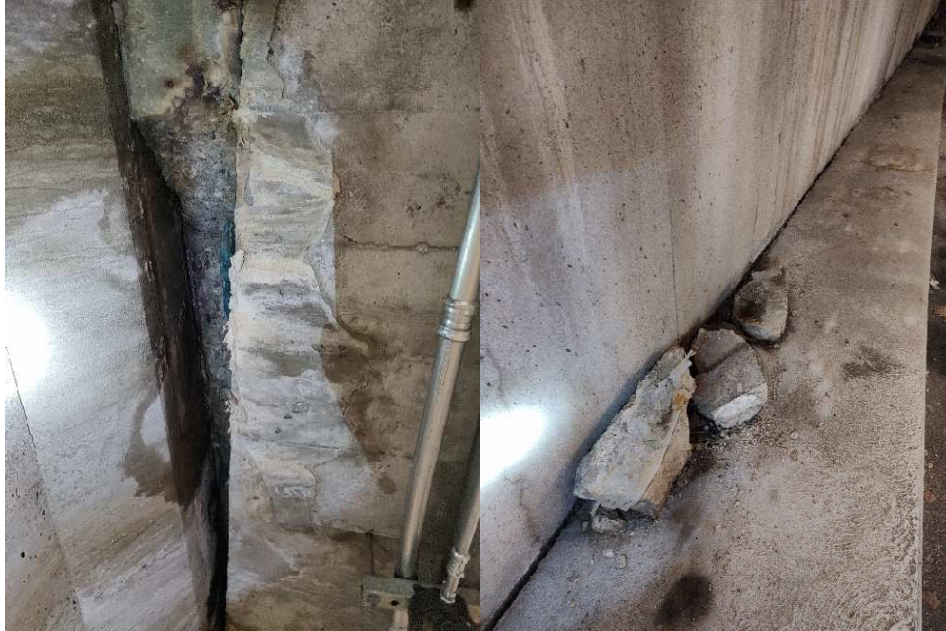
- 4) At the garage, many locations were experiencing spalling concrete. Most of the locations only require chipping off loose concrete, cleaning the reinforcing steel, and patching with a bonding agent. Most locations do not require structural rebar repair.

Figure 4 A&B – Spalled concrete at the garage.

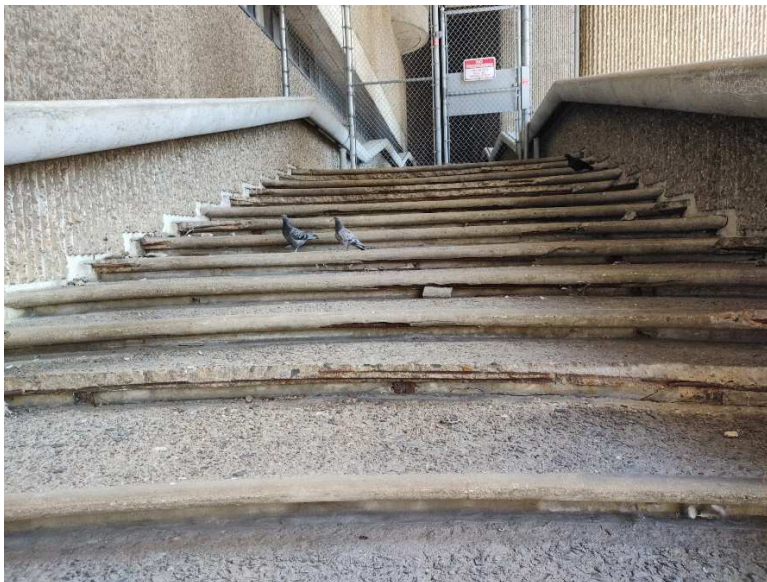
- 5) At the exterior stairs, many of the stair treads have nosing bars that have improper cover. The nosing bar has corroded and spalled off the concrete. We recommend chipping out the entire stair nosing and re-casting the stair nosing.

Figure 5 – Stair nosings are spalled.

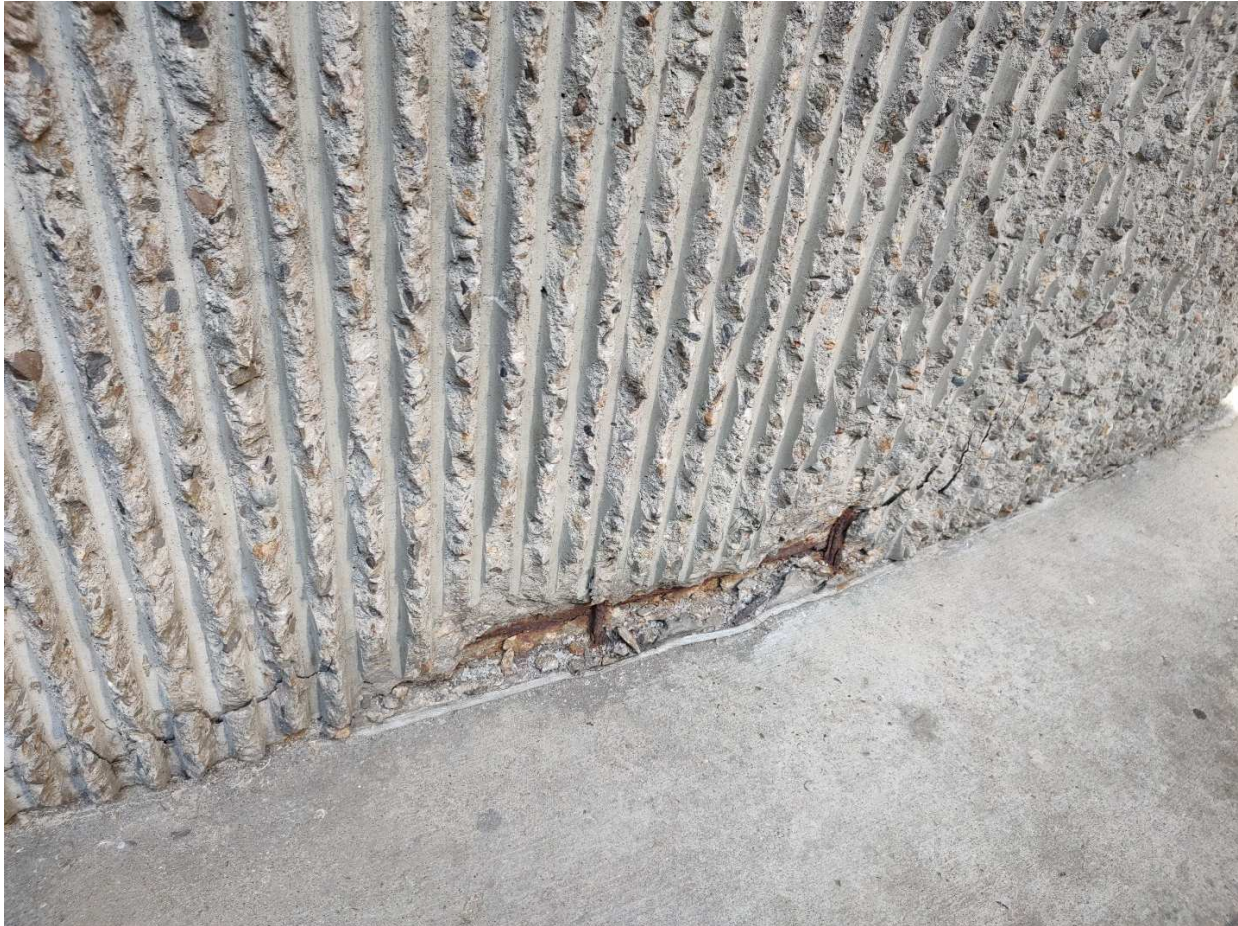
- 6) At the exterior face of the building, there are many locations where the reinforcing steel has improper coverage. At these locations, the rebar has rusted, and spalled the concrete. We recommend chipping and patching around rusted areas. The deterioration is worst near the plaza levels where they are exposed to the most de-icing salts.

Figure 6 – Corroded wall reinforcing near the sidewalk due to improper concrete coverage.
