***South Shore Coastal Infrastructure Inventory
and Assessment Demonstration Project
Coastal Hazards Commission***

Town of Duxbury

February 28, 2007

**Presented by:
Bourne Consulting Engineering
Franklin, Massachusetts**

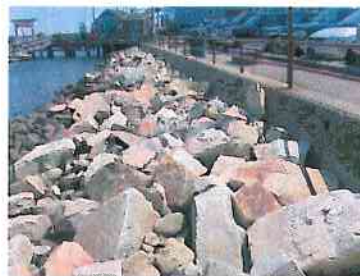
Revetment slope (100-500 lbs. stone) for 15' width in front of concrete seawall with railing (parking lot behind). Minor spalling.

*Condition***B***Rating***Good***Level of Action***Minor***Description*

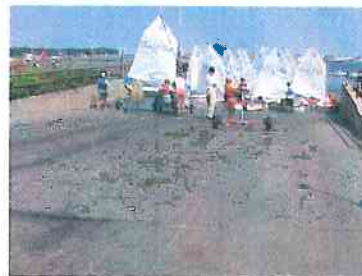
Asphalt boat ramp with concrete sidewalls. Some deterioration at outshore corners of concrete walls.

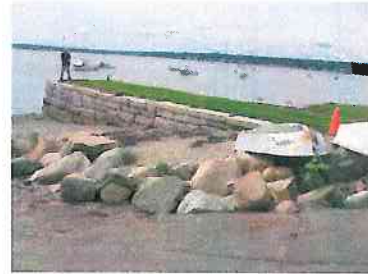
Stone block seawall (dryset) forming filled wharf. Minor voids in wall, but no movement or rotation of stones observed. Minor fill loss noted.

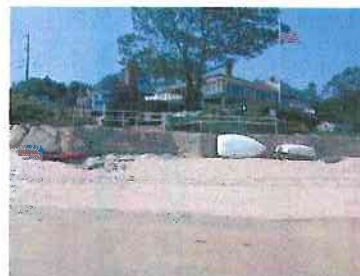
Stone seawall with mortared joints and stairs to access beach. Steel railing is deteriorated. Some cracks and voids in mortar in joint. Appears to have concrete footing buried and is connected to private seawall on one side.

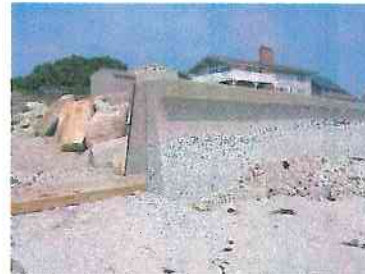
Concrete seawall in satisfactory condition with some cracking for full height of front outshore face. Some deterioration at joints. 30" wide wall with wave return face. 2' high x 6' wide revetment along face (1 ton stone)

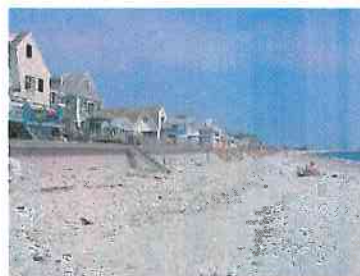
Concrete seawall in satisfactory condition with some vertical cracks for full height of front face. 30 inch wide wall with wave return face.

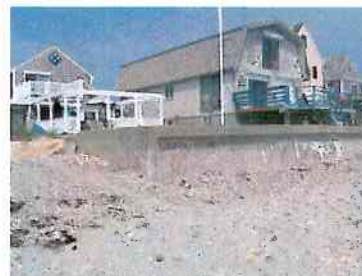
Concrete seawall in fair condition with cracking and spalling. Built 30 inch wide with wave return face.

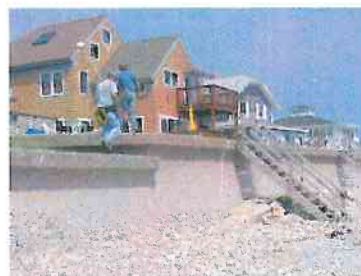
Concrete wall in fair condition. Evidence of lateral movement and slight tilt to outshore. Appeared to have failed previously and revetment (average 1 to 2 ton stone) placed along outshore face to stabilize.

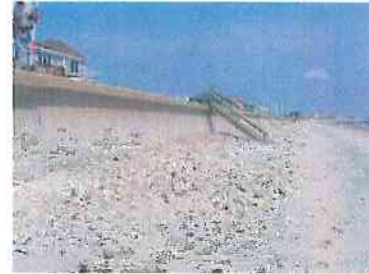
Concrete seawall in satisfactory condition with some minor cracking. Wall built with 30" wide cap and wave return face.

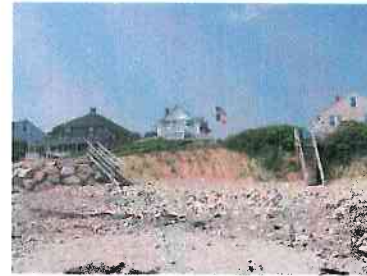
Historic DCR documents indicate bulkhead construction at location. No evidence of bulkhead found. Currently, cobble beach with dune (approximately 10 feet high) inshore. Erosion of material landward of historic bulkhead line. Temporary stabablization to prevent fill loss at ends of adjacent structures.

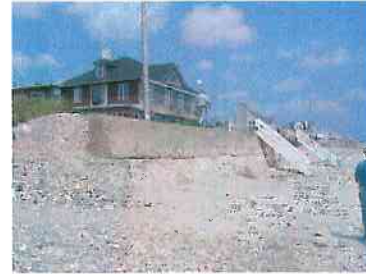
First 50' is precast concrete seawall in fair condition with horizontal joint at mid-height. Concrete cracking and spalling near wall top and apex of curve. Remainder of structure is condition "B" with minor cracking (construction similar to adjacent structures)

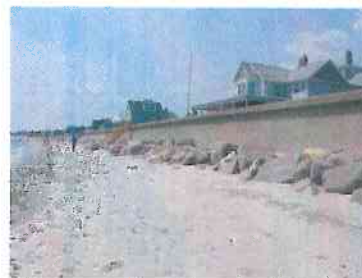
Concrete seawall with 30" cap and wave return face. Revetment is 3' to 4' high x 6' to 8' wide with stone size 1 ton to 2 ton. Horz. Movement of about 3 wall sections (40'ea = 120' total) Horizontal cracking at wall mid-Height
