*Massachusetts Coastal Infrastructure
Inventory and Assessment Project
Massachusetts Department of Conservation and Recreation
Office of Waterways*

Outer Cape Cod - North

July 6, 2009

MASSACHUSETTS COASTAL INFRASTRUCTURE INVENTORY AND ASSESSMENT PROJECT

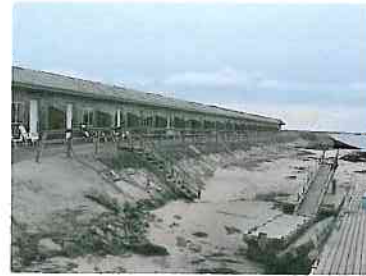
Placed stone riprap at a 1 on 2 slope. Stones are 3 feet by 2 feet by 2 feet on average. No visible scour. There has been many asphalt and concrete repairs. Behind is a hotel.

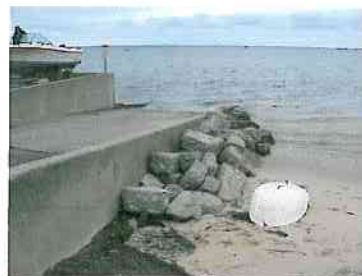
Concrete wall with sand beach in front. Parking lot and houses behind. No visible signs of erosion. Has ramp and riprap in front. There are concrete slabs in front of the riprap and stone. The slabs are 4 feet by 4 feet. Minor cracking on wall.

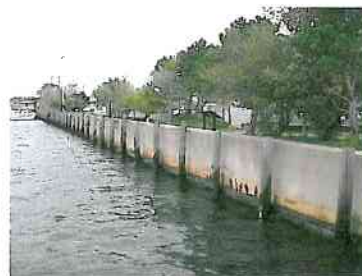
Sheetpile bulkhead is cased with concrete. There is moderate cracking and spalling on the concrete. Attached to the bulkhead is two piers. Behind is parking and buildings.

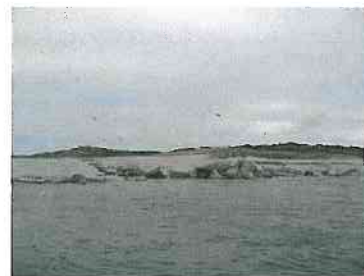
Placed stone jetty at the inlet of Pamet Harbor. Structure is heavily deteriorated. There is visible stone movement and section loss. Stones are 3 feet by 2 feet by 2 feet on average.

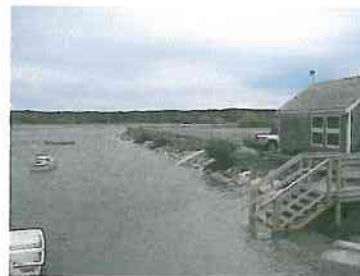
Placed stone riprap. Stones are 2 feet by 2 feet by 2 feet. There are many areas of concrete and asphalt repair. There are signs of stone movement, undermining and minor scour. There is a boat ramp in the middle of the structure.

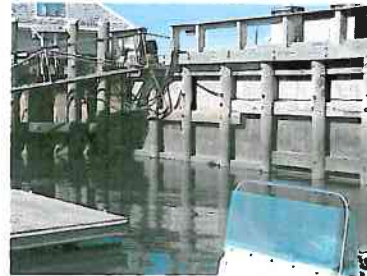
The timber bulkhead is in good condition. There is no visible deterioration. The timber piles and overlapping wales are in front to support the bulkhead. Gangways extend off the timber cap. A rail is along the cap. A parking lot with gas pump and storage for the boats is behind the structure.
