# Mass Central Rail Trail Evaluation of Existing Bridges

## Wayside Branch - Waltham to Berlin

### Summary of Evaluation

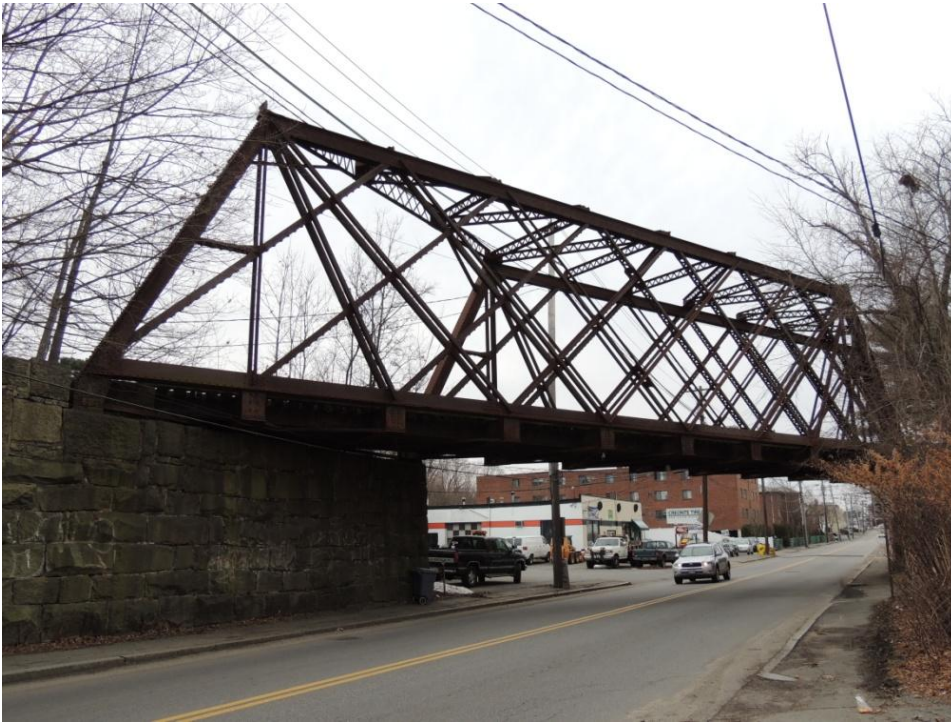
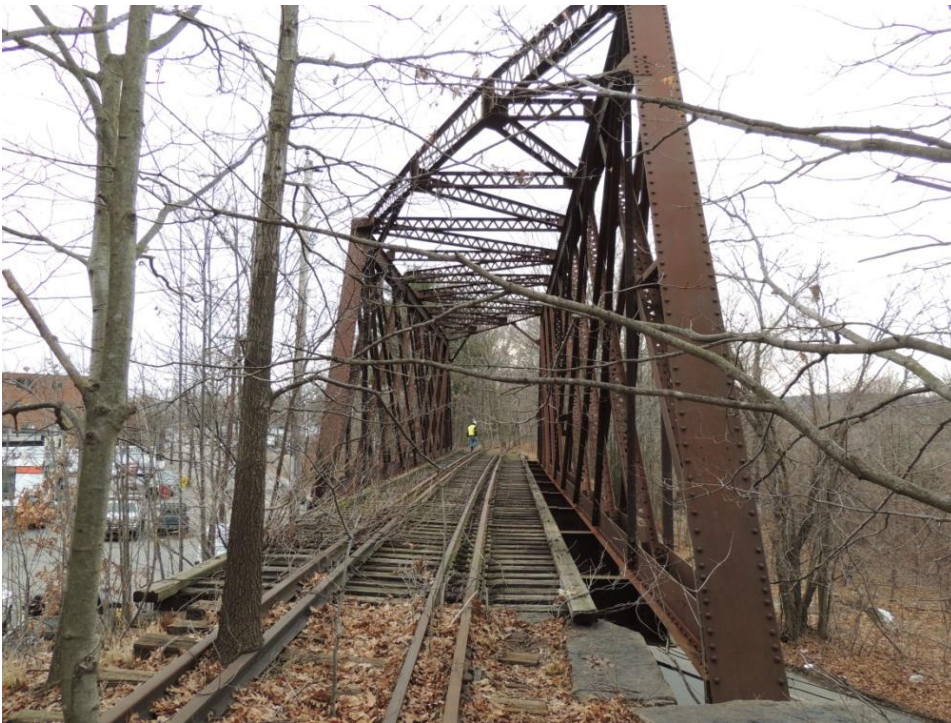
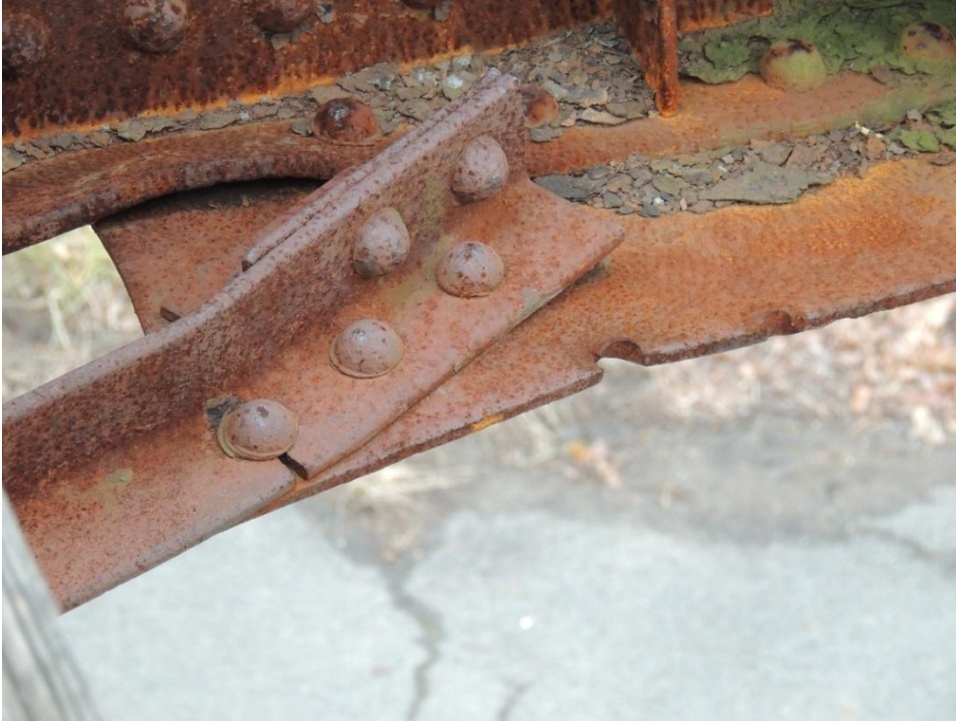
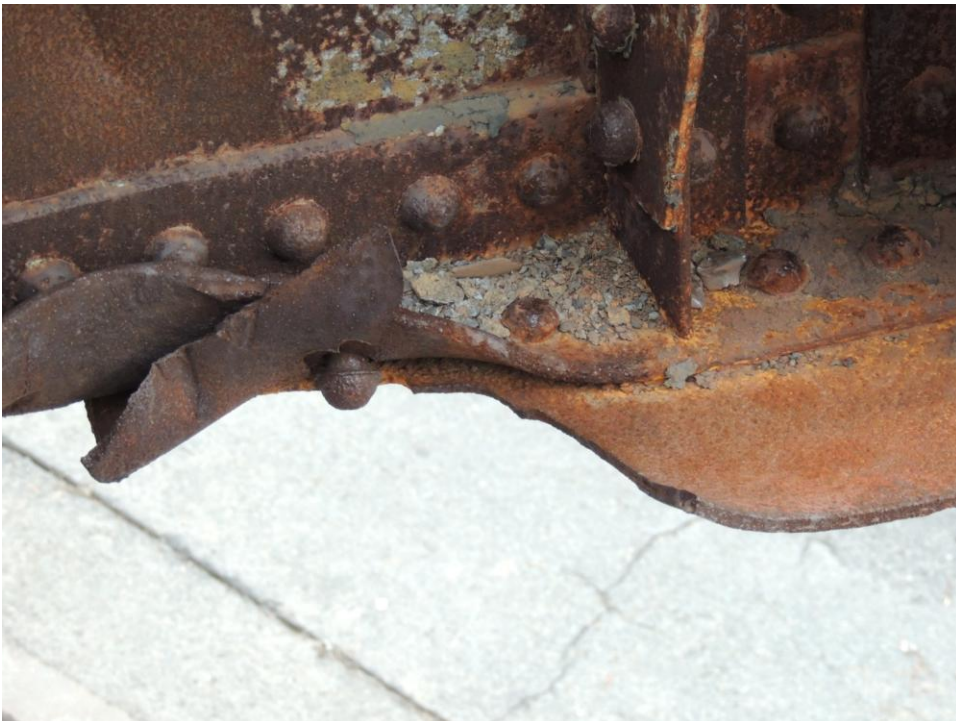
Linden Street, Waltham: 1894 Riveted Lattice Thru Truss on Stone Abutments

- Some minor impact damage to secondary bracing members under the deck
- No paint remaining on the steel
- Cracked, loose and missing mortar in the stone abutments

- Remove and dispose of existing timber ties and steel rails
- Repair bent, cracked/ broken gusset plates and bracing angles
- Clean and paint steel
- Replace mortar joints in the abutments
- Construct new concrete bridge deck, curbs and bridge railings (a concrete slab with curbs is recommended since this bridge is over roadway and pedestrian traffic to prevent ice hazards below)

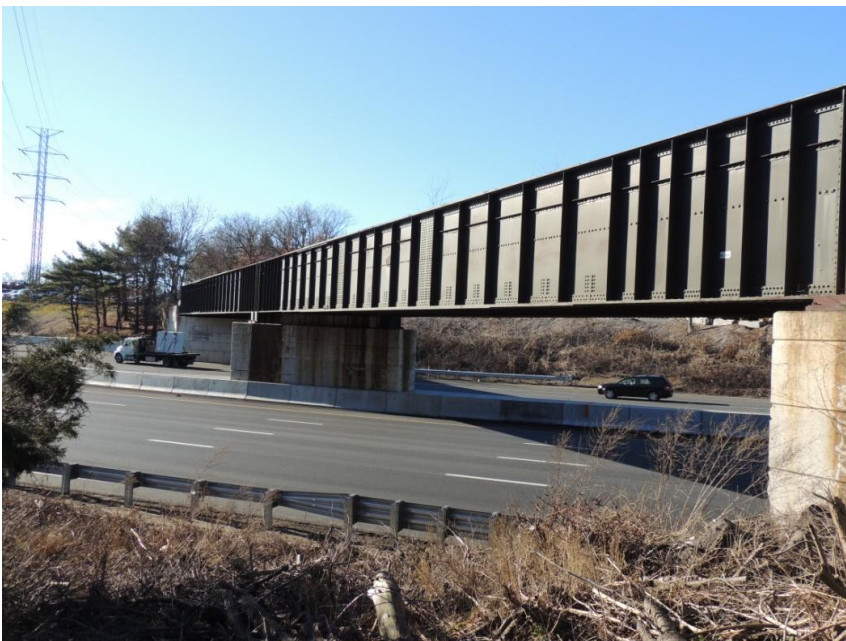
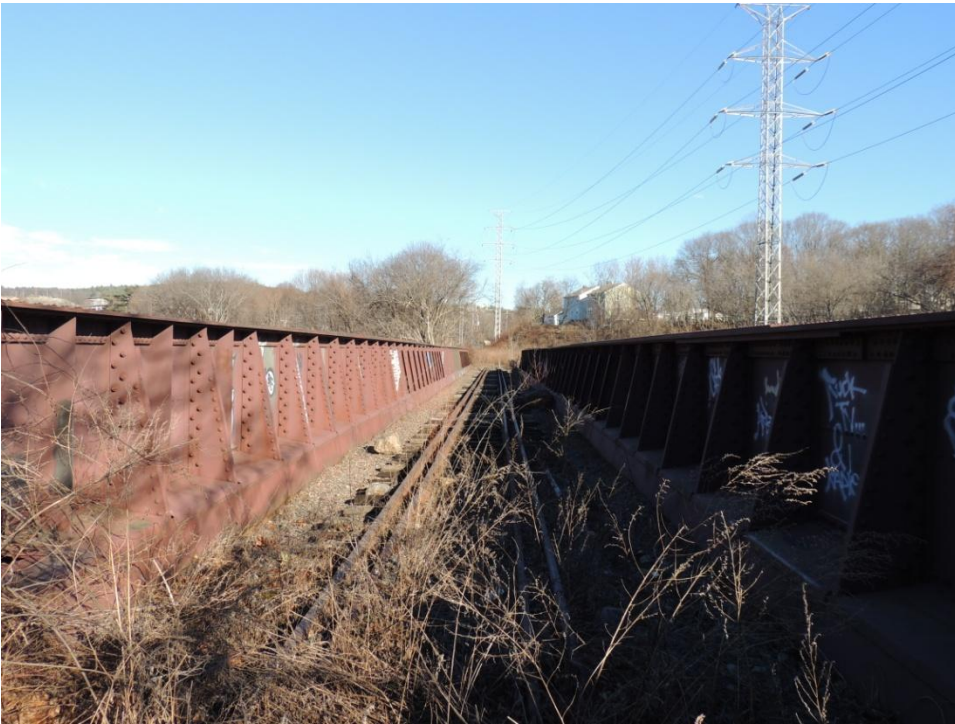
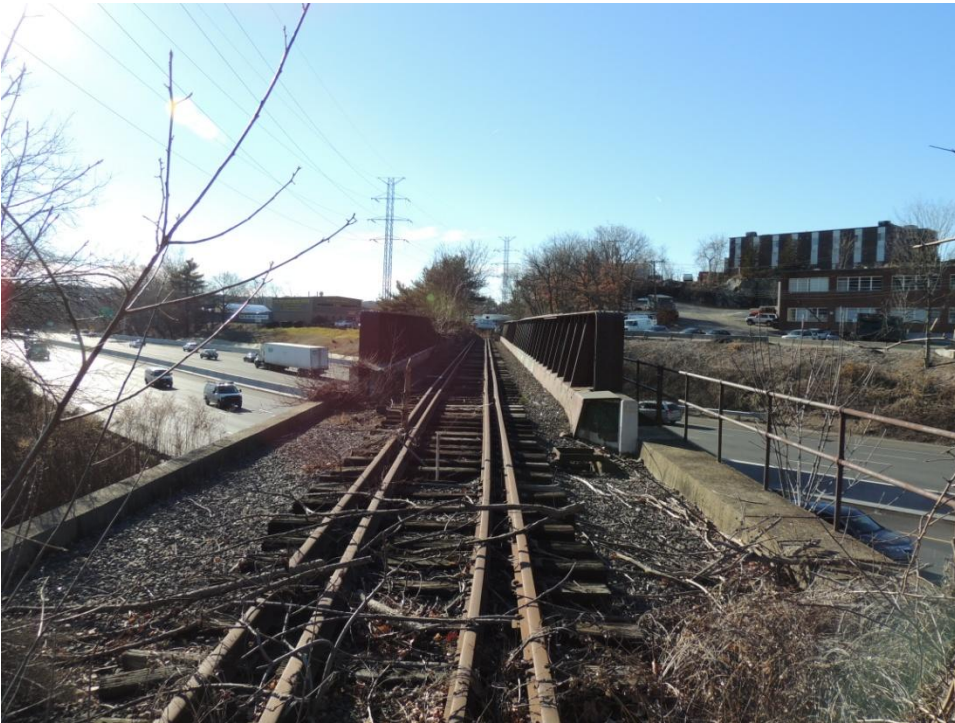
## Route 128, Waltham: 1960 Two Span Thru Plate Girder on Concrete Abutments and Pier

- Paint is in fair condition, except for graffiti on the inside face of the both girders and on the outside face of the north girder (accessible by a catwalk). The underside of floor beams, diaphragms and deck plate has peeling paint. Bridge was last painted in 1988.
- Verify adequacy of existing bridge drainage, make upgrades as required.

- Remove and dispose of existing timber ties and steel rails
- Clean and paint steel (cover graffiti surfaces only), entire structure will require future painting
- Upgrade bridge drainage system
- Pave pathway over the bridge
- Install a timber guardrails along the inside face of the girders
- Remove the catwalk along the north side of the bridge (potential safety hazard)

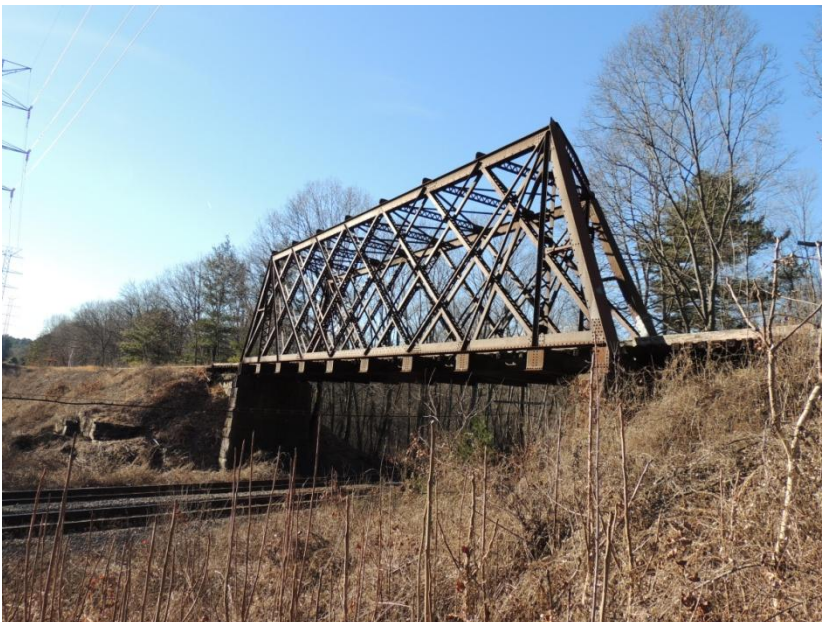
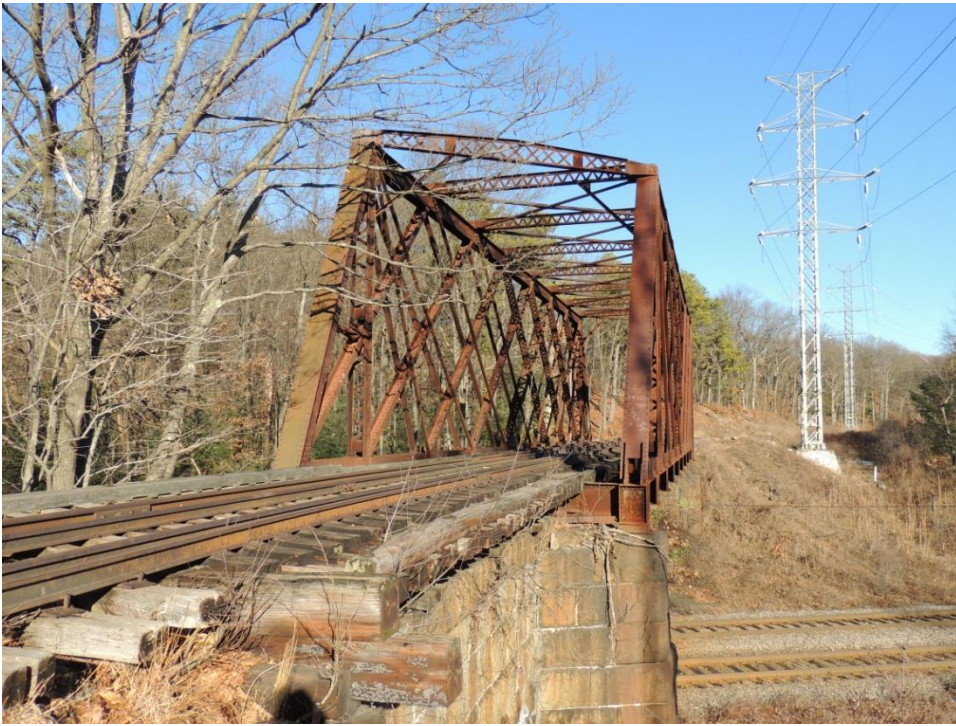
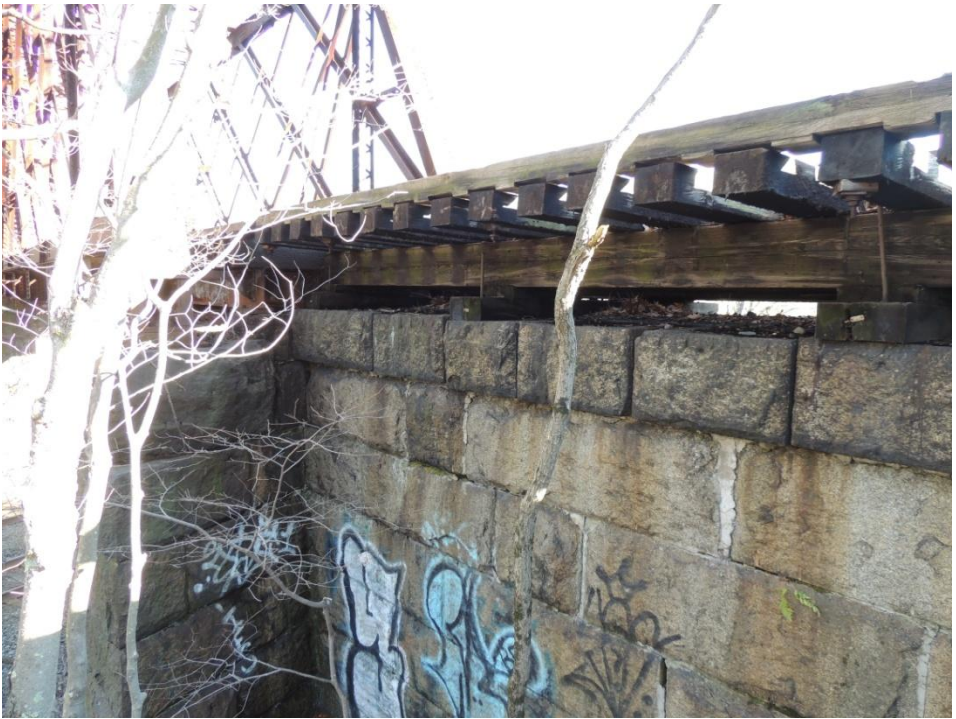
## Over MBTA Fitchburg Line, Weston: 1896 Riveted Lattice Thru Truss on Stone Abutments

- No paint remaining on the steel
- Cracked, loose and missing mortar in the stone abutments and wingwalls
- Timber ties are in fair condition, but will need to be replaced to widen the bridge deck

- Remove and dispose of existing timber ties and steel rails
- Clean and paint steel
- Replace mortar joints in the abutments
- Construct new timber bridge deck and railings
- Construct new backwalls/wingwalls to facilitate widening of the bridge deck to 14 feet

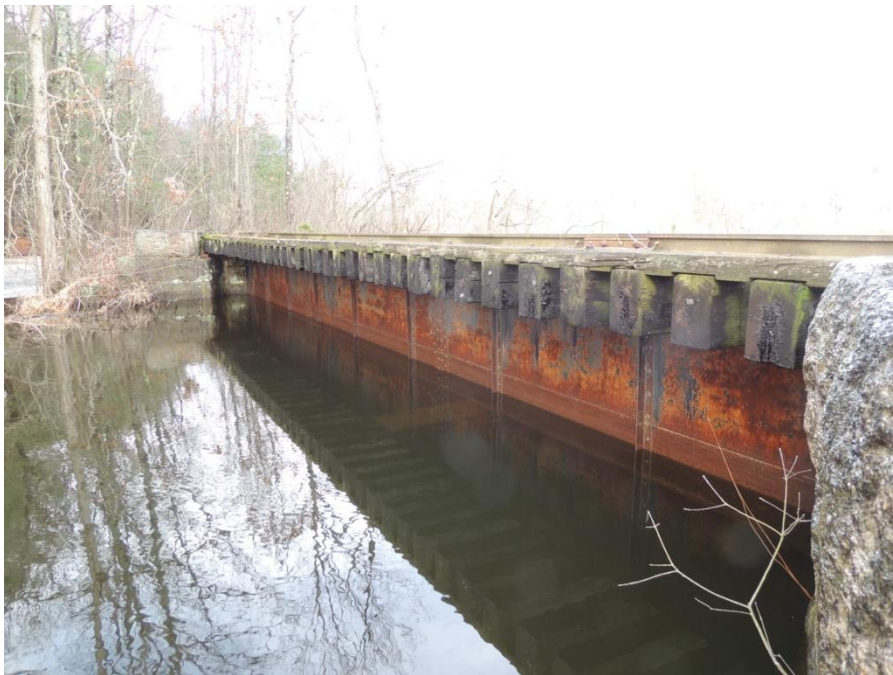
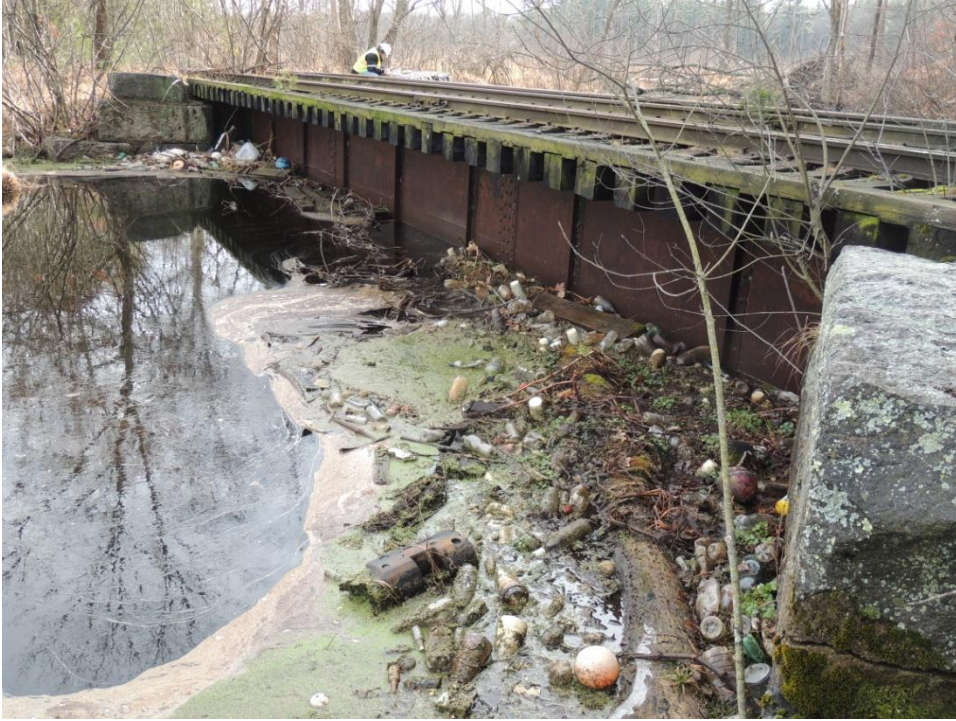
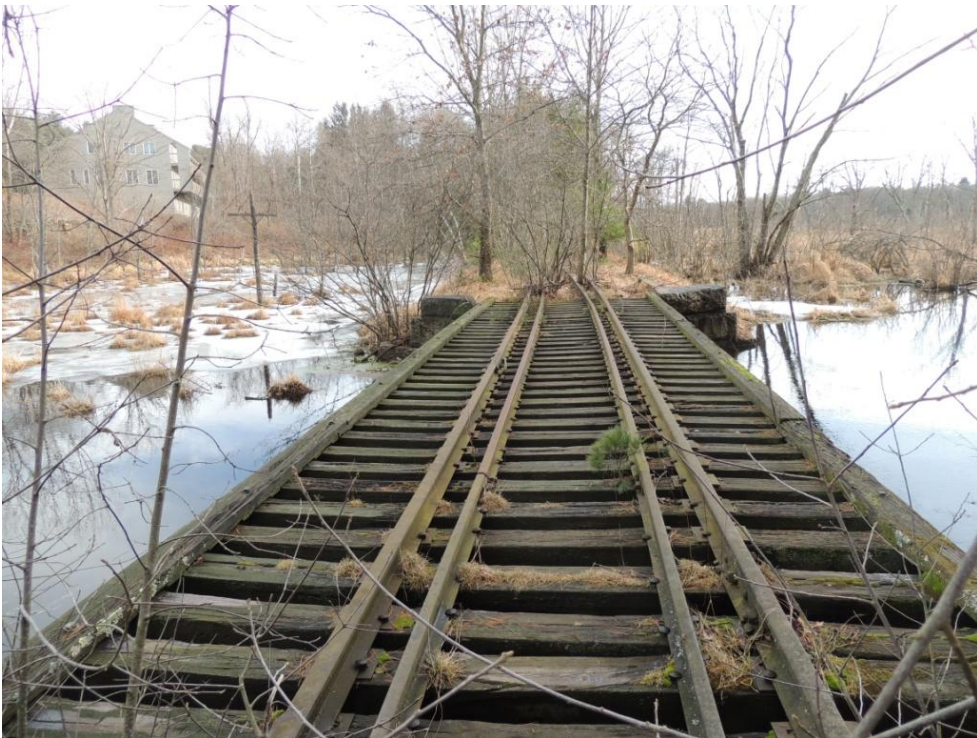
## #127 Hop Brook, Sudbury: 1881 Riveted Plate Deck Girder, Stone Abutments, Timber Piers

- Bottom of Girders are submerged (possibly due to flooding of wetland from beaver dams)
- No paint remaining on the steel
- Timber ties are in poor condition, and will need to be replaced to widen the bridge deck
- Condition of abutments and intermediate piers cannot be determined due to flooding

- Investigate the cause of flooding and rectify if possible
- If water level cannot be lowered, the bridge seats need to be raised and the girders reset (this will require considerable additional costs for raising the approach pathway profiles to meet the new bridge deck elevation)
- Remove and dispose of existing timber ties and steel rails
- Complete miscellaneous repairs to steel as required
- Clean and paint steel
- Install new timber transverse beams
- Construct new timber bridge deck and railings
- Replace mortar joints in the abutments
- Construct new backwalls/wingwalls to facilitate widening of the bridge deck and approaches to the proposed 14 feet trail width and raising of the bridge deck elevation and approaches
- Repairs/ replacement of intermediate piers

For this bridge an alternative option to rehabilitation of the existing superstructure is proposed; installation of a new superstructure that would allow for adequate freeboard under the span, with a comparable cost to rehabilitation of the existing superstructure.

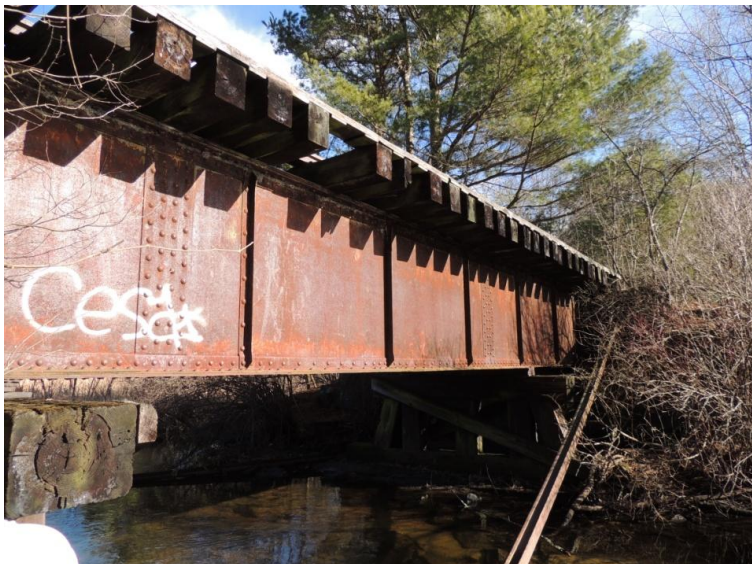
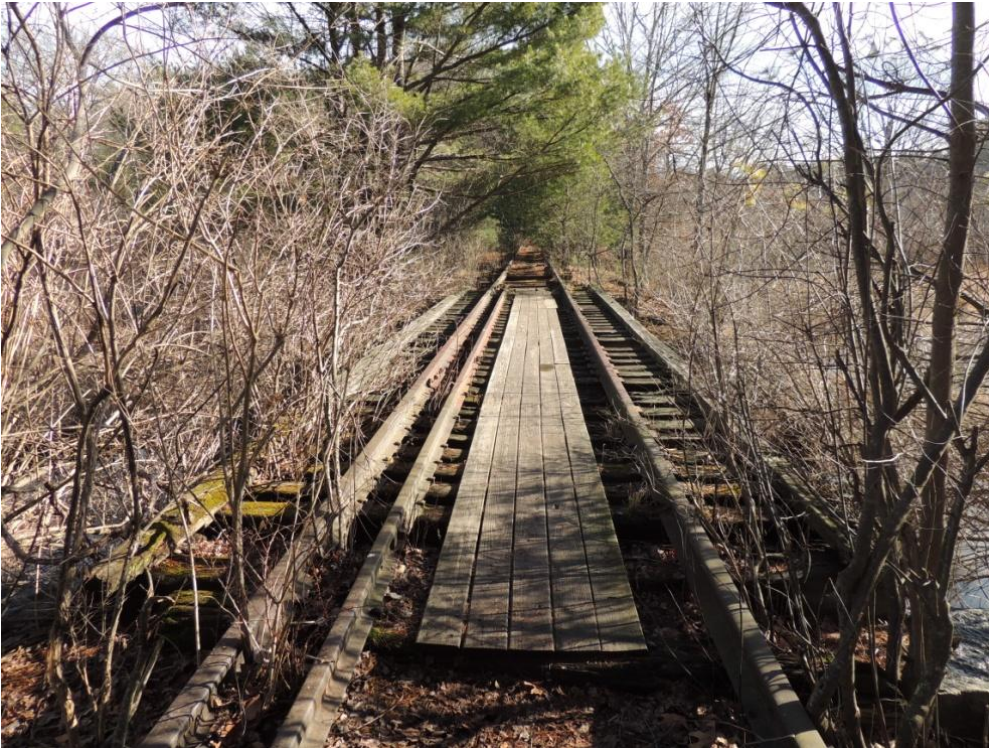
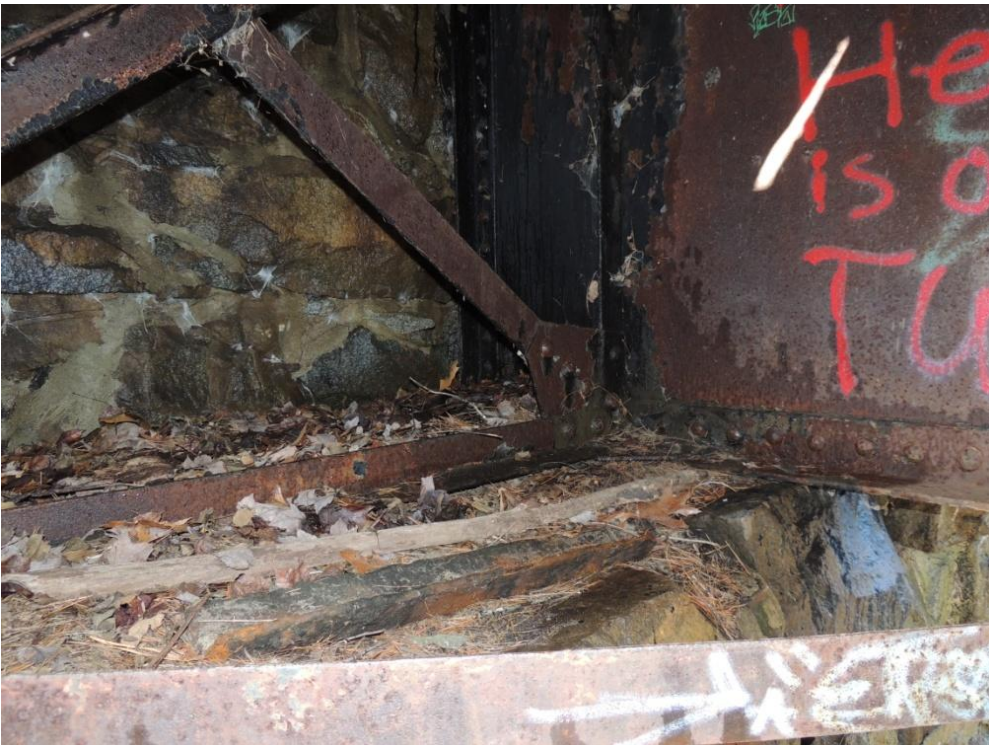
## #128 Hop Brook, Sudbury: 1881 Riveted Plate Deck Girder, Stone Abutments, Timber Piers

- No paint remaining on the steel, graffiti on inside faces of girders
- Timber ties are in poor condition, and will need to be replaced to widen the bridge deck
- Damp debris on bridge seats
- Missing, loose mortar joints in the stone abutments
- Ends of timber pier caps display some decay

- Remove and dispose of existing timber ties and steel rails
- Complete miscellaneous steel repairs as required
- Clean and paint steel
- Replace mortar joints in the abutments
- Repair/replace pier caps
- Modify backwall to facilitate widening of bridge and approach to the proposed 14 feet trail width
- Construct new timber bridge deck and railings

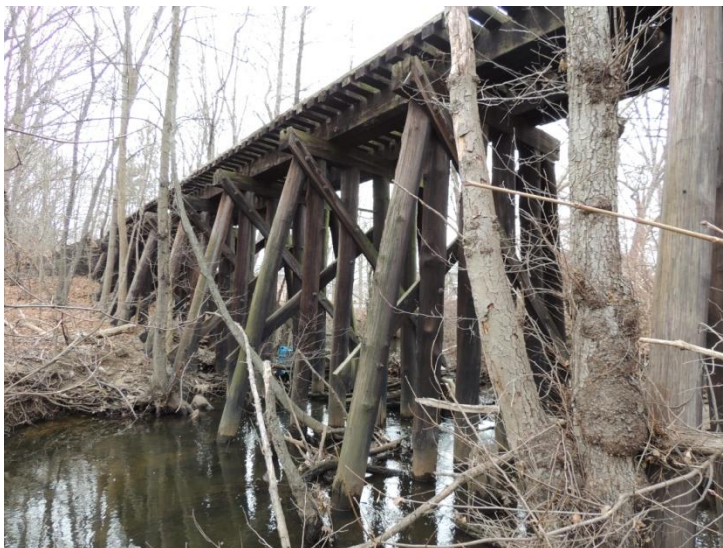
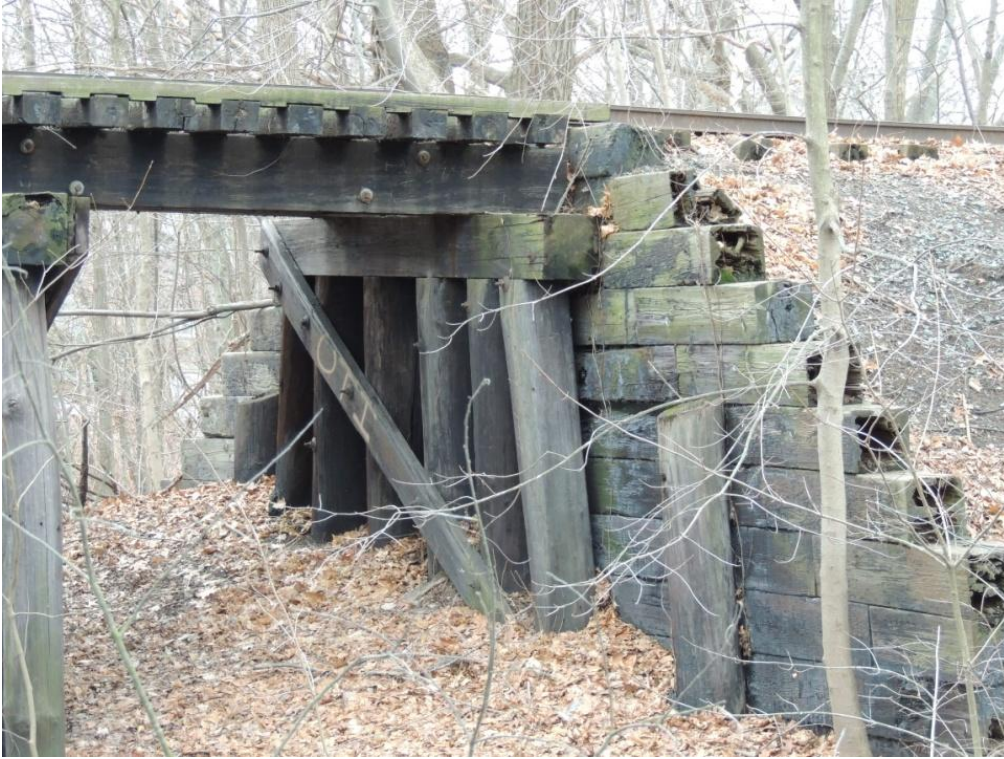
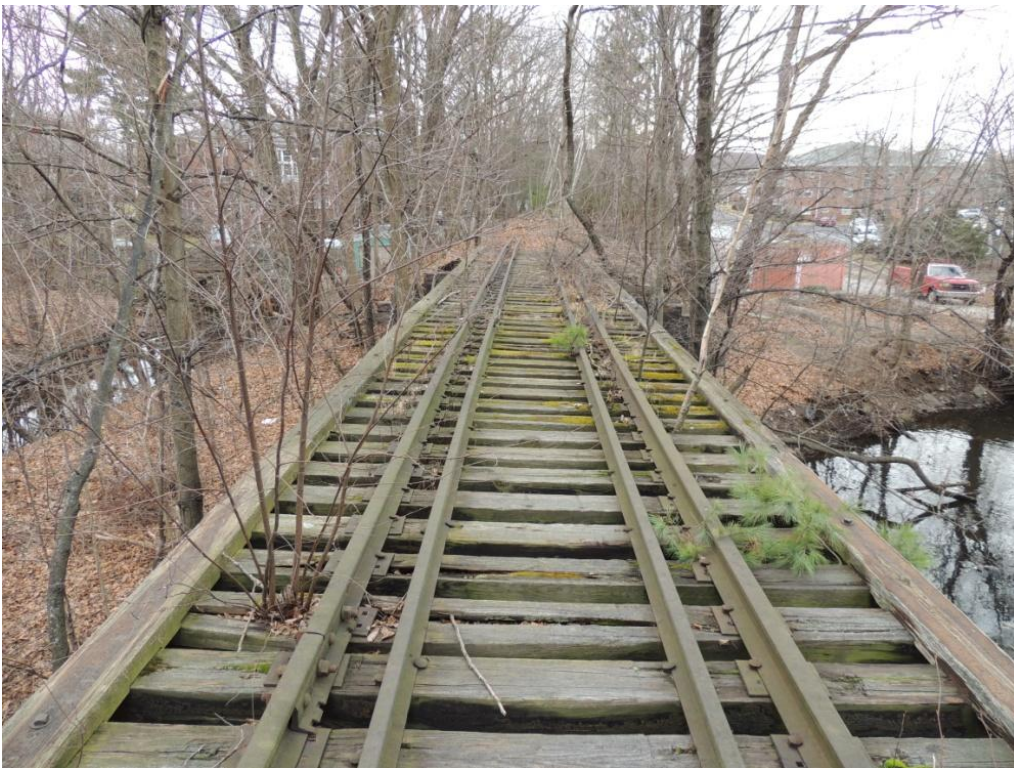
#### Clematis Brook, Waltham: Timber Pile Trestle (open timber tie deck)

- Timber ties are in poor condition, and need to be replaced to widen the bridge deck
- Timber backwalls have decay and need to be replaced
- Ends of timber pile caps display some decay
- Accumulating debris in stream is against the upstream side of the timber pile bents

- Remove and dispose of existing timber ties and steel rails
- Remove timber backwalls and reconstruct new backwalls and wingwalls to support backfill
- Repair/ replace timber pile caps as required
- Clear stream bed of accumulated debris against the pile bents
- Install new additional longitudinal timber beams and construct new timber deck and railings

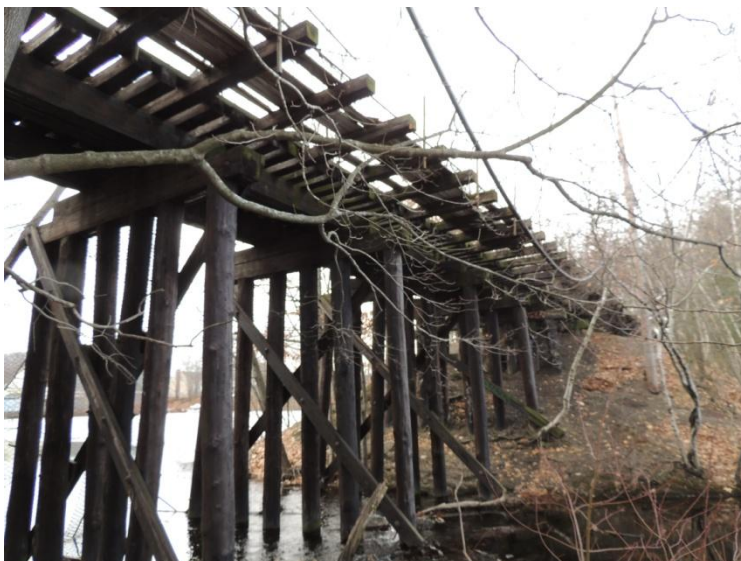
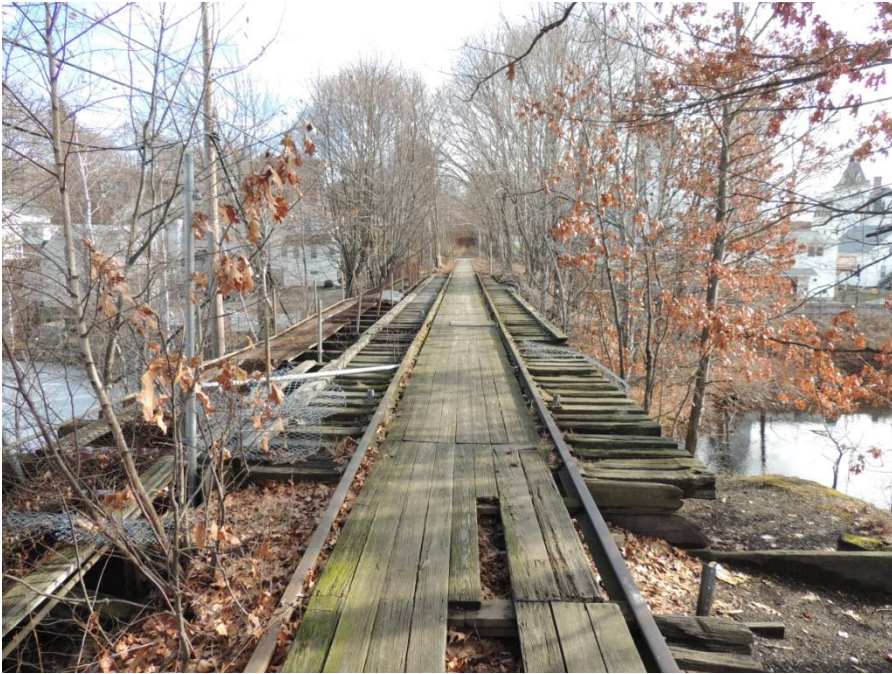
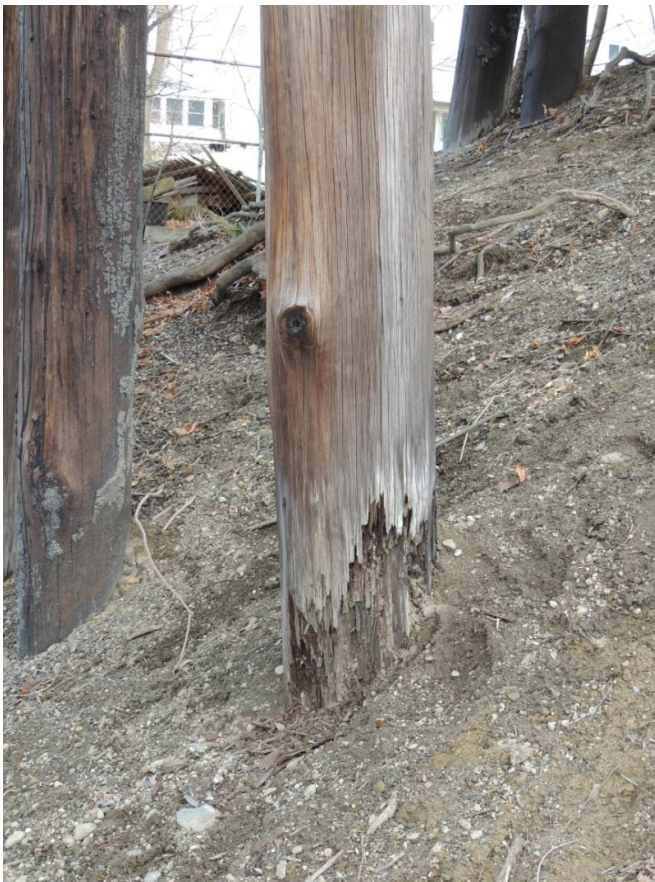
## Bruce's Pond, Hudson: Timber Pile Trestle (open timber tie deck)

- Timber ties are in poor condition, and need to be replaced to widen the bridge deck
- Timber backwalls have decay and need to be replaced
- One timber pile displays some decay
- Minor fire damage to timber ties and beams (damage to beams not significant)

- Remove and dispose of existing timber ties, steel rails, remains of timber catwalk and fencing
- Remove timber backwalls and reconstruct new backwalls and wingwalls to support backfill
- Repair deteriorated timber pile (cut out decay/ splice/plate and bolt repair section)
- Install additional longitudinal beams and construct new timber deck and railings

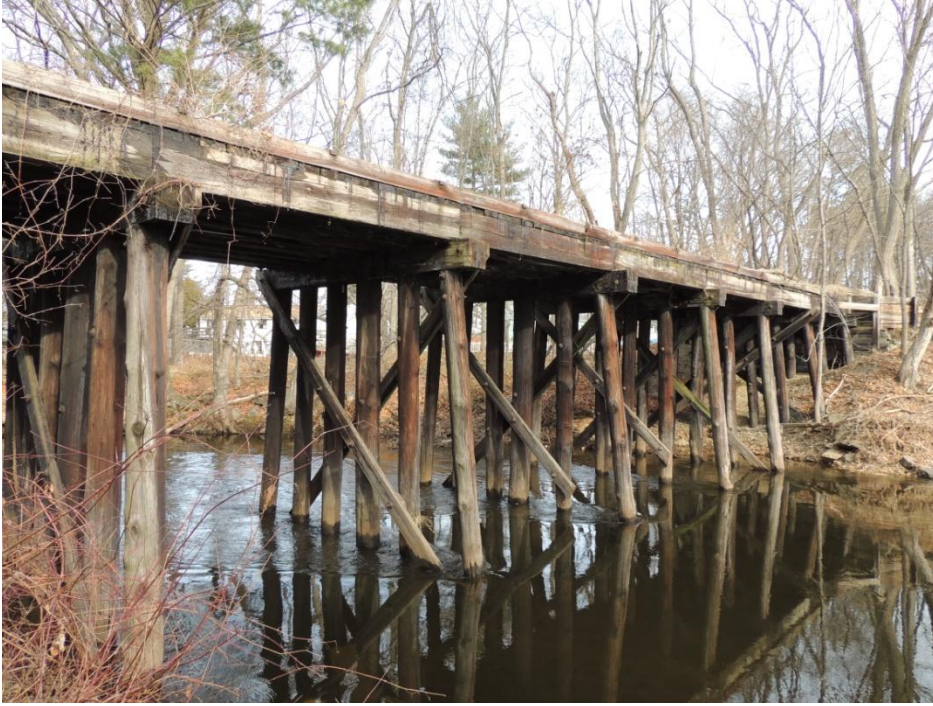
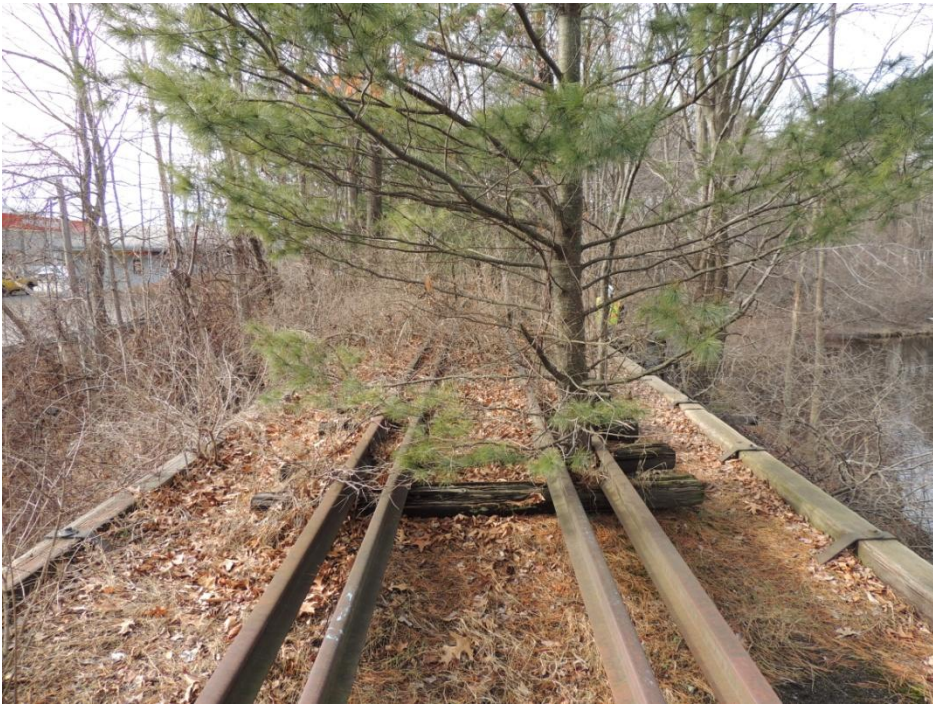
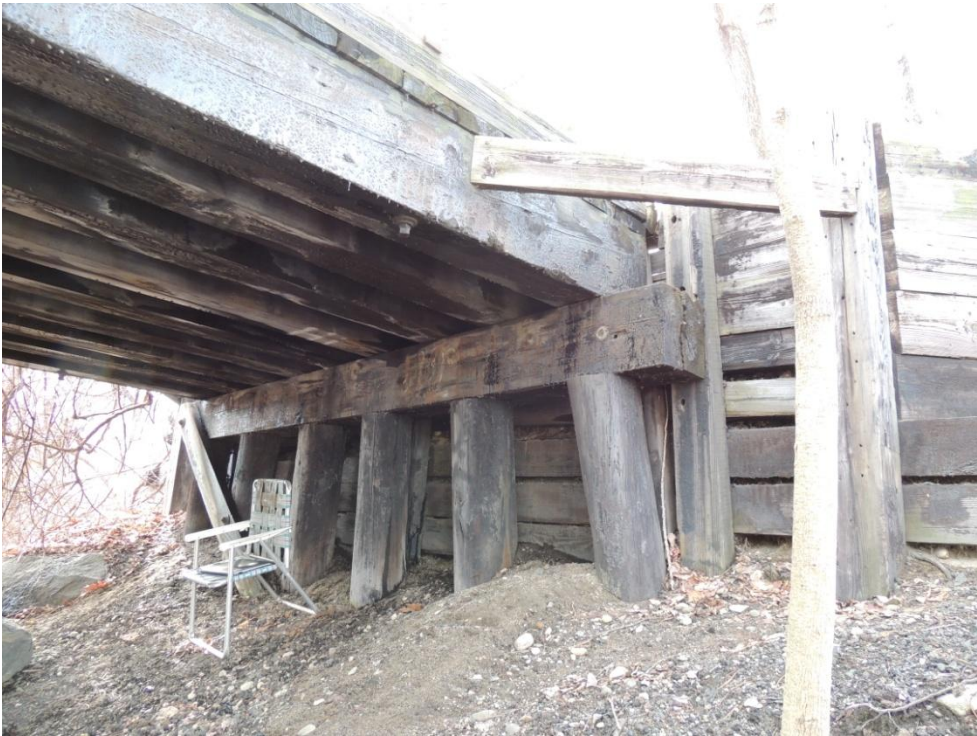
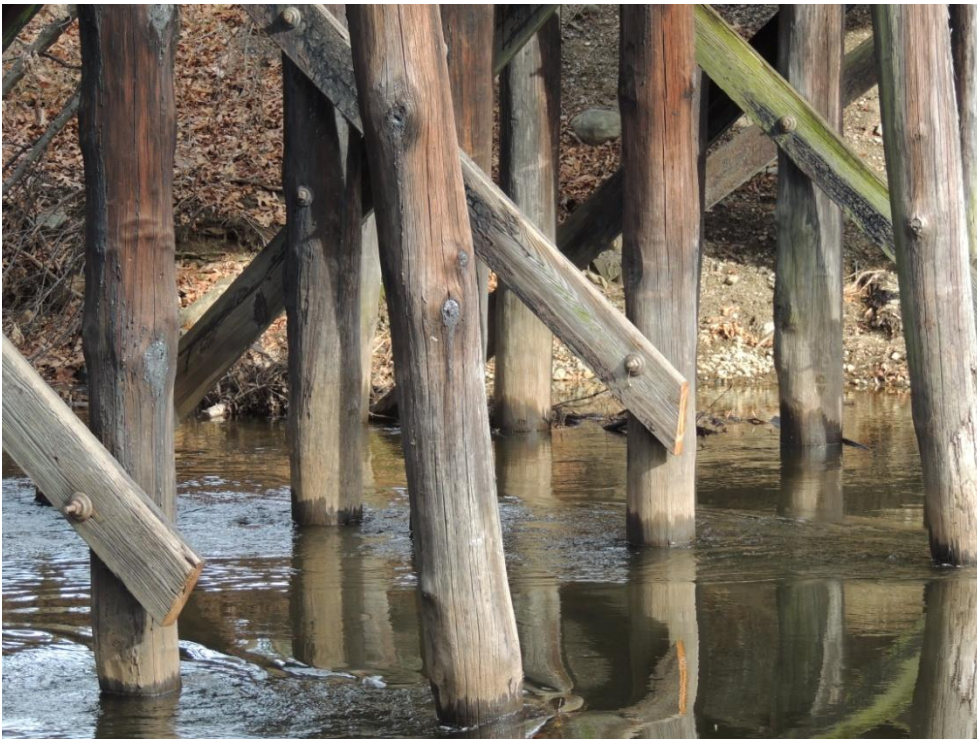
## Assabet River, Hudson: Timber Pile Trestle (timber deck with ballast)

- Ballasted timber deck supports significant vegetation growth (trees up to 8 inch in diameter); the condition of the wood deck is suspect to decay, will likely need replacement
- Timber beams appear to be sound, some decay at top of beams can be expected
- Timber backwalls and wingwalls have decay and need to be replaced
- Some cross bracing on the timber pile bents is split, cracked and weathered, and at two locations has been cut off near the waterline on the upstream side of the bridge (possibly damaged from floating debris)
- Condition of piles below the waterline could not be determined

Further in depth evaluation of this bridge should include an underwater inspection of timber piles and a hydraulic analysis of the bridge before consideration is given to investing capital to rehabilitate this bridge for the proposed rail trail. If it is determined that this structure warrants rehabilitation, the following is required:

- Remove and dispose of trees, timber ties, steel rails, and ballast
- Remove and dispose of timber curbs and timber decking
- Replace any deteriorated timber beams
- Remove timber backwalls and wingwalls; reconstruct new backwalls and wingwalls to support backfill
- Repair deteriorated timber pile cross bracing
- Construct new timber deck and railings

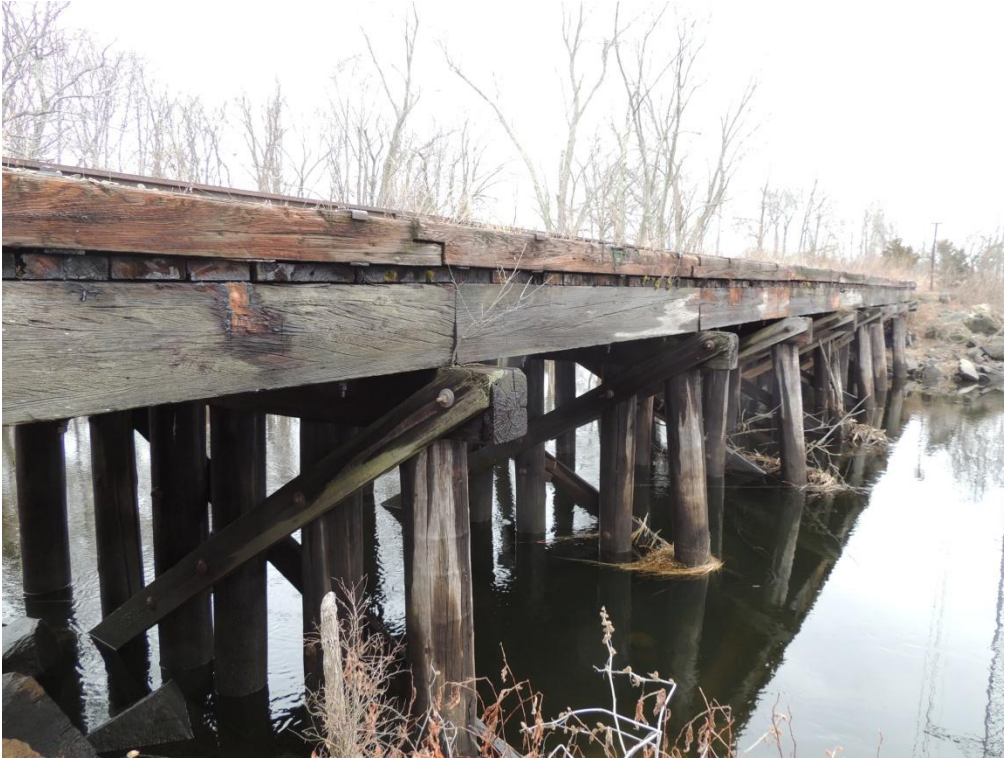
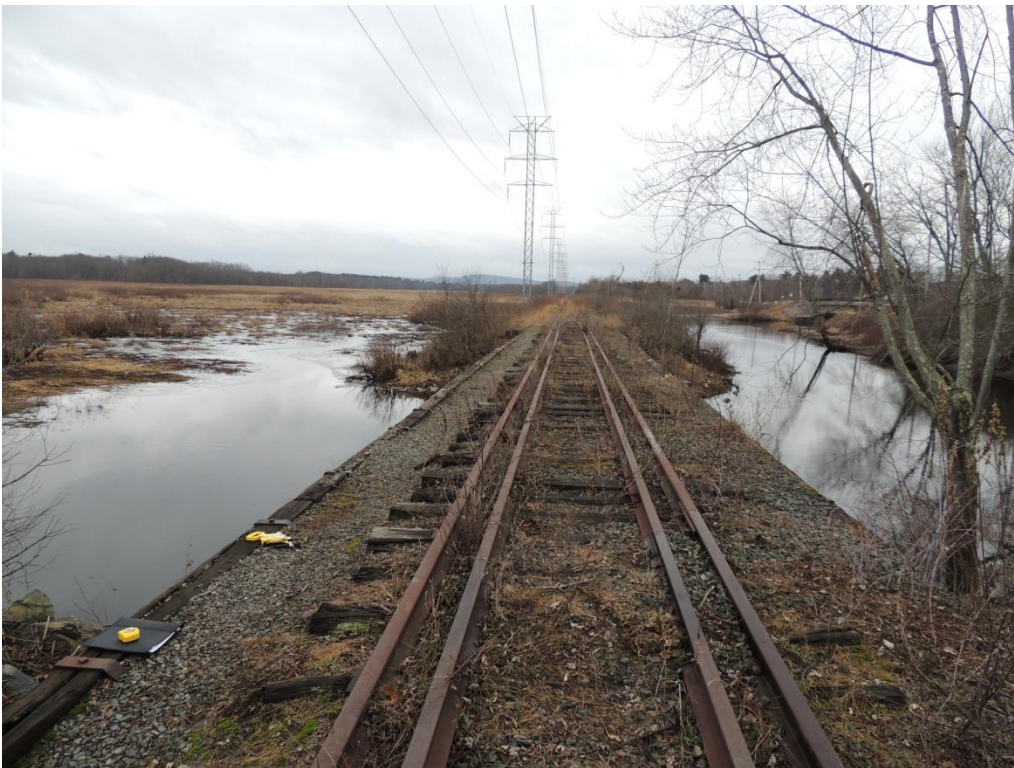
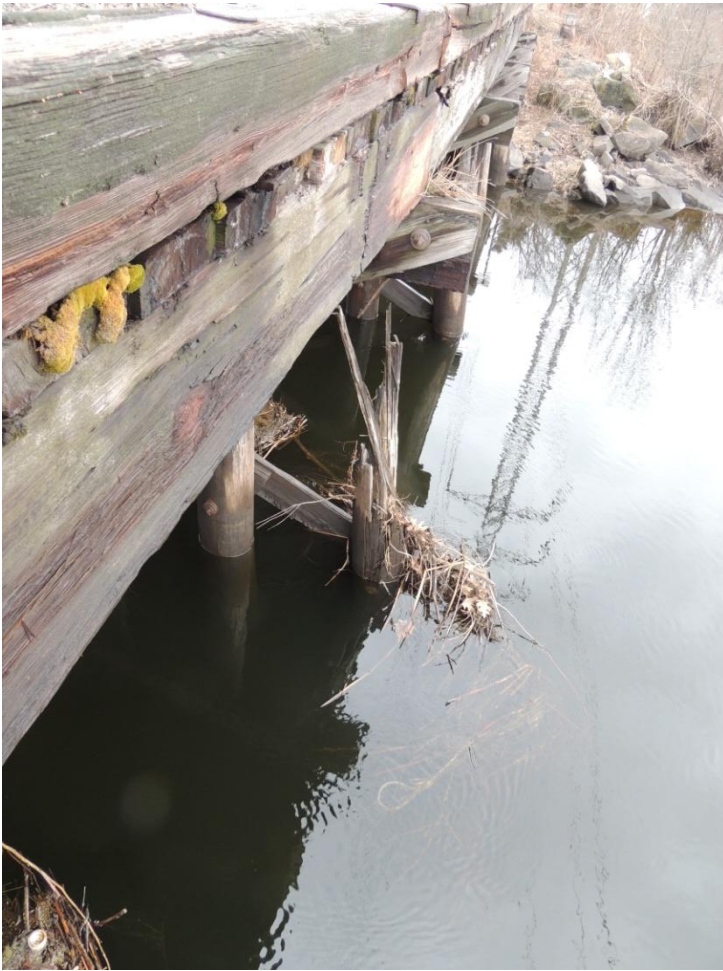
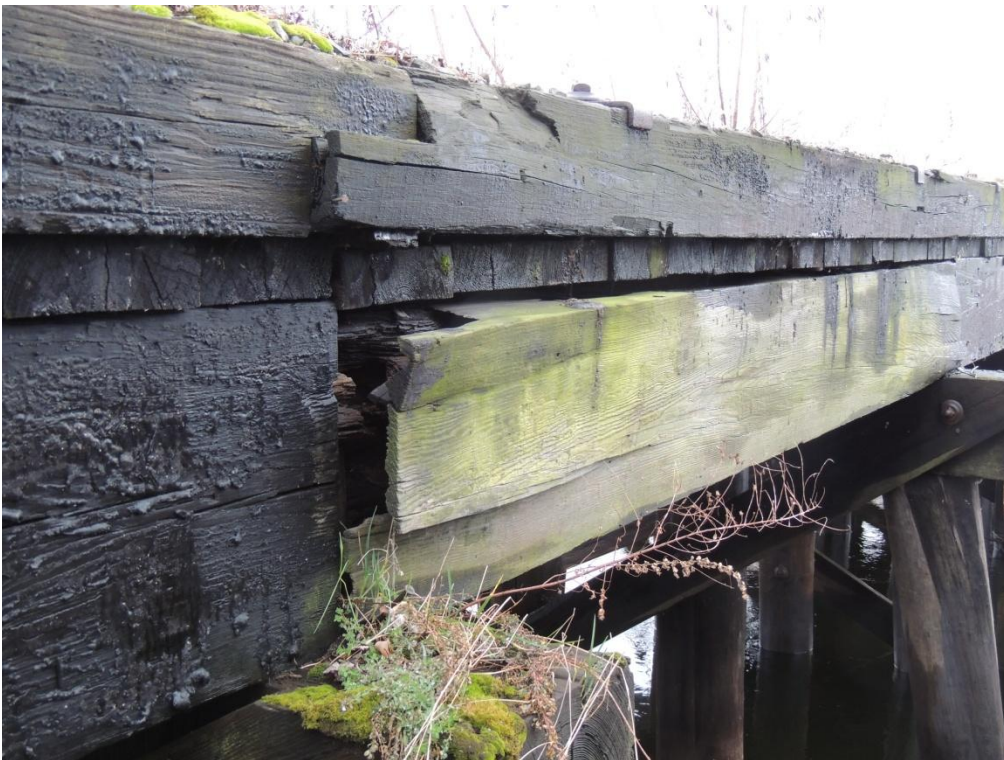
## Great Meadows Wildlife Refuge Sudbury River, Sudbury: Timber Pile Trestle (timber deck with ballast)

- Ballasted timber deck, the condition of the wood deck is suspect to decay, will likely need replacement
- Timber beams have some decay, expect some will require replacement
- Timber pile caps display some decay, with splits, cracks and weathering, suspect some may require repair or replacement
- One timber pile at mid span on the upstream side of the bridge is severed possibly damaged by floating debris, and will need to be spliced/reinforced
- Condition of piles below the waterline could not be determined
- Cross bracing on the timber pile bents is split, cracked and weathered

Further in depth evaluation of this bridge should include an underwater inspection of timber piles and a hydraulic analysis of the bridge before consideration is given to investing capital to rehabilitate this bridge for the proposed rail trail. If it is determined that this structure warrants rehabilitation, the following is required:

- Remove and dispose timber ties, steel rails, and ballast
- Remove timber curbs and timber decking
- Repair severed timber pile
- Repair deteriorated timber pile cross bracing
- Repair/ replace deteriorated timber pile caps as required
- Replace deteriorated timber beams as required
- Construct new timber deck and railings
