# Mass Central Rail Trail Evaluation of Existing Bridges

## Wayside Branch - Waltham to Berlin

### Summary of Evaluation

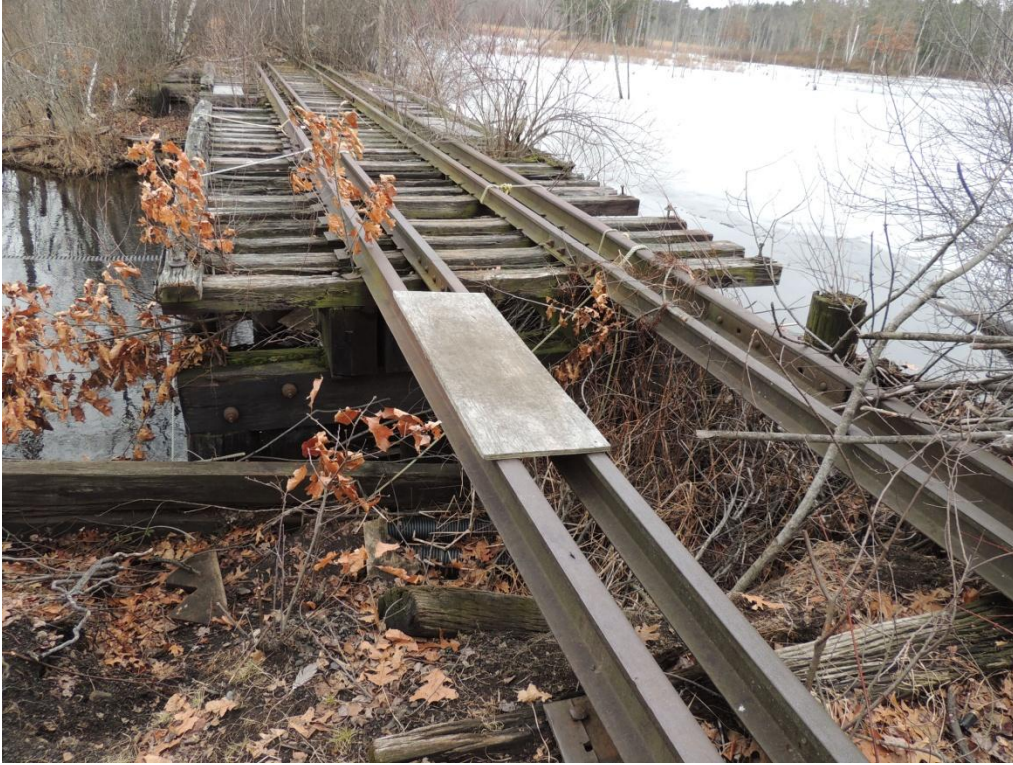
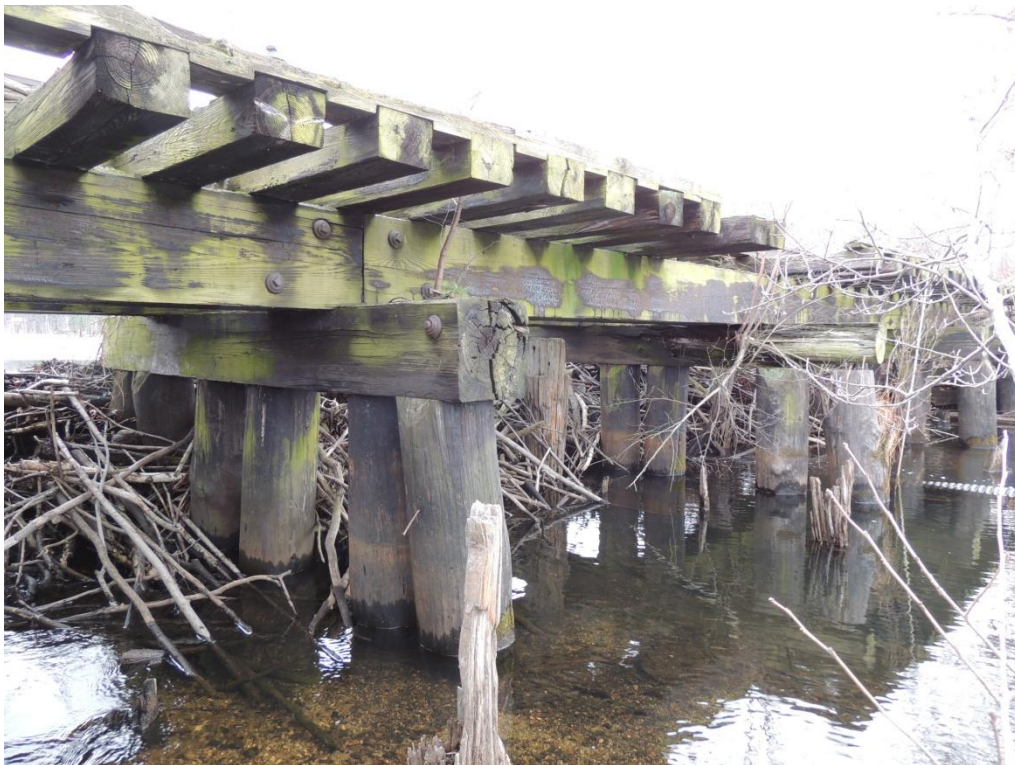
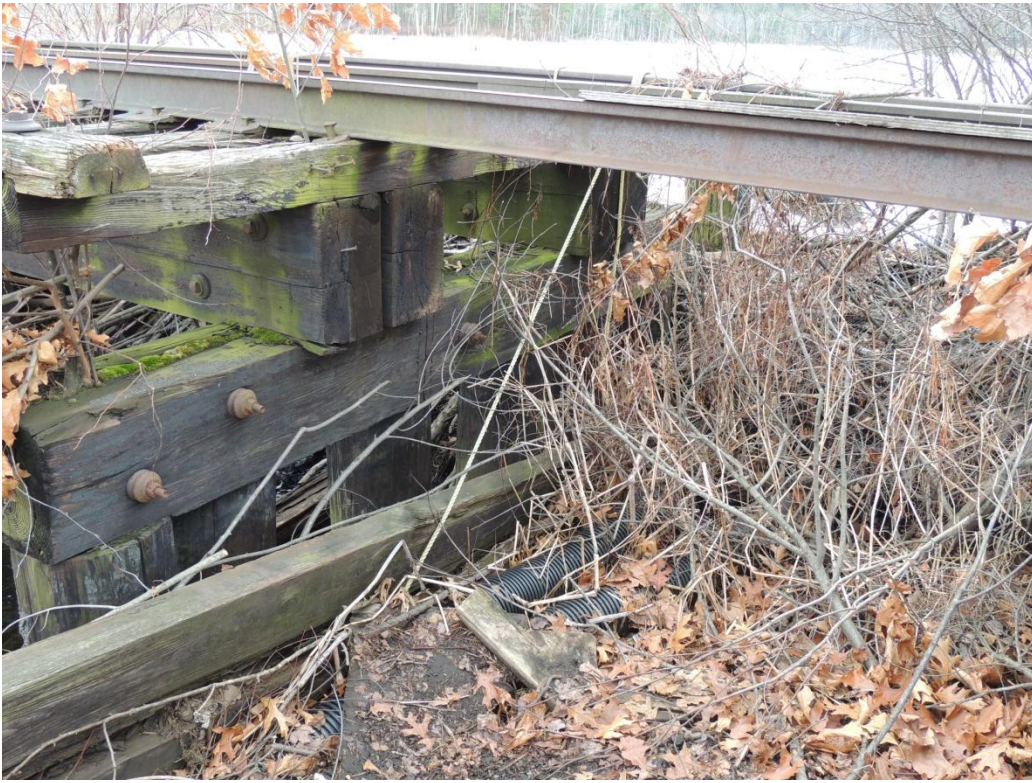
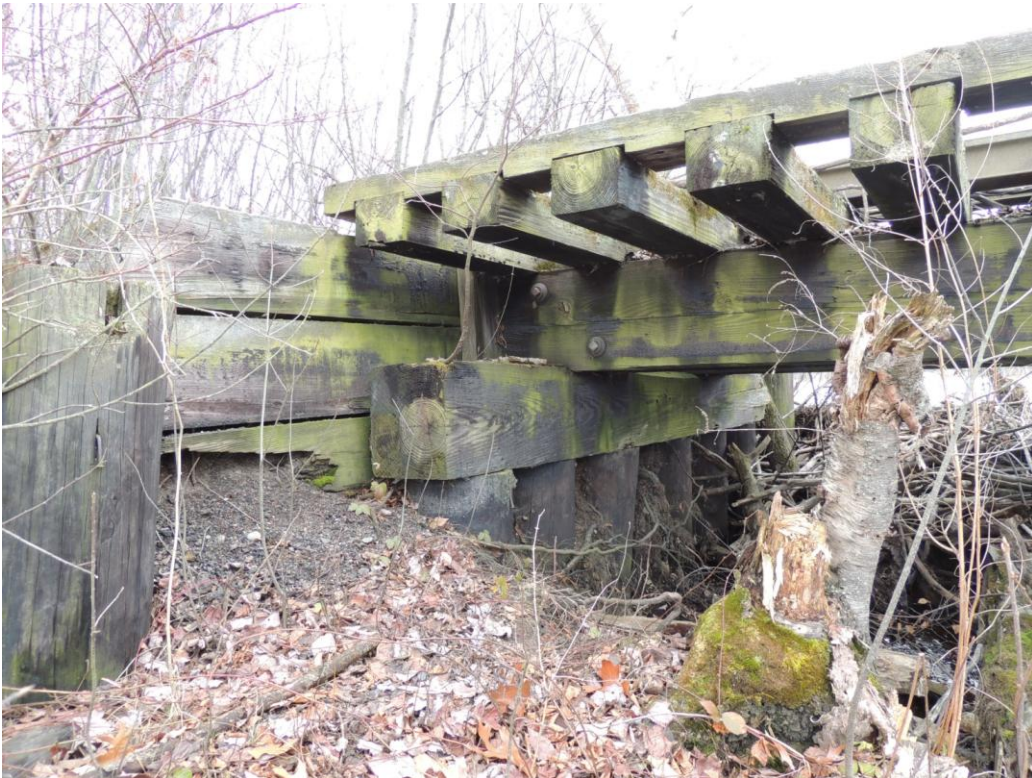
## Fort Meadow Brook, Hudson: Timber Pile Trestle (open timber tie deck)

- Entire structure is in poor condition; timber ties, beams, pile caps and backwalls (timber piles may be able to be re-used)
- Heavy debris built up against the pile bents on the upstream side of the bridge (possibly a beaver dam) is obstructing the flow and the west approach has washed out behind the end pile bent and backwall.
- An attempt has been made to divert the flow around the obstruction using flexible drainage conduits

Proposed Rehabilitation: As noted above, the timber piles are the only elements that could possibly be re-used for rebuilding of this bridge. The current multiple pile bent configuration has facilitated the collection of debris, and the removal of these pile bents and a complete replacement of this bridge with a new single span structure would be the ideal option for this bridge location. If budget considerations dictate reusing of the existing timber piles and rebuilding of the bridge, the following items with estimated costs will be necessary:

- Remove and dispose of existing timber ties and steel rails, timber beams and timber pile caps
- Remove timber backwalls and reconstruct new backwalls and wingwalls to support backfill
- Restore west approach embankment
- Replace timber pile caps
- Install new timber beams, new timber deck and railings
- Obtain approval to design and install water level control devices (WLCD) to regulate the water level behind the beaver dam obstruction to avoid future washouts of the adjacent embankments
