Town of Gill
Investment Grade Audit

Siemens Industry Inc
Building Technologies Division
85 John Road, Unit 1
Canton, MA 02021

May 21, 2010

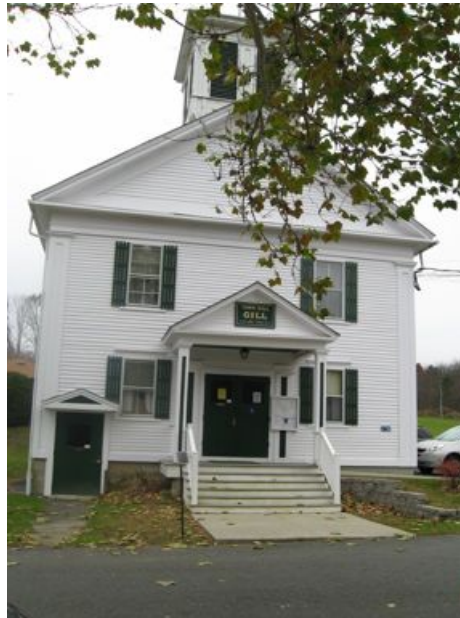
The Gill Town Hall comprises of a 2-story, clapboard building with single pane windows and exterior storm windows. In addition part of the buildings basement is utilized for office space as well. Occupied by 3 people, the Town Hall operates 4 days per week Mon 9:00 a.m. - 6:30 p.m., Tue - Thu 9:00 a.m. - 4:30 p.m.

There is no energy management system at this building. Building space temperature control is achieved with a programmable thermostat for the office area and a wall mounted thermostat without setback capability in the second floor auditorium.

Domestic hot water for the Town Hall is provided by a tankless hot water system. The associated heat exchanger is fed by the existing boiler. It was noted that the building appears to have moisture problems in the basement. A large dehumidifier manufactured by Comfort Air was found in the basement as well as a sump pump located in a small mechanical area adjacent to set unit.

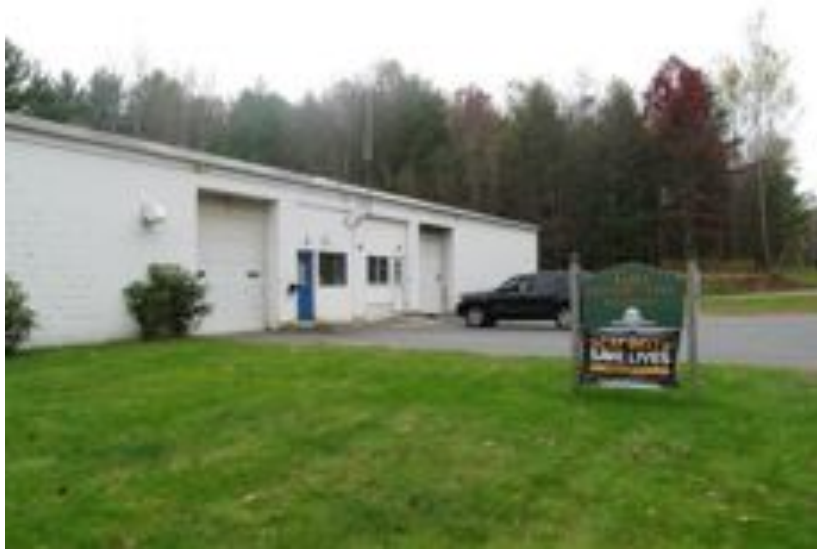
Gill Public Safety Complex

This building consists of a single story, brick faced building with original double pane, aluminum frame sliding windows. The facility serves the local police department, the volunteer fire department, the highway department and a small community center. Given its nature, the facility utilizes a variety of overhead doors for vehicle access. Only constant occupants for this building is the highway department.

The heating system for this facility comprises of a single, oil-fired cast iron sectional steam boiler manufactured by H.B. Smith. It is apparent that this boiler has reached the end of its physical life and should be replaced. This boiler provides low pressure steam for the garage as well as heating hot water for the PD and FD hydronic heating system. Heating hot water is produced with a steam to hot water heat exchanger. Several rooms of this building are also air conditioned via the use of thru-the-wall air conditioning units of various ages and efficiencies.

Only means of space temperature controls are wall mounted thermostats without night setback capabilities.

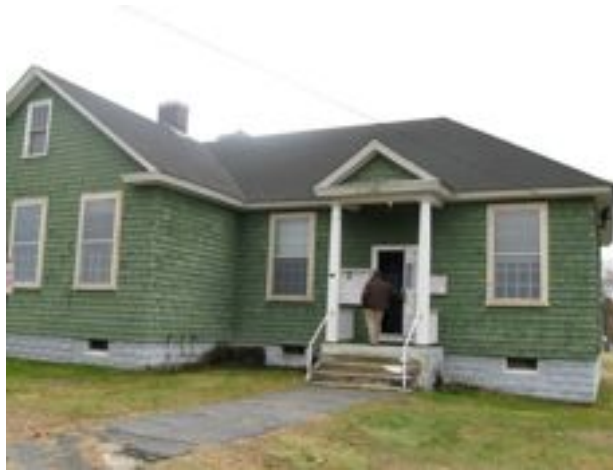
Riverside is a single story, wooden shingle sided facility with single pane, wooden sash windows with exterior storm and an asphalt shingled roof. The building is currently occupied by the Four Winds School; an independent middle school, as well as the historical society. The school has only two classrooms and operates 168 days per year.

Low pressure steam for heating is provided by a single H.B. Smith, cast iron sectional boiler. This boiler fires on # 2 fuel oil and shows clear signs of physical deterioration. The steam is distributed to cast iron radiators located throughout the building via a single pipe system.

A single programmable thermostat was observed in one of the classrooms of the Four Winds School. Given that no zone controls were found on the boiler this appears to be the only means of space temperature control and night setback.

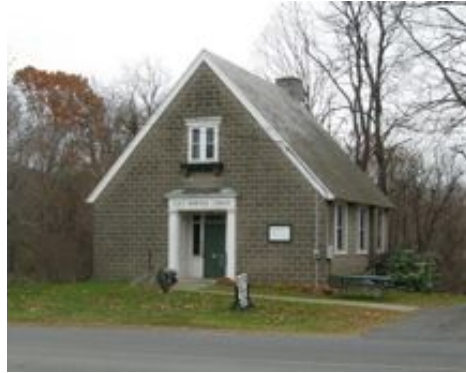
Originally build in 1921, the Slate Memorial Library comprises of a single story cinder block building with wooden sash windows and exterior storms. The building has a slate roof and a full basement. It was noted that the ridge cap is not wide enough and may cause water do be driven into the roof area during a heavy storm. We also noticed that the basement windows do not seal tight anymore and thus are cause for water damage and infiltration. The interior of the library has a drop ceiling with fiber glass lay-in panels.

Original T-12 fluorescent fixtures are utilized to illuminate this facility.

A single, oil fired hot air furnace is utilized to provide heating for the building. The furnace is manufactured by Williamson and is equipped with a Clarin oil burner.

Room temperature is controlled with a single, wall mounted thermostat without night setback capabilities.

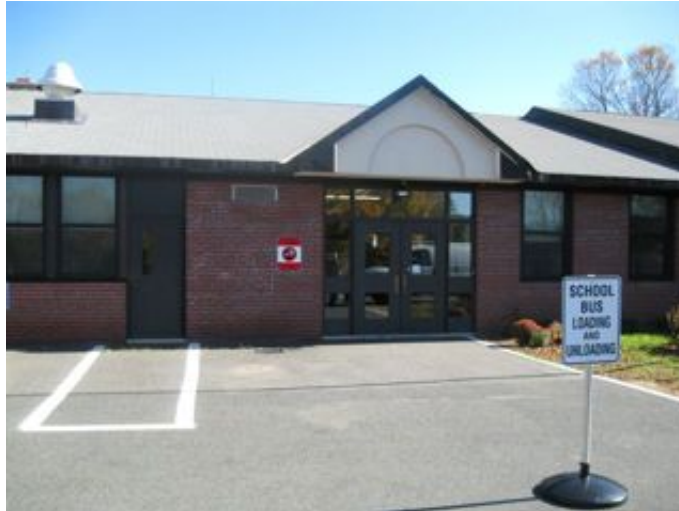
Gill Elementary School

With a total of 18,320 square feet the Gill Elementary is the smallest school within the Gill – Montague Regional School District. The school consists of a single story, brick faced building with aluminum frame, double pane windows and a sloped asphalt shingled roof. Occupied by 133 students and 21 teachers/ staff members building operating hours are 7:45 AM to 4:30 PM, Mon.-Fri.

Space temperature control is achieved via an original, pneumatic control system. Maintenance personnel stated that this system is no longer operating in a reliable fashion and needs to be recommissioned or replaced.

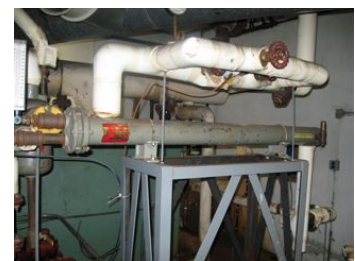
The buildings heating load requirements are met by a single Peerless steam boiler that appears to be original. It shows clear signs of age and physical deterioration and should be replaced. # 2 oil is the primary fuel source and the burner has an input rating of 18.8 GPH. Based on the name plate data this boiler does not seem to provide burner

modulating capabilities. Steam is used by the original classroom unit ventilators, and the single heating and ventilation unit that handles the multi purpose room. Heating hot water is produced through the utilization of a steam to hot water heat exchanger. Two in-line circulator pumps distribute the heating hot water to fin tube perimeter heating..

The general observation was made that much of the pipe located in the boiler room was uninsulated.

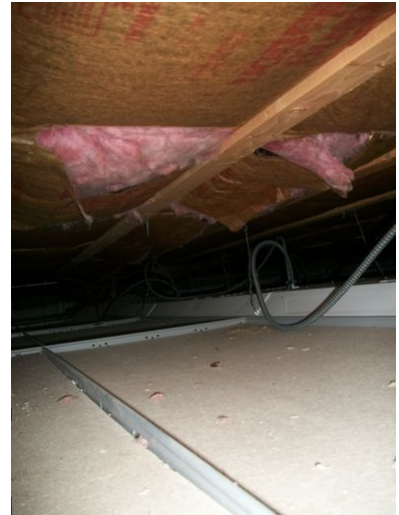
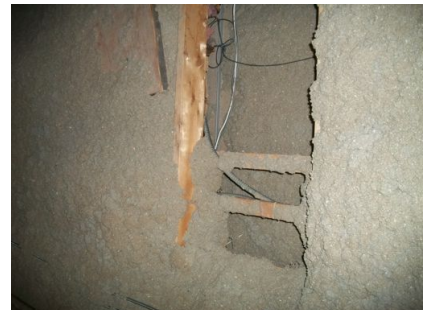
The main classroom areas have an unheated, passively vented attic space. The floor is insulated with 12" of blown cellulose insulation over 6" paper faced fiberglass batts fastened to the attic floor joists.

This method, while providing adequate "R" value as insulation, does not provide an air barrier. In places, the fiberglass attachment has failed, opening significant gaps to the conditioned space below. Additionally, there has been no air sealing around ventilation and soil pipe penetrations. This condition has resulted in significant air leakage from the conditioned space into this attic area. The heated air has caused the attic space to become heated, resulting in ice damming issues (reported, not observed), especially on the east side of the building. There is a passive damper at the south gable end that appears to be in place to increase ventilation to the attics.

This passive system (soffit vents, 4 passive "baker hat" vents and the gable vent) may actually contribute to the ice dams by de-pressurizing the attics with reference to the conditioned space and drawing heated air into the attics.

The correction for this is to air seal the attic from the classrooms by installing an air barrier below the ceiling joists. The current ceilings of the classrooms of the original wing are splined tiles fastened to the underside of the ceiling joists. In the newer addition, the classrooms have suspended ceilings that will be more cost effective to correct.

Additional testing (removal of splined tiles and evaluation of the assembly) is required before final correction pricing can be provided.
