July 15, 2022

RE: HVAC System Filter Inspection, Roderick L. Ireland Courthouse, 50 State Street, Springfield, Massachusetts (EH&E 25633)

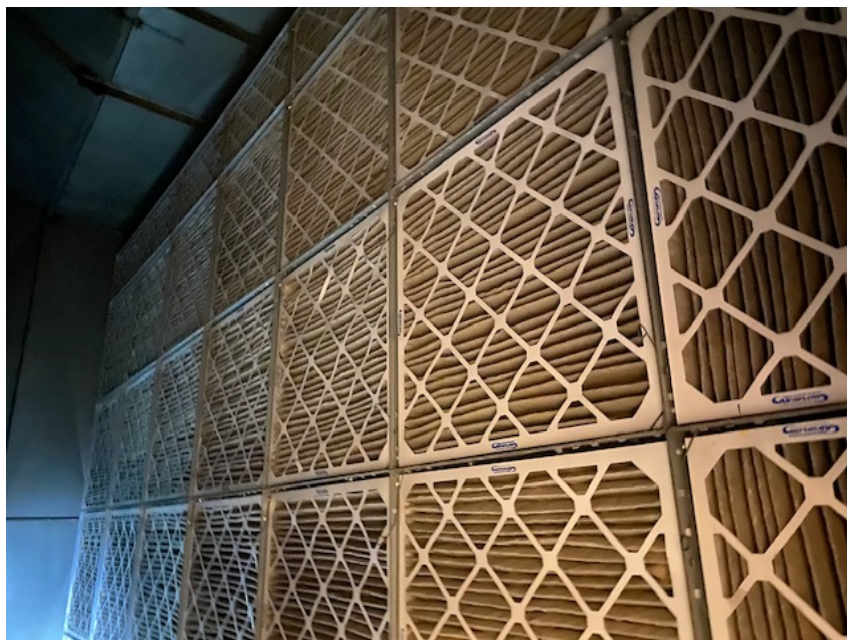
Inspection of the air filters in all AHUs showed that a few of the panels were installed with the pleats running horizontally as opposed to vertically. Although installing the panels with horizontal pleats does not reduce the level of filtration, installing the filters with the pleats running vertically reduces the potential for the pleat to partially collapse once the filter begins to load with particulate. EH&E recommends installing the pleated filters with pleats running vertical. Photograph 1 shows the MERV-13 filters installed in AC-1 and Photograph 2 shows the MERV-13 filters installed in AC-4.

Photograph 1 MERV-13 Filters AC-1, 50 State Street, Springfield, Massachusetts.

- Install the pleated filters with pleats running vertical in AC-1, AC-2, AC-3, and AC-4.
- Inspect FCU filters for signs of moisture and water damage during filter changes. Address sources of moisture, which may include condensation or small leaks.
- Install spacers or gap fillers between the FCU filter frames and filter racks to minimize air bypass.
- Ensure all FCU filters are rated by the manufacturer to have a MERV-13 efficiency.

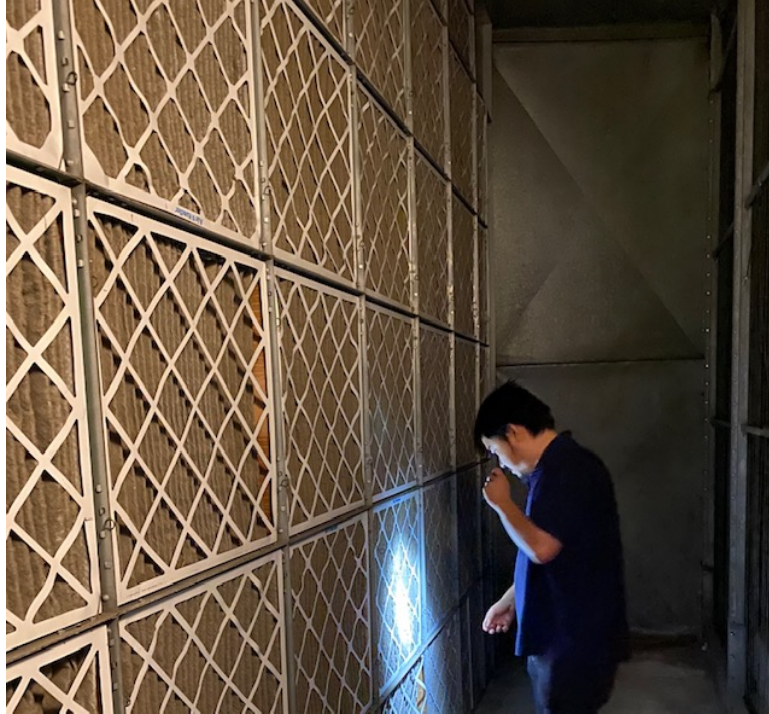
Photograph 2 MERV-13 Filters AC-4, 50 State Street, Springfield, Massachusetts.

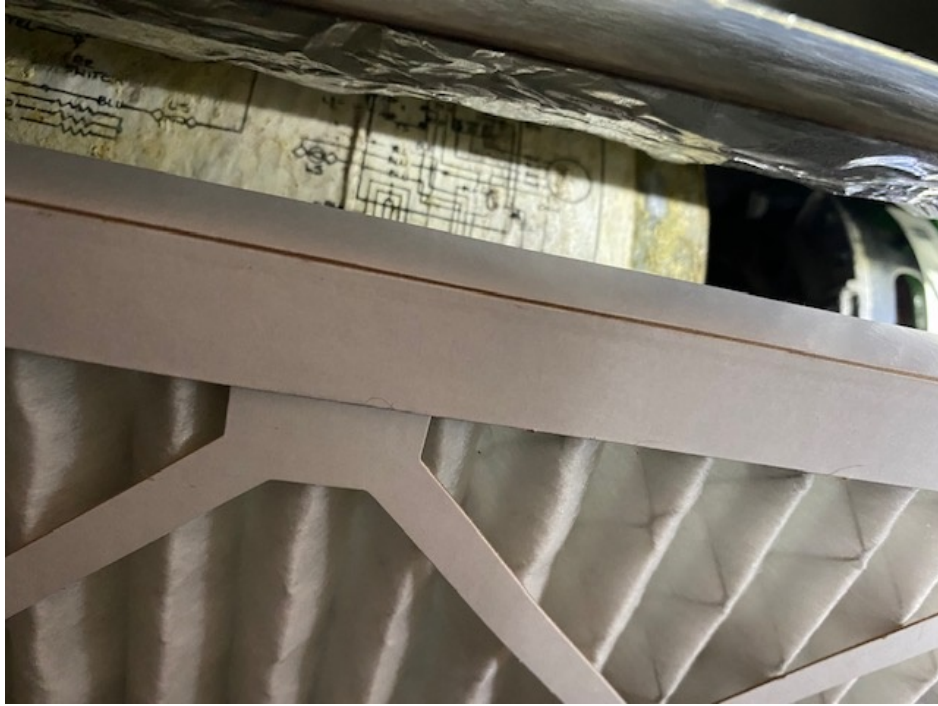
With the assistance of building maintenance staff, EH&E inspected the air filters in 61 perimeter FCUs on June 17, 2022. Most of the air filters installed in the FCUs were in good condition at the time of EH&E's site visit. Seven (7) of the 61 filters were noted by EH&E as being wet at the time of the site visit. Inspection indicated that a majority of the air filters (45/61) were not well fitted and showed evidence of air bypass between the filter frame and filter rack. In addition, EH&E was not able to confirm the filtration efficiency on 2 of the 61 FCU filters inspected as there was no identification marked on the filter frames. The Airflow AFP3000 filters observed in the majority of the FCUs were confirmed to be rated by their manufacture to have a MERV-13 efficiency. Photographs 3 and 4 show examples of gaps between FCU filter frames and the filter racks.

Photograph 3 Gap between Filter Frame and FCU Filter Rack in Room 422, 50 State Street, Springfield, Massachusetts.

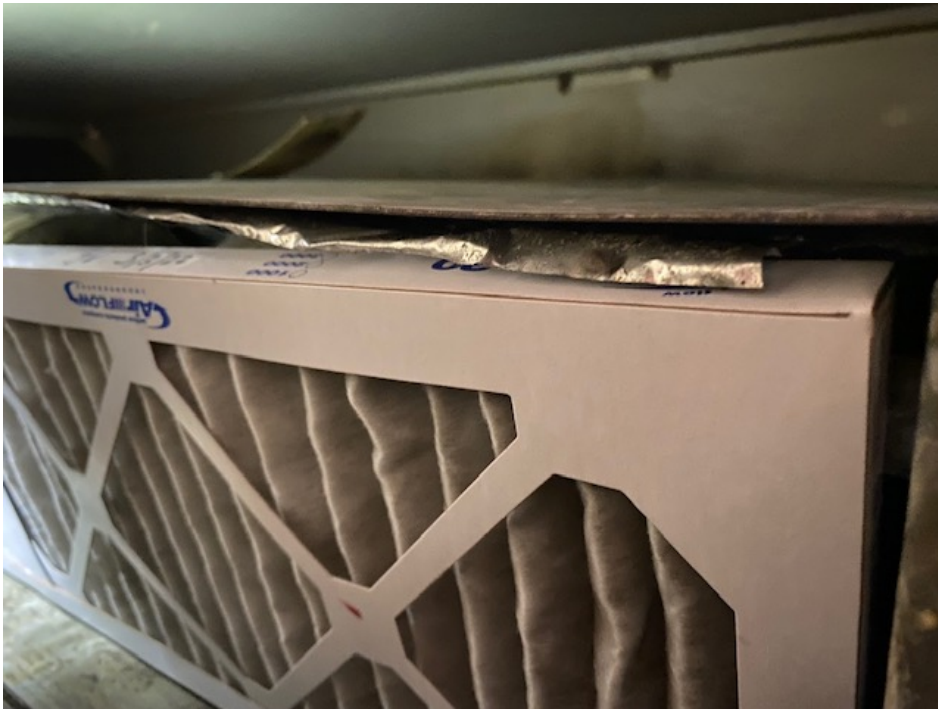
Photograph 4 Gap between Filter Frame and FCU Filter Rack in Jury Pool 446, 50 State Street, Springfield, Massachusetts.
