EWING ASSOCIATES

September 7, 2022

Subj: Roof Moisture Survey
Roderick L. Ireland Courthouse
50 State St.
Springfield, MA

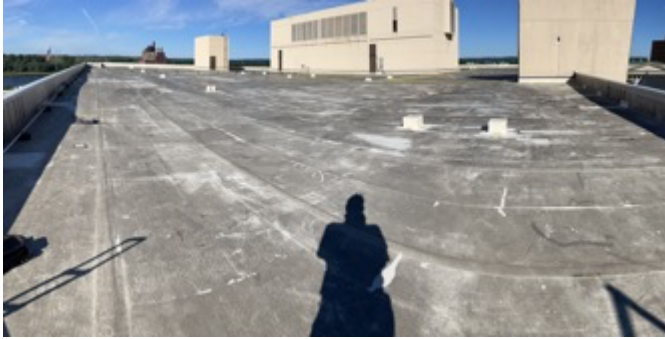
PHOTO 1

General view of main roof looking west/north from southeast corner.

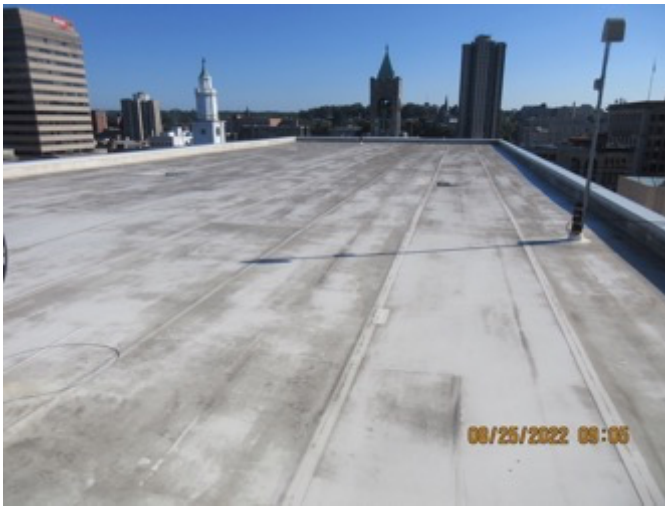
PHOTO 2

General view of mechanical room penthouse roof looking east.

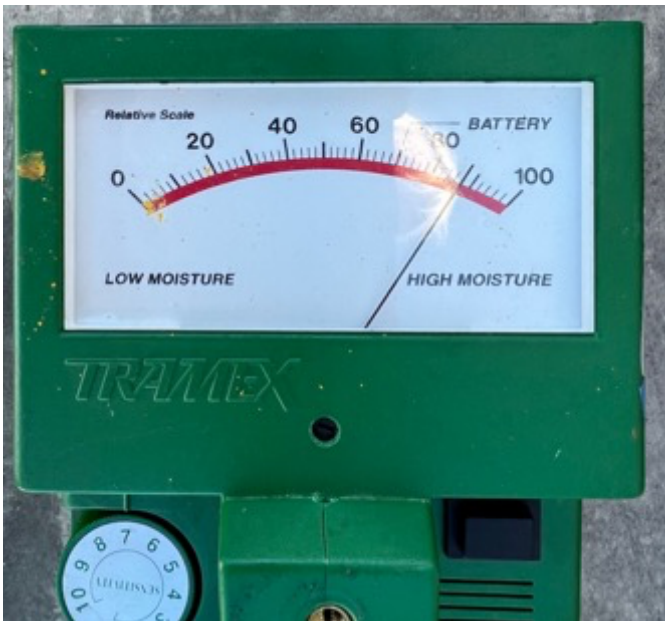
PHOTO 3

Capacitance meter indicating wetted material below membrane.

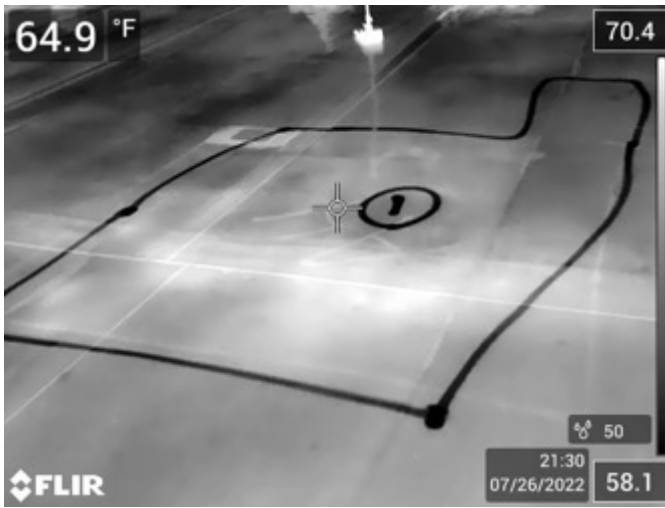
PHOTO 4

Thermogram. Wet Area #1.

- Removal and replacement of coverboard and insulation within 9 wetted areas.
- Mechanically attach membrane roofing to deck with termination bars on northeast portion of balcony roof.
- Replace fixed ladder leading to roof hatch.
- Replace roof hatch safety railing.
- Replace polyethylene drain strainers with cast iron. Install roof drain markers at each drain (Photo 36).
- Cover existing patches over uncleaned membrane with either heat-welded patches or addition PVC membrane adhered to existing roof. All edges to be heat welded to existing membrane.
- Mechanically attach condensers to sleepers and attach sleepers to roof deck.
- Replace pitch pan with roof penetration housing (Photo 37).

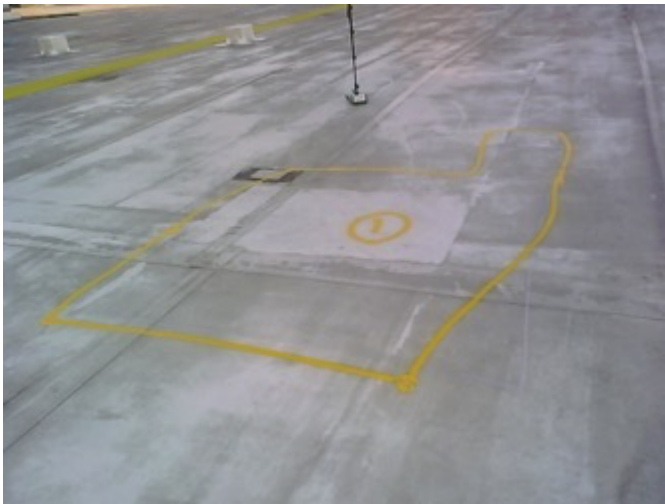
PHOTO 5

Daylight photo Wet Area #1.

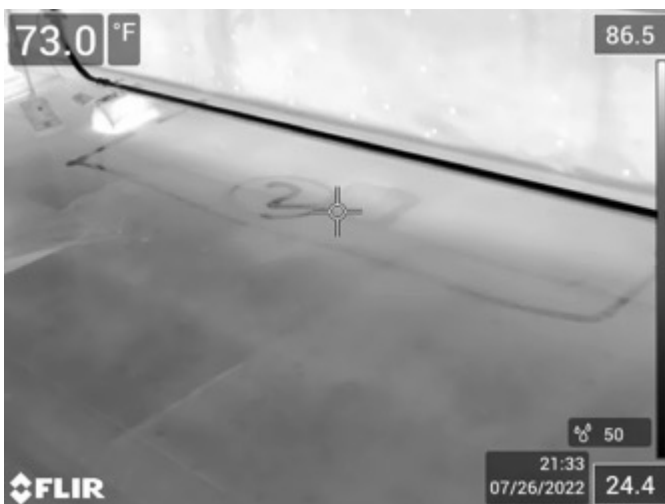
PHOTO 6

Survey Findings. During our surveys we located 9 areas containing anomalies – indicating at the time of the survey moisture was present within the assembly totaling 824 sq. ft. or 1.5% of the total roof area (Photos 4-19). A test cut into Wet Area #2 (southeast corner) indicated that the coverboard was wet and decomposing (Photo 20); but the insulation below was dry. A patch had been installed over a previous puncture within the wet area.

Thermogram. Wet Area #2.

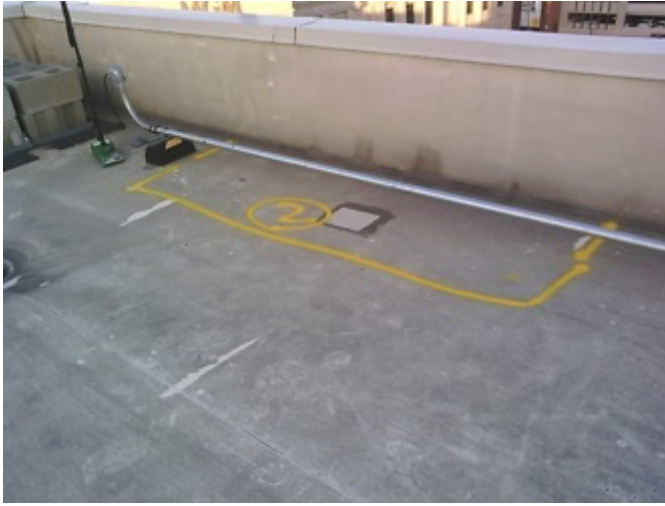
PHOTO 7

Daylight photo Wet Area #2.

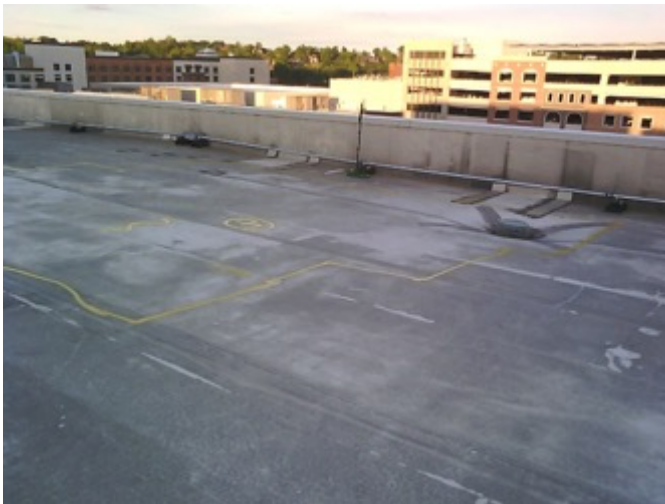
PHOTO 8

Daylight photo Wet Area #3.

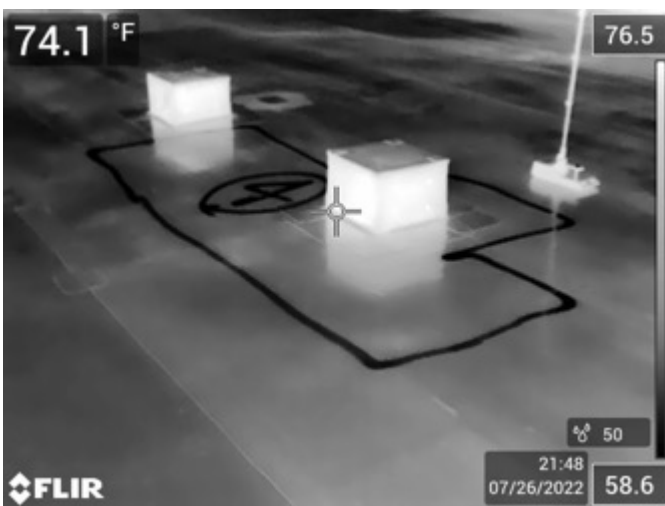
PHOTO 9

Thermogram. Wet Area #4.

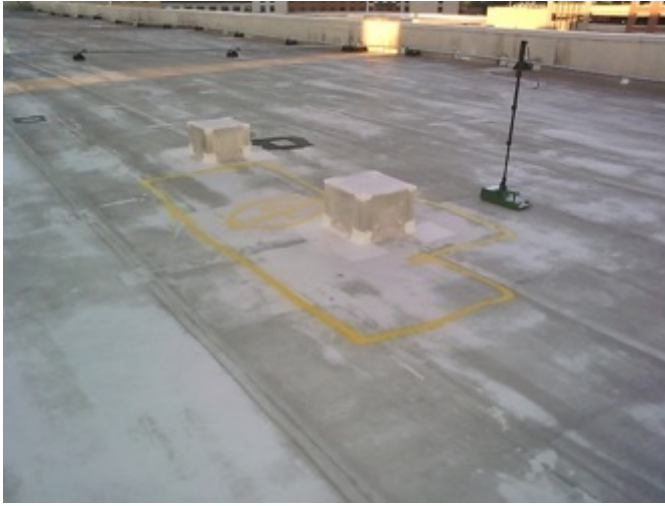
PHOTO 10

Daylight photo Wet Area #4.

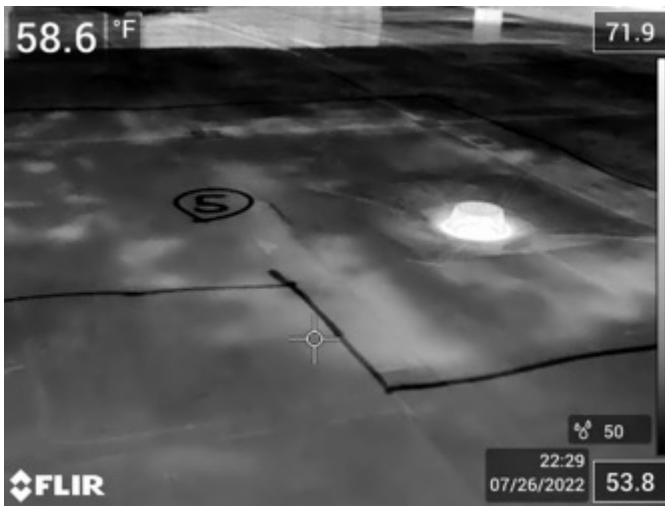
PHOTO 11

Thermogram Wet Area #5.

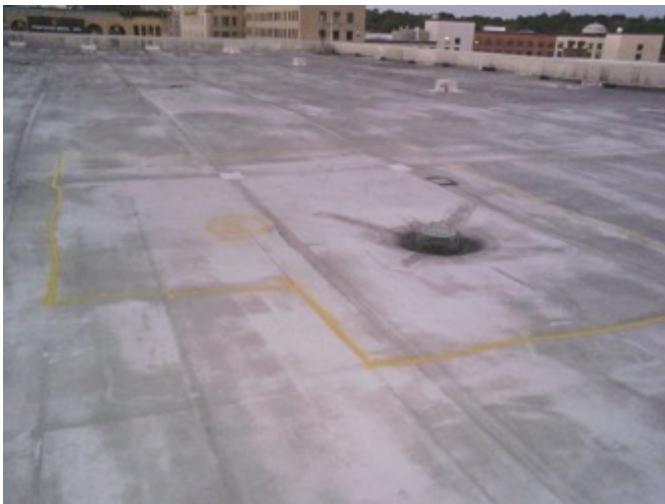
PHOTO 12

Daylight photo Wet Area #5.

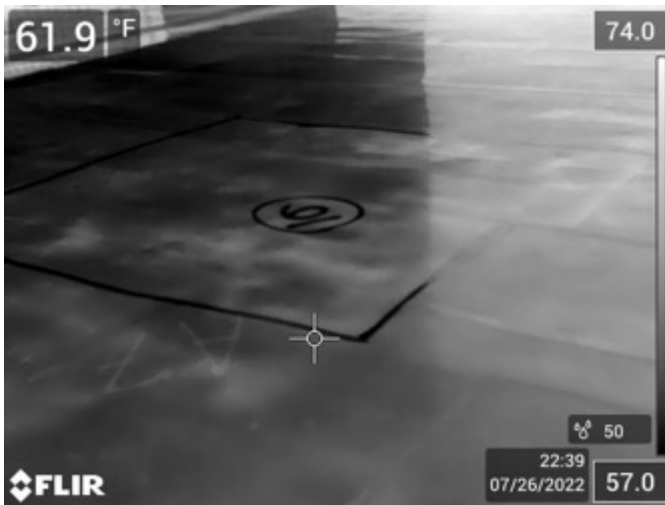
PHOTO 13

Thermogram. Wet Area #6.

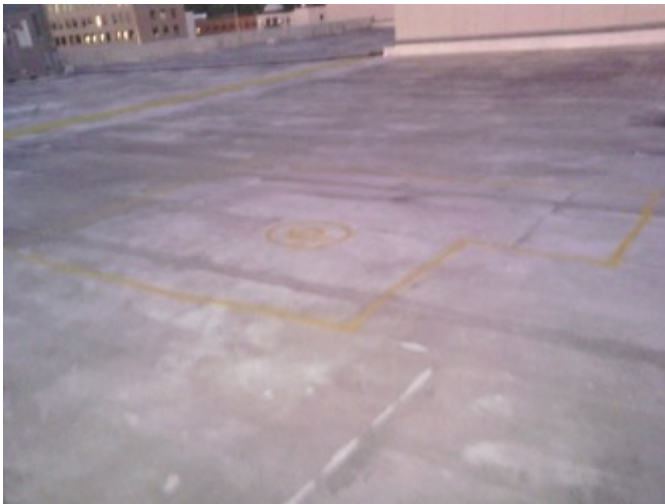
PHOTO 14

Daylight photo Wet Area #6.

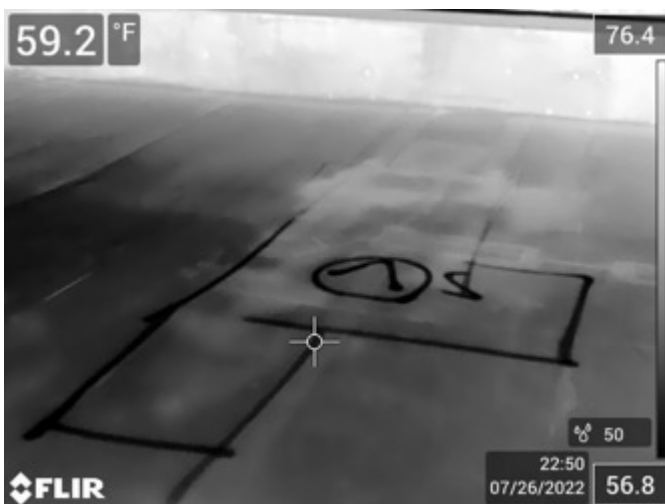
PHOTO 15

Thermogram. Wet Area #7.

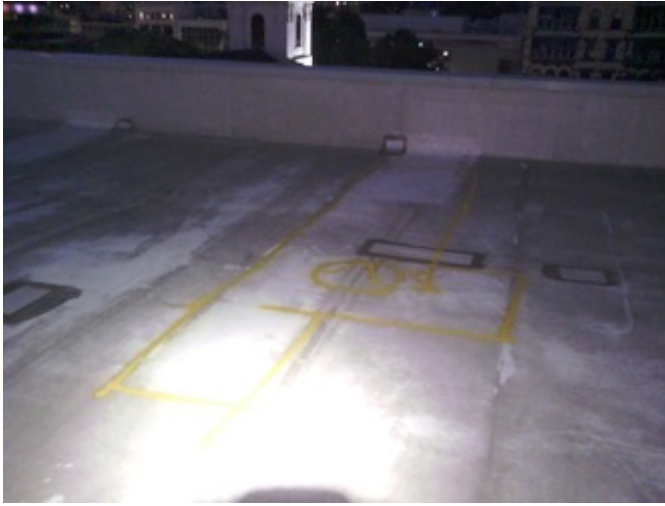
PHOTO 16

Wet Area #7.

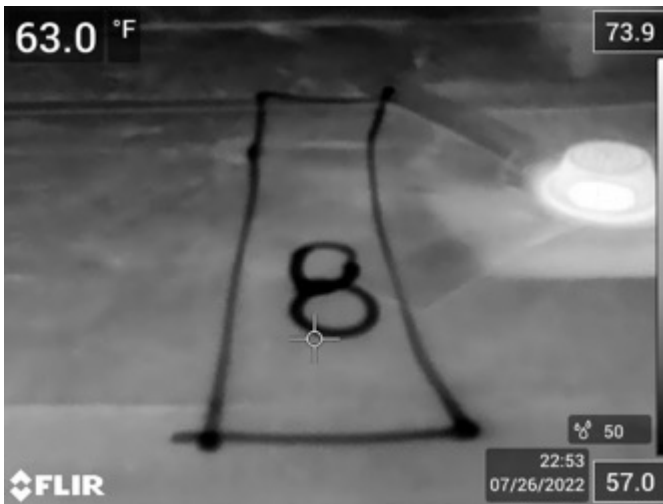
PHOTO 17

Thermogram. Wet Area #8.

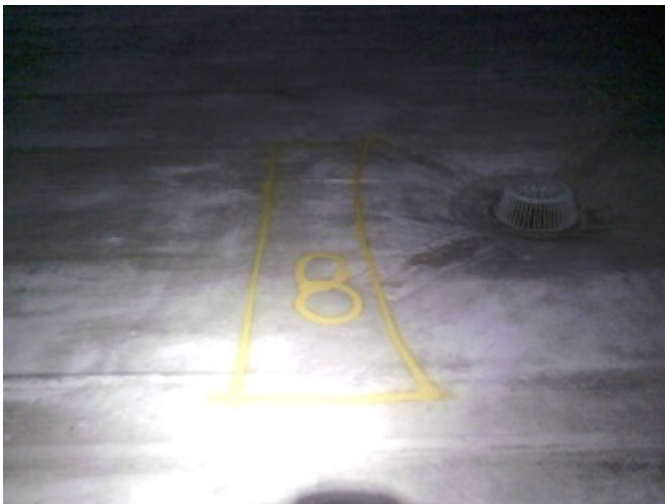
PHOTO 18

Wet Area #8.

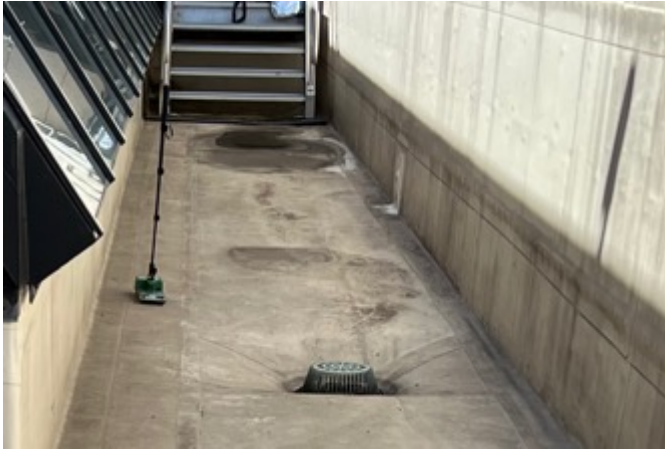
PHOTO 19

Wet Area #9 beginning at meter pole (slight beyond drain) to wall (under stairs).

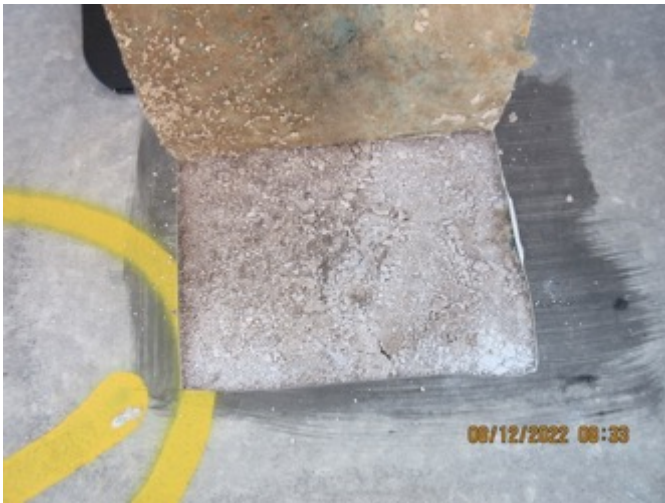
PHOTO 20

Decomposing coverboard due to moisture infiltration.

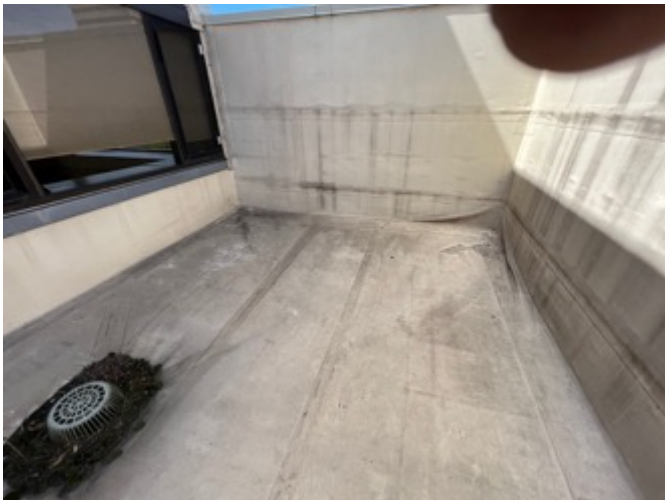
PHOTO 21

In addition to wetted areas, we observed a small section of roof (northeast section of balcony roof) has become unadhered to due wind uplift (Photo 21). Capacitance readings indicated that the coverboard below the membrane was dry. As a preventive measure, we recommend mechanical attachment of this area with two 1 in. wide termination bars attached to the deck on 6 in. centers, 3 ft. apart. Bars would be stripped watertight with PVC membrane heat welded to the existing membrane.

Unadhered membrane at north end of canooy roof. Note membrane at corner.

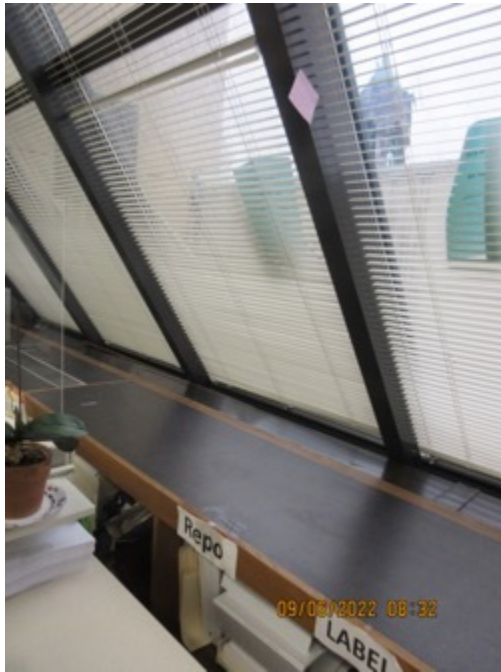
PHOTO 22

After two inches of continuous rain on September 7, 2022, Mr. Leibinger and I toured previous leak areas. We did not find any leakage associate with the roof. However, we did discover a leak at a center horizontal mullion along the shed skylight installed along the east elevation in the Probate administrative area (Photo 22).

Leak at shed window along east elevation of canopy roof.

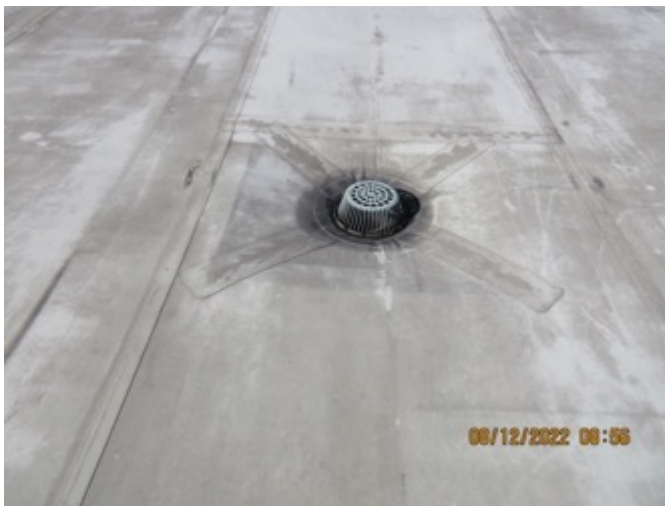
PHOTO 23

- Positive drainage within all areas of main roof/penthouse (some ponding on sections of balcony roof). 55 roof drains with 4 in. outlets (Photo 23).
- All drain bowls appear to have been replaced during 2005 reroof. Polyethylene dome strainers (Photo 23).

General infrared view of rear of roof looking north.

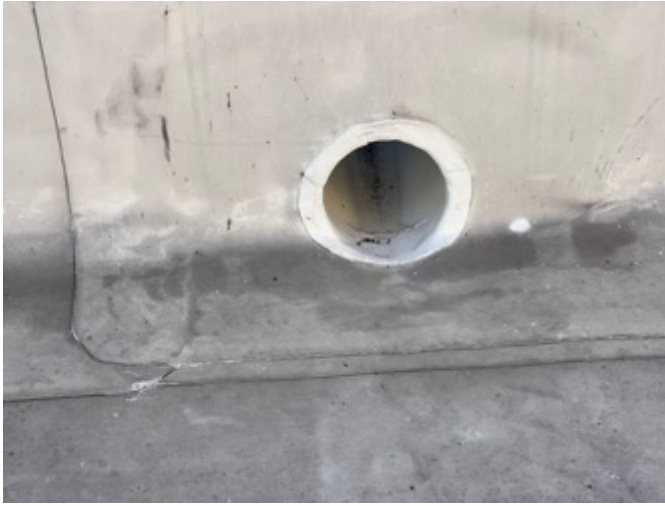
PHOTO 24

Typical secondary drain through parapet.

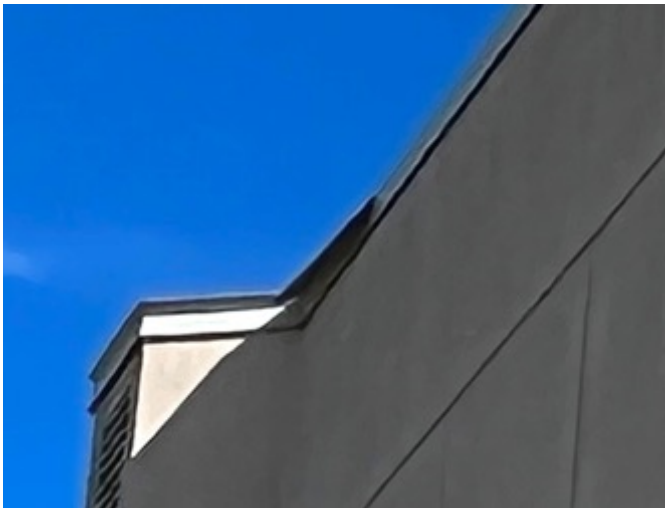
PHOTO 25

- Secondary drainage through parapets installed during 2005 reroof (Photo 24).
- Small section of 0.040 aluminum coping cap unlocked from cleat on west elevation of mechanical room penthouse (Photo 25).

Loose coping metal (west elevation penthouse roof).

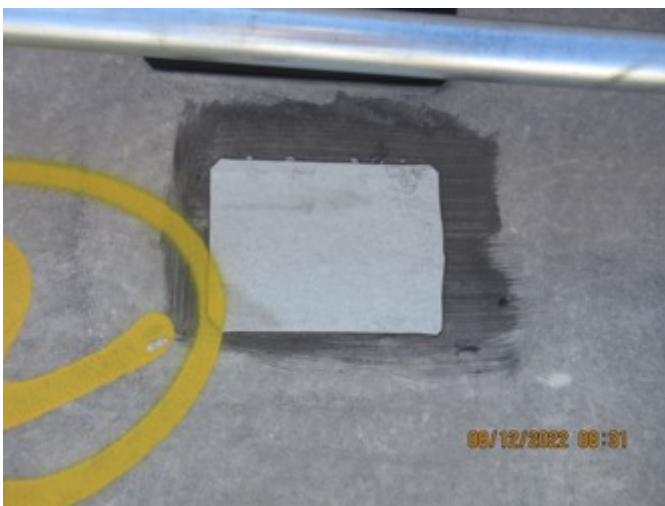
PHOTO 26

- Numerous patches made on uncleaned membrane. Patches appear to be working despite lack of cleaning (Photo 26).
- Numerous column caps have been reflashed as well as several areas along perimeter parapet (Photo 27).

Patch made over membrane not properly cleaned.

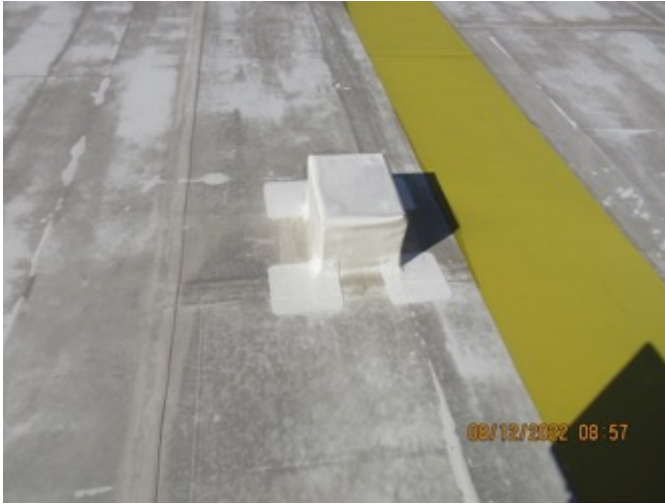
PHOTO 27

Column caps reflashed.

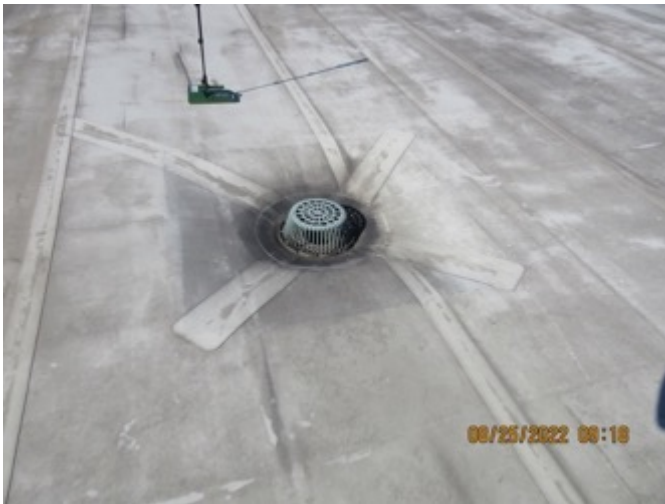
PHOTO 28

- Insulation sumps at roof drains caused installing contractor to cut roof membrane (to remove possible wrinkles) and patched. All patches functioning watertight. (Photo 28).

Membrane sliced and patched to accommodate membrane transition to deep insulation drain sump.

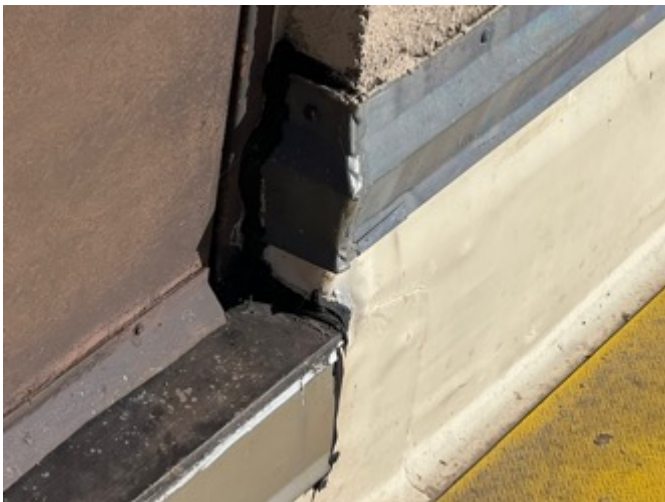
PHOTO 29

Surface-mounted counterflashing.

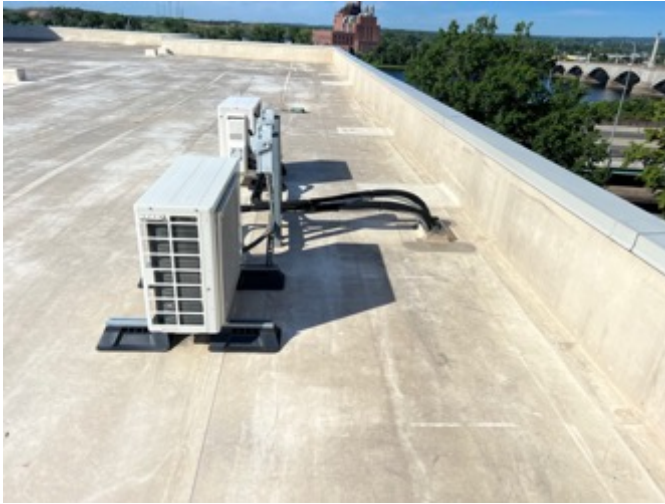
PHOTO 30

- Surface mounted counterflashing at rising wall flashings (Photo 29).
- Two condensers at north elevation have piping entering building through one pitch pan (Photo 30).

- Condenser not mechanically attached to structure (Photo 30).
- Fixed ladder leading to roof hatch of mechanical room penthouse roof has rungs spaced at 14 in. instead of normal 12 in. ((Photo 31). Uncomfortable and unsafe.

Condensers with pitch pan at roof entry.

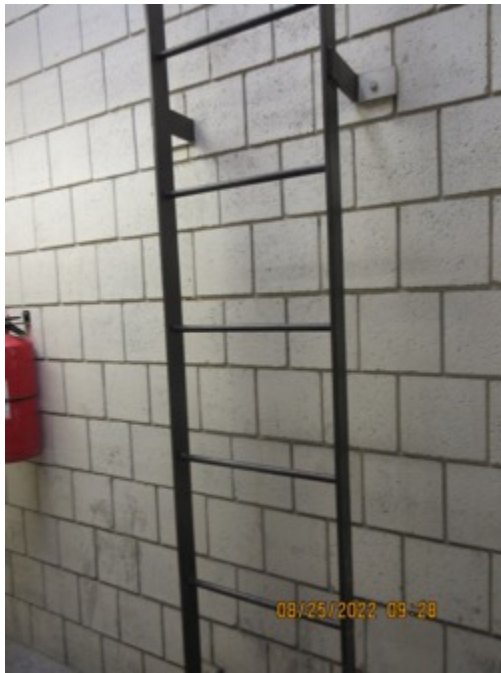
PHOTO 31

Fixed ladder to penthouse roof hatch. Rungs spaced at 14 in. instead of normal 12 in.

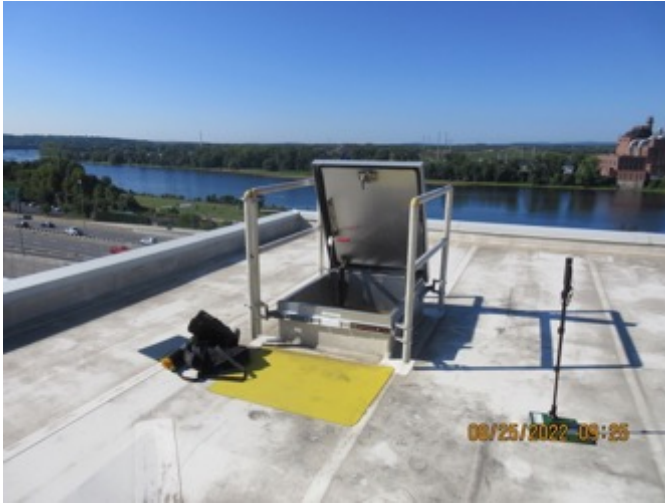
PHOTO 32

Penthouse roof hatch without self-retracting gate.

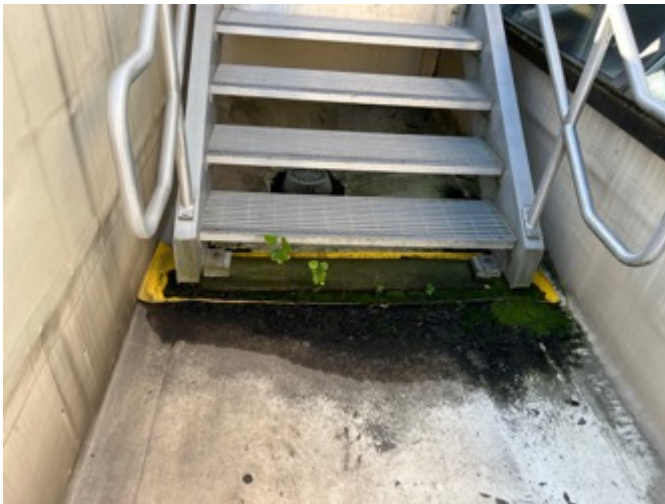
PHOTO 33

- Self-retracting gate missing on safety railing surrounding roof hatch (Photo 32).
- Stairs leading from four access to canopy roof cover drains preventing debris cleaning (grating must be removed to facilitate any cleaning) (Photo 33).

Roof drains located under stairs on canopy roof.

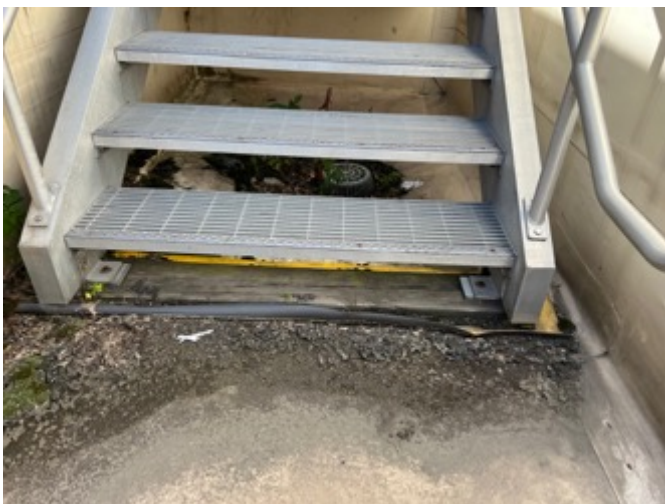
PHOTO 34

Canopy roof. Stair bottom bolted to 2x blocking setting on walkpad. Construction blocks drainage.

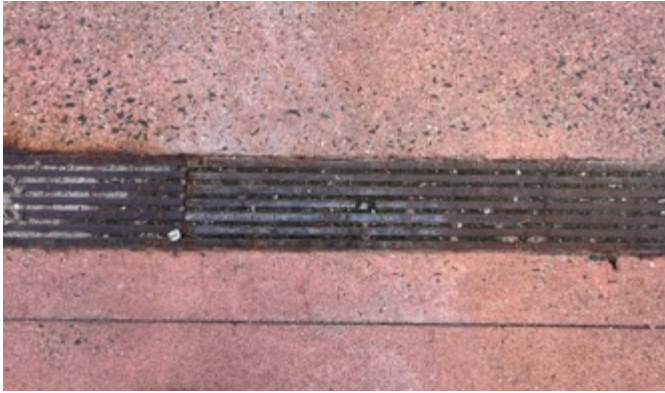
PHOTO 35

- Stair bottom bolted to 2x blocking setting on walkpad (Photo 34). Construction blocks drainage.
- Trench drain grating on main entrance plaza (before stairs) require cleaning. Most openings blocked (Photo 35).

Plaza drain grate openings clogged.

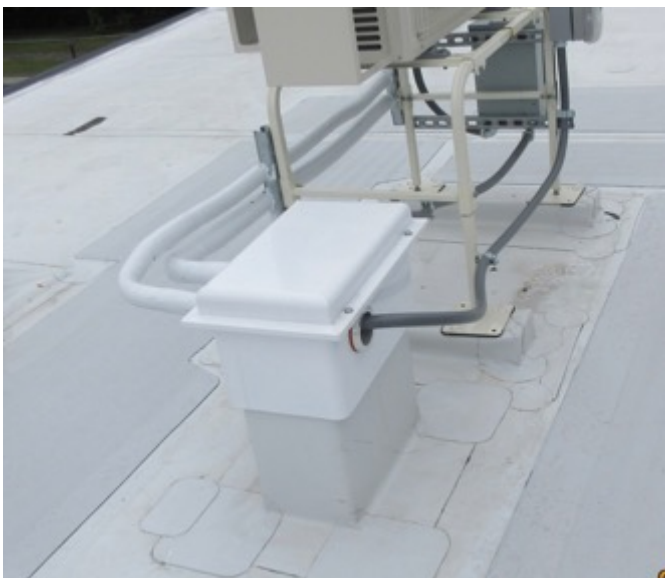
PHOTO 37

Typical pipe penetration housing.
