Massachusetts Road-Stream Crossing Assessment Integrated Water Infrastructure Vulnerability Assessment and Climate Resiliency Plan – Town of Charlton and Town of Spencer May 2019

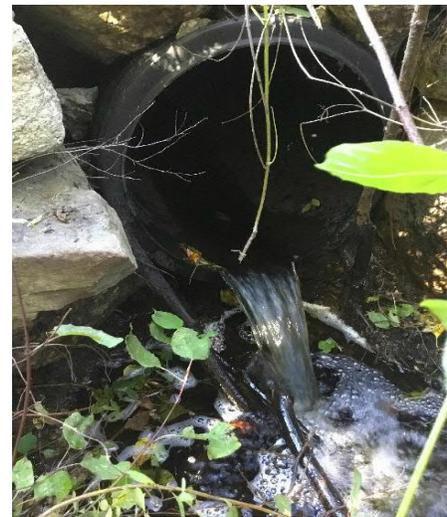
Blood Road crosses an unnamed stream approximately 0.6 miles north of Saundersdale Road. The crossing consists of a single, 30-foot long, 1.5-foot diameter smooth plastic pipe (Figure 15). There is a small dam, approximately 2-feet in height located 10-feet upstream of the crossing. Bankfull width could not be measured at this location due to the density of invasive multiflora rose on the downstream side of the crossing; however based on visual assessment, the degree of constriction was rated as moderate. The structure had both an inlet drop, and a freefall condition at the outlet, with a drop of 1.2 feet from the pipe to the stream bottom. Structural condition was not a major concern at this crossing, but geomorphic risks were considered moderate, and the crossing was rated poorly for hydraulic capacity. The existing structure is undersized for the 10-year peak flow under existing conditions, and is therefore also undersized for larger peak flows as well as expected increases in extreme flows under projected future climate conditions.

Figure 15. View of freefall condition at existing crossing outlet taken during field assessment on October 16, 2018.

Evaluate removal of the upstream, non-jurisdictional dam and replace the existing undersized culvert with an embedded box culvert sized to accommodate the 1.2 times bankfull width design standard of the Massachusetts River and Stream Crossing Standards (based on available information, it is estimated that the structure will need to be approximately 4-feet wide).

- Provide increased hydraulic capacity to reduce risks from road overtopping
- Reduce geomorphic risk associated with inlet drop and freefall conditions
- Reduce risk of flooding associated with potential dam failure

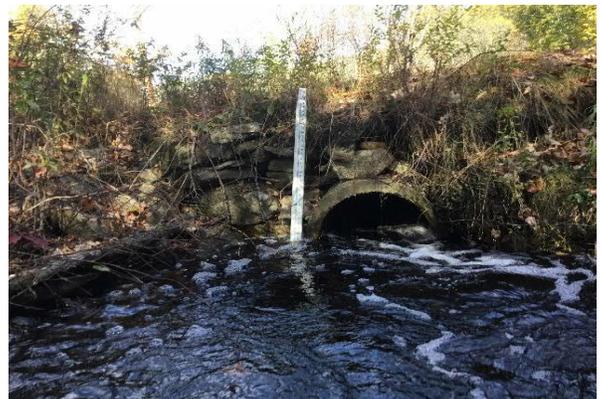
Center Depot Road crosses an unnamed stream approximately just northwest of Stafford Street. At the time of field assessment, the structure inlet was completely submerged, and the outlet was partially submerged (Figure 16). The outlet was observed to be a 2-foot diameter concrete pipe, representing a severe constriction relative to the stream's 6-foot bankfull width (note that in the immediate vicinity of the crossing, the bankfull width was measured at approximately 12 feet, likely due to backwatering from the nearby, downstream Stafford Street crossing). In addition to the geomorphic risk and barriers to wildlife passage associated with this level of constriction, the existing structure is undersized for the 10-year peak flow under existing conditions, and is therefore also undersized for larger peak flows as well as expected increases in extreme flows under projected future climate conditions.

Figure 16. View of partially-submerged outlet at existing crossing taken during field assessment on October 31, 2018.

Replace the existing undersized culvert with a 7.5-foot wide embedded box culvert to accommodate the 1.2 times bankfull width design standard of the Massachusetts River and Stream Crossing Standards.

- Provide increased hydraulic capacity to reduce risks from road overtopping
- Eliminate the observed backwater condition which is resulting from insufficient structure capacity
- Improve aquatic and terrestrial passage

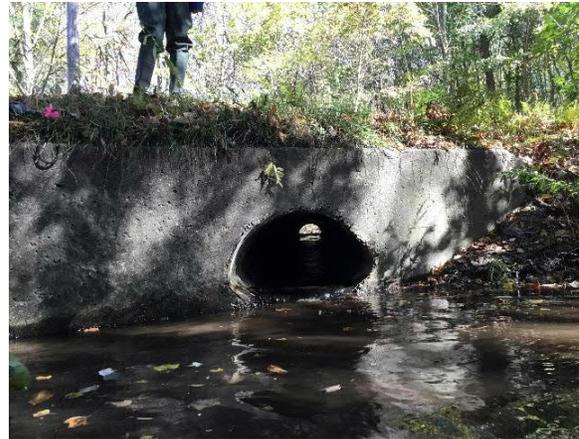
Freeman Road crosses an unnamed stream just south of Mugget Hill Road and approximately 600 feet from Wabash Pond. The crossing consists of a 2.5-foot wide, corrugated metal elliptical arch pipe set into a concrete headwall (Figure 17). The structure is severely constricting relative to the stream's 8-foot bankfull width. The constricted condition has led to the formation of a large downstream scour pool and deposition of sediment both upstream and downstream of the crossing. Structural condition was rated as adequate for all assessed features. The existing crossing is sized to pass the 10-year peak flow, but is undersized for larger peak flows and for future climate conditions.

Figure 17. View of outlet and scour pool at existing crossing taken during field assessment on October 18, 2018.

Replace the existing undersized culvert with a 10-foot wide embedded box culvert to accommodate the 1.2 times bankfull width design standard of the Massachusetts River and Stream Crossing Standards. Restore the stream banks and stream channel to repair scour.

- Provide increased hydraulic capacity to reduce risks of flooding
- Reduce the potential for scour and erosion and associated geomorphic risk by reducing constriction
- Improve hydrologic connectivity of the upstream and downstream ecosystems

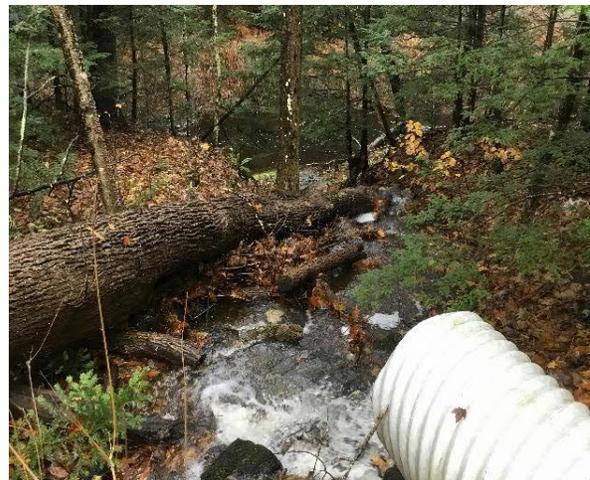
Wire Village Road crosses an unnamed tributary to Turkey Hill Brook (xy42267367198603). The crossing consists of a single, 37-foot long, 2-foot diameter corrugated metal pipe which projects out from the embankment at the outlet and terminates in a 3.7 foot freefall onto a cascade of rocks to reach the stream bottom (Figure 18). The structure severely constricts the stream's 14-foot bankfull width. These combined conditions present significant barriers to aquatic passage at a site which has a high Index of Ecological Integrity rating, an indicator of stream habitat quality and overall ecological benefit of removing an existing barrier. Embankment piping was also noted during the field assessment,

Figure 18. View of outlet freefall condition looking downstream from existing crossing outlet during field assessment on November 6, 2018.

which resulted in an elevated structural risk score. The existing structure is undersized for all evaluated return interval peak flows, including the existing 10-year peak flow.

Replace the existing undersized culvert with a 17-foot span bridge to accommodate the 1.2 times bankfull width design standard of the Massachusetts River and Stream Crossing Standards. Reconstruct the stream channel and banks through the crossing to match the existing channel and banks, including stream substrate and slope.

- Provide increased hydraulic capacity to reduce risks from flooding and road overtopping
- Reduce geomorphic risk associated with freefall conditions and the fact that the crossing slope is significantly less than that of the natural channel
- Eliminate a significant barrier to aquatic passage in a high-value habitat area

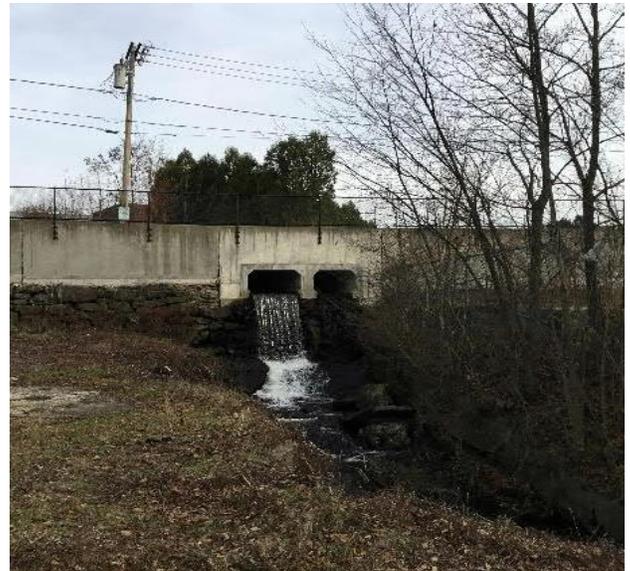
Elm Street crosses an unnamed tributary to the Sevenmile River approximately 300 feet south of Route 9. Because of its location in a densely developed town center area, the crossing received one of the highest scores for flood impact potential across all assessed structures. The crossing consists of two concrete box culverts, each of which is 5 feet wide and 3.3 feet high. The structures outlet to a freefall of nearly 12 feet to reach the stream bottom (Figure 19). This creates an insurmountable barrier for aquatic wildlife. The stream is also channelized between concrete walls in the area immediately downstream of the crossing. There were no concerns recorded relative to structural condition, and the crossing's two structures provide adequate width to approximately match the stream's bankfull width. Hydraulically, however, the existing crossing is undersized for all evaluated return interval peak flows, including the existing 10-year peak flow. There is a mapped FEMA 100-year flood zone located approximately 2,500 feet downstream of the crossing.

Figure 19. View of freefall condition at existing crossing outlet during field assessment on November 12, 2018.

Replace the existing undersized culvert with a bridge of minimum 12-foot span to accommodate the 1.2 times bankfull width design standard of the Massachusetts River and Stream Crossing Standards. Reconstruct the stream channel and banks through the crossing to match the

- Provide increased hydraulic capacity to accommodate peak flows and reduce risks from flooding
- Reduce geomorphic risk associated with freefall conditions and the fact that the crossing slope is significantly less than that of the natural channel
- Provided limited improvements to aquatic passage

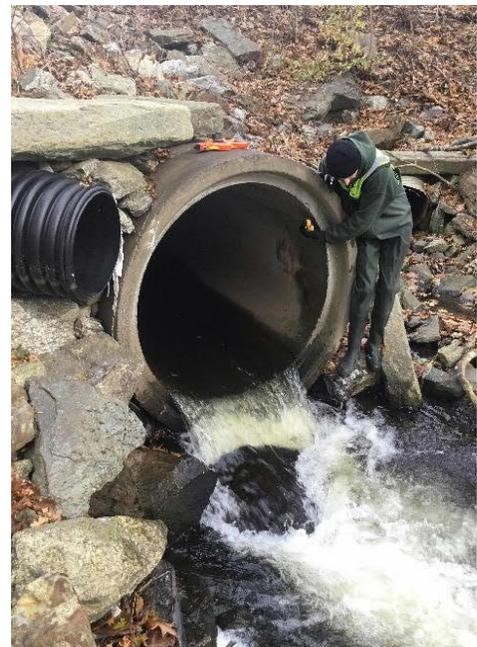
Water Street crosses an unnamed tributary to the Sevenmile River approximately 500 feet southeast of Route 9 (as the crow flies), and just west of the intersection of Water Street and Valley Street. The crossing's outlet consists of a 4-foot diameter, round concrete pipe. The inlet was unassessed, as the culvert is buried under an adjacent factory/warehouse building located at 1 Water Street. Based on aerial imagery, the inlet appears to be located on private property at or near the rear of the building. Field assessment indicates that the structure changes material approximately 30 feet from the outlet. The material further inside could not be identified with certainty, but appeared to be metal. It was noted that rock and sediment are collapsing in on the structure; structural integrity of the culvert barrel was therefore rated as critical and deformation was evident within the structure. The crossing severely constricts the channel's 15-foot bankfull width, and both a large scour pool and downstream sediment deposition were present at the crossing. The structure length is estimated from aerial imagery to be at minimum 120 feet; there is a freefall condition at the outlet with a drop of 1.2 feet to the stream bottom (Figure 20). Hydraulic capacity could not be calculated due to the limited data available at this site. However, based on the partial information collected for the outlet and the estimated peak flow rates at the crossing, it is anticipated that the existing crossing is undersized for the 10-year and larger peak flows, as well as for future climate conditions. Because of its location in Spencer's densely developed town center area, the crossing received one of the highest scores for flood impact potential across all assessed structures. There is a mapped FEMA 100-year flood zone located approximately 950 feet downstream of the crossing.

Figure 20. View of freefall condition at existing crossing outlet during field assessment on November 15, 2018.

Due to the nature of the site, it is likely that any proposed replacement of the Water Street crossing will need to be done in conjunction with redevelopment of the site at 1 Water Street. If such redevelopment were to occur in the future, the Town should evaluate a stream re-alignment and/or daylighting project that allows the stream to flow at its full 15-foot bankfull width. The proposed replacement crossing at Water Street should consist of an 18-foot span bridge or open-bottom arch to accommodate the 1.2 times bankfull width design standard of the Massachusetts River and Stream Crossing Standards. The stream channel and banks should be reconstructed to match the existing upstream and downstream channel and banks, including stream substrate and slope.

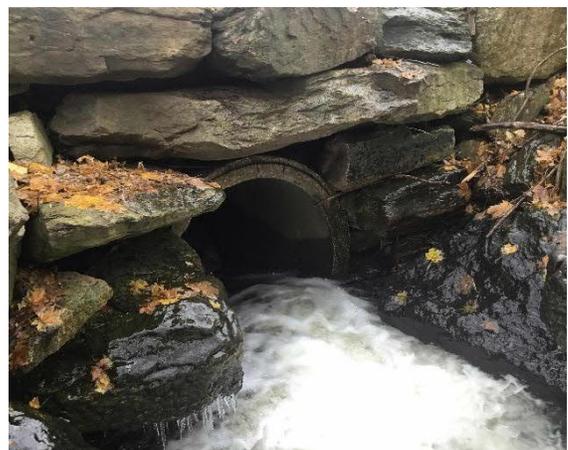
Mill Street crosses an unnamed tributary to the Sevenmile River approximately 270 feet from Route 9, and 125 feet west of Valley Street. The crossing consists of a 4-foot diameter, round concrete pipe which severely constricts the channel's 10-foot bankfull width (Figure 21). A freefall onto cascade at the outlet, downstream scour pool, and high bank erosion along the channelized stream contribute to high geomorphic risk at this crossing. The channel banks have been armored with large rip rap in an attempt to control erosion. Hydraulically, the structure is undersized for all evaluated return interval peak flows, including the 10-year peak flow and is expected to become further undersized relative to future climate conditions. Because of its location in Spencer's densely developed town center area (and between adjacent high priority crossings both upstream and downstream), the crossing received one of the highest scores for flood impact potential across all assessed structures. There is a mapped FEMA 100-year flood zone located approximately 1,500 feet downstream of the crossing.

Figure 21. View of existing crossing inlet during field assessment on November 15, 2018.

Replace the existing undersized culvert with a 12-foot wide open-bottom arch to accommodate the 1.2 times bankfull width design standard of the Massachusetts River and Stream Crossing

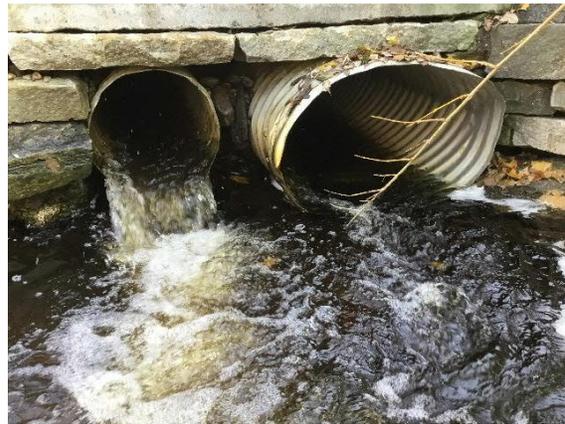
May Street crosses an unnamed tributary to the Sevenmile River mid-way between Cherry Street and Holmes Street, approximately 1,000 feet south of Route 9. This crossing is not located on a mapped stream, but was identified by field staff while conducting assessments at other crossings in the neighborhood. The crossing is located approximately 1,000 feet upstream of Muzzy Lake, which is mapped as a FEMA-designated 100-year flood zone. The crossing consists of two corrugated metal pipes, one of 1.5-foot diameter, and a second pipe which appeared to be a round pipe, but had been crushed, yielding effective dimensions of 3-feet wide by 2-feet high (Figure 22). The combined 4.5-foot width of the two culverts is severely constricting relative to the 8-foot bankfull width of the channel. A freefall at the outlet of the smaller pipe drops 1 foot to the stream bottom. There is an additional drainage pipe which empties into the smaller culvert inside the pipe; its origin could not be determined. A downstream scour pool, and sediment deposition both upstream and downstream of the crossing are indicative of high geomorphic risk at this location. Hydraulically, the crossing is significantly undersized for all evaluated return interval peak flows, including the 10-year peak flow. Note that the peak flow estimates and hydraulic capacity analysis do not account for additional flows entering the smaller culvert from the contributing storm drainage pipe. Because of its location in Spencer's densely developed town center area, the crossing received one of the highest scores for flood impact potential across all assessed structures.

Figure 22. View of existing crossing inlet during field assessment on November 8, 2018.

Replace the existing undersized culvert with a 10-foot wide embedded box culvert to accommodate the 1.2 times bankfull width design standard of the Massachusetts River and Stream Crossing Standards. Reconstruct the stream channel and banks through the crossing to match the existing channel and banks, including stream substrate and slope. Determine the contributing drainage area for the drainage pipe that empties into the smaller of the two stream

culverts and investigate green infrastructure opportunities to infiltrate or retain this water upstream.

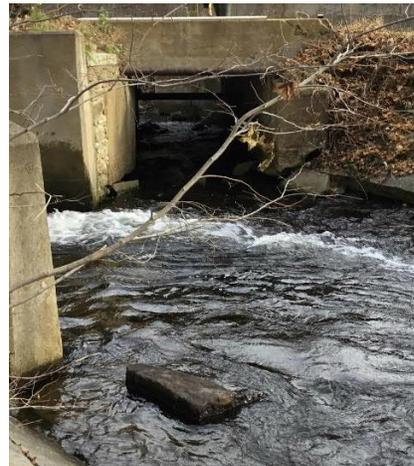
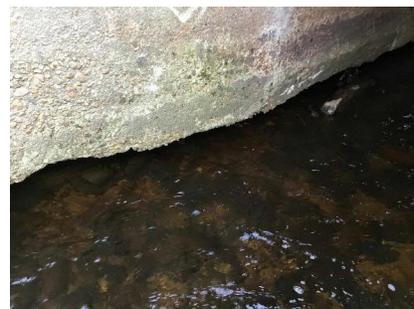
Valley Street crosses an unnamed tributary to the Sevenmile River approximately 300 feet from Route 9, and 220 feet west of Elm Street. The Valley Street crossing is just 200 feet downstream of the high-priority Elm Street crossing. The crossing consists of a 6.5-foot wide by 5.5 foot tall concrete box/bridge (Figure 23). The stream enters the inlet at a sharp bend due to poor alignment of the structure, roadway, and stream. Bankfull width at this location was measured to be 28 feet, although this assessment may be unduly influenced by the proximity of the adjacent crossings and the extensive channelization and armoring of the stream; although the true bankfull width may be narrower, the crossing is believed to severely constrict the stream. A secondary structure enters just below the crossing outlet (at left in Figure 23); that structure's origination point is unknown. Both the crossing and secondary structure are flanked by concrete wingwalls and there is considerable bank armoring downstream of the crossing. The upstream channel is also directed into the crossing inlet by concrete wingwalls and armored with large riprap. Hydraulically, the structure is sized to pass the existing 25-year peak flow, but is undersized for the larger return interval peak flows that were evaluated, and is expected to be undersized for all but the 10-year peak flow under future climate conditions. The crossing also received high structural risk scores due to erosion and undermining of the concrete footings (Figure 24), poor alignment, and condition of the wingwalls and armoring. Because of its location in Spencer's densely developed town center area (and between adjacent high priority crossings both upstream and downstream), the crossing received one of the highest scores for flood impact potential across all assessed structures. There is a mapped FEMA 100-year flood zone located approximately 2,200 feet downstream of the crossing.

Figure 24. View of undermining and erosion of concrete structure during field assessment on November 12, 2018.

Replace the existing undersized crossing with a 12-foot span bridge (this value should be adjusted to match more detailed assessment of bankfull width) to accommodate the 1.2 times bankfull width design standard of the Massachusetts River and Stream Crossing Standards. Reconstruct the stream channel and banks through the crossing to match the existing channel and banks, including stream substrate and slope. Determine the origin of the secondary pipe and evaluate green infrastructure or other opportunities to infiltrate or retain this water upstream, and redesign the crossing to better integrate the two structures.

- Improve alignment of the stream with the crossing to reduce geomorphic risk
- Provide increased hydraulic capacity to accommodate peak flows and reduce risks from flooding
- Alleviate failure risks due to undermining of the structure
- Explore potential to decrease peak flows by reducing contributions from the secondary structure

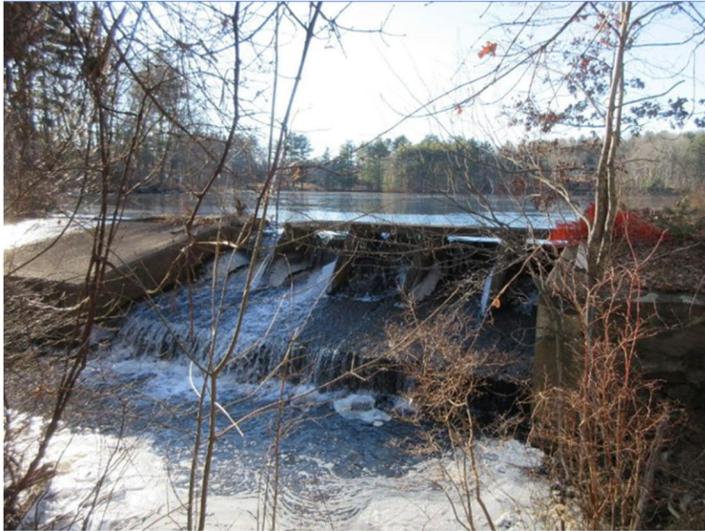
Lower Sibley Pond Dam Spillway

- The structure is currently considered to be in poor condition due to a five-foot long slide (area of soil that has collapsed and fallen down the dam embankment) on the downstream slope with seepage observed flowing from the right side of the slide.
- Trees, brush, stumps, and other vegetation are present on the embankment
- Many of the concrete appurtenances are displaced, cracked, spalled, and/or delaminated.
- Additional details on conditions at the dam are available from the follow-up inspection conducted January 14, 2019.
- The dam and its impoundment do not currently have any known use, and have a low flood mitigation potential.
- The dam has a low stream continuity potential as measured by DER's Restoration Potential Model tool.
- The dam has a Significant Hazard class.
- The dam is privately owned. As of April 2019, the dam is believed to be in probate.

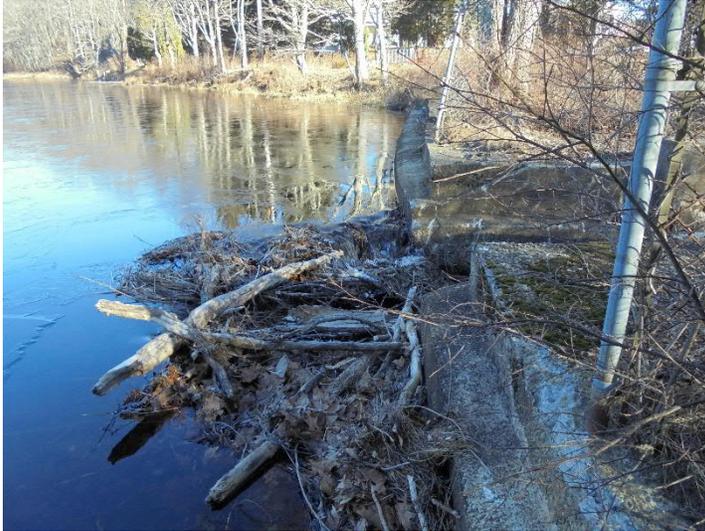
- The structure was determined to be in poor condition due to the presence of a beaver dam at the dam spillway that has raised the level of the impoundment by approximately one foot. Additional debris is caught in the spillway.
- Large and small trees, brush, stumps, and other vegetation are present on the embankment.
- The concrete appurtenances on the dam are delaminated, displaced, cracked, and/or spalled. The left training wall is leaning inward.
- Additional details on conditions at the dam are available from the Phase I inspection conducted December 2, 2014.
- The dam and its impoundment do not currently have any known use, and have a low flood mitigation potential. The impoundment was historically used for irrigation and as an ice pond.
- The dam has a low stream continuity potential as measured by DER's Restoration Potential Model tool.
- The dam has a Significant Hazard class.

Wee Laddie Pond Dam Spillway. Note the beaver dam, which has caused the level of the impoundment to rise by approximately one foot.

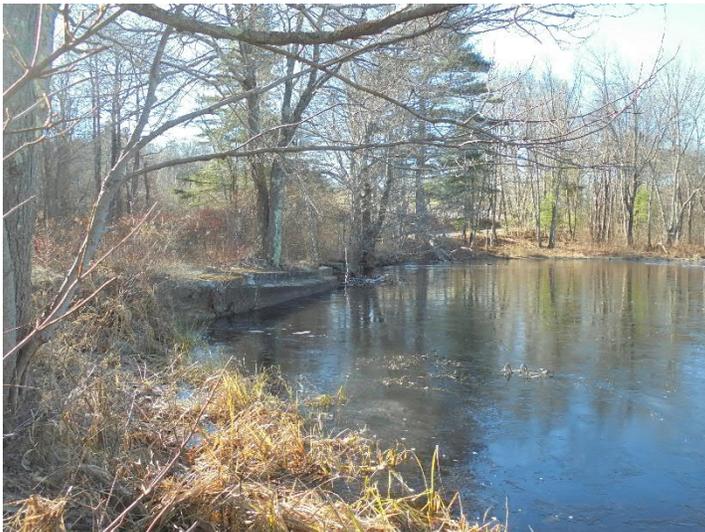
Trees on the crest of Wee Laddie Pond Dam.

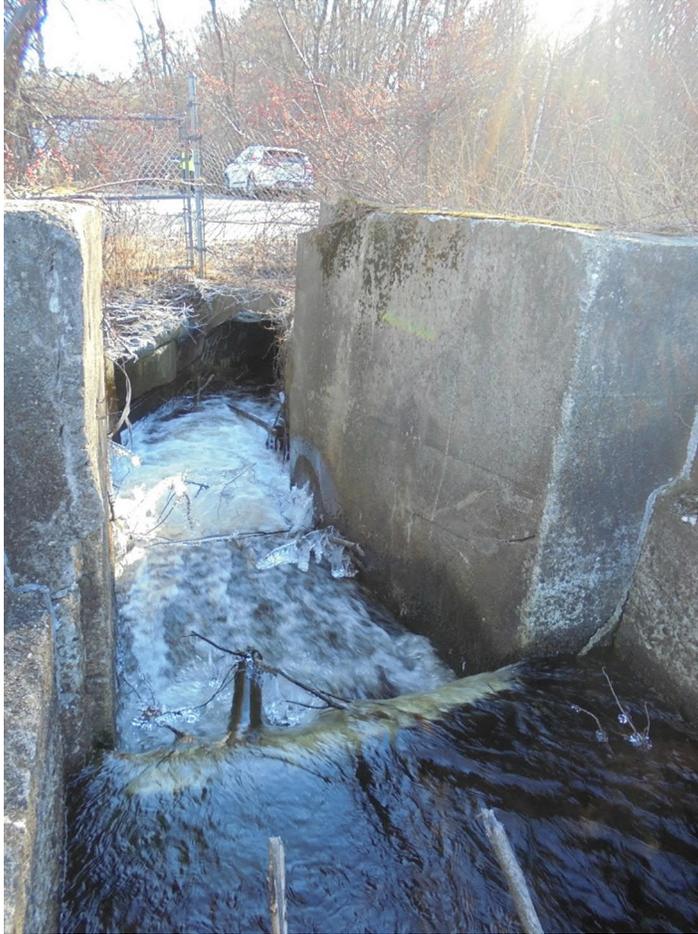
Water from the spillway of Wee Laddie Pond Dam flows directly into a culvert under Gould Road.

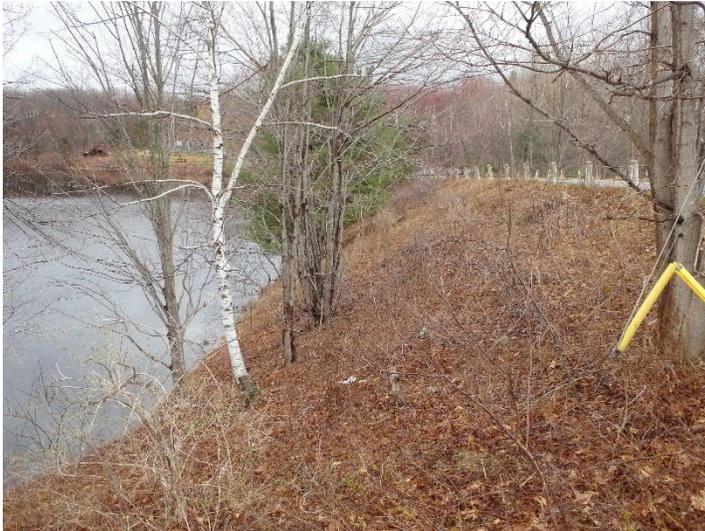
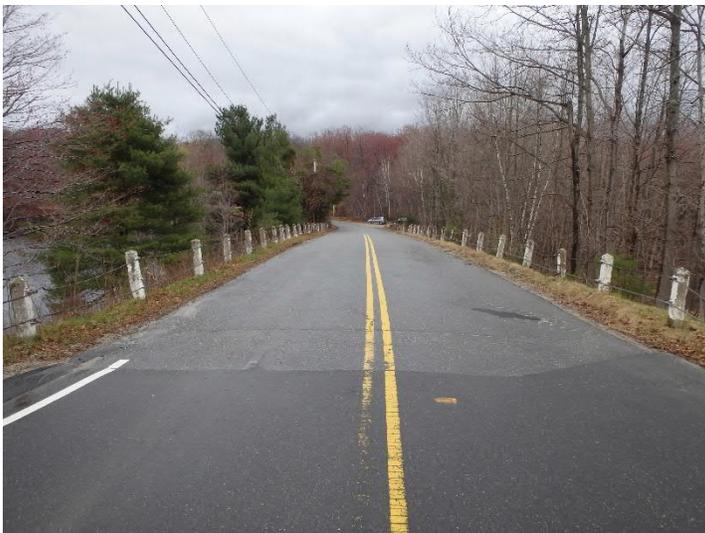
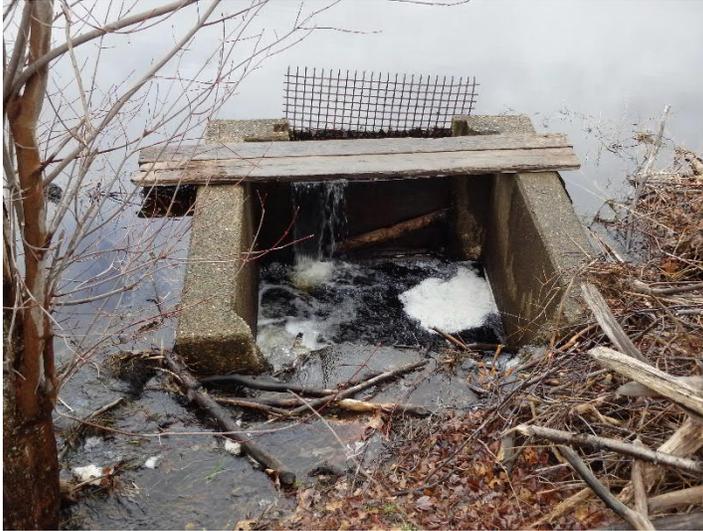
- The structure was determined to be in poor condition due to the presence of heavy vegetation and tree growth on the dam, including both the upstream and downstream embankments, and the presence of debris clogging the spillway on both sides of the trash rack.
- Additional details on conditions at the dam and photos are available from the follow-up inspections conducted November 19, 2018 and January 8, 2016 and the Phase I inspection conducted June 15, 2015.

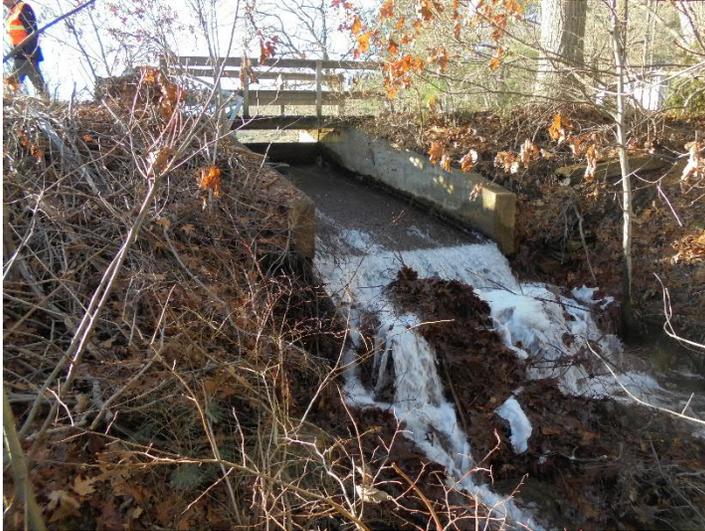
Cranberry Meadow Pond Road Dam spillway. Note the voids beneath and on either side of the spillway, and vegetation on the embankment and left abutment.

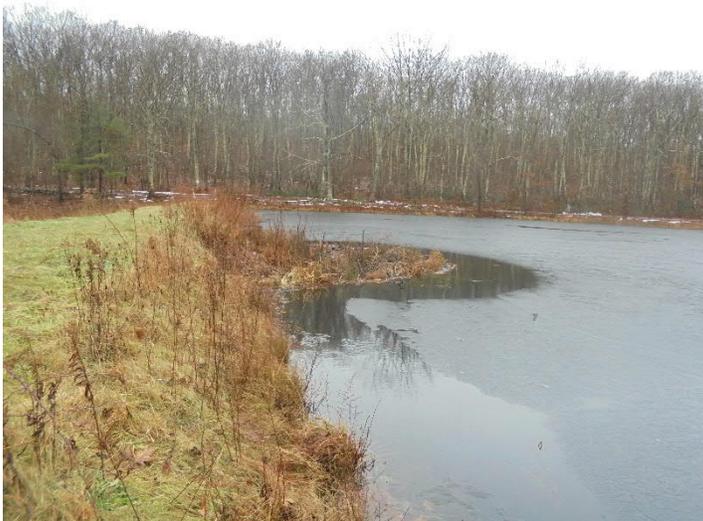
Embankment and spillway inlet at Buck Hill Conservation Dam. Note debris in spillway and vegetation on upstream bank.

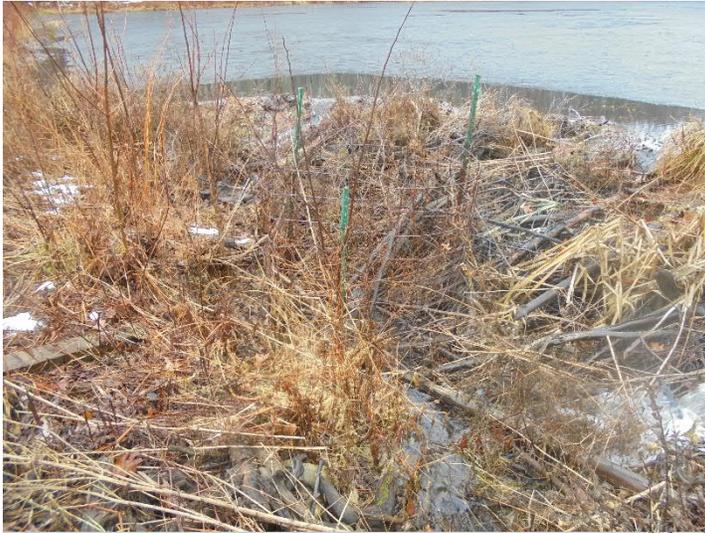
Close-up of Buck Hill Conservation Dam Spillway, showing debris and beaver activity at spillway. The damaged inlet and trash rack are difficult to see through the debris and vegetation.

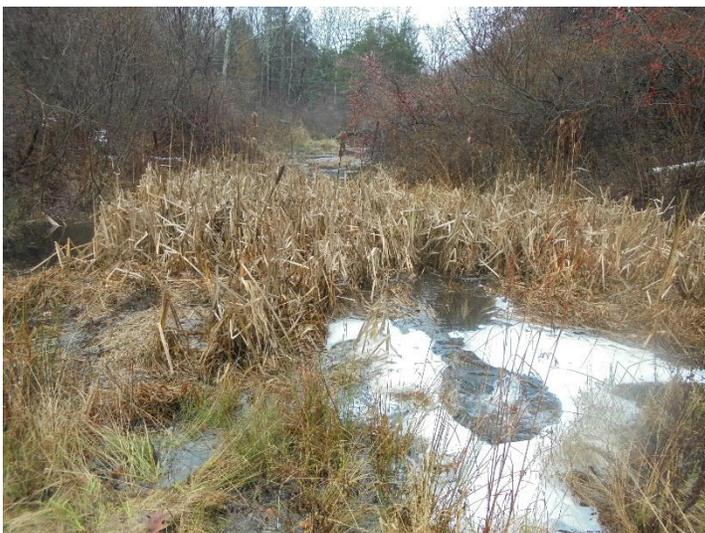
Outlet of Buck Hill Pond Spillway. Note the boil at the bottom right of the image, which may be due to submergence of the outlet pipe, should be investigated to confirm that seepage and piping are not threatening the dam. The outlet pipe and downstream channel should be cleared.

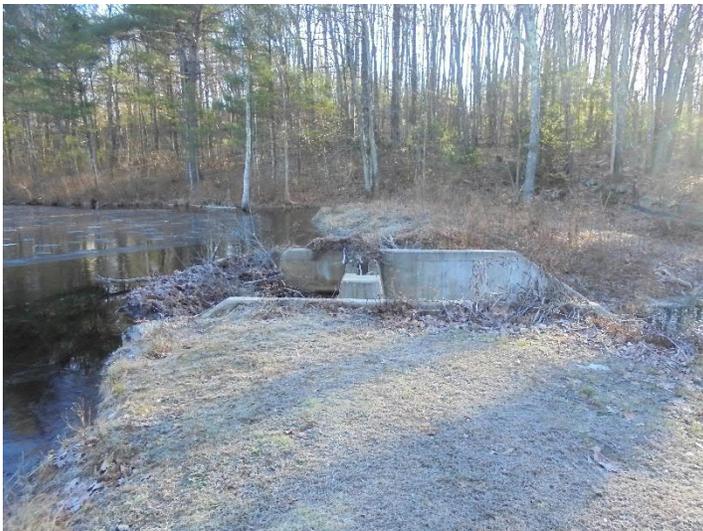
Beaver dam at the spillway of Lambs Pond Dam. Note that the presence of the beaver dam has caused the surface of the impoundment to rise nearly to the crest of the dam.

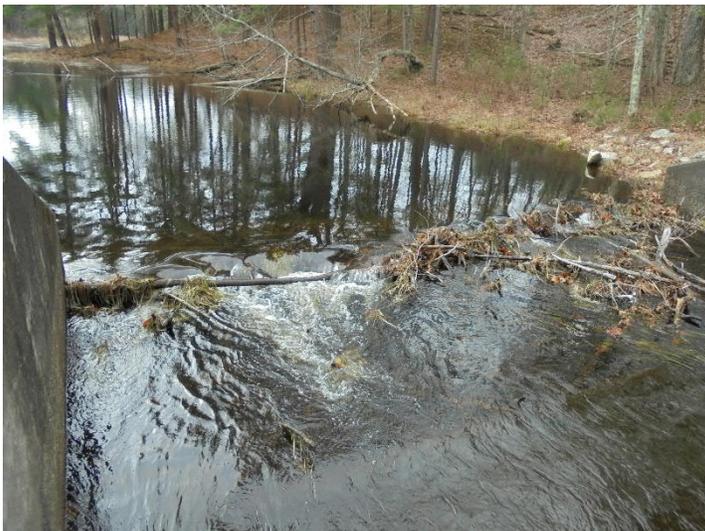
Debris placed by beavers in an effort to form a dam at the spillway of Howe Reservoir Pond. Note that the debris has caused the level of the impoundment to rise.

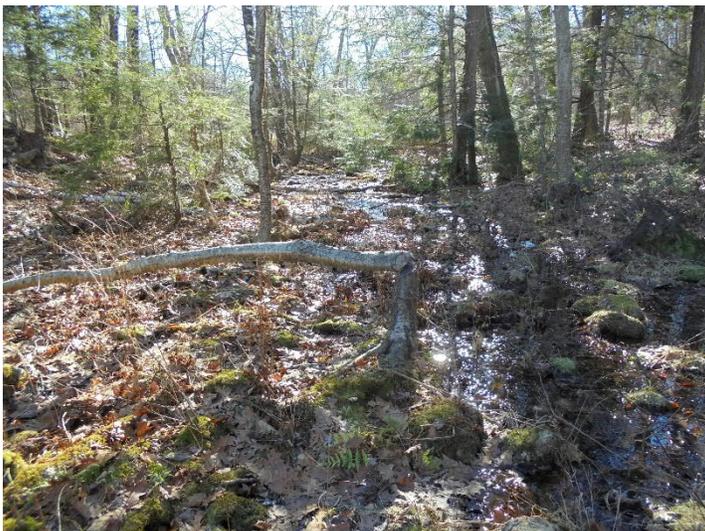
Tree felled by beaver near the dike at Little Nugget Lake Dam.
