Wood-Pawcatuck Watershed Flood Resiliency Management Plan  
DAM INSPECTION FIELD ASSESSMENT

Charlton-Spencer Integrated Water Infrastructure Vulnerability Assessment and Climate Resiliency Plan  
VISUAL DAM ASSESSMENT

# Charlton-Spencer Integrated Water Infrastructure Vulnerability Assessment and Climate Resiliency Plan

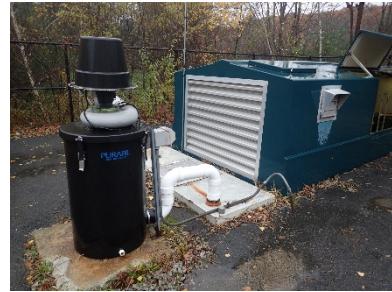
- Backup generator (1)
- Automatic transfer switch (2)
- power transformer (2)
- control panel, (3)
- the two pumps (3)
- Sump (4)

The floor of the station shows rust and there is distress at the joint between the wall and floor as seen in Photo (5).

Barriers are recommended to protect the station and its critical components below grade against flooding. Further, the main service outside should be protected against flooding. This can be accomplished through walls around the facility or by upgrading the facility and elevating critical components above grade in a new structure.

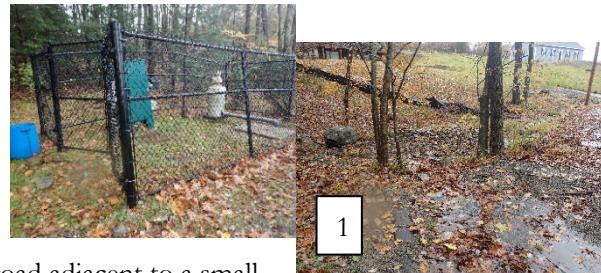
Over the last few years, the surface runoff from the hill just to the south of the station (Photo 1 and Photo 2) and the road runoff from Steven's Park Road to the east have caused issues at the station. Specifically, the fence posts have heaved and the concrete pad for the electrical panel has lifted and stressed the conduit and cabinet sitting on top of the pad.

The runoff from the hill just south of the station still needs to be re-directed. The Town will look to submit an application for an MVP Action Grant to address this runoff and repair the pump station including the fencing around the facility and electrical power/control cabinet. Installing drains and bioswales around the facility is recommended to capture and redirect the runoff to the small stream adjacent to the station.

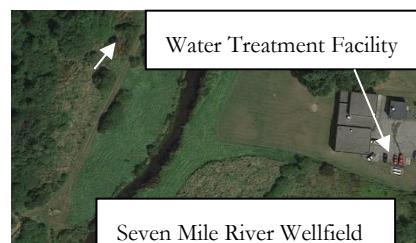
The well casing extends 6 feet 8 inches (See Photo 1) above the ground elevation of approximately 631.3 using LIDAR elevations. This is 2 feet 6 inches above the 100 year flood elevation of 635.5 based on FEMA mapping.

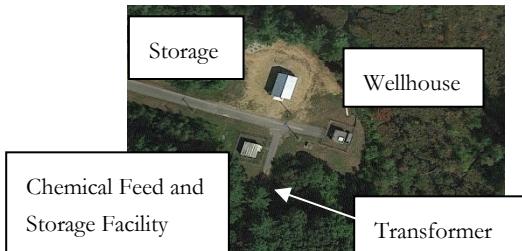
Just outside the building is the main power transformer for the site which rests on the ground (Photo 2). This would be adversely affected if the site was flooded. This should be raised to protect it against potential flooding.

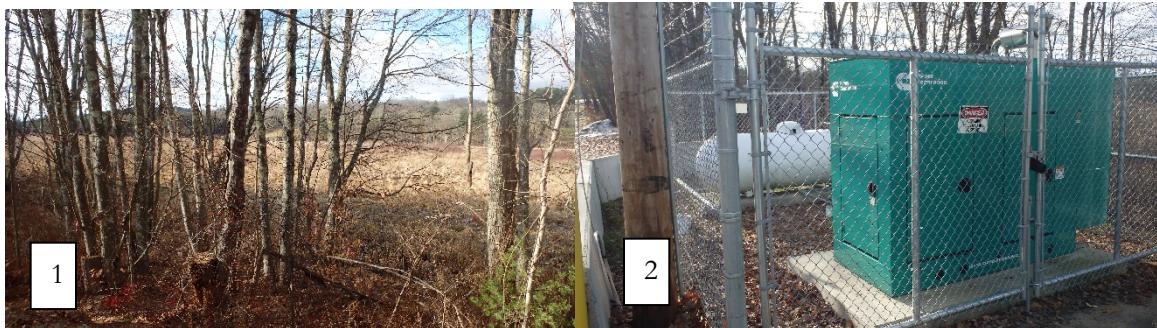
ground on a housekeeping pad) and the liquid propane storage tank (also on a concrete pad just 6 inches off the ground). See Photo 2.

Because the elevations of critical components of the pump station are very close to the 100 year flood elevation, fortification of the critical equipment including the backup generator, and propane storage tank as well as the items less than 3 feet off the floor should be considered. This would require the electrical cabinets, the ATS and the pumps be raised at least 3 feet above the floor.

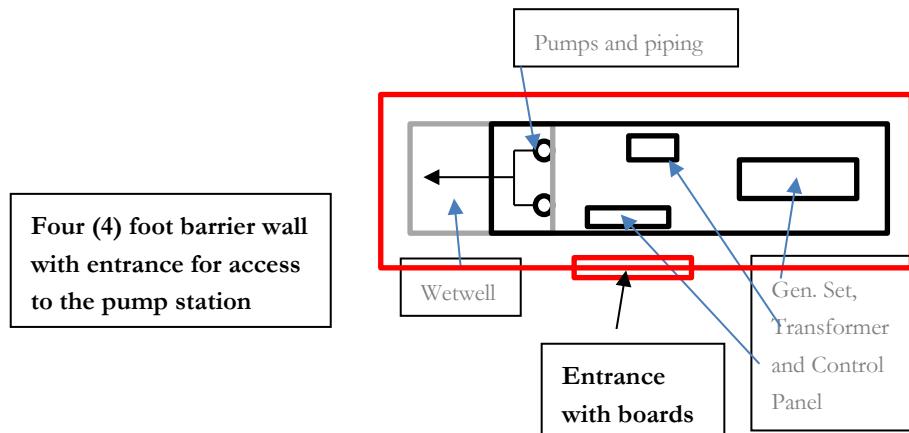
recommendations to protect the facility from flooding given their proximity to flood zones range from providing a barrier around the structure to minimize floodwaters from entering the partially buried station to constructing a new above-ground facility and locating all critical components above the base flood elevation. For this effort, we have budgeted for providing a barrier around the existing structure. A conceptual layout of the proposed improvements is included in the sketch shown below.

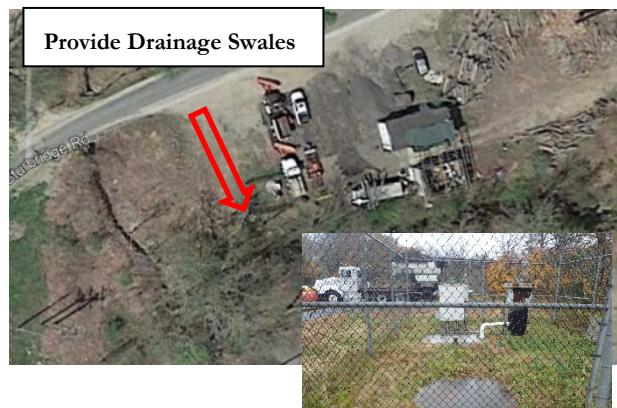
This facility is another wetwell pump station which is in a low lying area adjacent to a truck parking area and garage. The facility has a power/control panel and ventilation/odor control system above grade within the fenced in area. The station is adjacent to the 100 and 500 year flood zones for Cady Brook. There is no generator for backup power.

Resiliency improvements for this site include providing drainage swales to guide runoff and floodwaters away from the structures and raising the electrical equipment to further fortify these critical items.
