Fitchburg District Court Fitchburg, MA

HVAC SYSTEM EVALUATIONS COVID-19

Office of Court Management

August 4, 2021

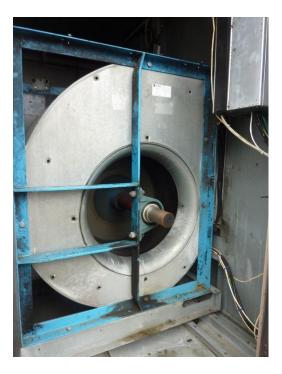
The unit contains a set of 2" pleated MERV-8 filters in a v-bank arrangement. This is favorable because more filter area is presented to the airflow, which lowers velocity, reduces pressure drop, and increases holding capacity. The upstream face of the adjacent heating coil appears to be clean. Facilities personnel confirmed that the coil and its drain pan are cleaned regularly. We noted the presence of suspect visible mold (SVM) on the painted steel frame of the fan assembly.

Photo 1 – Suspect visual mold on RTU fan assembly

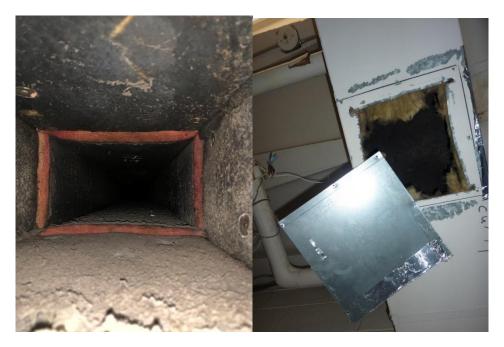
The distribution ductwork is sheet metal and externally insulated with fiberglass wrap for the runs between the RTU and the VAV boxes. Aft of the VAV boxes, the ducts are lined with fiberglass insulation. This was done for acoustical reasons but can adversely affect indoor air quality (IAQ) even when the liner is fully intact. The fiberglass liner was tested for mold or hazardous materials recently, as was evident from sheet metal patches in all visible ducts. It is assumed that these tests came back negative, although we did not have access to the test results to confirm this assumption. However, the sampling method left exposed loose edges of insulation in the air stream, which is not good for IAQ. TABLE 1

Photos 2 and 3 – Fiberglass duct liner and loose edges at test panel

2.7.4 Repair Duct Liner Where Samples Were Taken

The distribution ductwork aft of VAV boxes is lined with fiberglass insulation. In numerous locations these ducts were cut open to inspect and test the liner material. In the locations inspected by Tighe & Bond, the edges of the cutout portion were irregular, rough, and left exposed to the air stream. This is an IAQ concern, both for the ability of the loose edges to attract and hold debris, and for friable glass fibers to enter the air stream. We recommend reinstalling the patches in a manner that seals the loose edges and eliminates contact between fiberglass and the supply airstream, and also seals the duct against leakage.

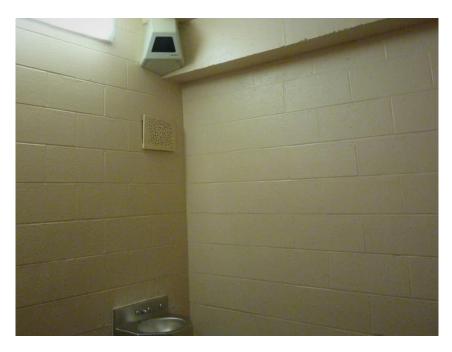
Each holding cell has an exhaust grille near the toilet/sink fixture. The original metal grilles have been replaced with tamper-proof units made by drilling holes in plywood, and given the small size and quantity of holes, it is likely that the holding cells are receiving less airflow than intended.

Photo 4 – Holding cell with modified exhaust grille

2.7.1 Provide Proper Ventilation Air to Holding Cells

It is unlikely that the ventilation rates required by current code are currently provided to the holding cells. We recommend replacing the exhaust grilles, rebalancing or replacing the exhaust fans, and rebalancing or replacing the VAV boxes that serve this area in order to provide the proper volume of outdoor air to these important spaces.

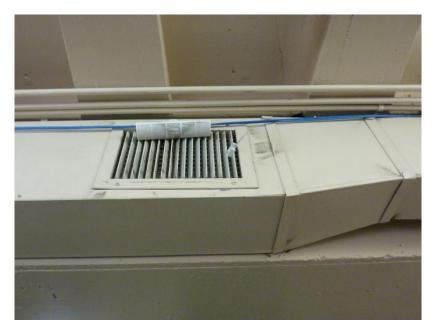
Ventilation air is provided to the holding cell area through supply diffusers in the corridors. Air fresheners zip-tied to these diffusers are an indication that ventilation may be inadequate. At the time of our visit, each cell had a solid door, with two openings that can be secured from the outside. It is unlikely that the undercut was adequate to provide required ventilation to the individual cells. Trial Court Facilities Management & Capital Planning informs us that these doors are being replaced.

Photo 5 – Supply diffuser in corridor outside holding cells

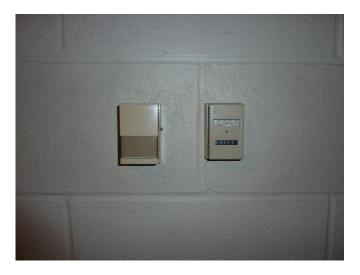
It is our understanding that the existing VAV boxes and space thermostats are not connected to Metasys and are controlled by the original pneumatics. There are two pneumatic thermostats in each zone, a cooling stat that controls the VAV box, and a heating stat that controls perimeter radiation and reheat coils (second floor only) to satisfy space temperature requirements.

Photo 6 – Dual Pneumatic Thermostats Serving a Typical Zone

2.7.6 Expand and Enhance Building Management System

We recommend expanding a BMS to schedule, control, and monitor the VAV boxes, perimeter heating, and any other major HVAC equipment currently under local control. The pneumatic control systems are antiquated and do not offer the same benefits as a BMS.
