# MassDEP Field Assessment and Support Team (FAST)

After Incident Report

DEP RTN 4-22,693

Foxboro Jet Fuel Tanker Spill

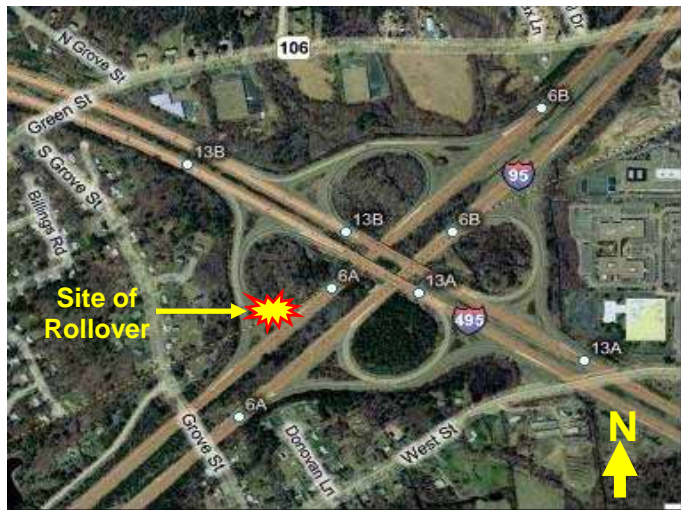
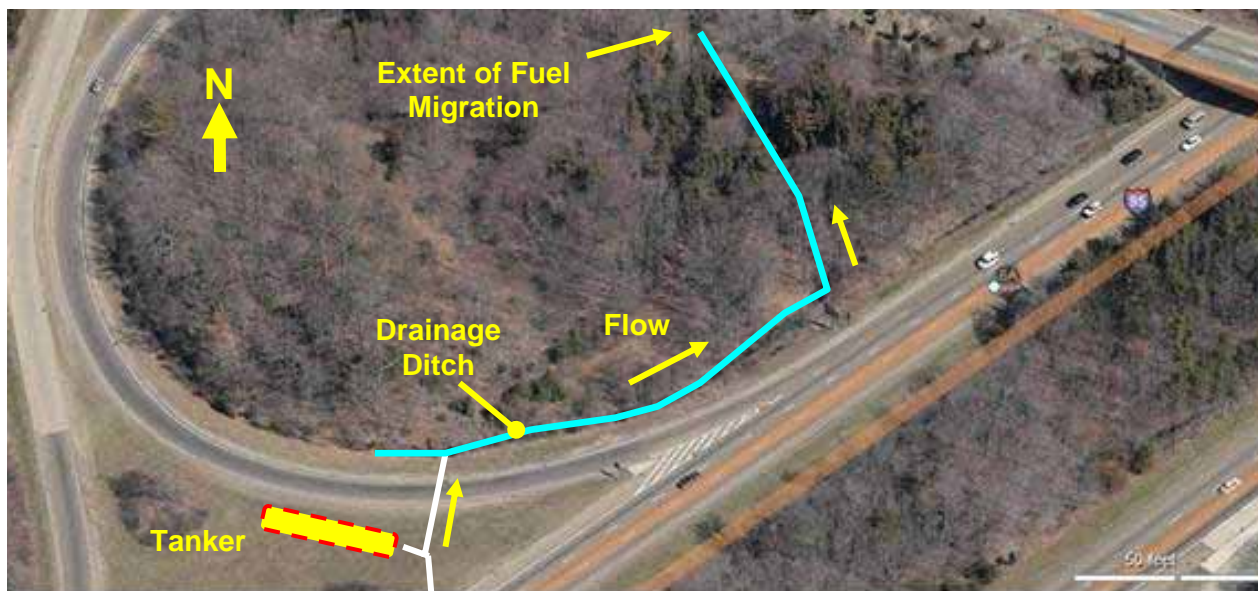
**Figure 1 – Spill Site**

The tanker landed on its side, in a grassy area just off (southwest of) the ramp (see cover). Later in the morning, it was ascertained that all 11,000 gallons of fuel had spilled from the tanker. The fuel had discharged onto the ground, and flowed into a nearby catch basin. The catch basin discharged to a nearby manhole, which flowed into a culvert that discharged to a drainage ditch on the north side of the ramp (See Figure 1).

Because there was virtually no flow of water in the culvert system or drainage ditches, the fuel did not migrate beyond the wetland within the “clover leaf” area proximate to the release (about 500 feet). Migration was also constrained by sediment within the culvert system, and timely booming by a response contractor.

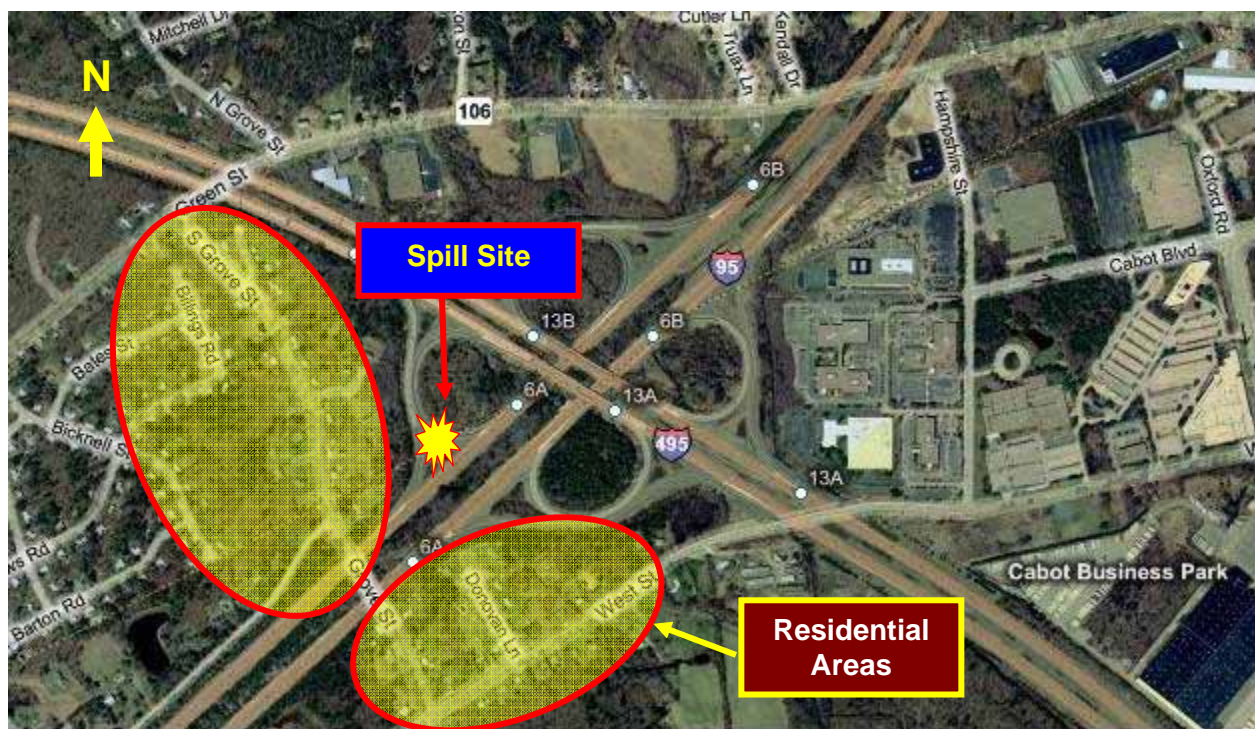
**Figure 2 – Nearby Residential Areas**

The orthographic maps indicated the presence of residential areas approximately 500 feet west of the site, and 1000 feet south of the site (see Figure 2).

Fortunately, the FAST on-board weather station was recording a wind direction out of the south/southwest (the best possible scenario), indicating that vapors (and odors) from the spill area were not being transported to sensitive receptors.

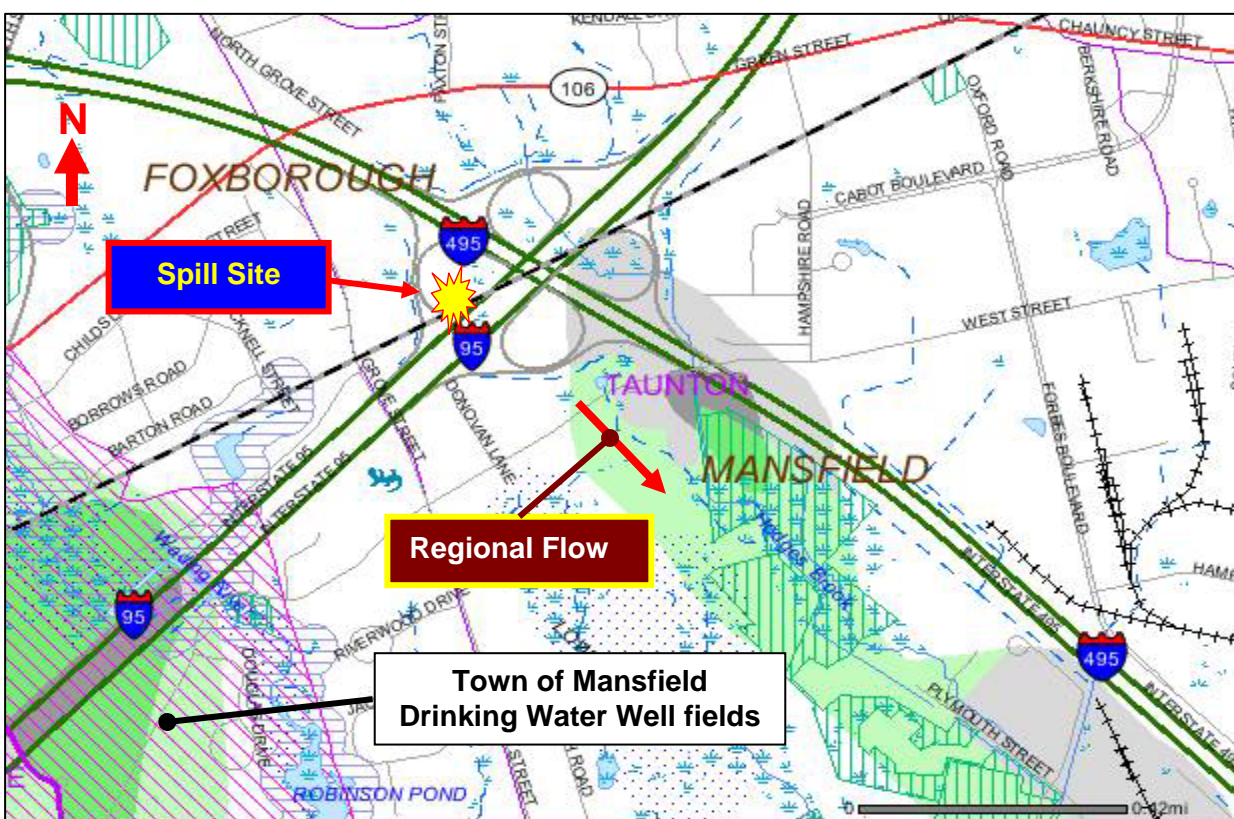
**Figure 3 – Proximate Sensitive Resources**

GIS maps of the surrounding area indicated the presence of a number of drinking water wells for the town of Mansfield to the southwest of the spill area, with the nearest Zone II boundary within ½ mile of the rollover. However, an examination of a topographical map indicated that surface water flow from the site was towards the southeast, away from the drinking water wells of concern (see Figure 3). Specifically, drainage ditches/streams from the spill site flowed to the northeast under Route 495, then easterly and southerly into Hodges Brook. No areas of concern were seen on or near Hodges Brook for at least one mile downstream of the site.

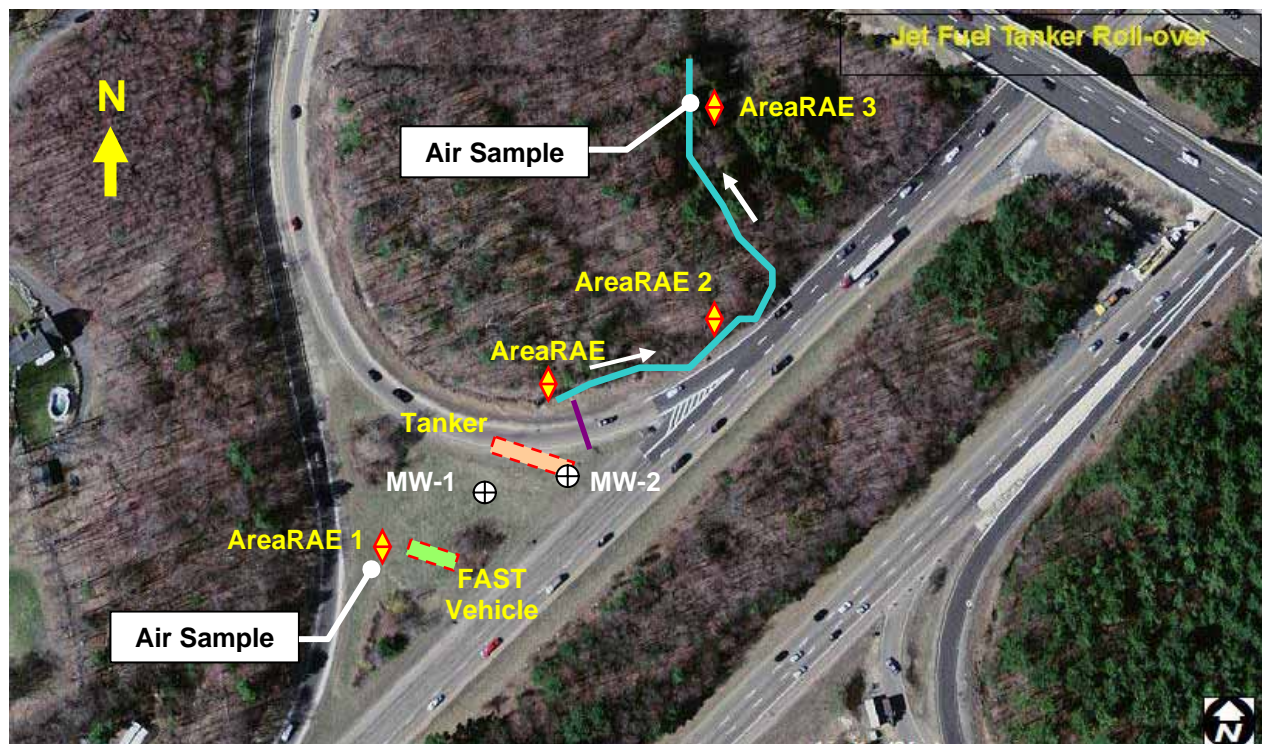
Figure 4 – FAST Sampling/Monitoring Locations

Two small-diameter-driven-wells were installed by FAST personnel in the grassy area where the tanker had overturned and released its contents. Both wells were 10 feet deep, with a 5 foot well screen. The purpose of these wells was to determine (a) depth to groundwater, and (b) whether separate-phase jet fuel was pooled at the water table interface. Such information is useful in determining the fate of the 11,000 gallons of fuel, and in scoping out soil excavation activities in the impact zone. The location of air and groundwater monitoring points is depicted in Figure 4.

The depth to groundwater in both wells was approximately 4.75 feet below ground surface. Groundwater obtained from each well did not contain a separate phase of jet fuel.

The lack of separate-phase jet fuel at the groundwater table interface suggest that most of the jet fuel released from the overturned tanker travel via overland flow into the nearby catch-basin, and then into the drainage ditches to the east via a storm water culvert.

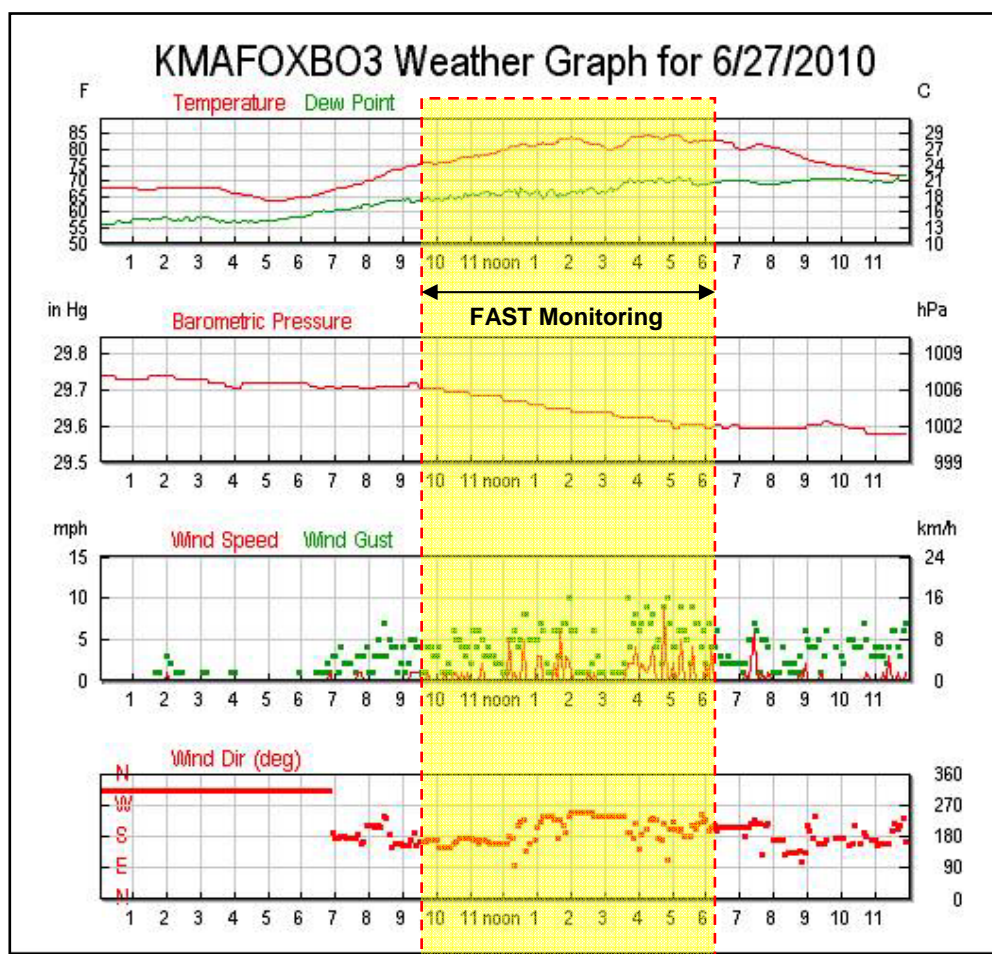
**Figure 4 – Metrological Conditions for 6/27/10**

Metrological data from 6/27/10 from a weather station in Foxboro located 3.5 miles northeast of the site is provided in Figure 5. Observations from the on-board FAST weather station during the hours of deployment verified that on-site wind direction was consistent with data from this weather station.

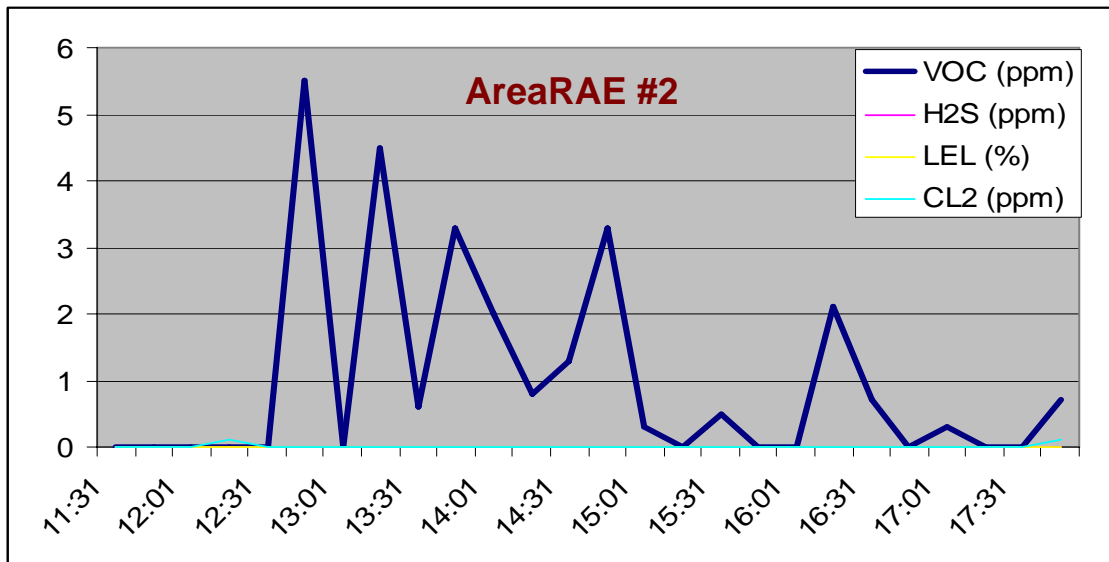
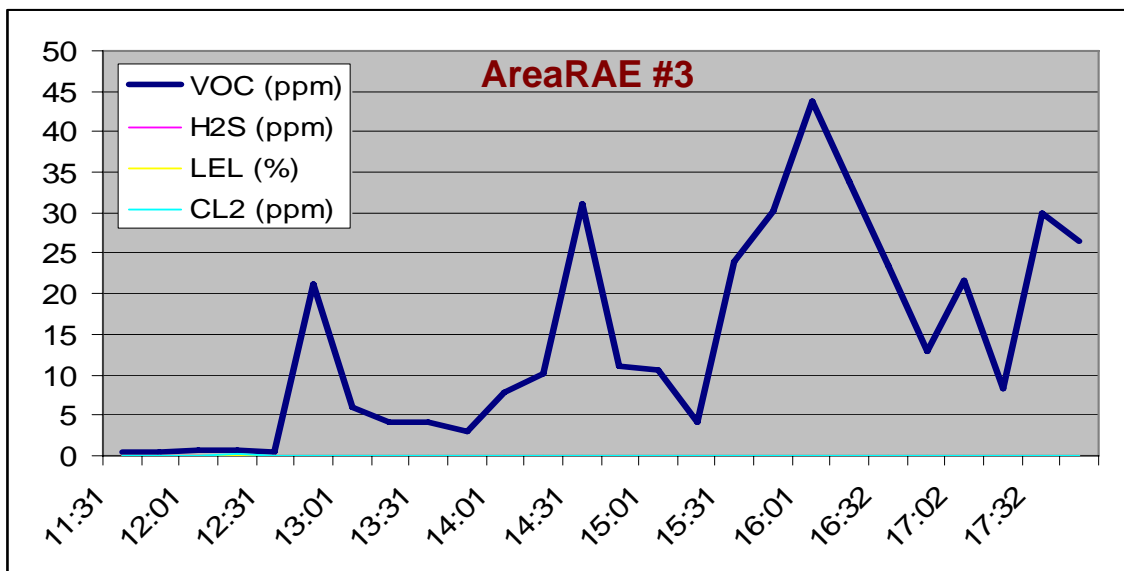
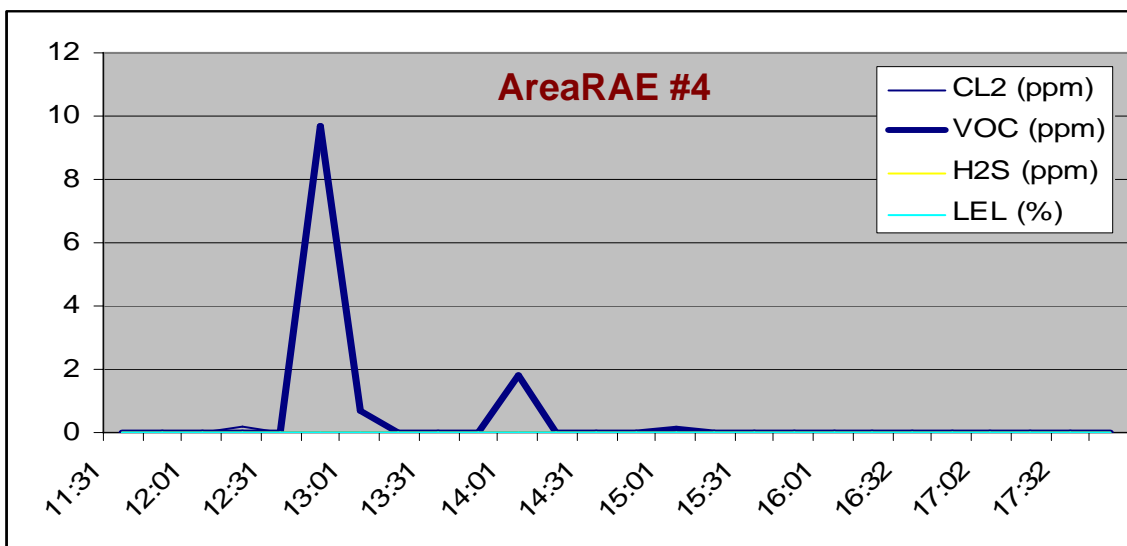
**Figure 5 – AreaRAE Air Monitoring Data**

Data from AreaRAE unit #1 did not detect any levels of VOC hydrocarbons or any other contaminant during the time of monitoring (12:30 PM to 6:00 PM). This is not surprising, given its location upwind of the spill and work area. Data from AreaRAE Units 2, 3, and 4 are displayed in Figure 5, with data normalized over a 15 minute averaging period.

As can be seen in Figure 5, the highest concentrations of VOCs (i.e., volatile Jet Fuel Hydrocarbons) were seen in AreaRAE unit #3, which was located near where fuel oil was being recovered (via vac truck) from a wetland area. The highest 15-minute average concentrations of VOCs at this location were 45 ppmV at about 1620 hours (4:20 PM). Assuming a (isobutylene-to-jet fuel) correction factor of 0.67, this equated to about 30 ppmV of jet fuel hydrocarbons. While this value is approaching the 35 ppmV OSHA limit for occupational exposures, the 8 hour average concentration at this location appears to be less than 20 ppmV.

Lower levels of VOCs were recorded on AreaRAE units 2 and 4, also located in or near impacted areas. Consistent with its flash point (i.e., > 100° F), levels of vapors in the ambient air were no where near explosive levels (i.e., non-detect on the % LEL sensor).
