**REPORT#:** 22MA058

**REPORT DATE:** May 29, 2025

## Freight Mover Struck by Backing Dumpster Truck at Freight Transfer Facility— Massachusetts

At 6:32 a.m. on December 16, 2022, a 31-year-old Hispanic Black laborer for a transportation company was struck and killed by a backing waste haul dumpster truck at a freight transfer facility. [READ THE FULL REPORT>](#) (p.3)

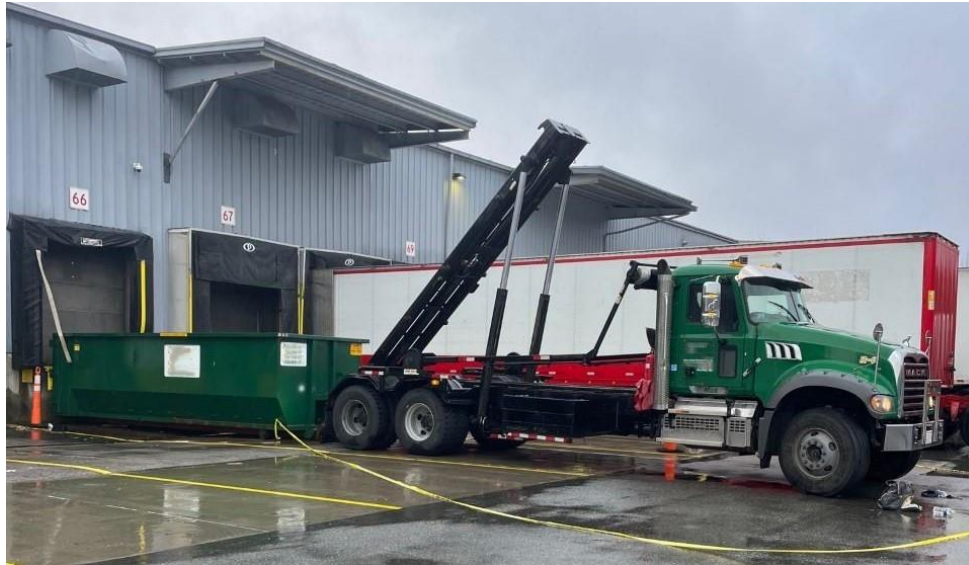
The waste haul truck was a 10-wheeler Mack dumpster truck with a 12.8 liter diesel engine and 248-inch wheelbase. It had a 6x4 drivetrain with eight wheels on two drive axles in the rear. It belonged to the waste haul management company. It was a 2019 model year and received its first state inspection on 6/12/2018. The truck was inspected by authorities after the event. This description contains relevant findings from that inspection, from routine state emissions and commercial vehicle safety tests, and specifications from the manufacturer. The truck had a reverse back-up alarm that was operating as designed and audible in the vicinity of the truck. The truck had headlights that were on at the time of the incident. The truck had two lamps on the rear passenger side that were not functioning. The vehicle's state inspection report from ten months prior to the event showed that the lighting devices received a pass. The truck had working windshield wipers that were on at the time of the incident. The truck had a circular convex rearview mirror mounted at each front corner fender and mirrors mounted near the driver and passenger door frames. The truck was equipped with a dashcam that was mounted approximately centrally in the cab and was facing forward. The truck had a gross vehicle weight rating of 72,000 pounds.

**Image 1. Truck and dumpster involved in the incident. (Photo courtesy of local responders.)**

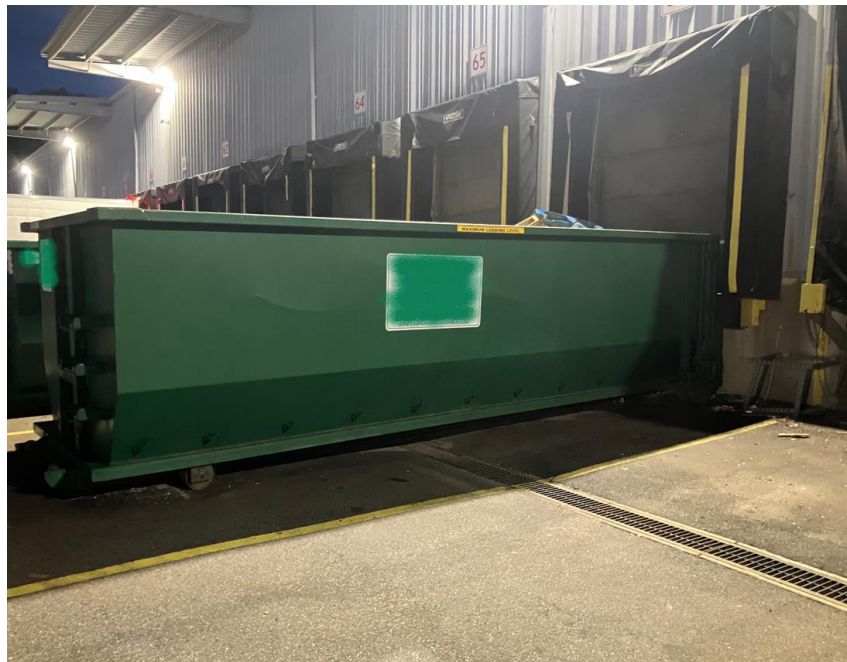
The dumpster was a 30 cubic yard steel dumpster. A similar model dumpster owned by the waste haul company was measured at 89 inches wide and 75 inches tall. It had a nominal length of 22 feet.

**Image 2. Similar dumpster in position at loading dock. (Photo taken by MA FACE.)**

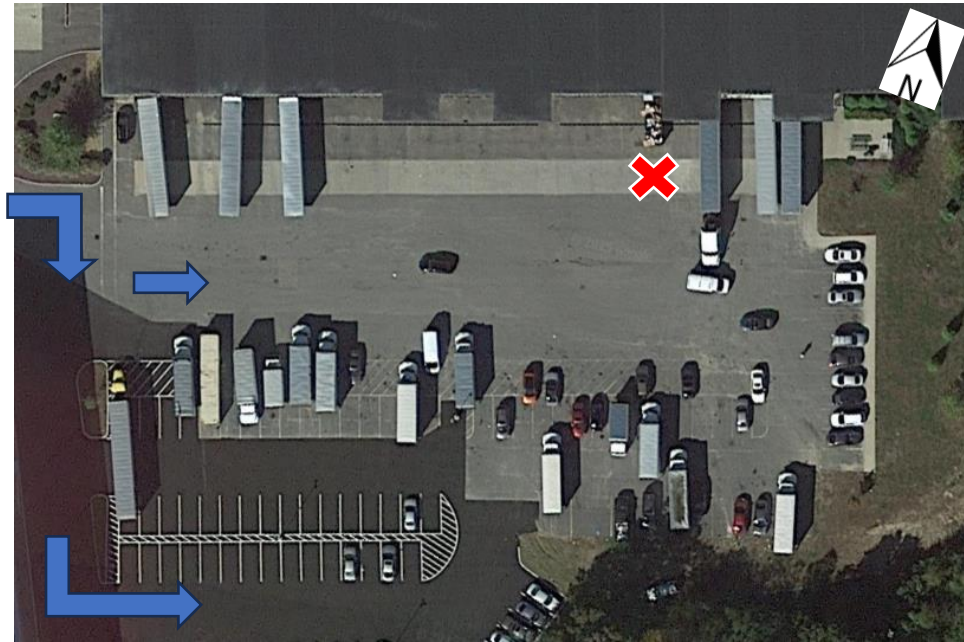
The main parking lot was located on the south side of the building. Personal vehicles and inactive trucks were parked in the lot. The overall layout had an area for vehicles and trucks to pass between the parking spaces and the building, with enough room for trucks to back up to the loading docks. There was a raised sidewalk on the east perimeter of the parking lot that led to exterior steps and an entrance to the building. On the west side of the lot, there were two faded white lines painted on the pavement that led from the first row of parking spots to an entrance on the southwest corner of the building. The two white lines were from a prior parking lot configuration, when the lot was larger and had more parking spaces and hashed no-parking zones that extended west of the lines. No other pedestrian walkways or painted zones were around the parking lot or near the docks. A dumpster was consistently located at a specific dock door on the south side of the building.

**Image 4. Aerial view of the parking lot. The red X marks the approximate location of the incident. Blue arrows mark traffic patterns. (Photo courtesy of Google Earth.)**

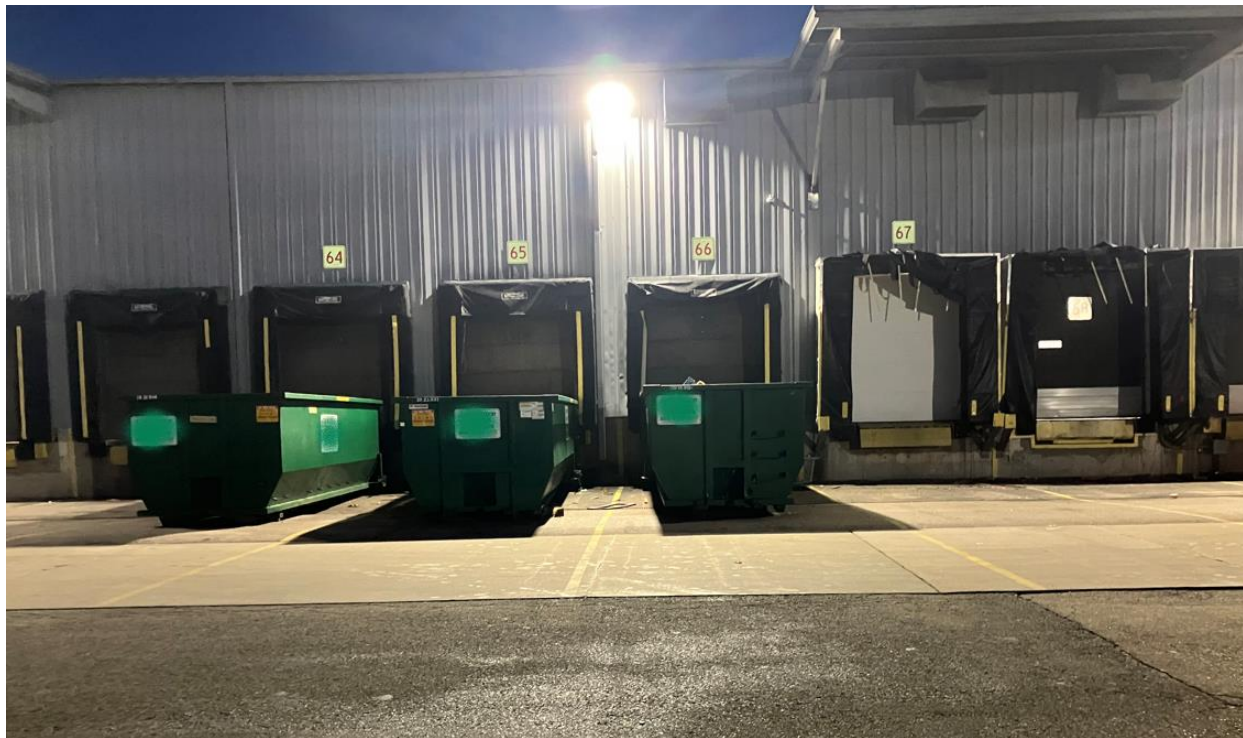
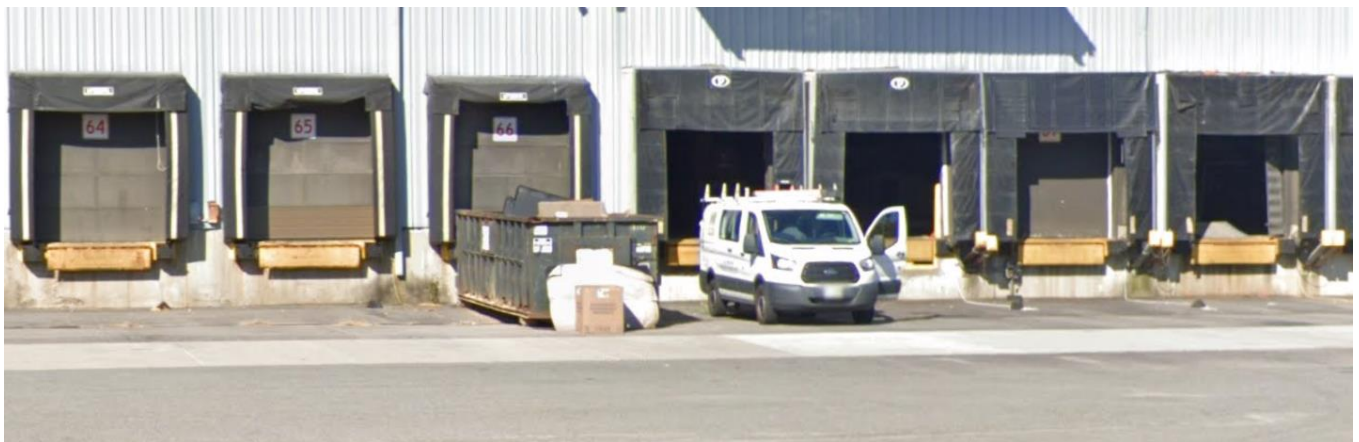
The area of the incident was near the loading dock where the dumpster was to be positioned. This area consisted of paved asphalt and a concrete pad that was located away from the loading dock. The concrete landing pad was a strip that ran the length of the loading dock area. Concrete is used because it has the strength to support the focused weight of a loaded trailer's landing gear or feet once a trailer is parked and disconnected from a tractor truck.

Image 5 & 6. Loading docks and dumpster. (Photo taken by MA FACE and courtesy of Google, respectively.)

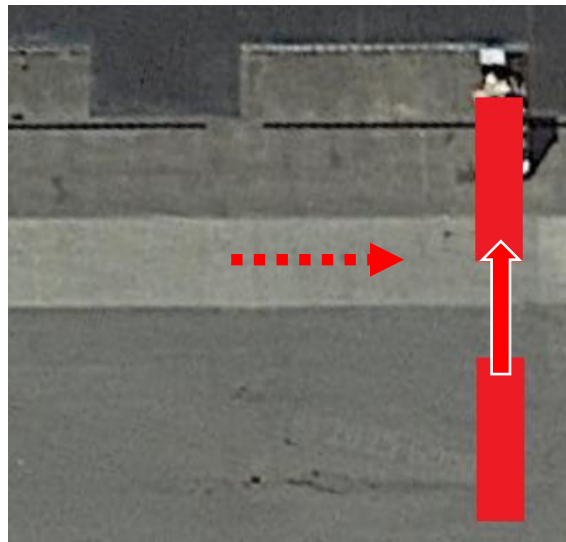
The approximate walking route of the victim and the approximate positioning of the dumpster truck before and after the collision are shown in Image 7.

When the truck was backing, the dumpster and the bed were in a raised position. This changed aspects of the lighting on the back of the truck that directly affected the illumination of the area and how visible the lights would be to someone walking near the vehicle. Tilting the bed and dumpster and lowering the dumpster to near the ground changes the surfaces that are illuminated. The dumpster effectively blocks the lights from projecting behind the truck and affects how visible the lights would be from the side or rear of the vehicle.

**Image 7. Approximate movement of the backing truck and walking route of the victim. (Photo courtesy of Google.)**

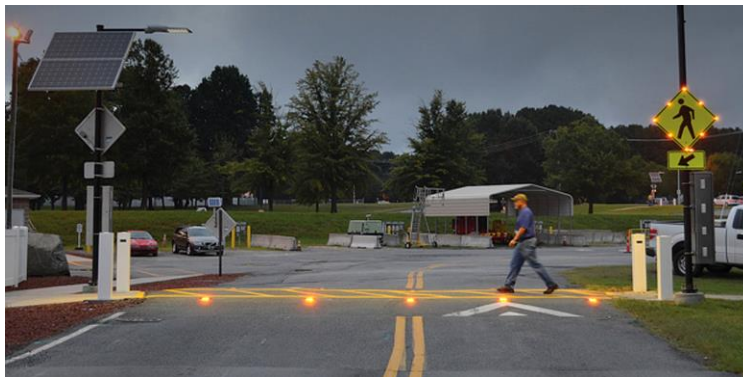
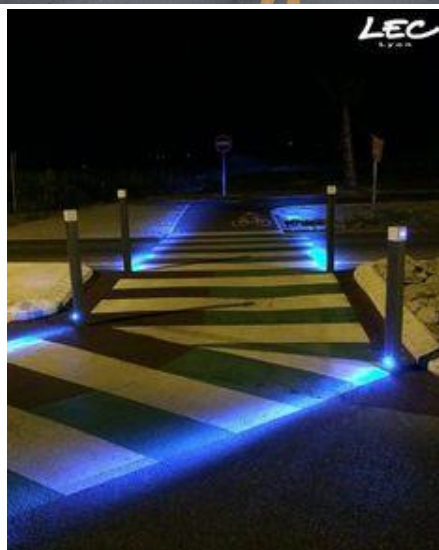
**Image 8 & 9. Examples of illuminated pathways. (Photo courtesy of The Traffic Group and Stockport Council.)**

Employers should evaluate traffic patterns in their parking lots and work spaces and designate walkways and crosswalks with painted lines to create spaces that allow employees to safely transit in designated zones. It will be safest if the moving vehicles and pedestrians are separated, either by creating a walkway protected by physical barriers or by creating a route on the perimeter of the driving area. Employers are recommended to discourage employees from walking into high-traffic areas unless at a designated crosswalk. The walkway should be clear and visible for both pedestrians and drivers of moving vehicles. Signs warning pedestrians of moving vehicles and signs emphasizing the drivers of moving vehicles to be aware of pedestrians should be placed near walkways. In times of darkness and low visibility weather, the walkways should still be clear for both pedestrians and drivers. An example of a method to ensure the pedestrian walkway is visible even in undesirable weather and light conditions is to implement an illuminated pathway for the pedestrian. An illuminated pathway can be installed for improved visibility (examples are shown below). Another option is to install more parking lot lights near pedestrian pathways to illuminate the areas.
