The Commonwealth of Massachusetts
DEPARTMENT OF PUBLIC UTILITIES

PIPELINE ENGINEERING AND SAFETY DIVISION

INCIDENT REPORT

76 Eastern Avenue, Gloucester Massachusetts
January 25, 2009

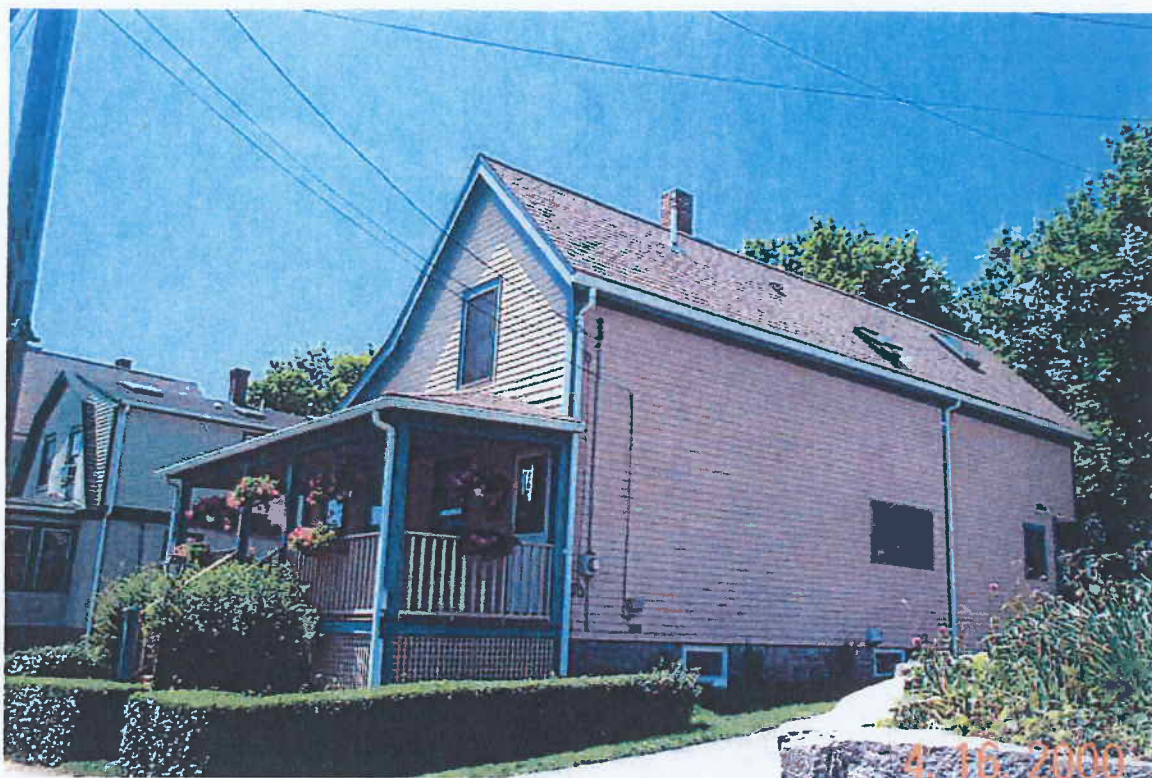
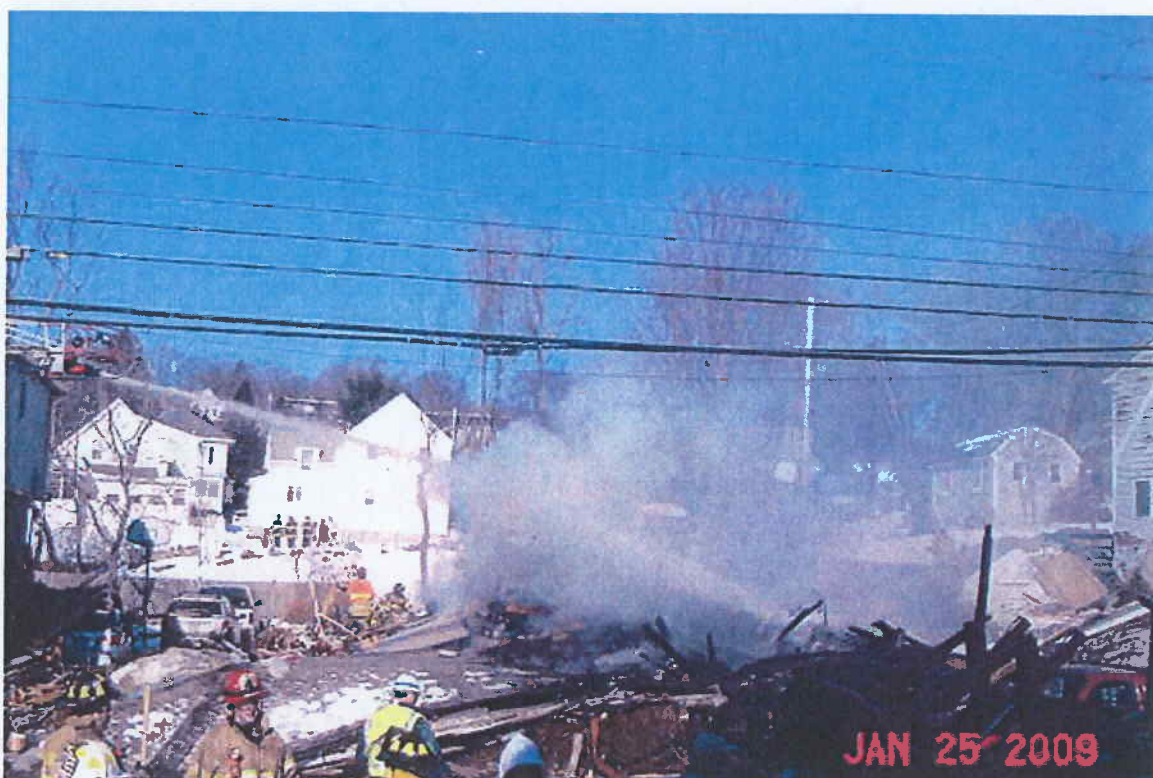
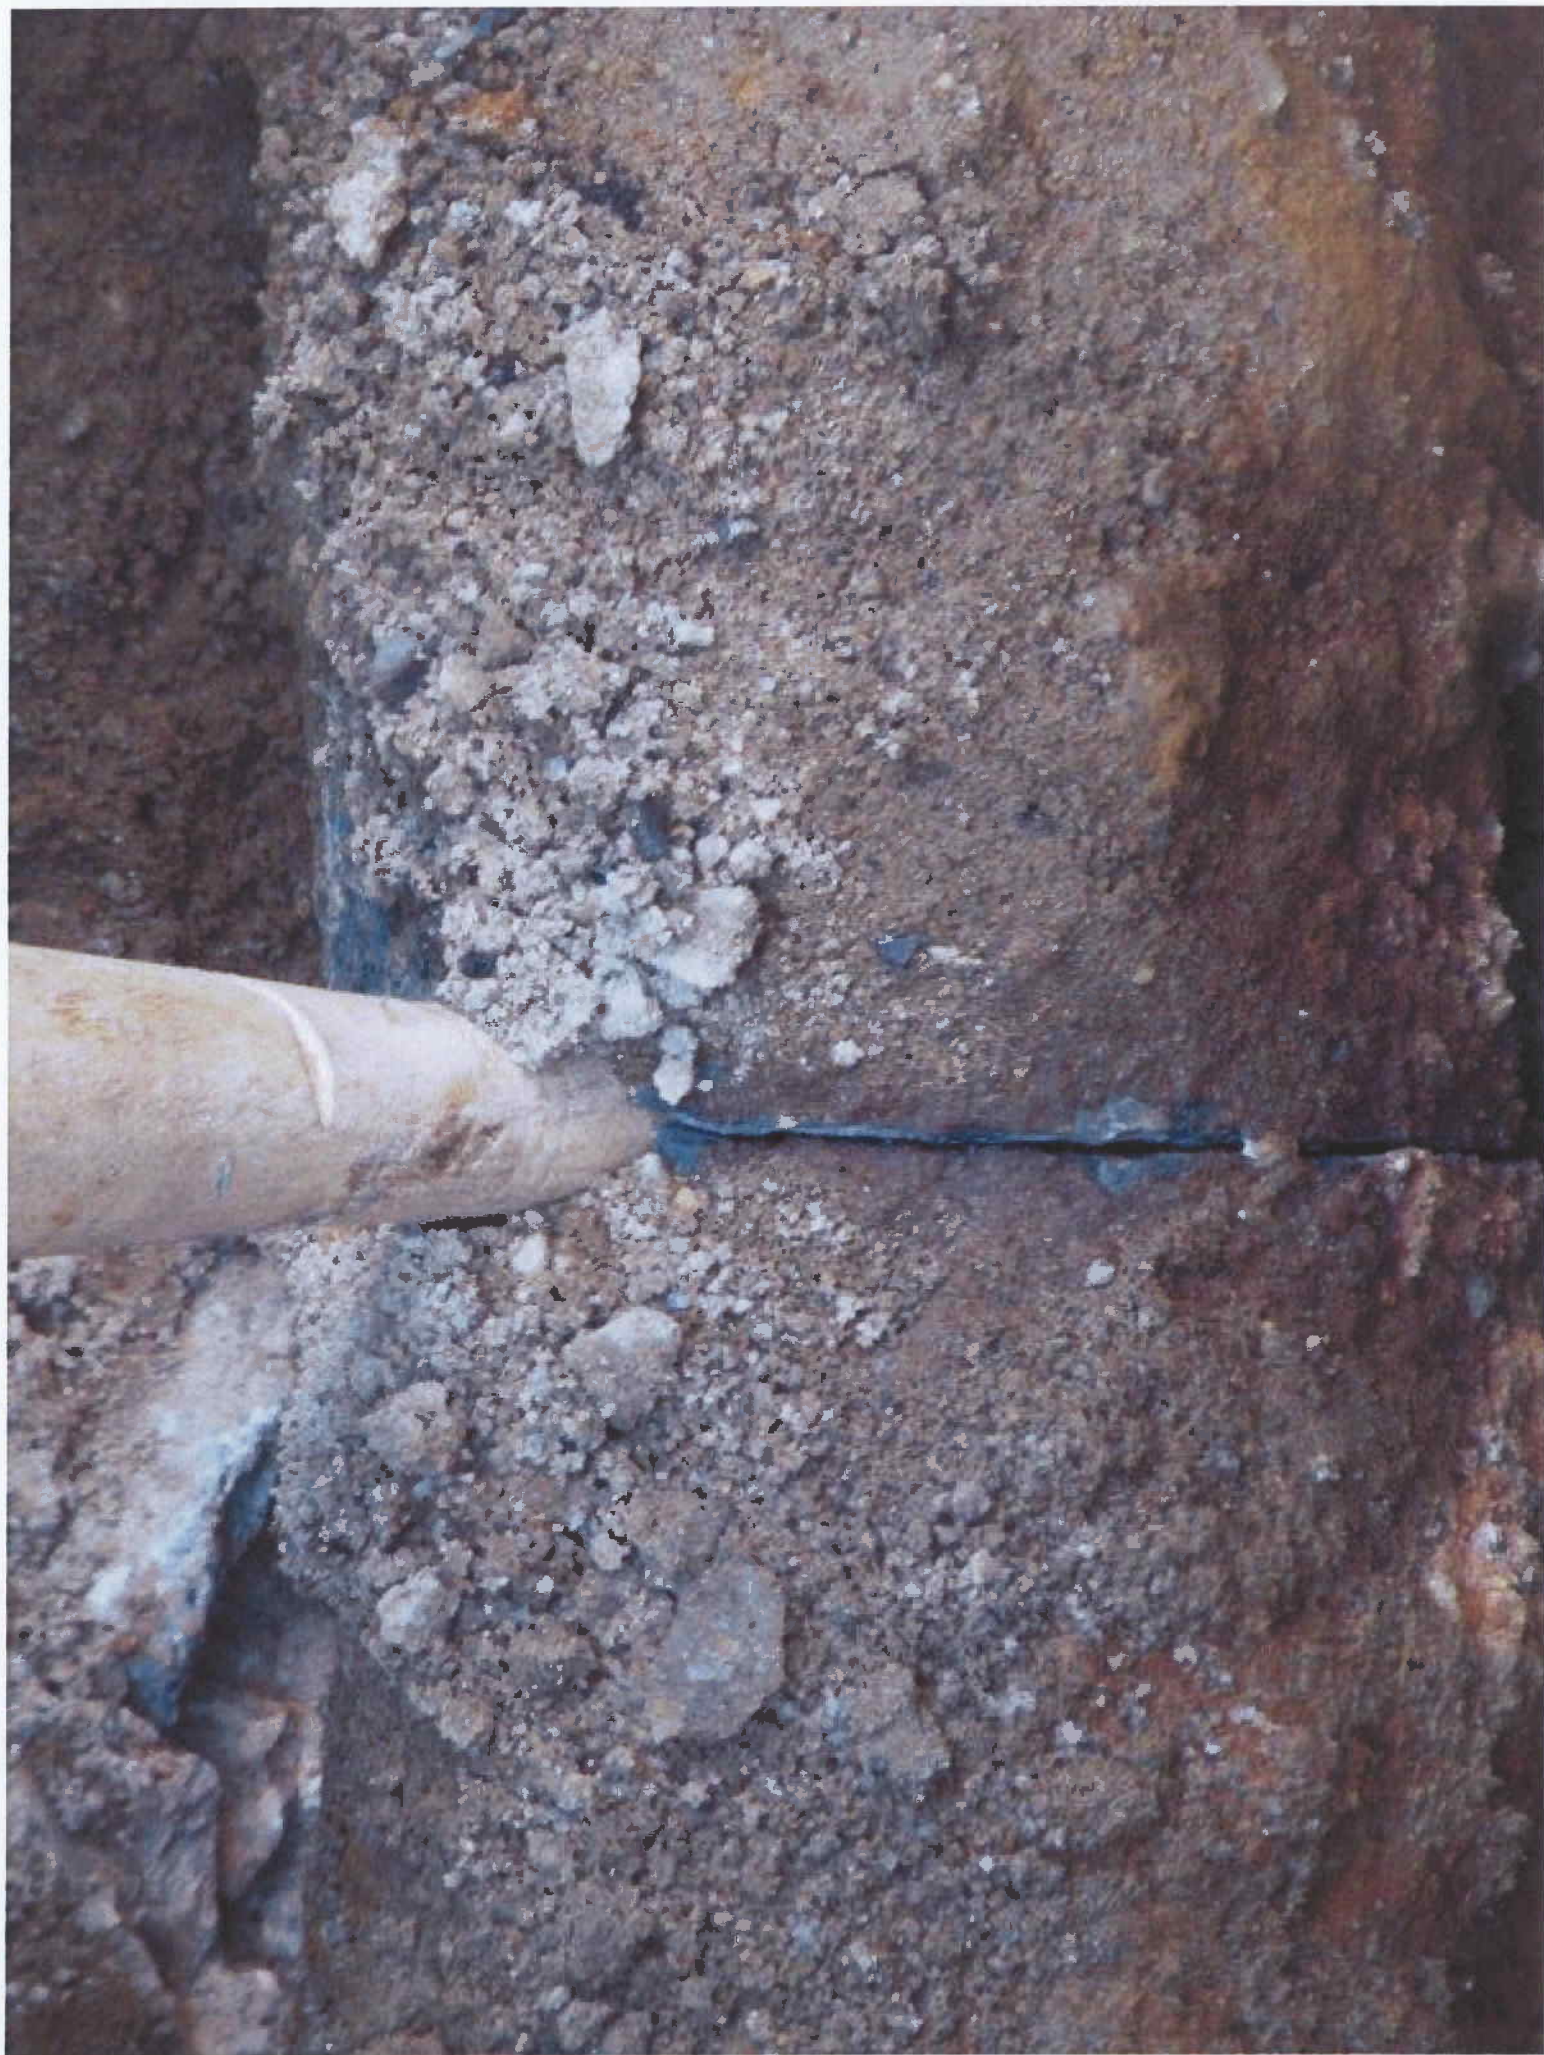
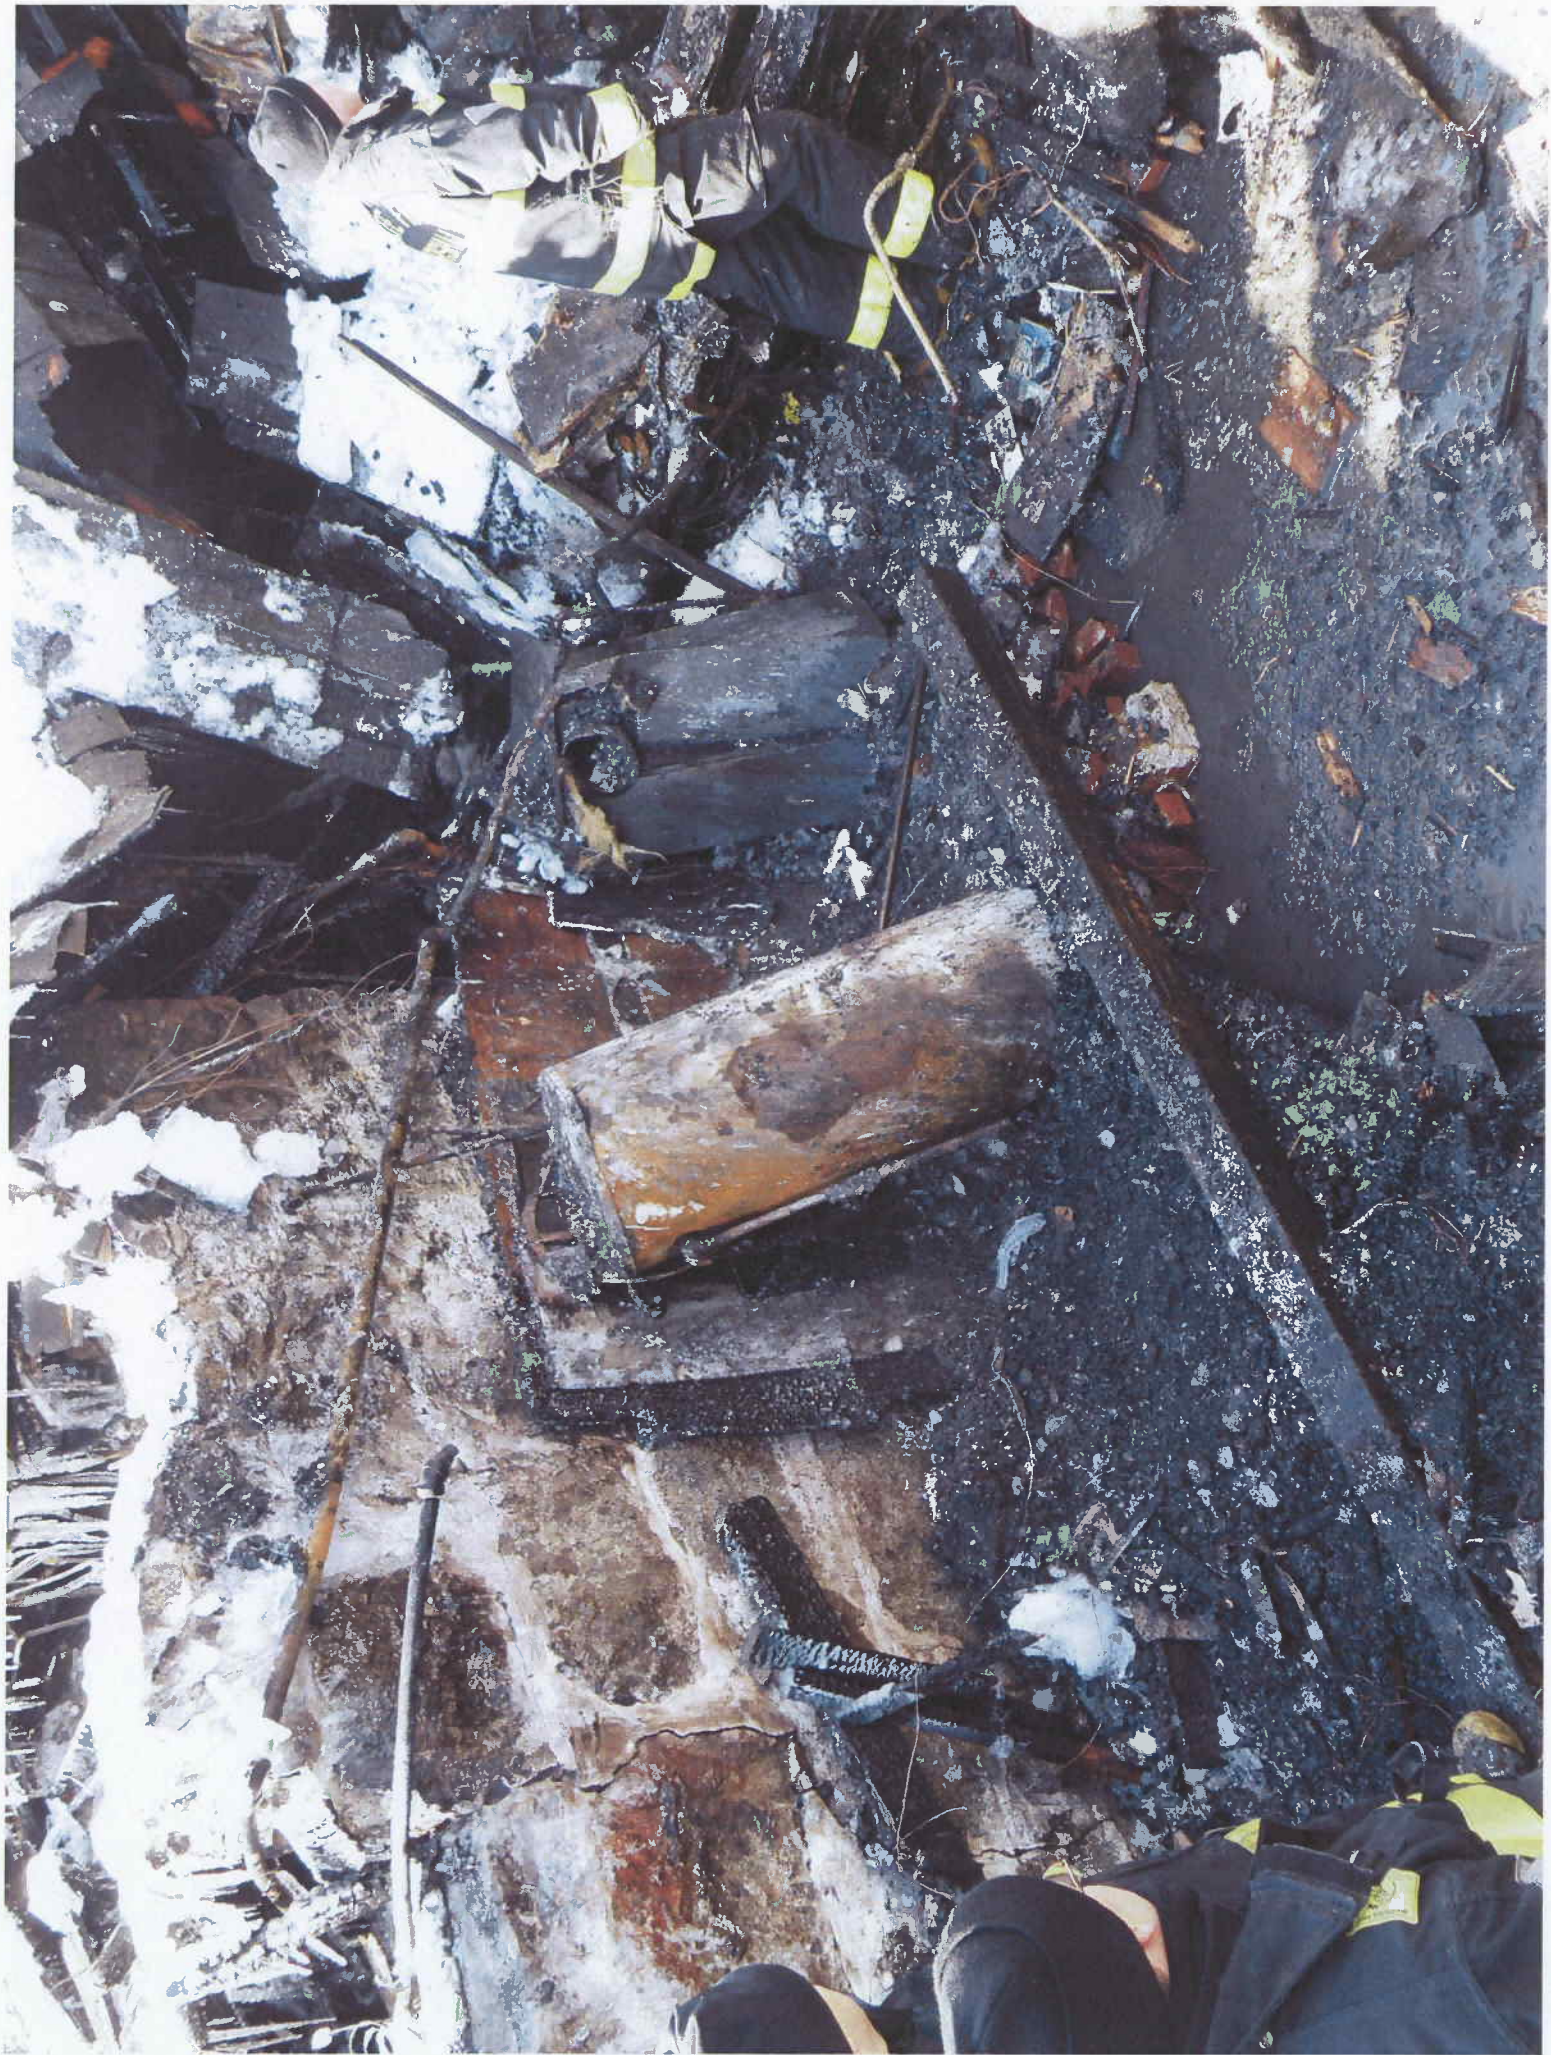
76 Eastern Avenue; Broken Main;
House Heater and Water Heater

The house at 76 Eastern Avenue was destroyed by the explosion and ensuing fire (Exh. 6). The house collapsed into the foundation, debris had been blown onto the street and into adjoining properties (Exh.9).

National Grid distribution personnel pinpointed a gas leak on the gas main in front of 76 Eastern Avenue, and began digging in the street to expose the gas main. When the Operator exposed the gas main, National Grid found a circumferential crack on the six inch cast-iron main at the 1 ¼" gas service tee supplying 77 Eastern Avenue (Exh. 6). The cracked cast iron main was in front of, and in proximity to, the left front corner of 76 Eastern Avenue (Exh. 9).

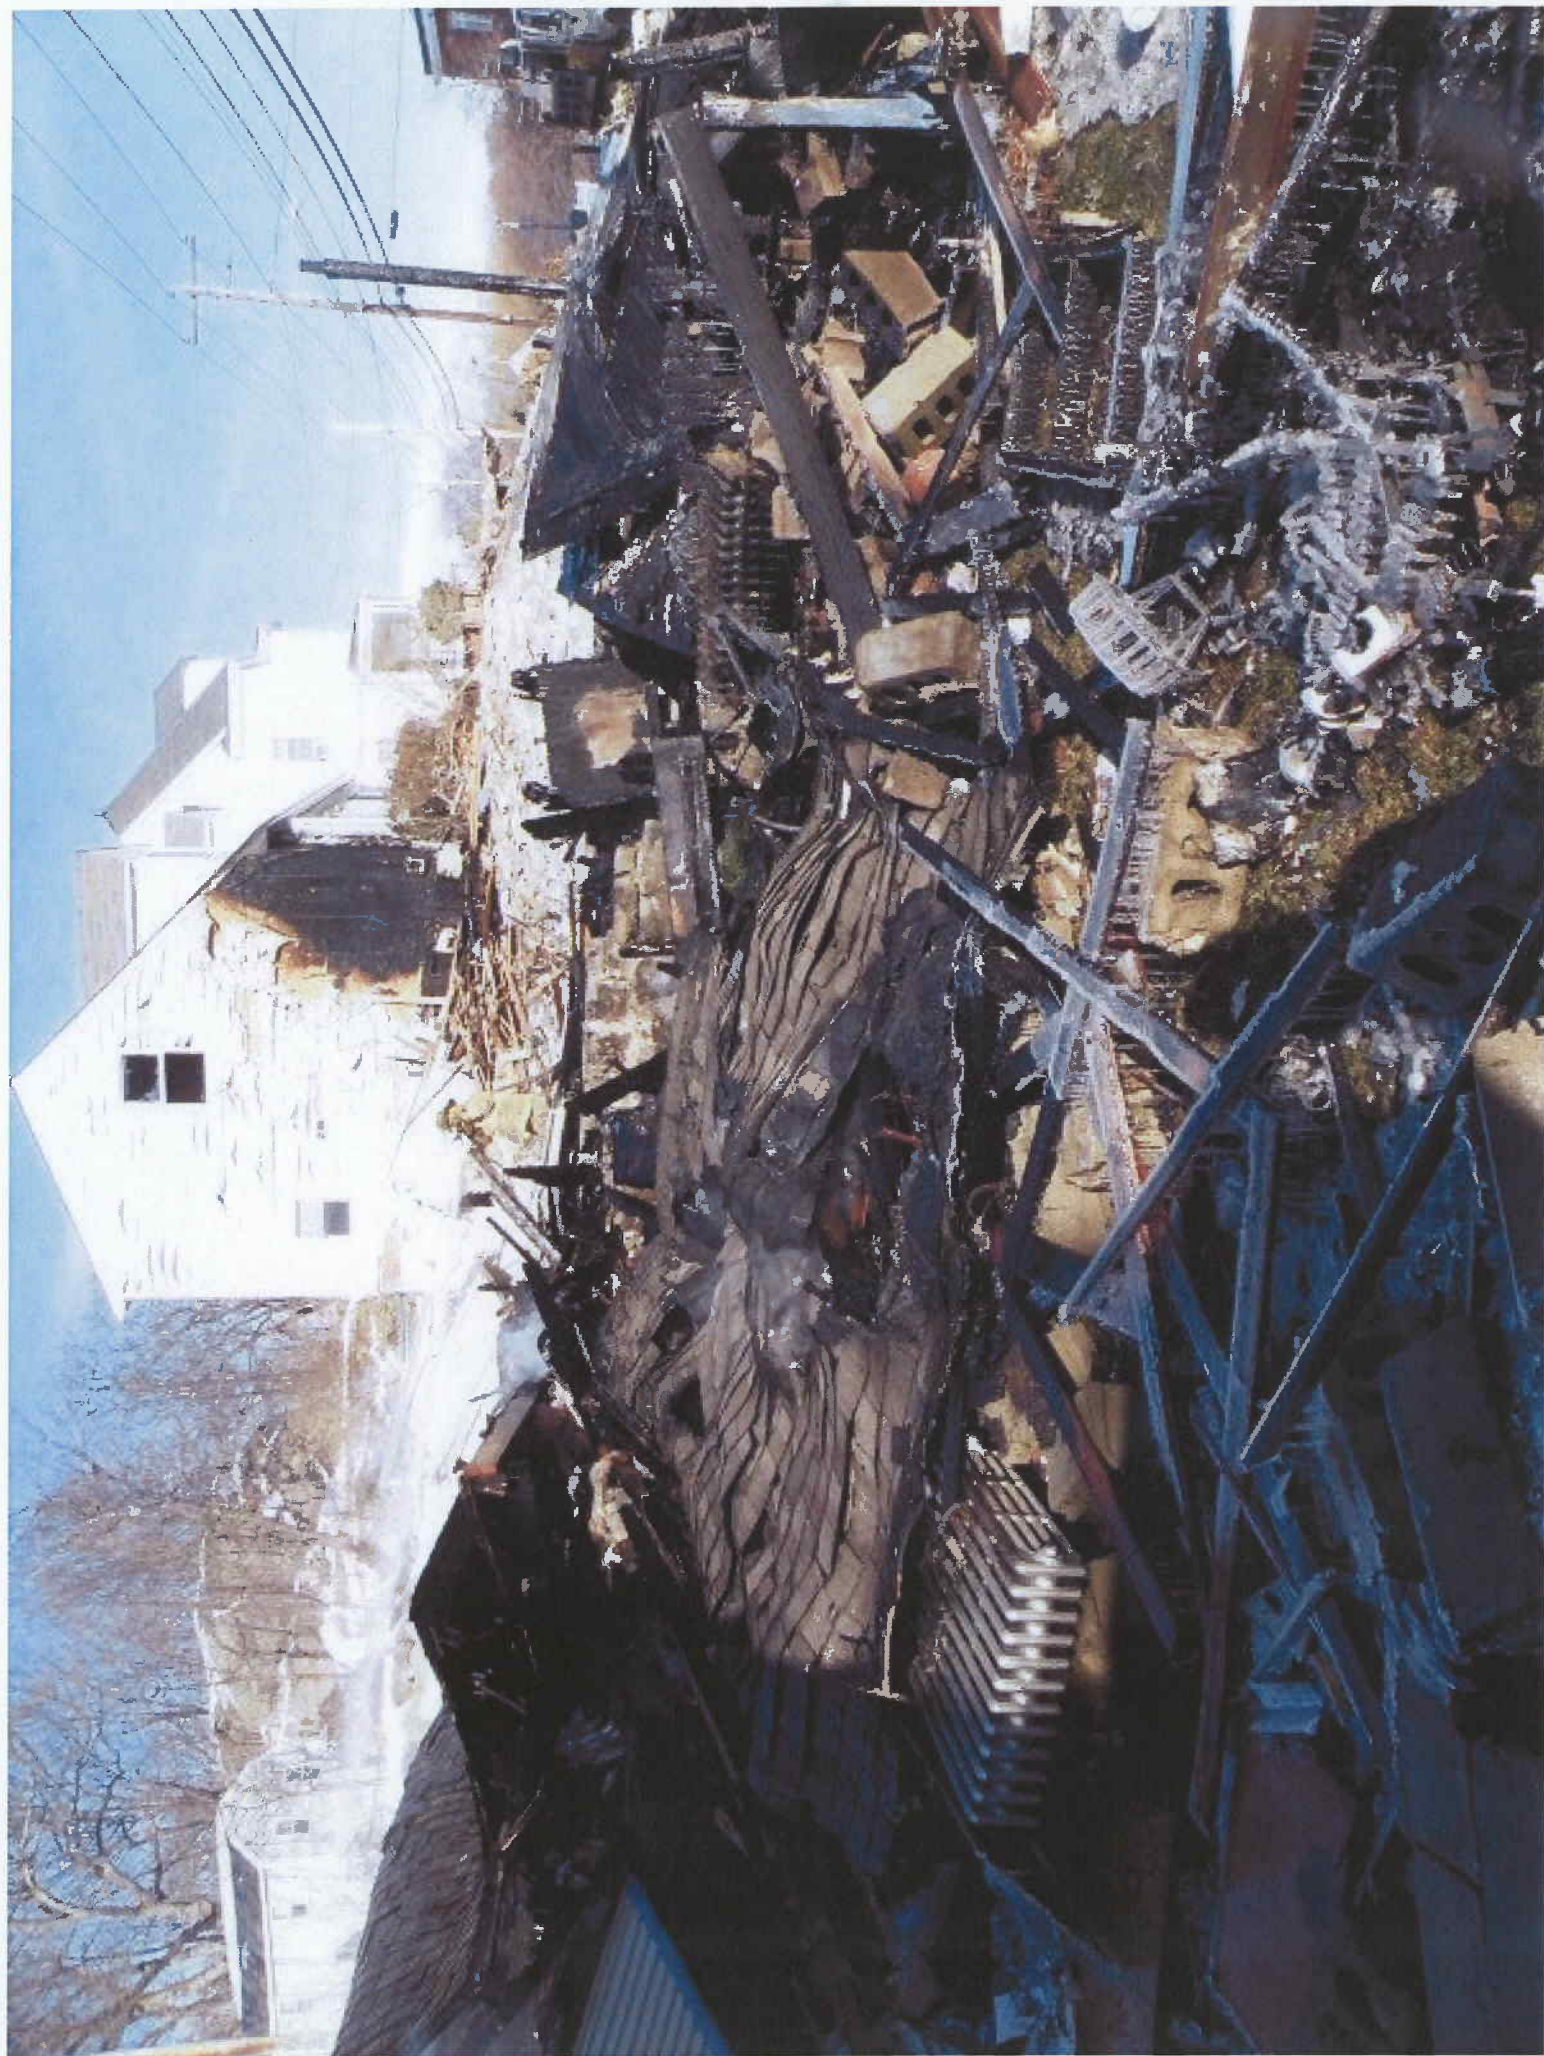
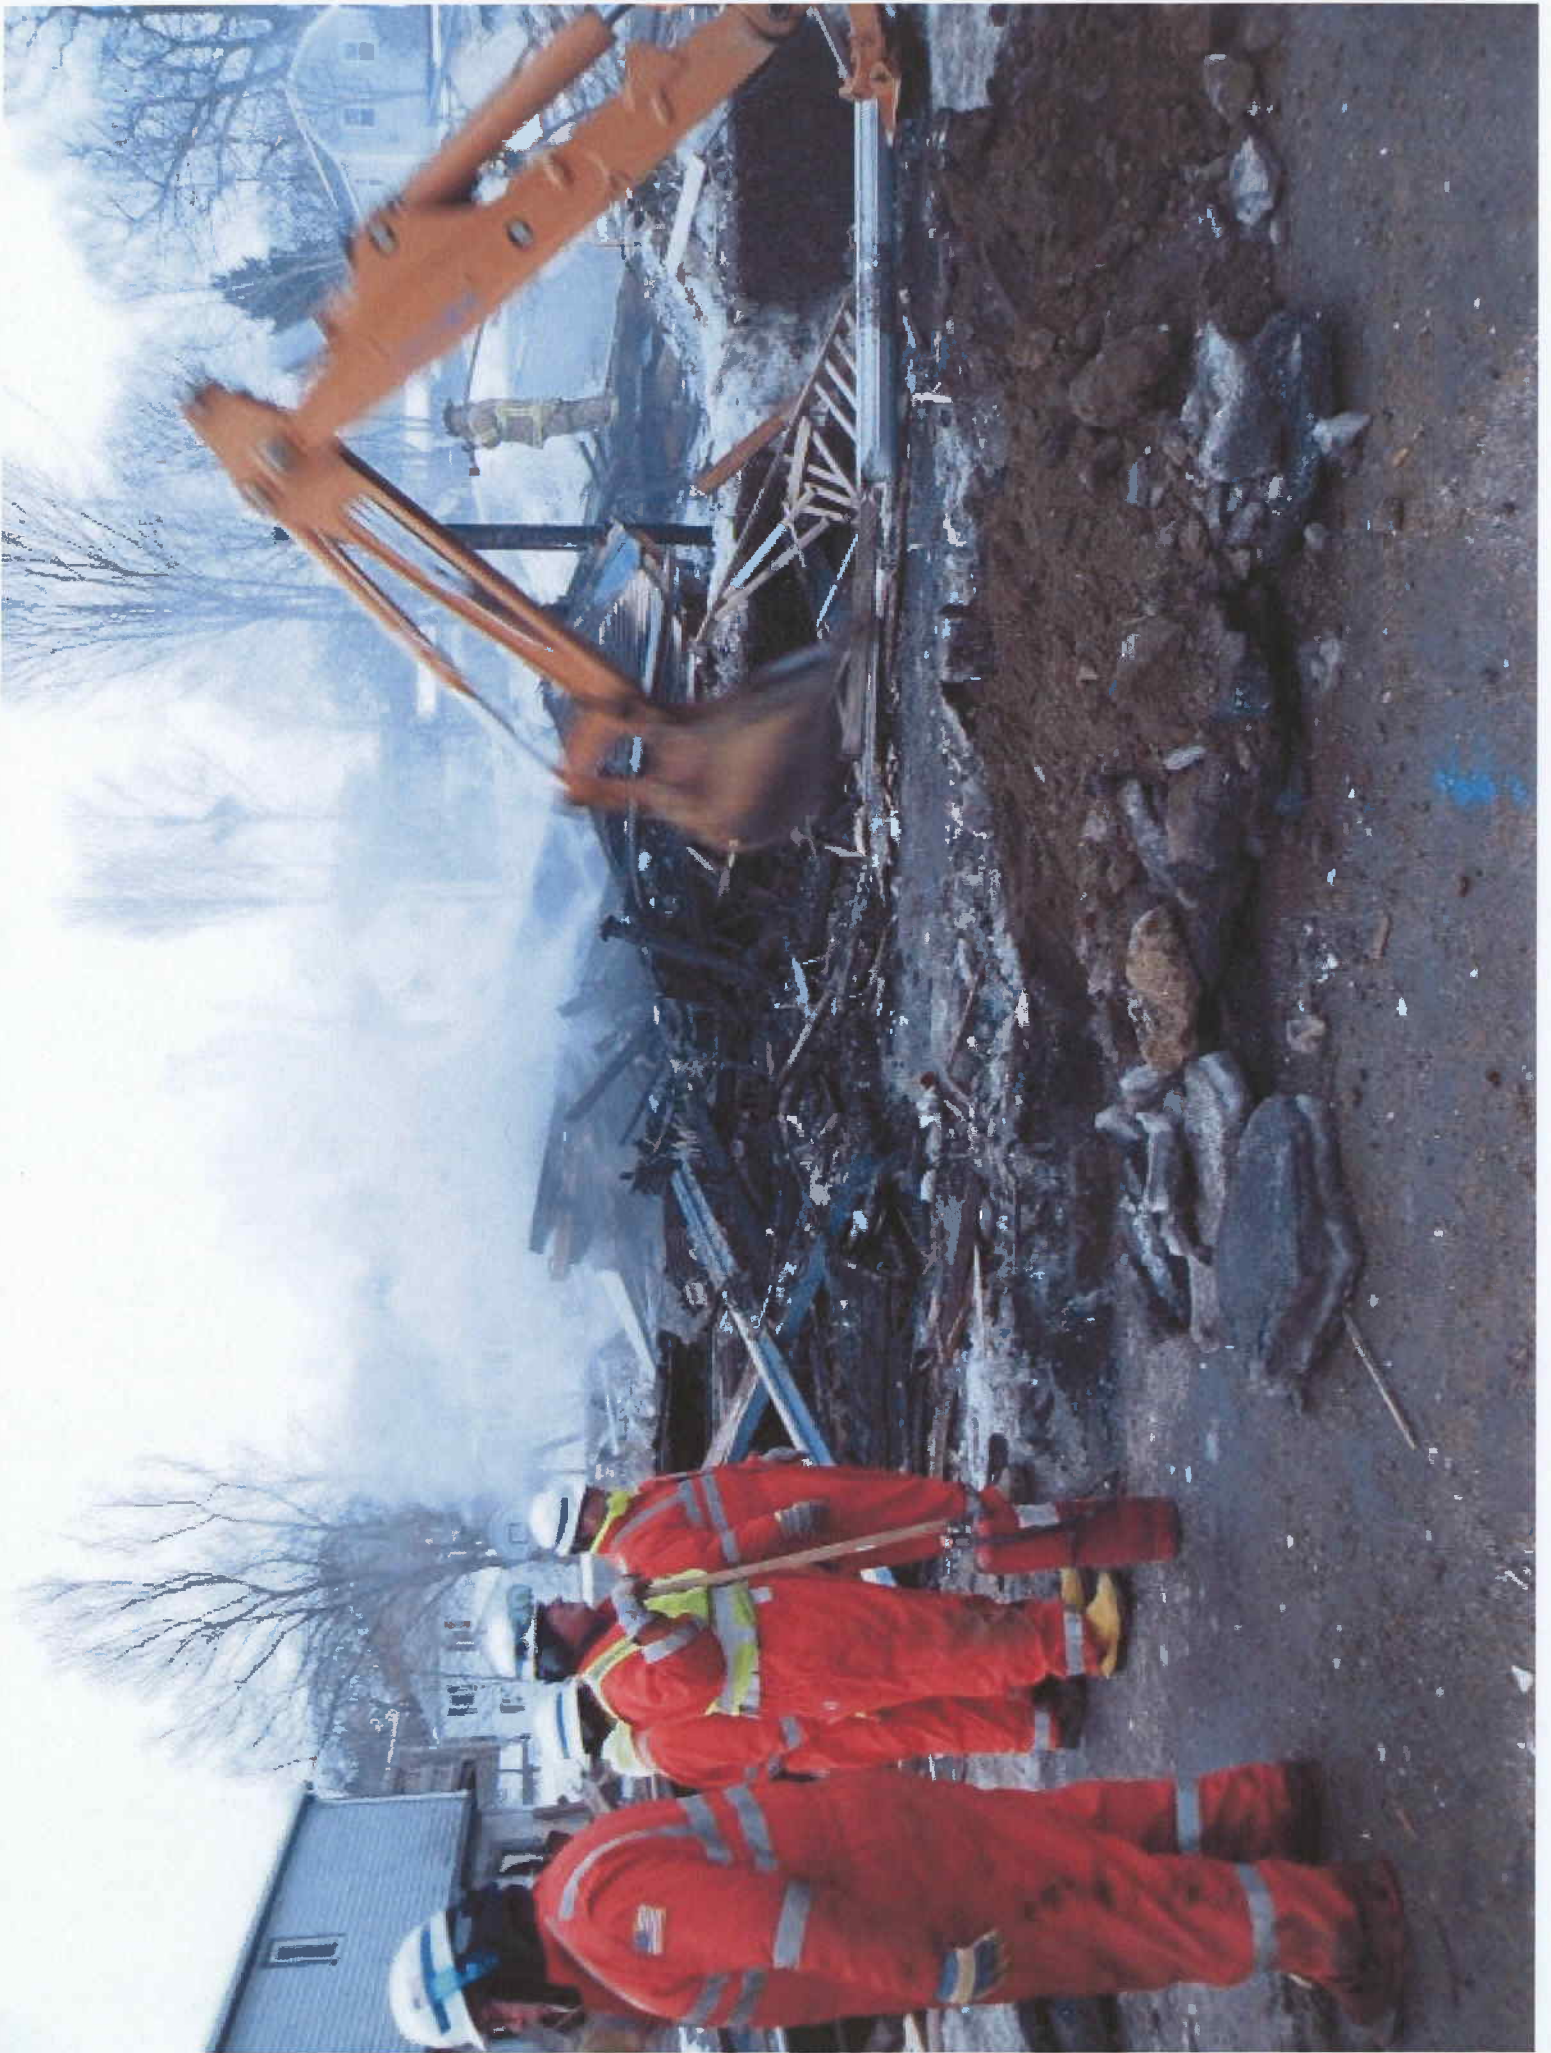
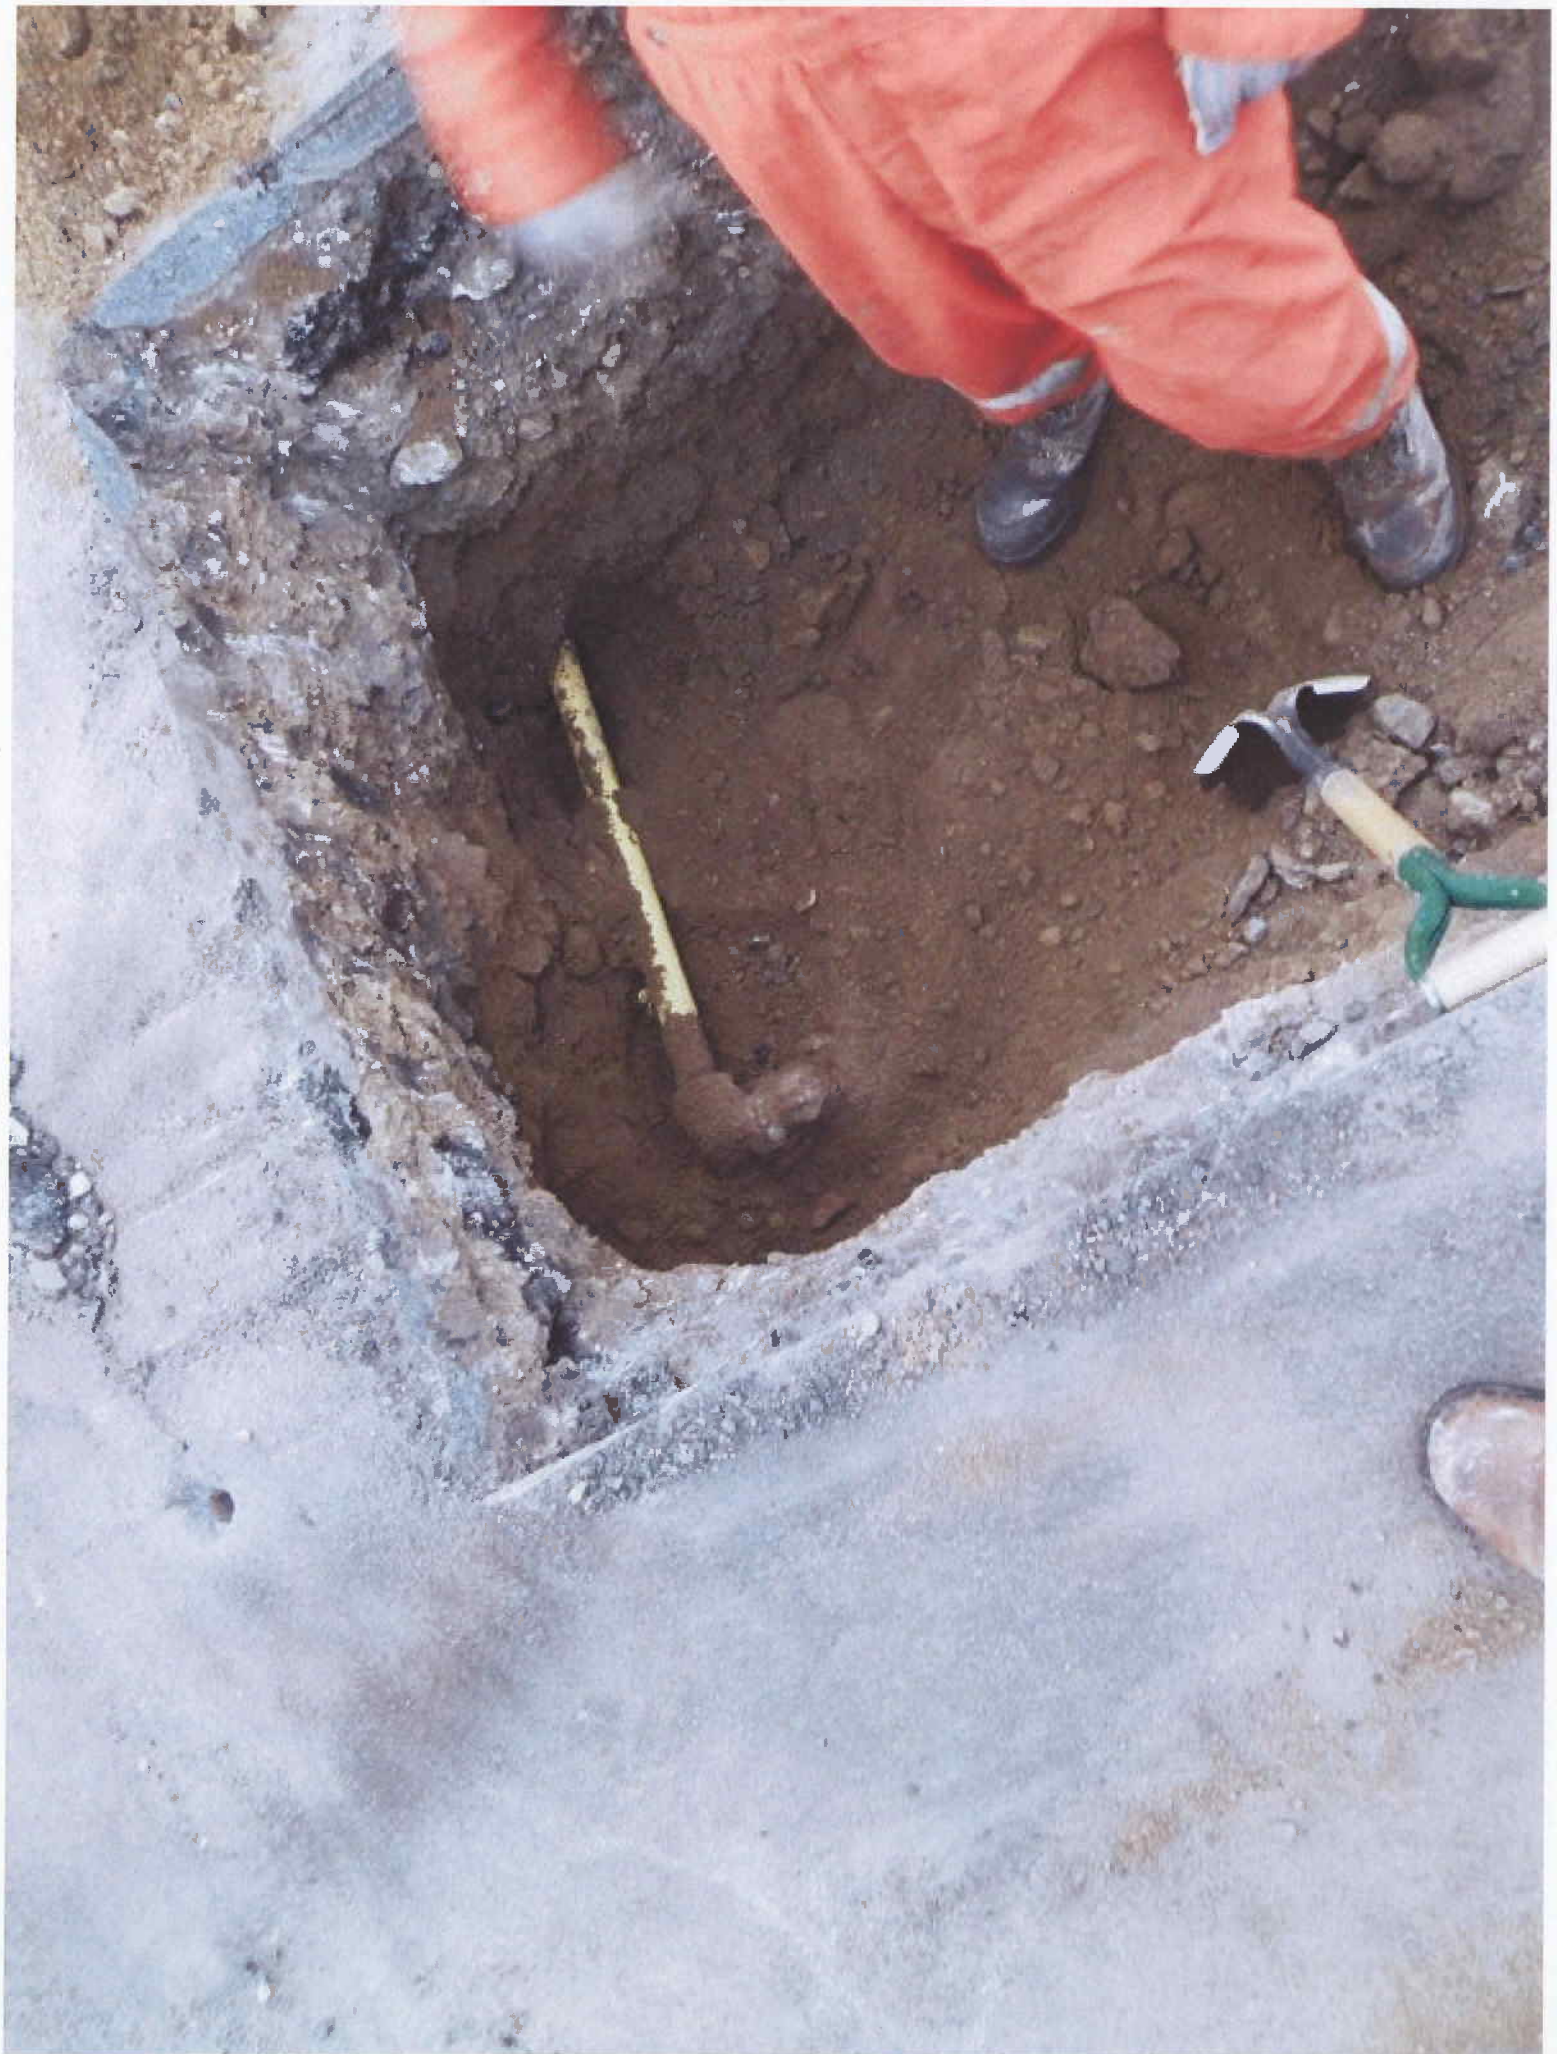
Excavation for Broken Main;

The Operator removed the service tee, cleaned the main, and installed a Servi-Seal clamp to both secure the leak and provide a temporary tap for the replacement service for 77 Eastern Avenue. To install the clamp, National Grid personnel had to clear away a large piece of ledge directly below the section of the cracked main (Exh. 4).

The MMR Report's conclusions that cause of the crack in the main appears to be a combination of graphitic corrosion at the service tap location, combined with the effect of differential frost heaves between the pipe and the tap are reasonable, and based upon substantial and specific evidence.
