The Commonwealth of Massachusetts
DEPARTMENT OF PUBLIC UTILITIES

PIPELINE ENGINEERING AND SAFETY DIVISION

INCIDENT REPORT

76 Eastern Avenue, Gloucester Massachusetts
January 25, 2009

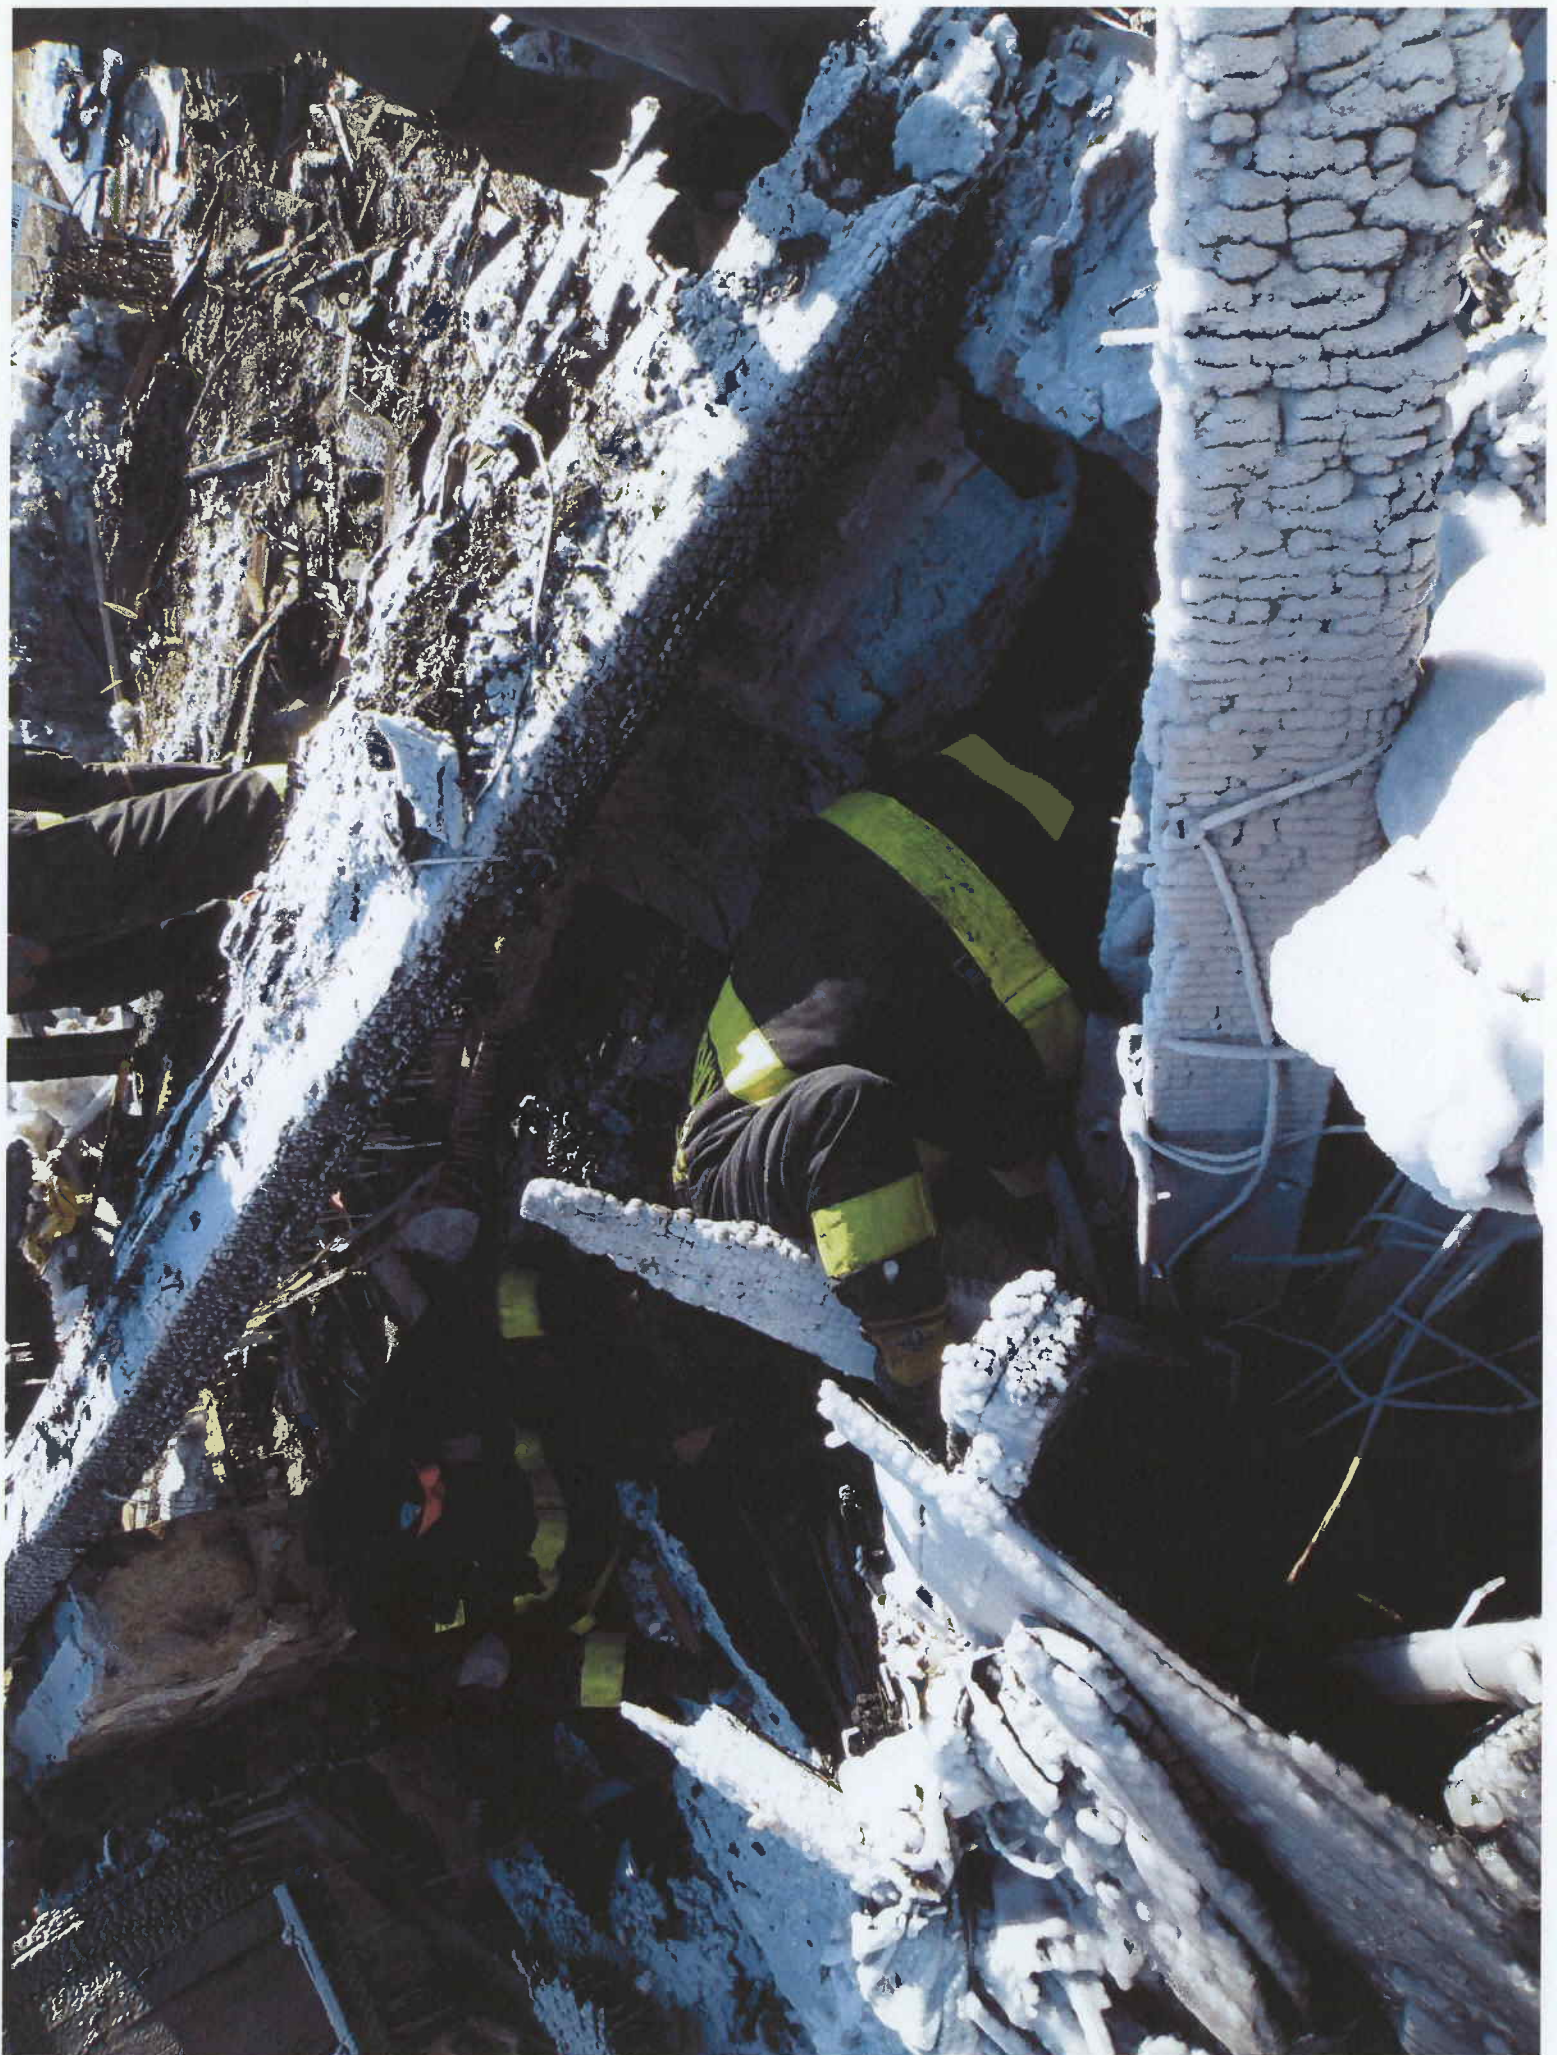
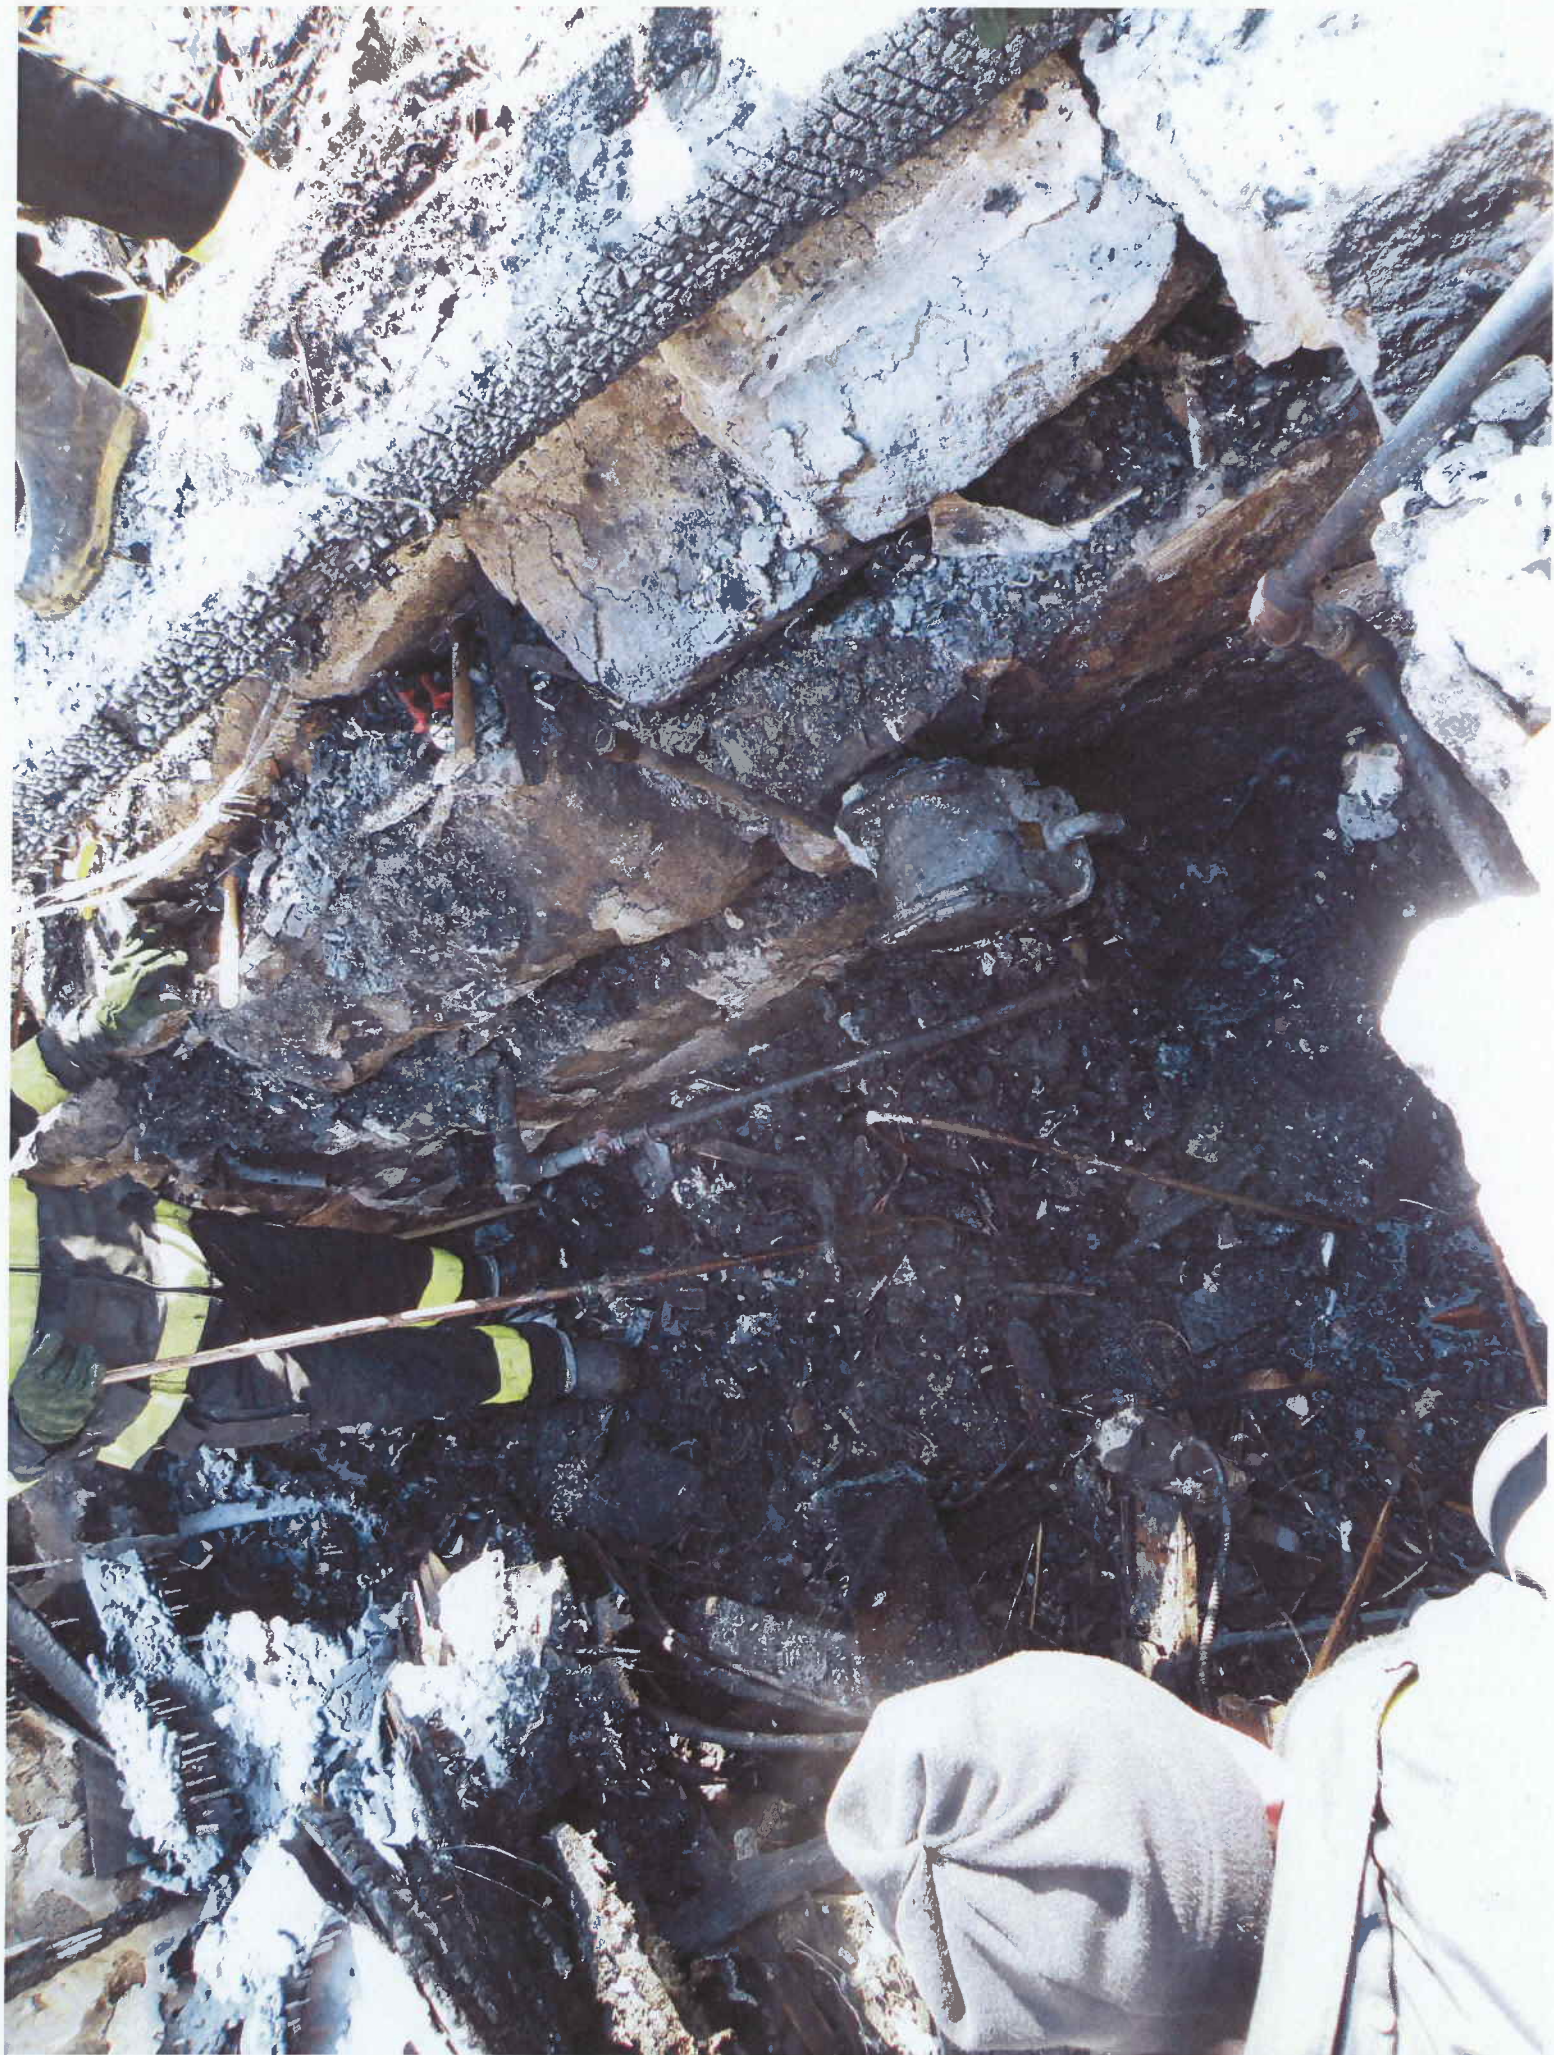
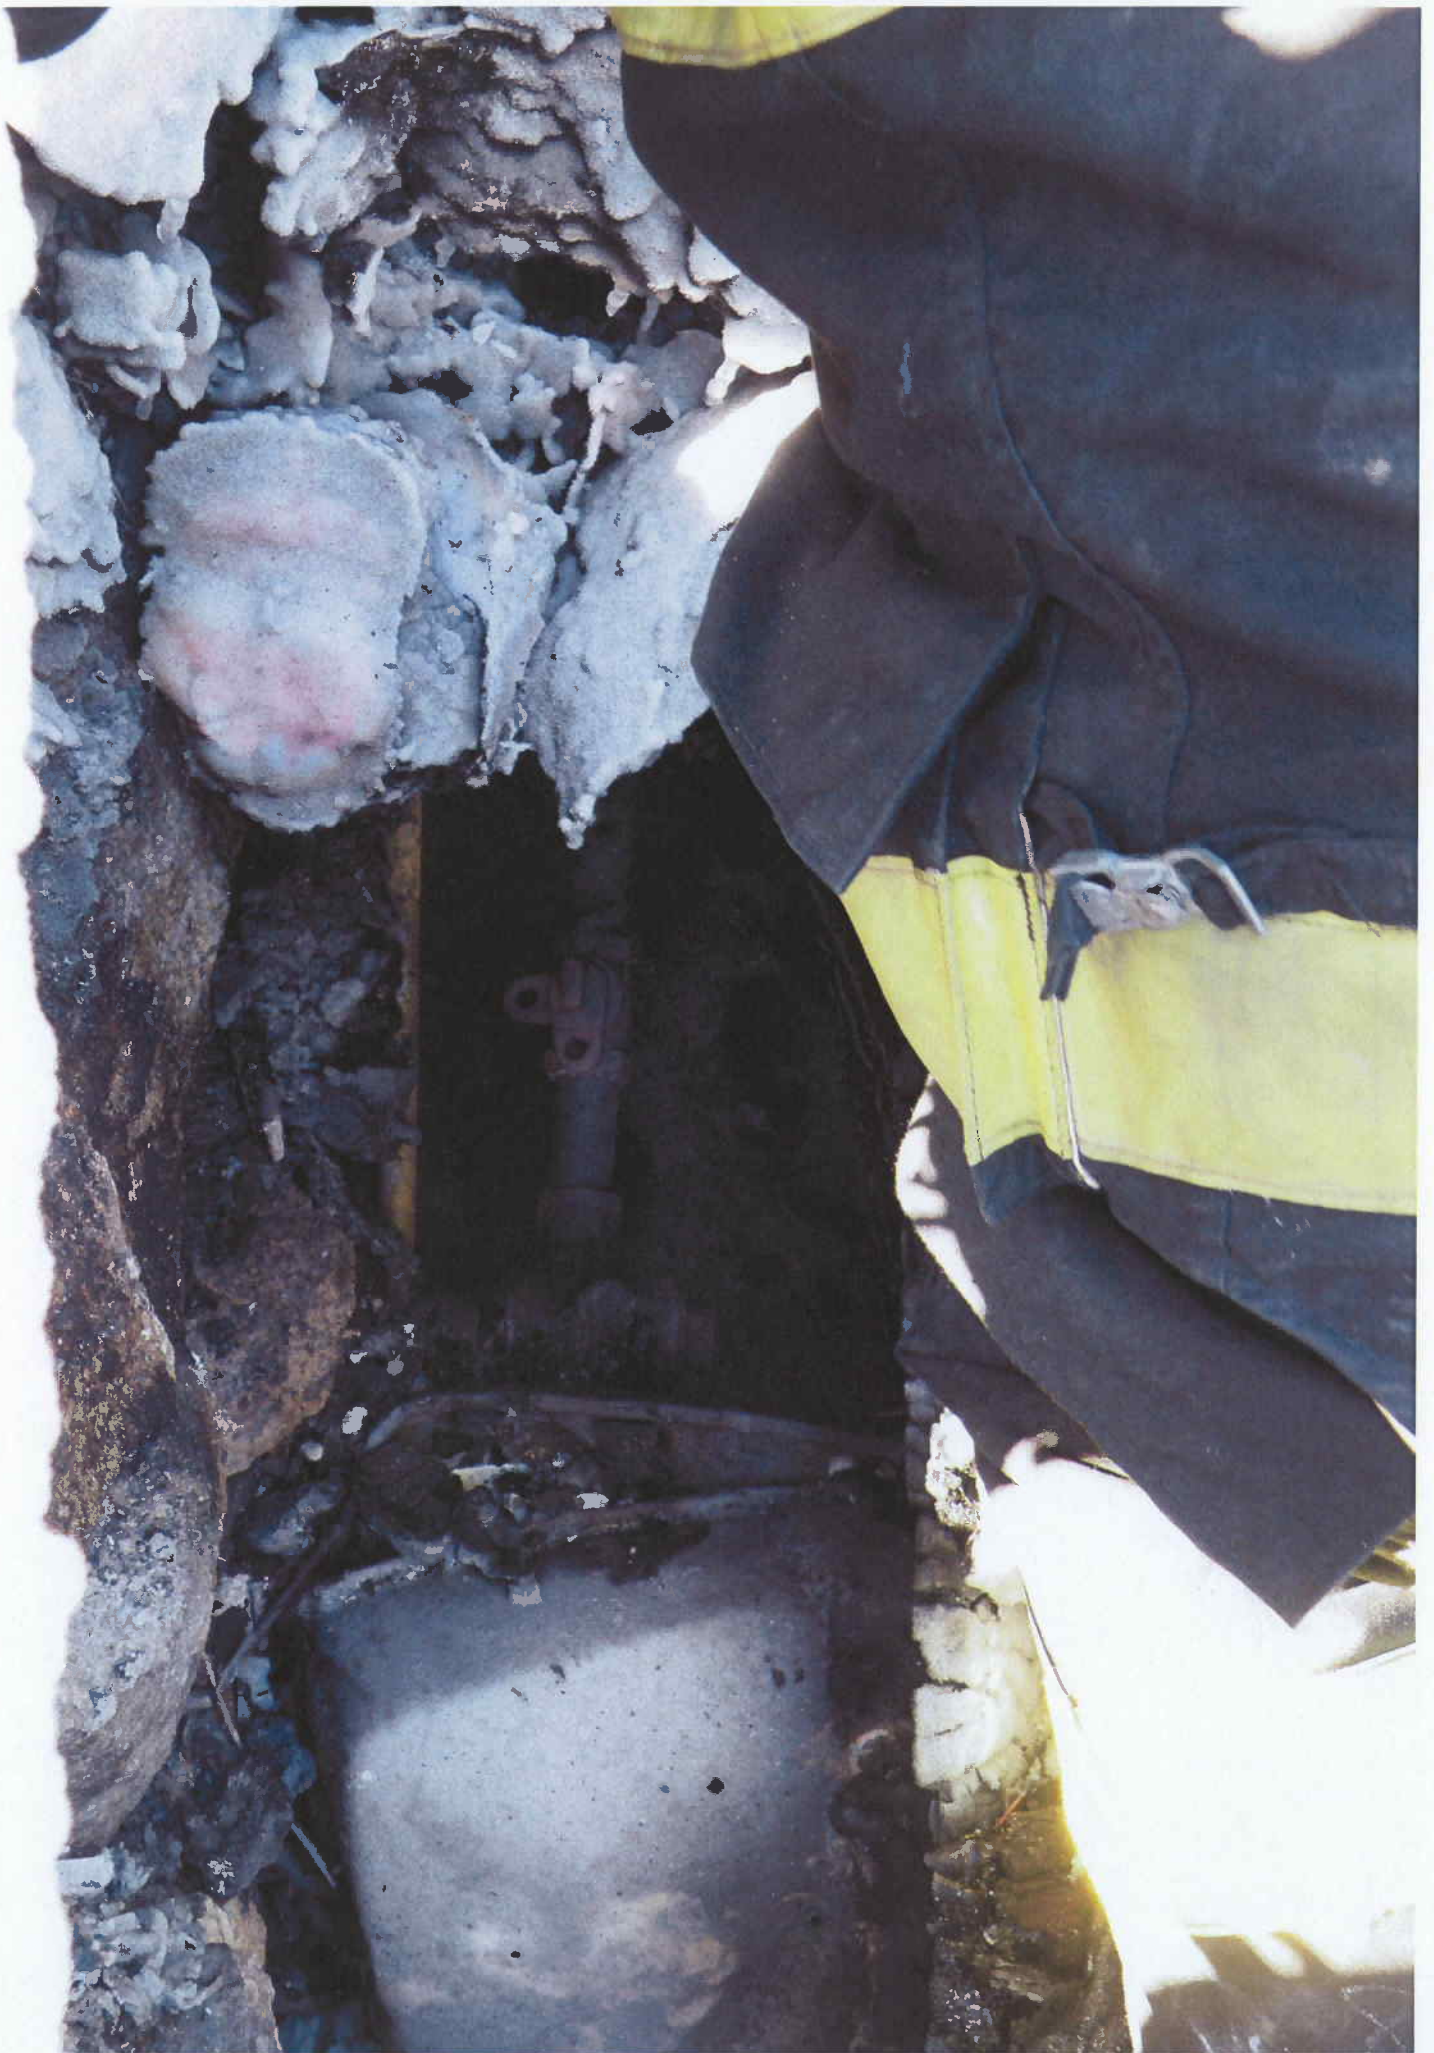
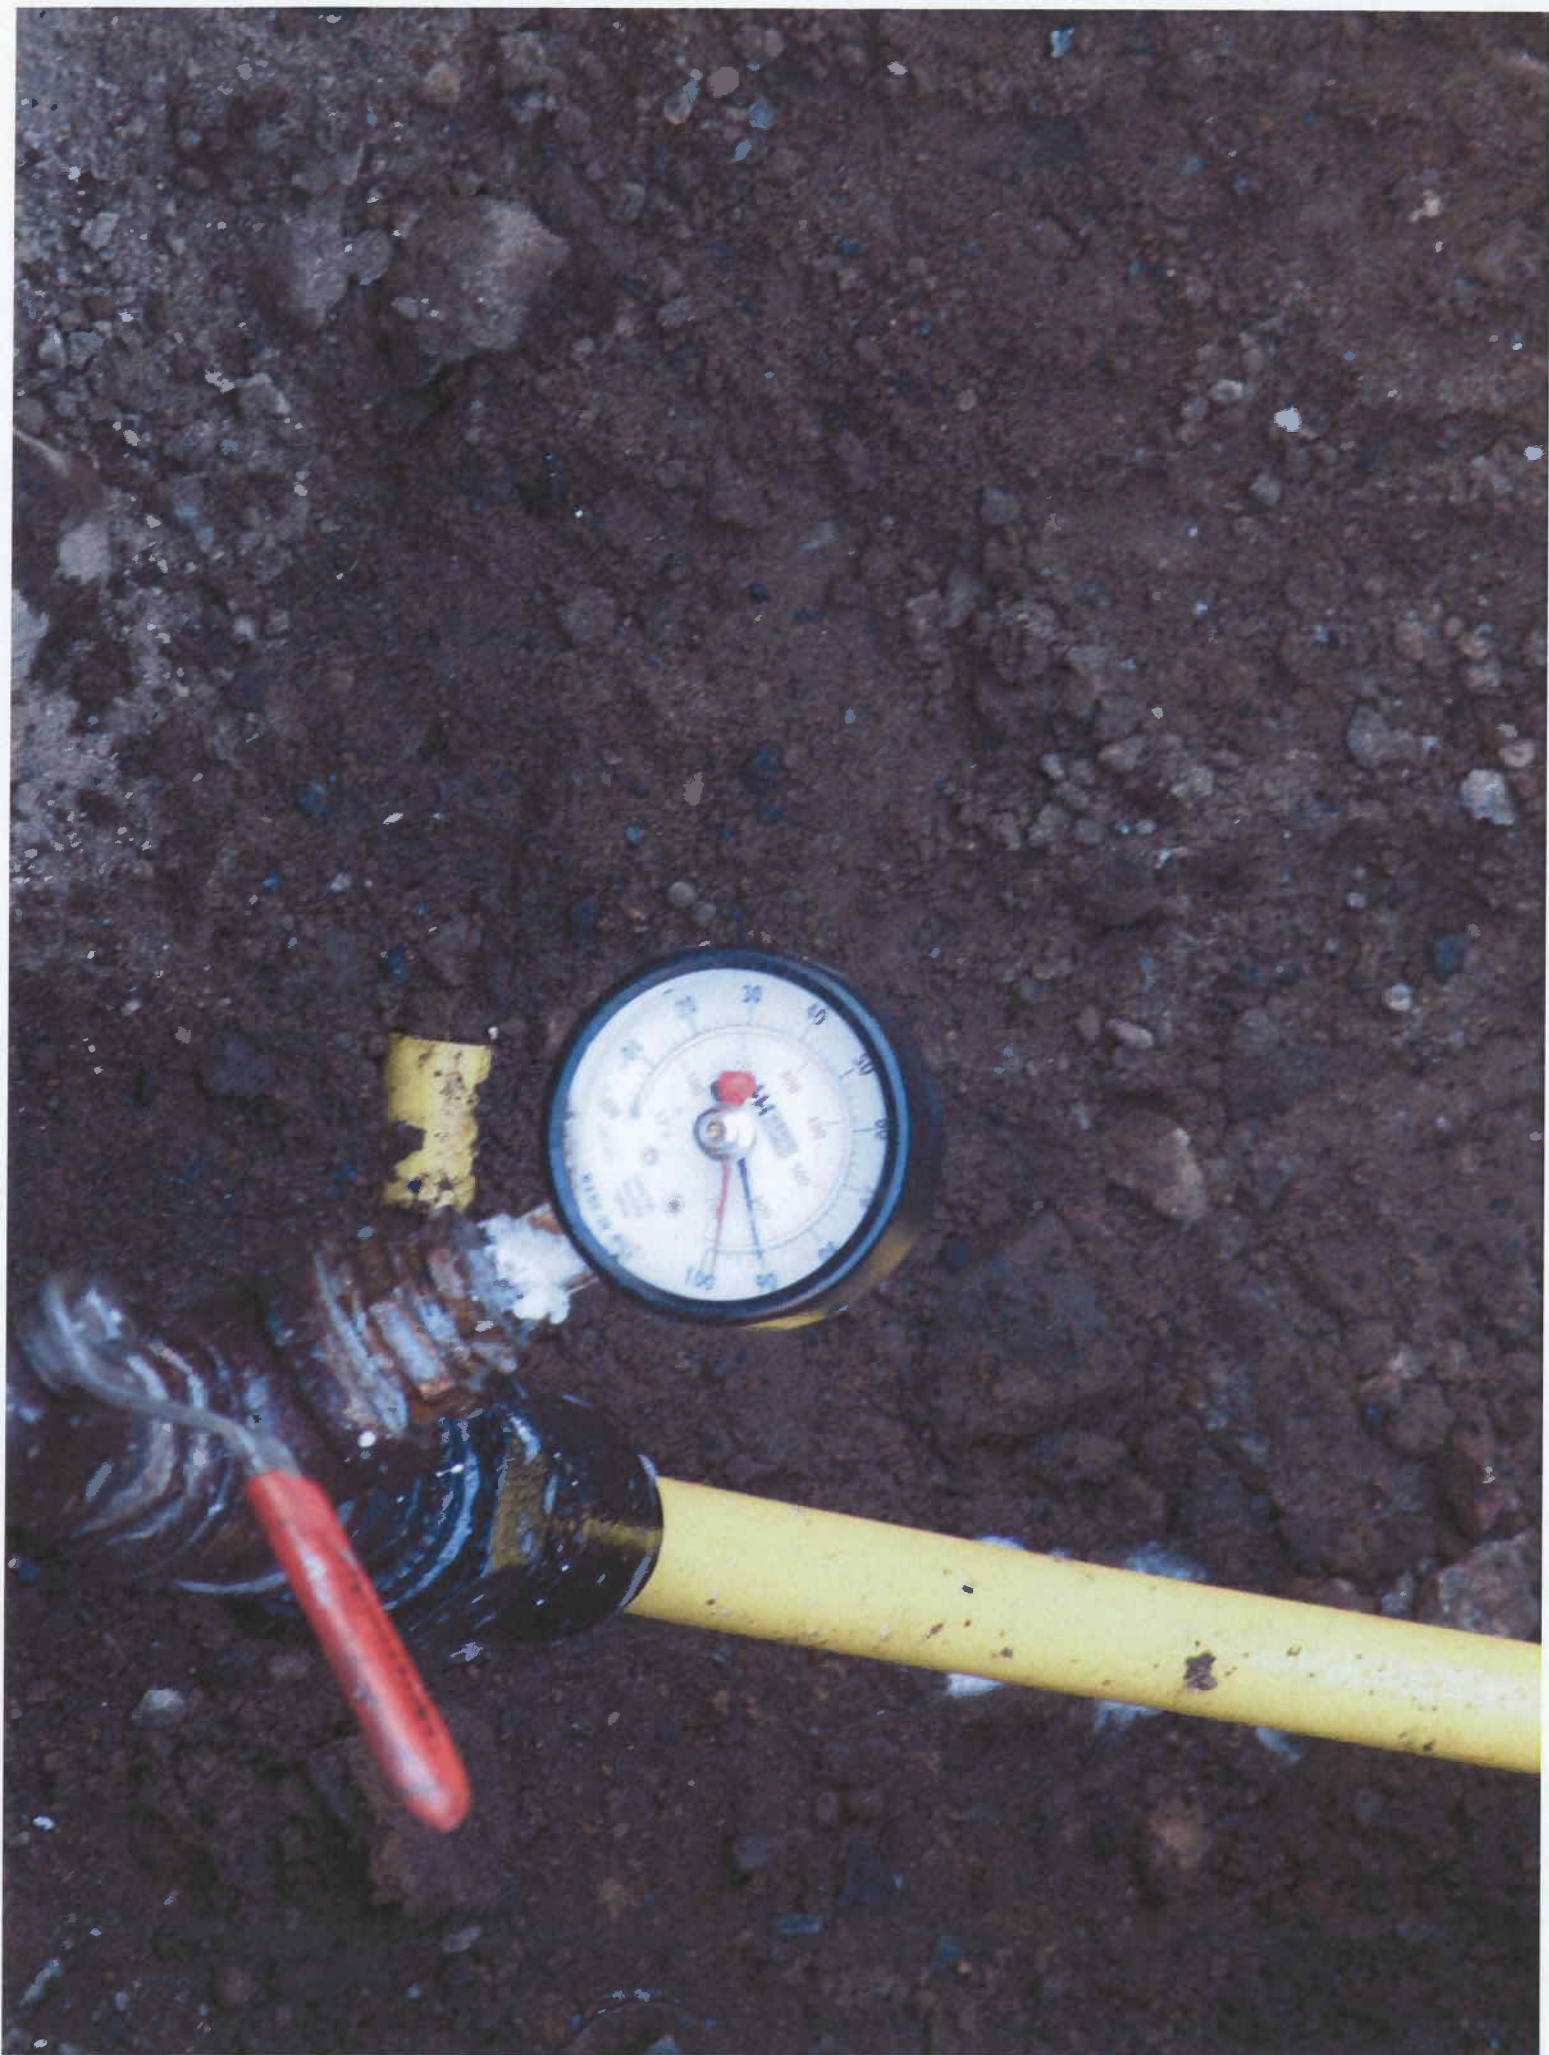
**Photographs
State Fire Marshal Scene Investigation
Inside Service Piping
Service Shut-off
Gas Service Pressure**

The gas service, meter and inside piping were intact to the outlet of the meter. The inside piping was broken off at an elbow above the meter. The meter assembly and the inside service piping were bent over at a 90° angle as the tee on the service had been turned down by the falling debris (Exhs. 4, 12).

The service cock inside the basement was found in the on position (Exhs. 4, 12). In order to perform the pressure test, the service cock was shut off. The Operator introduced ten pounds of air pressure into the gas service to determine if the piping was tight (Exhs. 4, 12). The test did not hold, and the fittings in the basement were soap tested (Exh. 4). A leak was found on a nipple between the tee and service cock (id.).

The gas pipe above the service cock was cut (id.). The service cock was un-threaded from the tee, attached were the leaking nipple below the cock and the small section of pipe cut above the cock (id.). The service tee was plugged with a steel plug and again ten pounds of air pressure was introduced into the gas service (id.). The fittings, piping and pressure test assembly were soap tested and no leaks were present (id.). The gas service was pressure tested for 17 minutes and the test held (id.). The air pressure in the test was then increased to 90 pounds and again the fittings were soap tested, the test held for 18 minutes and the gas service to 76 Eastern Avenue was determined to not be leaking (id.).
