*Massachusetts Coastal Infrastructure
Inventory and Assessment Project
Massachusetts Department of Conservation and Recreation
Office of Waterways*

Cape Ann

July 6, 2009

**Bourne Consulting Engineering
Franklin, Massachusetts**

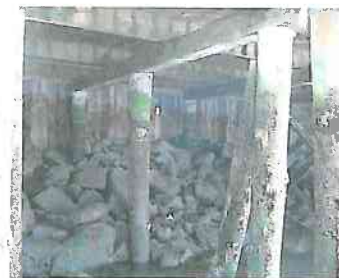
Steel sheetpile wall fronted by dumped riprap. The top are half ton stones. Sheetpile has heavy corrosion at tidal zone. Erosion behind the concrete cap on the sheetpile (3 feet by 2 feet). No sign of cracking. Above is timber pier.

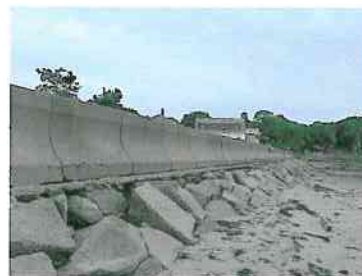
Precast concrete wall with riprap in front. Precast wall is 4 feet high by 4 feet wide. There is some cracking at the edges. Dumped riprap is 5 feet by 2 feet by 2 feet; in front is a sandy beach. Some undermining under and behind the wall. Behind is a walkway, small park, and road to Rocky Neck.

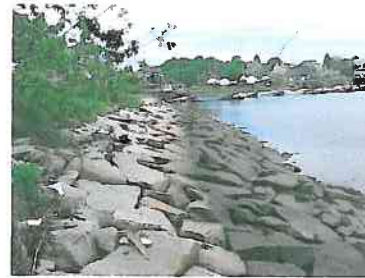
Placed stone riprap revetment. 5 feet by 2 feet by 2 feet at the top. 1 on 2 slope. Behind is parking lot and the only road to Rocky Neck. Toe is intact. No stone movement found. Mean high water is approximately half way up the slope.

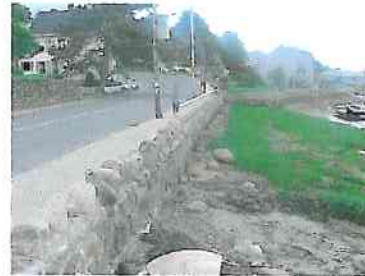
Mortared stone seawall with sidewalk and road behind it. The concrete cap is approximately 2 feet wide. Some cracks and loose mortar visible, but no scour.

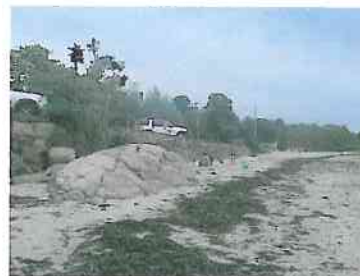
The stone seawall is mortared. There is parking lot above the wall and a road behind the wall. No scour found. 2 feet by 1 foot stones. Sandy beach in front.

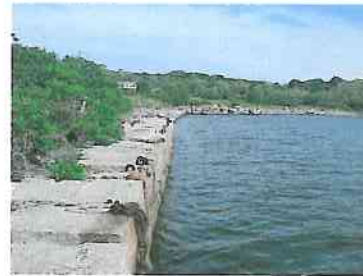
Stone block seawall with stones that average 7 feet by 2 feet by 2 feet. Erosion behind the wall and stones have shifted and settled. Slope 1 on 1 to 1 on 0.5 The wall is in better condition inshore.

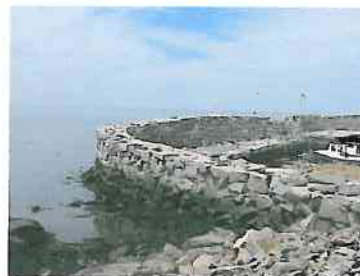
Stone breakwater with stones approximately 4 feet by 3 feet by 2 feet. The corners appear to have been unraveled and repaired using staples. The breakwater protects the cove behind it and the channel adjacent to it. There is a 20 foot landing behind the breakwater, followed by a 15 foot bulkhead. Inshore the stones have signs of rotation and movement.

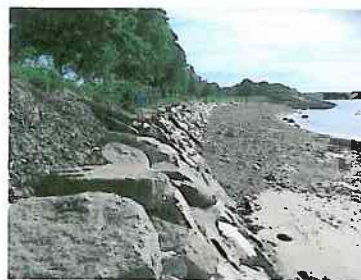
Mortared stone seawall. Some areas with loss of mortar. No scour found. The top is approximately 2 feet wide. Cobble and sand beach fronting. There are two stair beach accesses.

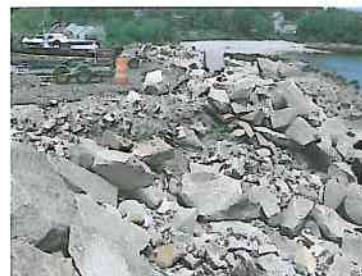
A stone riprap revetment with two sections approximately 30 feet long have unraveled due to storm damage. The understone is exposed. The top has areas of erosion. There is some movement and settling of the stones throughout. There is a crushed stone parking area on top.

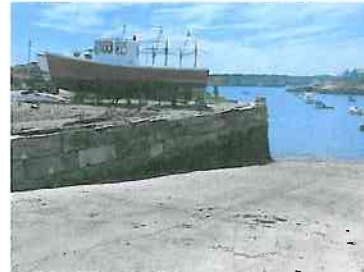
Stone bulkhead with stones approximately 8 feet by 3 feet by 3 feet. The top is concrete and crushed stones are used for boat storage. Some stones have been stapled together. A few stones are missing at the tidal zone.

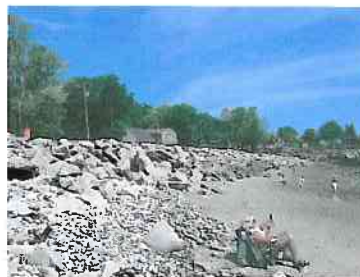
The stone riprap is approximately 5 feet by 3 feet by 3 feet. The toe is still in place and buried. Some sections of the stone have settled and caved in. Behind the riprap is a road and houses; in front of the riprap is a beach. The middle of the revetment has been washed out and replaced and filled in with cobble. The ends are still intact.

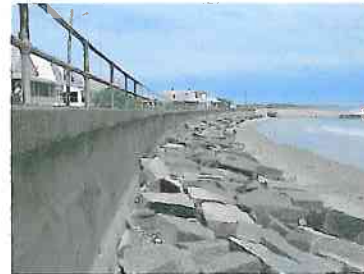
The concrete seawall has a wave return face. It is 3 feet wide at the top. Many homes are close behind the wall and a sandy beach in front. Minor cracks and spalling on the wall. There are many visible repairs. There are a few sink holes behind the wall and the walkway is heaving. The riprap is one stone high starting at the wall and continuing out 20 feet. The riprap is on average 6 feet by 3 feet by 3 feet.

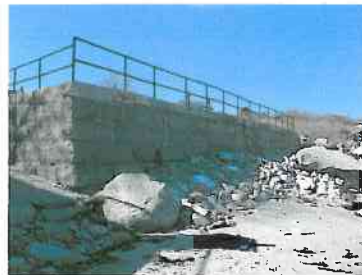
Stone blocks that are approximately 4 feet by 2 feet by 2 feet set six courses high. No shifting or rotating visible in stones. Mortar is intact. Minor erosion behind wall, which has been repaired. In front of wall is beach rocks used as riprap. Rocks are scattered and minor scour is visible.

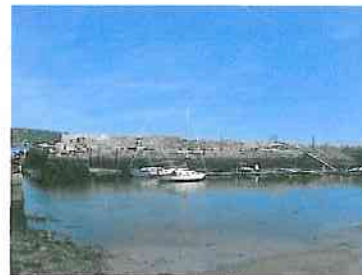
Stone bulkhead with stones that are 5 feet by 2 feet by 2 feet. There is no visible scour. Some settling of stones and erosion and cracking at the top. The wall never had or has lost chinking stones. Some stones have been stapled together. The out shore face was built twice as high then steps down. Adjacent to it is a channel for a small cove. The higher section has been mortared. There looks to have been recent repairs.

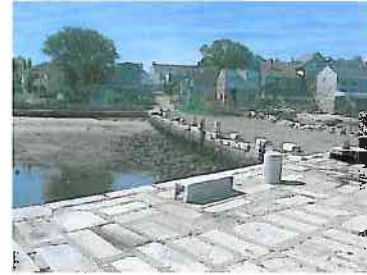
Stone bulkhead with stones that are 5 feet by 2 feet by 2 feet. There is no visible scour. Some settling of stones and erosion and cracking at the top. The wall never had or has lost chinking stones. Some stones have been stapled together. The outshore face was built twice as high then steps down. Adjacent to it is a channel for a small cove. The higher section has been mortared.

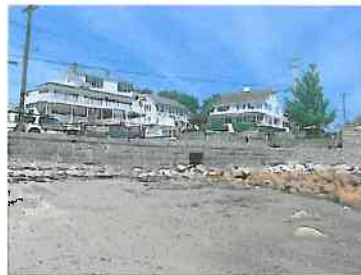
Stone wall with concrete mortar. Stones are 4 feet by 2 feet by 2 feet. Appears to be recently repaired. Behind the wall there is a road and houses; in front, there is a sandy beach. There is a stair access to the beach.

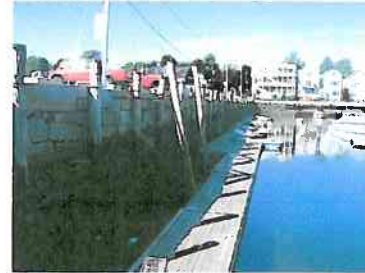
The stone bulkhead with a parking lot above it and floats attached to it with average stone size of 4 feet by 2 feet. Some stone movement and unraveling. There is no visible scour. The west side has concrete on top of the wall that is cracking at sections.
