*Massachusetts Coastal Infrastructure
Inventory and Assessment Project
Massachusetts Department of Conservation and Recreation
Office of Waterways*

Outer Cape Cod - South

Orleans
Brewster
Harwich
Chatham

July 6, 2009

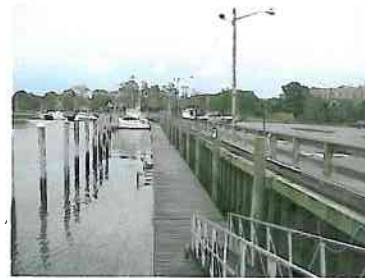
Steel bulkhead with steel cap. There were fender piles in front with a ramp and floats. Behind is a parking lot. There is minor corrosion at the tidal zone. There is no visible erosion or scour.

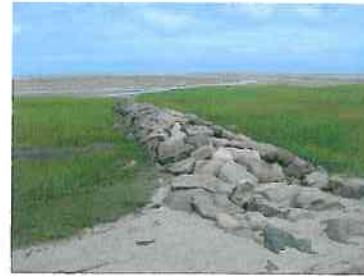
These structures are the two groins at Paines Creek Beach. The side slopes and crest are in fair condition. Some loss of fill stone is evident.

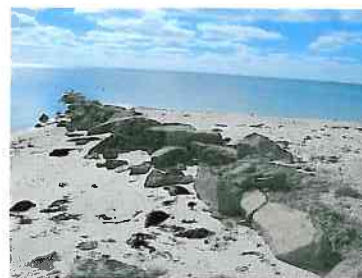
This structure is a groin at the end of Central Avenue. It is unraveled and leaking sand. There is very little interlocking evident between adjacent armor stones.

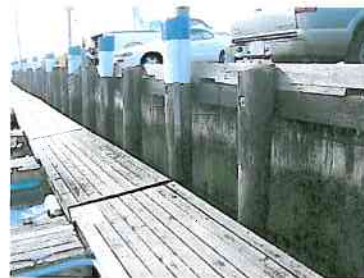
This structure is a bulkhead at Allens Harbor. This structure fronts a parking lot for the marina and has floating dockage on the water side. The timbers on the wall front are weathered while the cap is cracked and splintered in places. No inspection below water line.

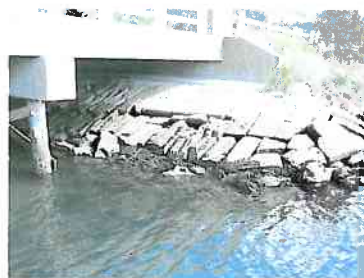
These structures are the abutments at the Lower County Road bridge over Allens Harbor (East Side). They are generally in good condition but there is some slumping in the southwest corner.

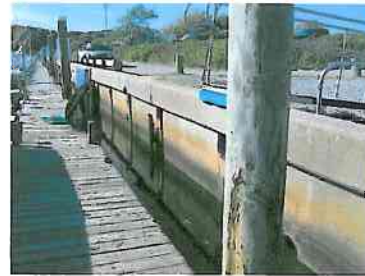
This structure is a concrete bulkhead fronting the parking lot at Saquatucket Harbor. The concrete is discolored but solid. There is a minimum of cracking and spalling evident.

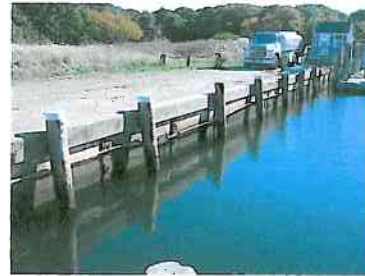
This structure is a concrete bulkhead on the east side of Squatucket Harbor. It is aged and discolored. There is some minor cracking and spalling evident.

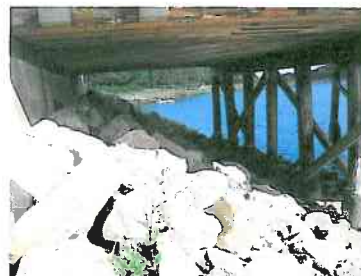
These structures are the armored abutments at the Lower County Road bridge over the Herring River (West Side). The riprap is in good condition. There is some slumping at the southwest corner that has begun to undermine the bridge footing.

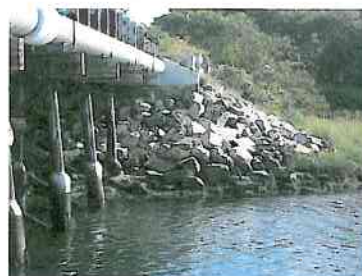
These structures are the armored abutments at the Lower County Road bridge over the Herring River (East Side). The riprap is in good condition. There is some minor slumping along the north side.

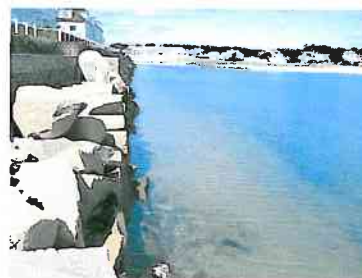
This structure is a stone revetment along the west bank of the entrance to Wychmere Harbor. The stones are almost stacked vertically and the revetment abuts a vertical stone wall. The armor stones are cracked and slumped in sections.

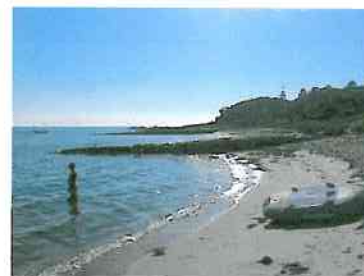
This is a field of stone groins at Forest Beach. They are low profile groins with weathered armor. Some armor stones have become displaced and there is little interlocking apparent. 14 groins were noted.

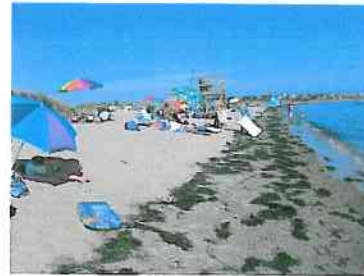
This structure is the Cockle Cove beach nourishment. The beach is in good condition, showing no erosive hot spots or other issues. A typical beach profile is evident. The backing dune shows a small scarp at the toe.

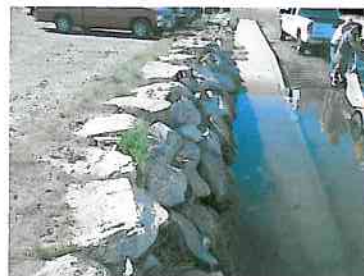
This structure is a riprap slope adjacent to the Barn Hill boat ramp. The stone is weathered but solid. The side slopes are in good condition. Vegetation is growing out along cap and between stones.

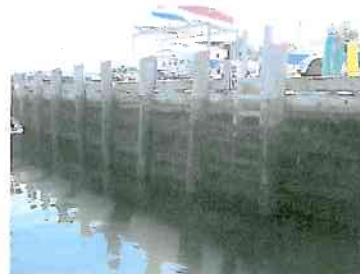
This structure is a timber bulkhead located at the end of Ryder Cove Road. The bulkhead is solid but weathered with some cracking at the crest.

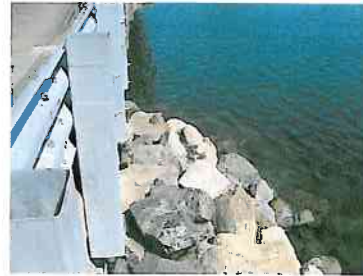
This structure is the armored abutment on the east side of the Bridge Street bridge. There are some displaced stones but they are generally in good condition.

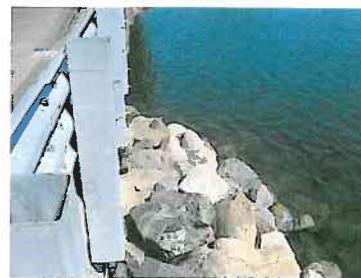
These structures are the armored abutments on the west side of the Bridge Street bridge. There are some displaced armor stones but they are generally in good condition.

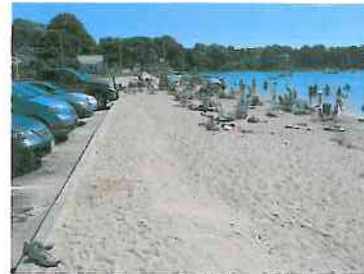
This structure is a beach fill located at the east end of Oyster Pond on the west side of Stage Harbor Road. The beach is in good condition but the elevation is somewhat low. A typical beach profile is evident.

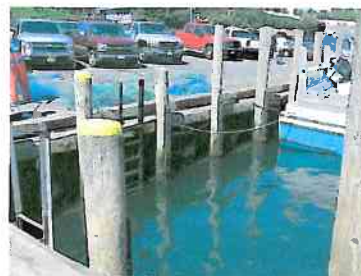
This structure is a bulkhead south of the Fish Pier. There has been repair to the sheetpile and anchors and new tiebacks. The bulkhead was repaired in 1999-2000.
