NO. 2006-0673-3A

**INDEPENDENT STATE AUDITOR'S REPORT
ON THE PHYSICAL CONDITION
OF STATE-AIDED PUBLIC HOUSING UNITS
AND RESOURCES ALLOCATED FOR THE
OPERATION AND UPKEEP OF THE
HAVERHILL HOUSING AUTHORITY
JULY 1, 2003 TO JUNE 30, 2005**

**OFFICIAL AUDIT
REPORT
JANUARY 2, 2008**

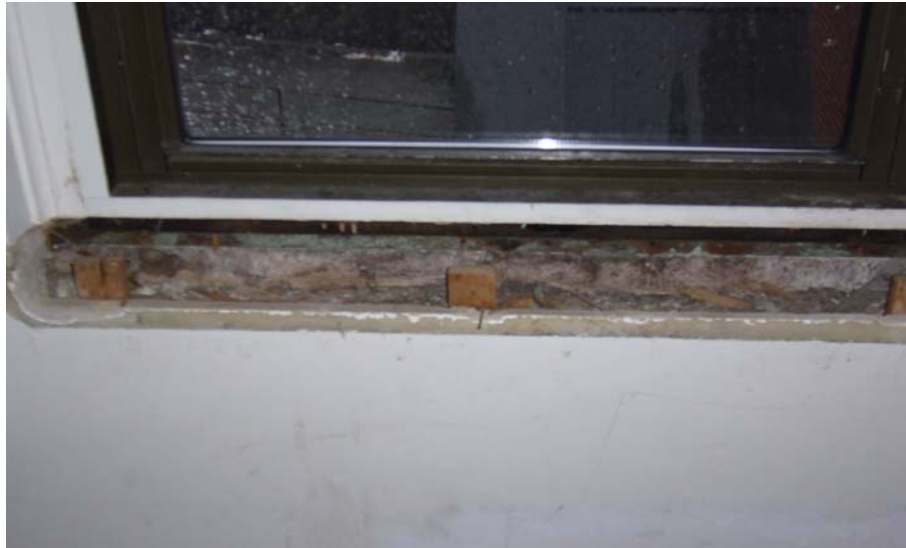
**200-2 Family Development, 21 Mt. Vernon Street, Unit #29
Cracked and Draft- Ridden Window Sill in the Bedroom**

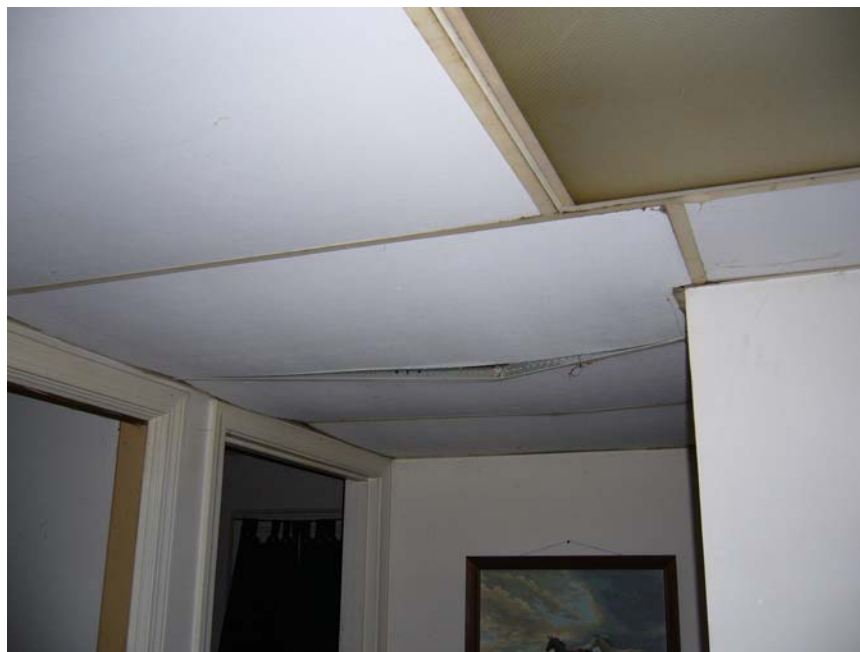
Unit #1 The water damage on the ceiling was from the bathroom on the second floor and this was repaired.

**200-2 Family Development, 134 Summer Street, Unit #1
Water Damage on Ceiling in the Living Room**

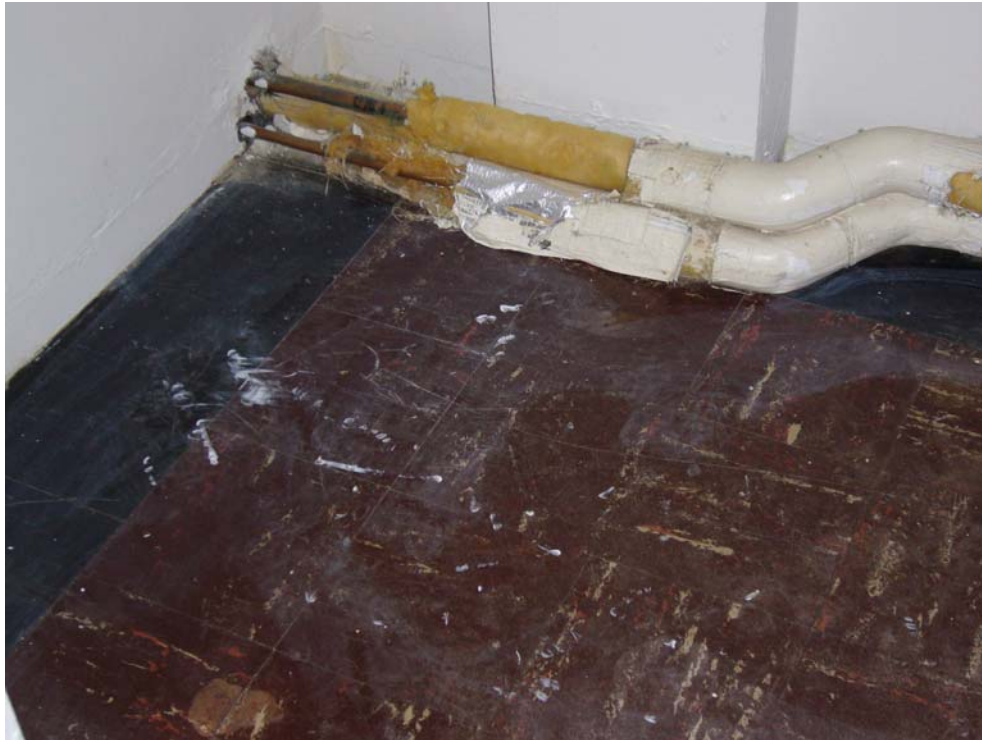
**200-2 Family Development, 134 Summer Street, Unit #3
Cracked Asbestos Pipes in the Bedroom**

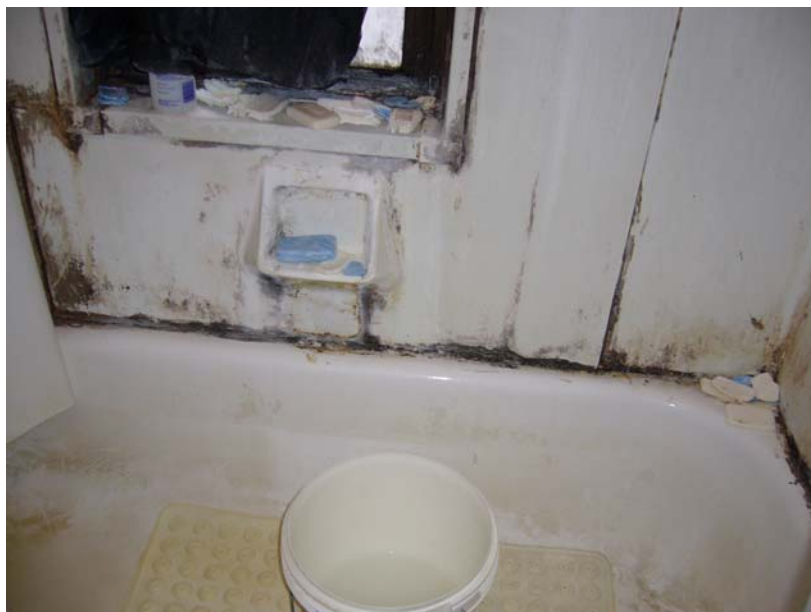
Unit #5 The tenant in this unit was evicted. While I am not denying we have a moisture and mold issue I assure you it is not as bad as the photo shows. This is how the tenant was living. There was no housekeeping in that unit. This was not the only reason for the eviction but it did contribute to the eviction. Unit #9 shows a mold condition. We do have a problem especially in the bathrooms that we are hoping will be addressed with the completion of the CBI study.

**200-2 Family Development, 134 Summer Street, Unit #5
Health-endangering Black Mold on Walls**

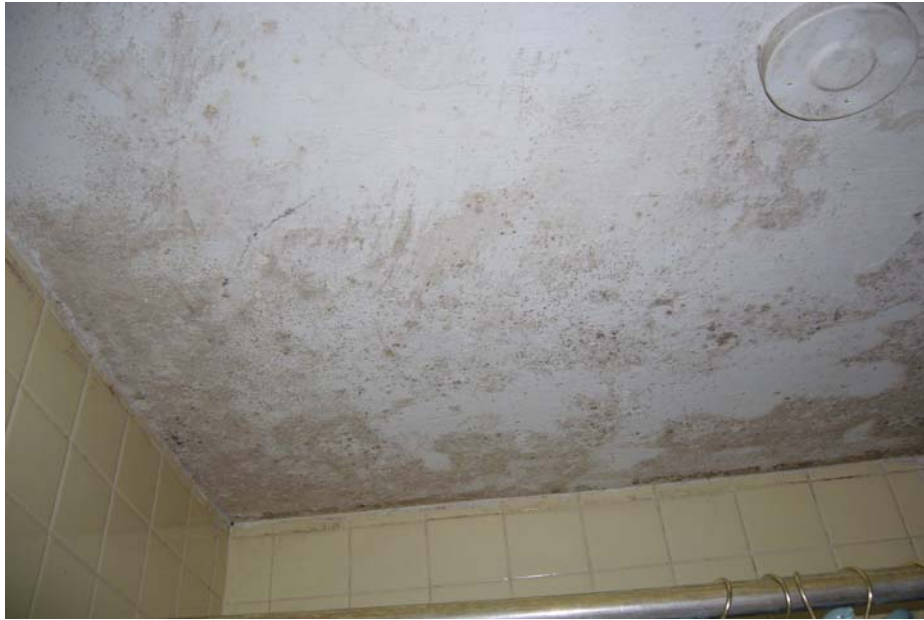
**200-2 Family Development, 140 Summer Street, Unit #9
Health-endangering Black Mold on Ceiling in the Bathroom**

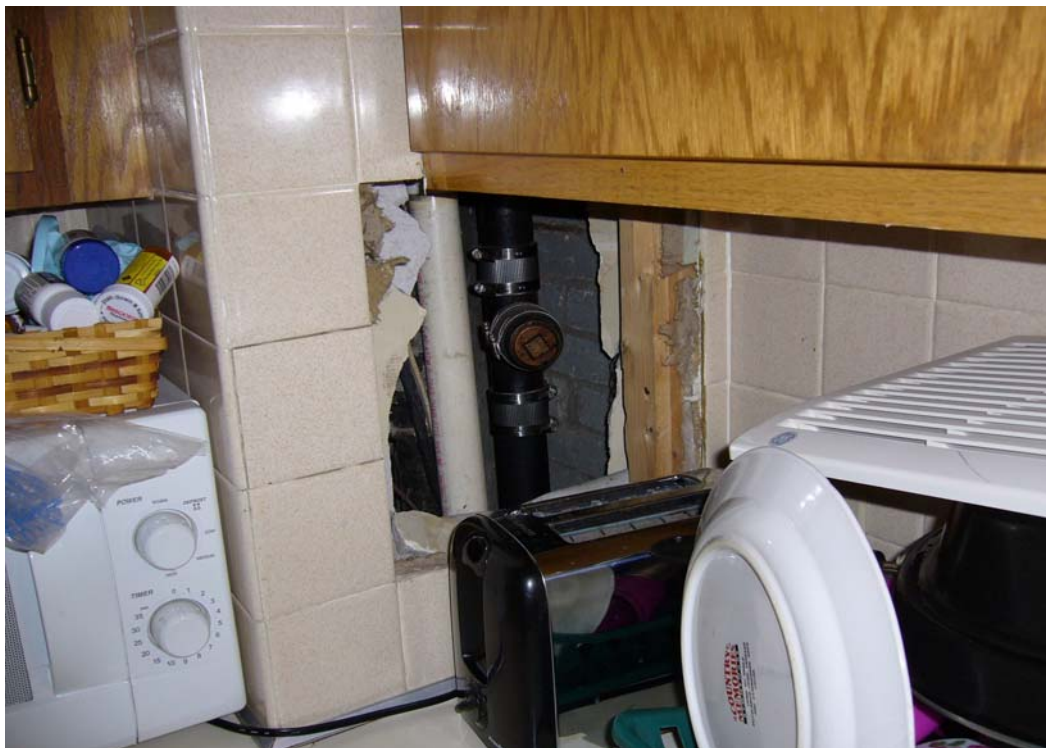
Unit #8 This photo shows a hole in the wall. In the hole you can see the stack pipe is white PVC. The original cast iron pipes in the walls are deteriorating. According to our plumber this is not surprising as the quality of the post World War II metal was poor. The hole therefore was intentionally cut in order to repair this stack pipe. This section of the pipe was repaired and the wall tiles were also repaired. Unit #29 is a third floor apartment. This three-story building does have roof leaks.

**200-2 Family Development, 140 Summer Street, Unit #8
A Gaping Hole on Wall in the Kitchen**

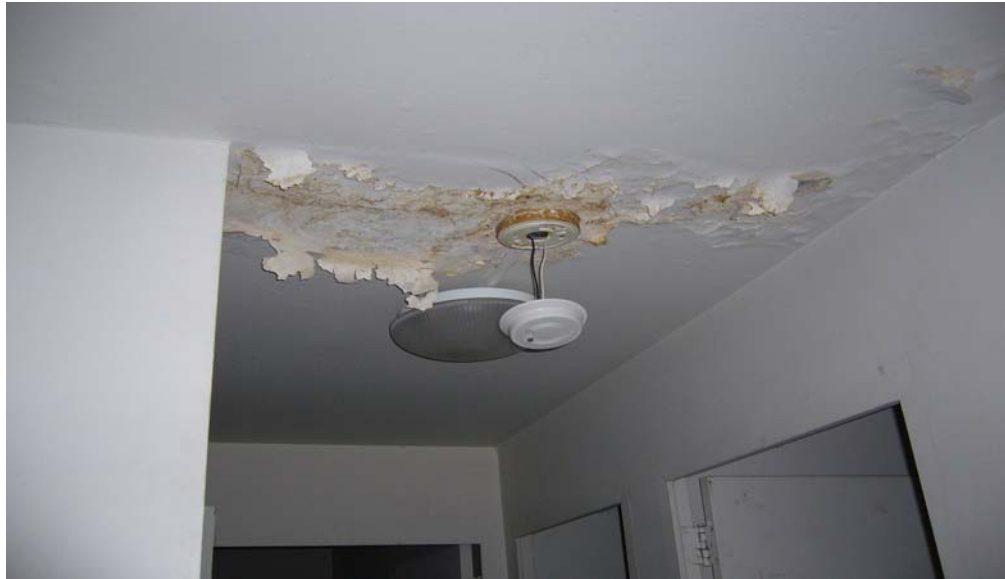
**200-2 Family Development, 21 Mt. Vernon Street, Unit #29
Water Damaged Ceiling – Electrocution Risk/Electrical Fire Hazard**

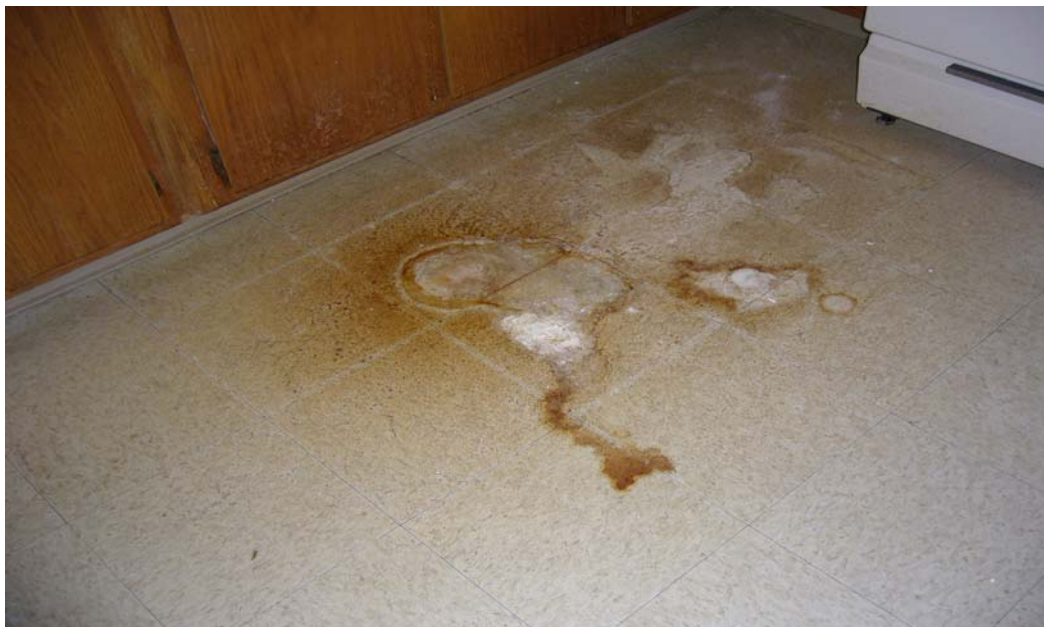
Unit #35 is also a third floor apartment. Most of the third floor apartments are off line due to the roof leaks. The second photo shows an entrance porch at our 667-2. While this is somewhat unsightly, the Kennedy Circle complex overall is a very nice development. This item would not be a priority; our priorities would be outlined in the response to the June 9th questionnaire.

**200-2 Family Development, 21 Mt. Vernon Street, Unit #35
Unchecked Water Damage on Kitchen Floor – A Trip Hazard**

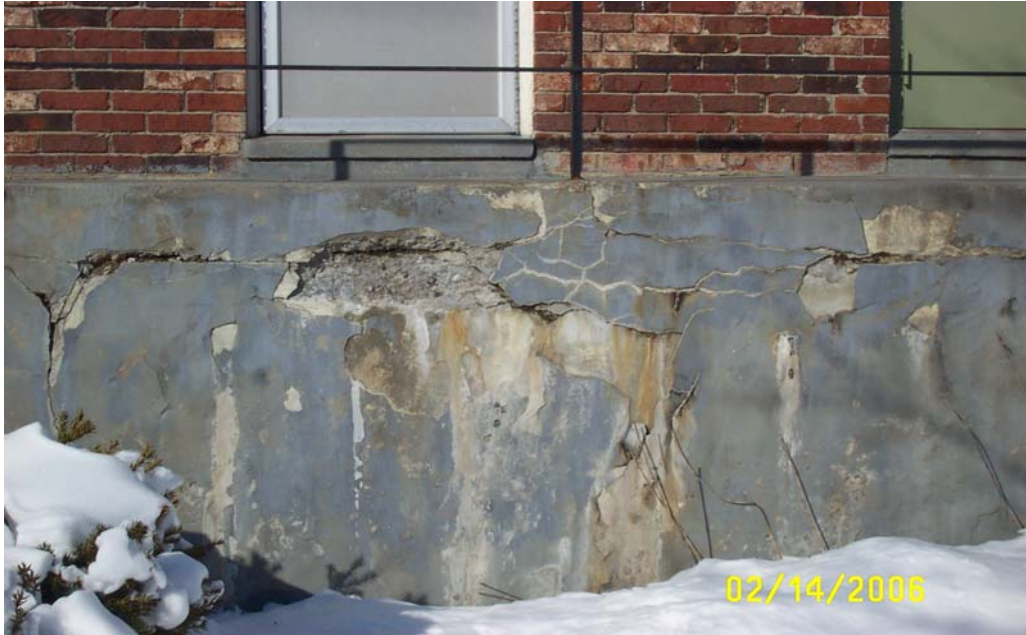
**667-2 Elderly Development, Kennedy Circle, Unit #8
Crumbling Concrete Foundation**

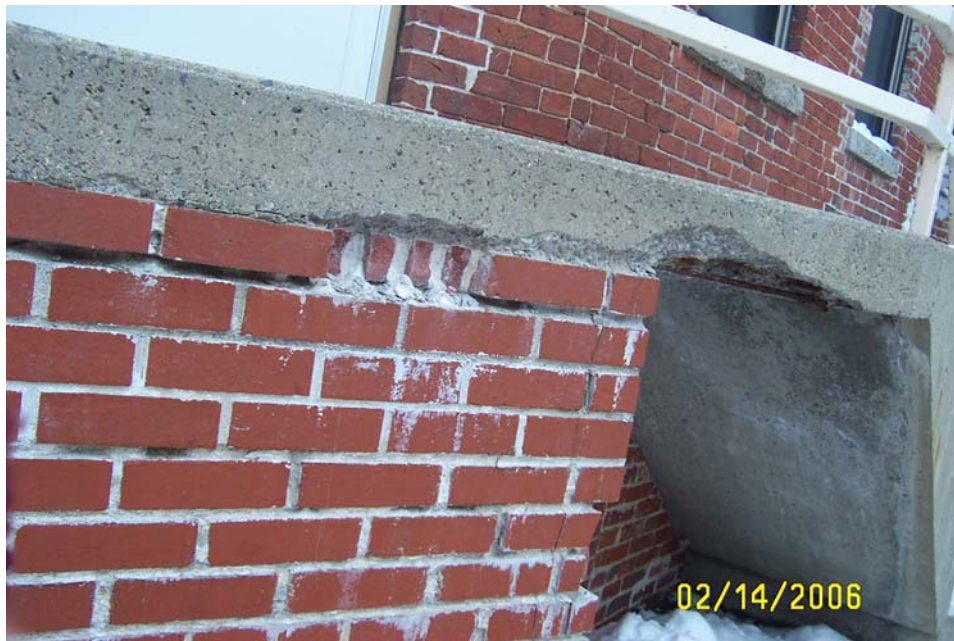
**667-4 Elderly Development, 25A Washington Square
Cracks in Bricks' Mortar Joints Allow Water into Wall System**

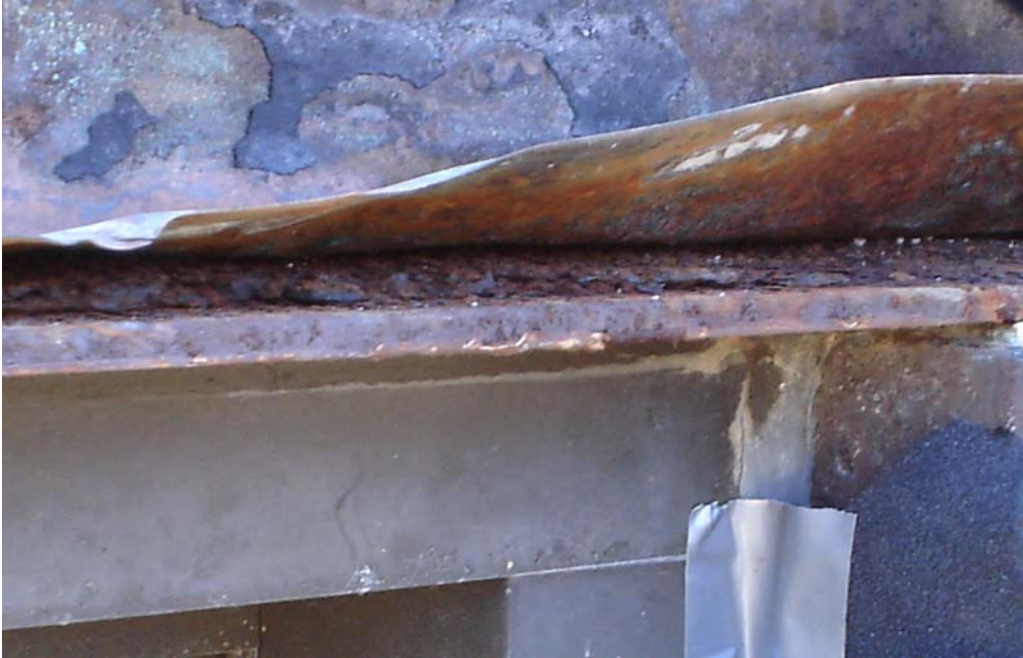
This picture at 25 Washington Square is also a porch and does not affect the inside of the unit. Please again refer to the June 9th questionnaire for concerns at this 667-4 development. The second photo shows rusted window lintels. This rust did not force the copper flashing upward. This was done intentionally for the study in order for the architect to see the condition. What the rusted lintels have done is created a condition called "rust jacking". Rust jacking is when the force of rusting metal lifts the section of the building at its weakest point in this case it would be above the third floor windows in a three-story building.

**200-1 Family Development, 17-25 Mt. Vernon Street
Rust on Window Lintels Forces Copper Flashing Upward and Outward**

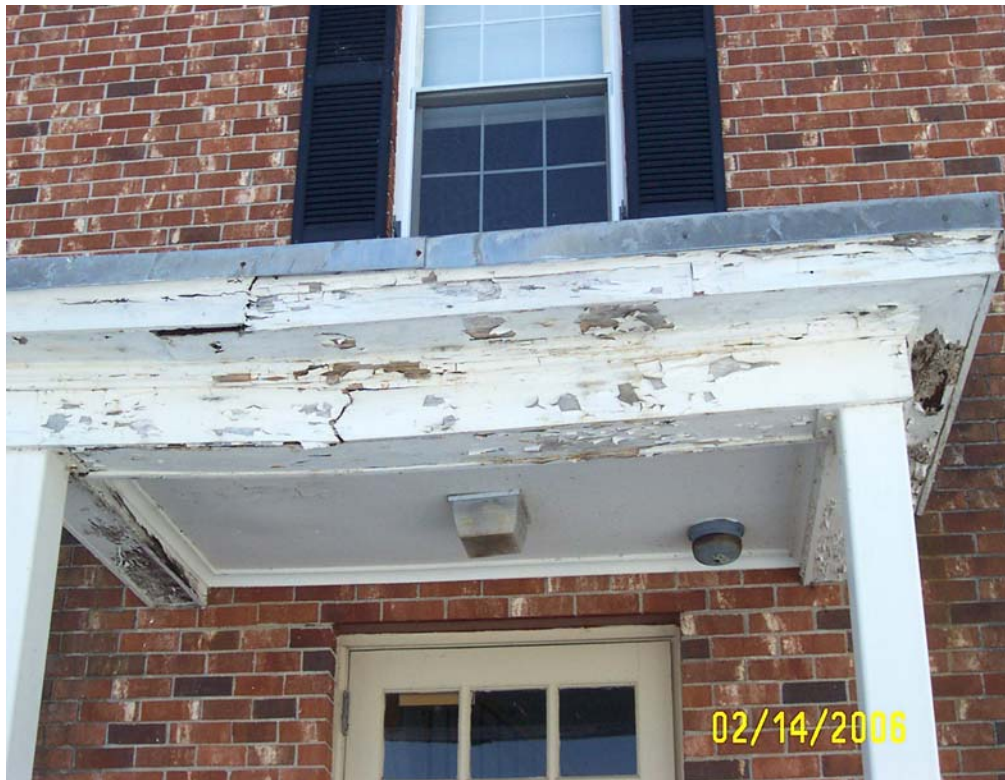
770 Washington Street. What happened here was a huge icicle fell from the main roof above the lower entrance overhang roof. The icicle penetrated the roof membrane on this entrance overhang. The water from the melting snow, ice and rain caused this damage. This overhang was repaired by HHA maintenance and is in good condition. A change in either the overhang design or the roof material would assist in preventing this from happening in the future.

**667-3 Elderly Development, 770 Washington Street
Entrance Door Overhang in Need of Replacement**
