**Hingham District Court
Hingham, MA**

**HVAC SYSTEM
EVALUATIONS
COVID-19**

Office of Court Management
November 29, 2021

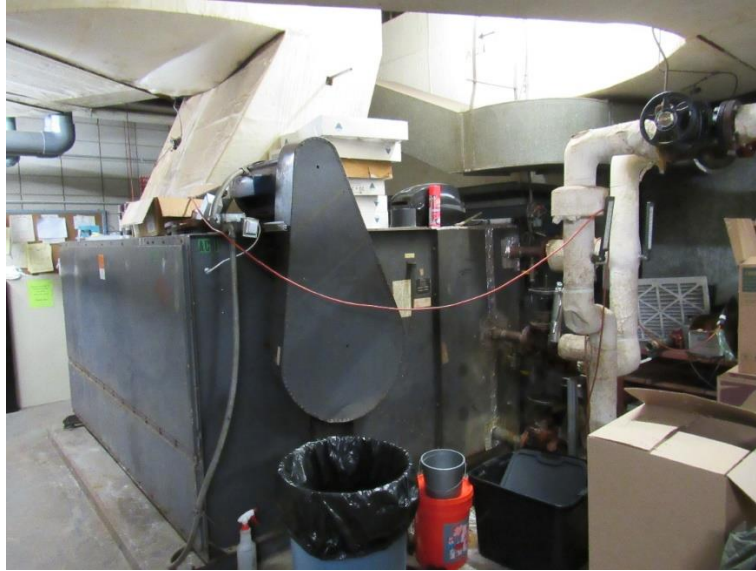
Photo 1 – AHU-1 Air Handler

AHU-1 contains a mixing section with return and outdoor air dampers, 2" MERV 10 filters, a chilled water cooling coil, and a supply fan. A dedicated return fan operates in conjunction with the air handling unit. Each zone has a hot water reheat coil in the supply ductwork to that zone. The AHU is in fair condition. The pneumatic damper actuator is disconnected, although the return and outdoor dampers appear functional. The outdoor air damper was manually set to approximately 20% open. According to staff, a UVGI lamp was installed in the fan section of the AHU in December of 2020.

Unit	Original Design Airflow (CFM)	Original Design Min. O.A. (CFM)	Filters	Condition
AHU-1	18,000	3,600	2" MERV 10	Fair
AHU-2*	Unknown (1,400 est)	Unknown	1" Pleated (MERV unknown)	Fair
FC-1 (Typical)	300	75	None	Poor
FC-2 (Typical)	400	100	None	Poor
FC-3 (Typical)	500	125	None	Poor
3rd Session UV's	Unknown	Unknown	None	Inoperable
4th Session UV's	Unknown	Unknown	None	Inoperable

Replace dampers and actuators that are not functioning properly. At the time of the visit, the pneumatic damper actuator for AHU-1 was not operational.

Indoor air handling units have a life expectancy of 35-45 years. AHU-1 is approximately 45 years old and is at the end of its useful life. Consider replacing this unit in the next 5 years.

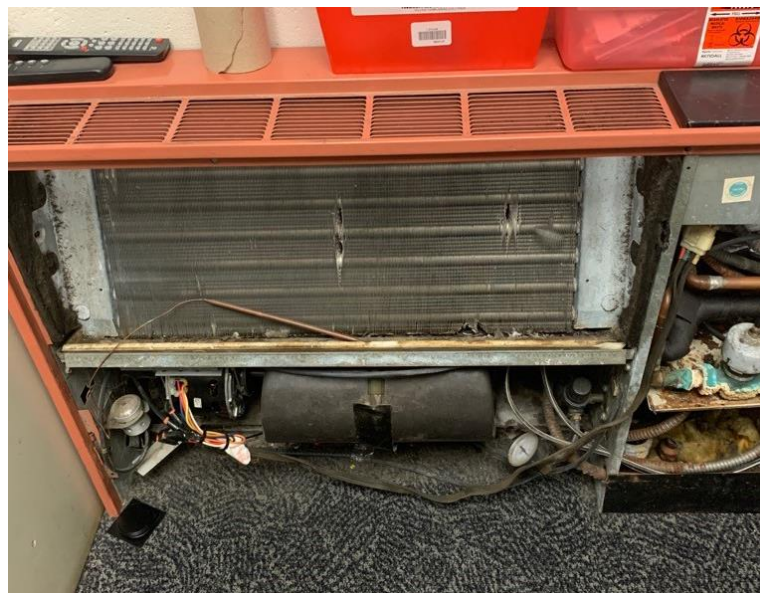
Photo 2 – Fan Coil with Cover Removed

The fan coils contain separate hot and chilled water coils with pneumatic valve actuators, and small permanent outdoor air openings without dampers. There are no air filters installed in the fan coils, and as a result, the coils were fairly dirty. According to staff, the fans operate continuously. Overall, the units are in poor condition.

At the time of the visit, the fan coils did not have filters in place. This eliminates the benefit of the circulating air and will cause the coils to become dirty more quickly. We recommend installing 1" pleated filters in these units, with the highest MERV rating possible without compromising airflow (likely MERV 8 to 11). The filter brackets may need to be repaired or replaced to implement this measure.

We recommend replacing the fan coil units within the next five years. The average life of a fan coil unit is approximately 25-35 years. The fan coil units appear to be original and are 45 years old and in poor condition, exceeding their expected useful life. This recommendation is primarily an energy saving measure and does not increase the indoor air quality of the building.

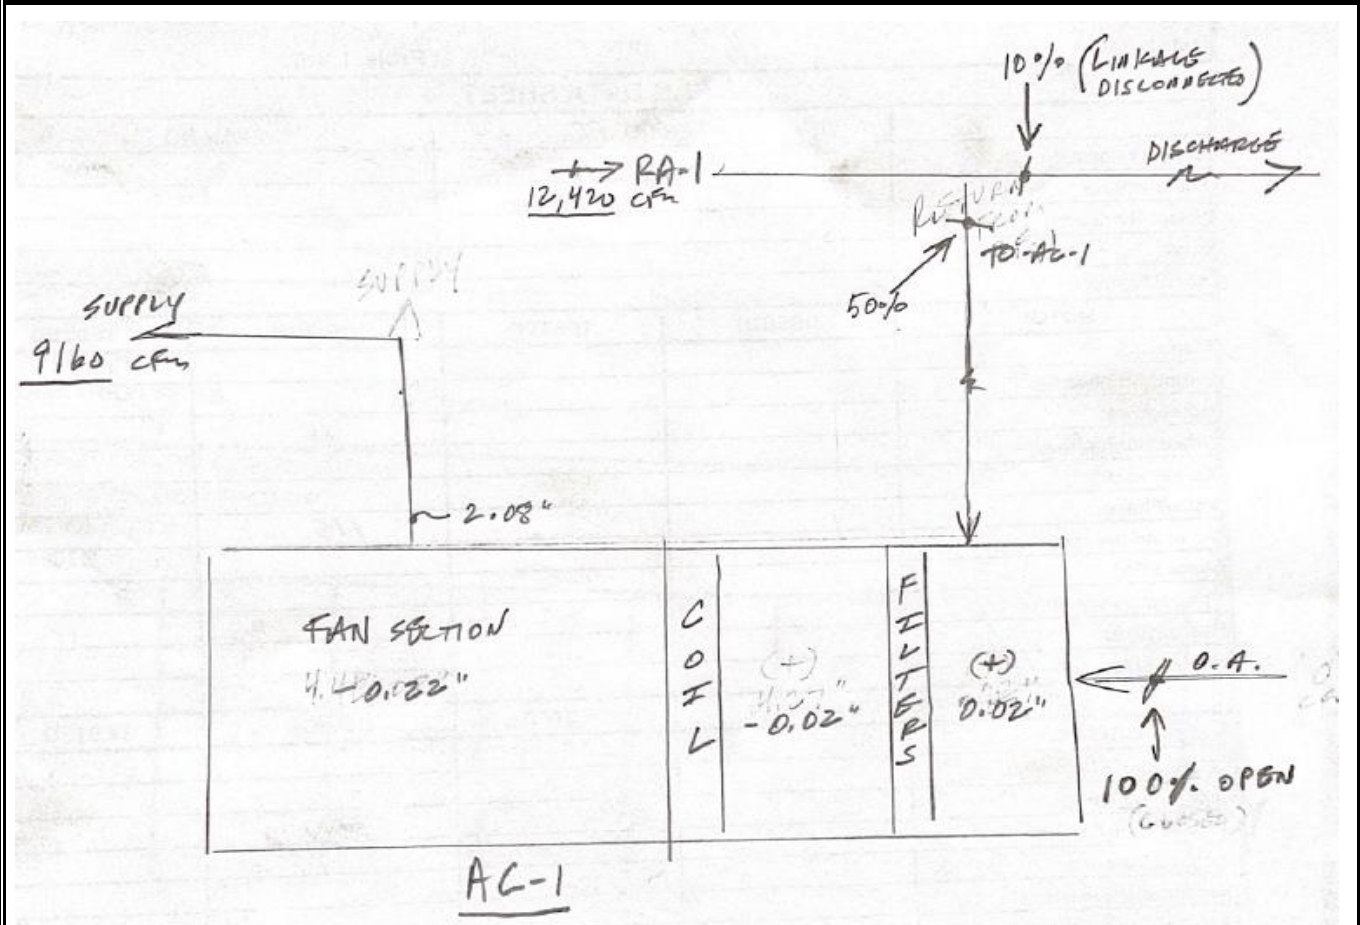
STATIC PRESSURE PROFILE

- b. The pressure drop through the ductwork is relatively high. This suggests that dirty reheat coils or ductwork may be contributing to the low airflow. The supply ductwork and reheat coils should be inspected and cleaned if necessary.
