***South Shore Coastal Infrastructure Inventory  
and Assessment Demonstration Project  
Coastal Hazards Commission***

**Town of Hingham**

**Prepared for:  
Office of Coastal Zone Management  
Boston, MA**

**Presented by:  
Bourne Consulting Engineering  
Franklin, Massachusetts**

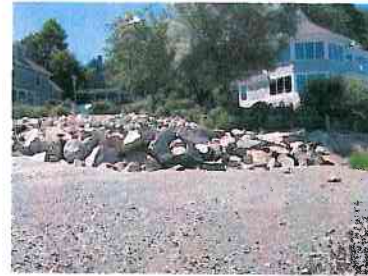
Concrete seawall (30 inches high) behind placed rip rap slope. Concrete wall is tilted outshore slightly with some cracking. Revetment with 1 to 1 slope. Top is jumbled due to placing of concrete wall. Toed in well.

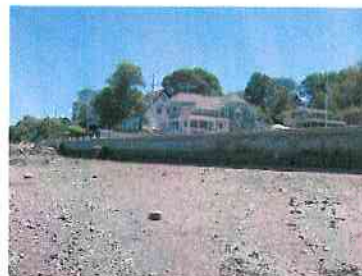
Concrete seawall with wave return face. Minor spalling and deterioration of outshore face. Weep drains about 8 feet on center.

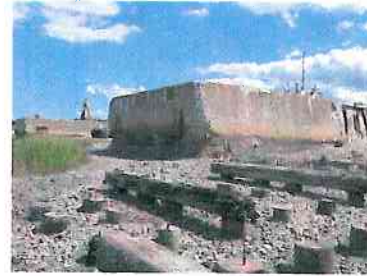
Concrete seawall forming wharves formerly for Hingham Shipyard concrete ramps between wharves. Heavy spalling & deterioration of concrete with exposed and corroded reinforcing.

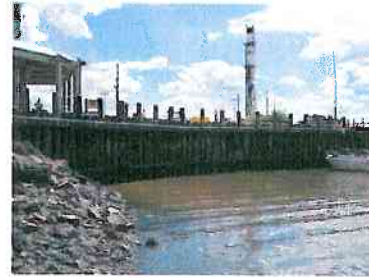
Concrete seawall with timber fender system. Minor cracking in concrete cap. Wall face is not even (constructed that way).

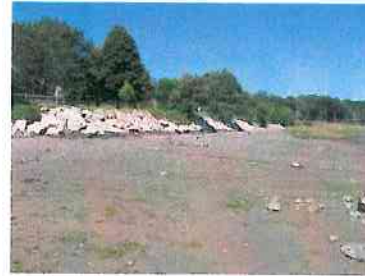
Placed rip rap slope (45 degree) along coastal bank with park and road directly inshore. Slope toed into beach. Stone size 500 to 2000lb. Northern 100 feet is smaller stone and loose with some erosion.

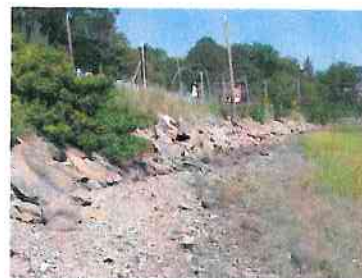
Placed rip rap slope (45 degree) about 10 feet high. Toed into beach, but some locations are scoured out. Some stones loose or dislodged. Fill at top of wall washed out. Top of wall not well defined. Road directly behind revetment.

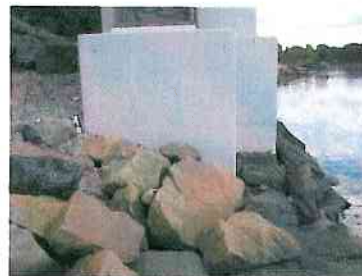
Concrete bridge pier foundation in excellent condition. Placed rip rap slope (1 vertical by 1 horizontal) between bridge pier abutments. 500 to 2000 lb stones.

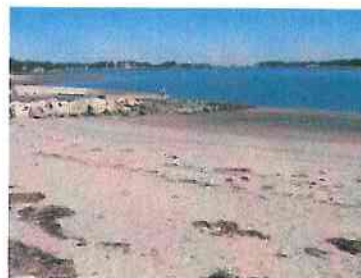
Public boat ramp (concrete) with revetment on south side and precast barriers on north side (some revetment). Some cracking of concrete ramp. Exposed, corroded reinforcing at top of ramp (approximately mean high water). Toe of ramp buried in sand.

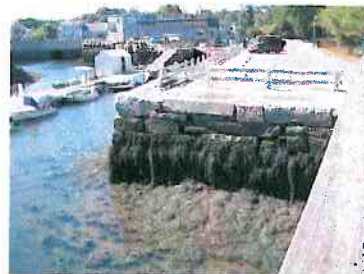
Stone block seawall (dryset) for park and town landing. Some fill loss inshore of seawall. No noted movement or bulging.

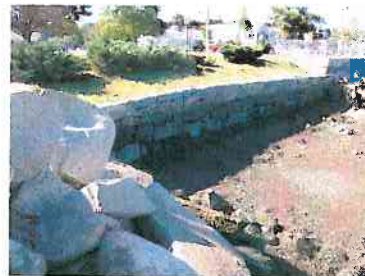
Stone block seawall (dry set). Eastern portion failed previously and repaired with dumped rip rap (1 to 3 ton stones). Median strip between seawall and Route 3A. Remaining seawall is stable, although heavy fill loss inshore.

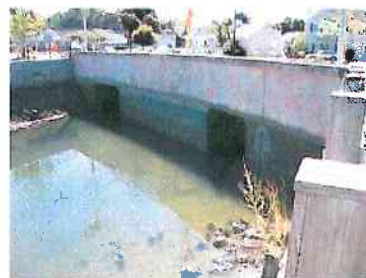
Concrete wall constructed on top of mortared stone foundation for Route 3A. Outshore face is satisfactory condition, constructed 1970.

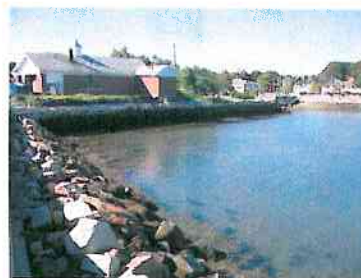
Stone block seawall (dryset) that leans inshore noticeably (possible constructed this way). 3 foot wide concrete slabs directly inshore of wall which are broken and deteriorated along outshore face. Significant fill loss behind seawall (5 feet wide by 2 to 4 feet diameter). Building and park directly inshore.

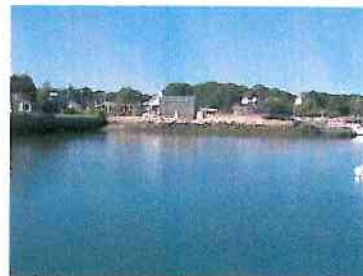
12 inch wide concrete seawall with revetment slope outshore. Concrete seawall is mixture of cast in place sections and stacked precast sections. Peastone fill inshore. Concrete is spalling at top with precast sections moved or loose. Revetment is 100 lb to 1000 lb stones dumped along face (1 vertical to 2 horizontal)

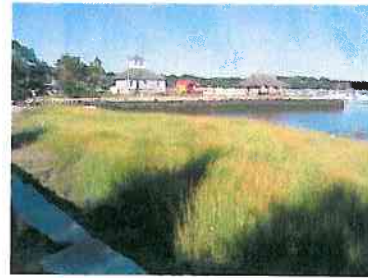
Stone block seawall (dryset) around filled wharf. Heavy fill loss at outshore end. Patching with dumped stone (1 inch or less) and concrete to fill washed out areas. Minor movement of stones noted.
