***South Shore Coastal Infrastructure Inventory  
and Assessment Demonstration Project  
Coastal Hazards Commission***

**Town of Hull**

**February 28, 2007**

**Presented by:  
Bourne Consulting Engineering  
Franklin, Massachusetts**

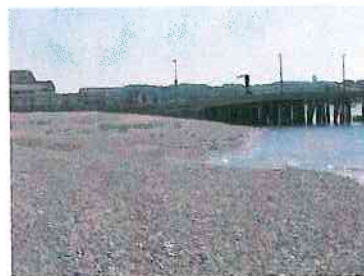
**Mortared stone seawall/abutment for fixed pier. Restaurant and residence on wharf.***Condition***B***Rating***Good***Level of Action***Minor***Description*

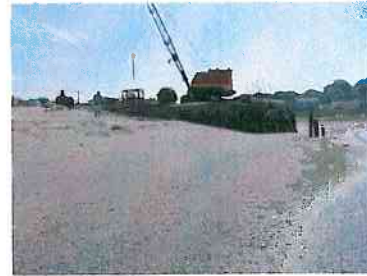
Stone seawall (dry set) / wharf. Remnants of timber fixed pier offshore. Outshore end in fair condition with several repairs previously performed.

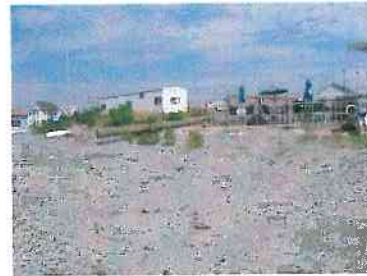
**Revetment buried under sand. Few stones visible (1000 lbs.)****Condition****B****Rating****Good****Level of Action****Minor****Description**

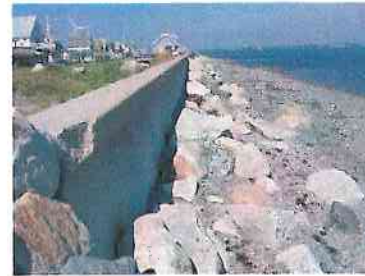
30 foot wide concrete seawall with revetment protecting toe. Average stone size is 1000 lbs. Revetment is satisfactory condition for protecting toe of wall. Wall has minor transverse cracking and broken piece (4 foot long X 3 feet high X 2 inches thick) on inshore face.

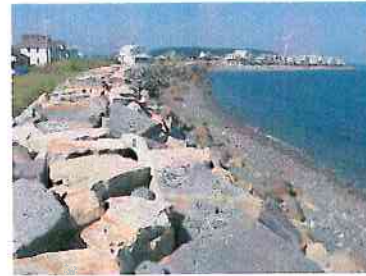
Stone revetment wall with 10 foot wide flat top. Mean high water about mid height of wall. Toed into beach. Inshore grade about 4 feet below top of slope. A few loose/dislodged stones. Outshore face at 2 vertical or 3 vertical to 1 horizontal slope.

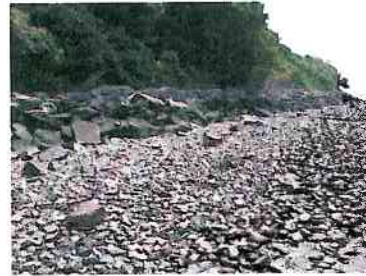
**Average stone 1 to 2 ton. Slope 45 degree toed into beach. 4 foot wide flat toe.***Condition***A***Rating***Excellent***Level of Action***None***Description*

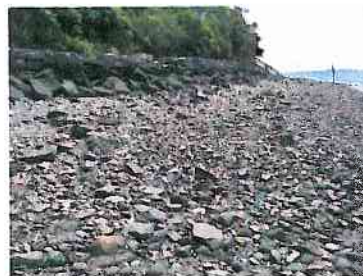
Stone seawall (dryset) with steep earth slope behind (over 50 feet high) revetment dumped along toe of wall. Western 200 feet toppled and appears more like revetment than wall. Most of wall stones are loose or dislodged. Little to no structure at Vautrinot Ave.

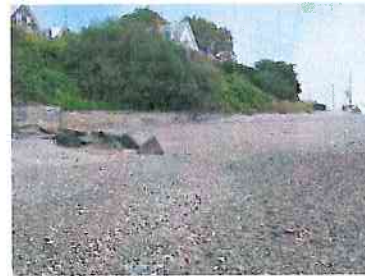
24 inch wide concrete seawall with coastal beach outshore and earth slope behind (approximately 20 feet rise at 1 vertical to 2 or 3 horizontal slope). Large horizontal cracks and spalling.

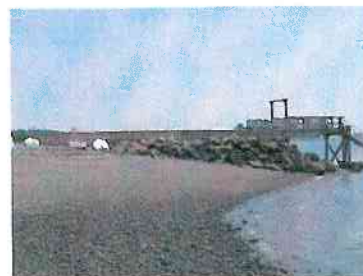
Stone block wharf (mortar at top) with 2 foot high concrete cap wall around top perimeter. Revetment (200 to 1000 lbs. stone) at 45 degree slope around structure. Dumped rip rap in fair condition.

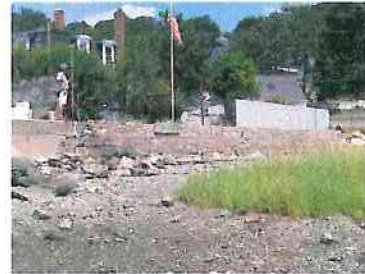
18 inch wide stone masonry wall (mortared). Concrete repairs made to structure. Grout washing out.

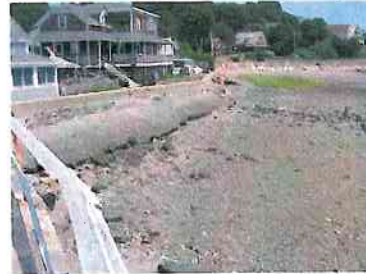
Concrete seawall in fair condition. Width changes at center from 2 feet to 1 foot. Concrete poured along offshore toe where wall looks to have failed previously.

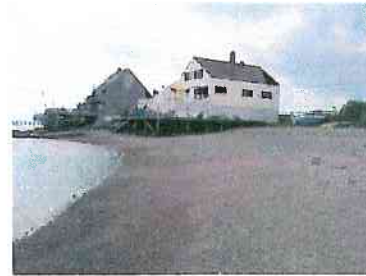
6 feet 6 inches high stone masonry wall. Revetment is buried and/or missing for 1st half of structure (few portions of rock visible). 1000 lb. Average stone at 45 degree slope for eastern half.

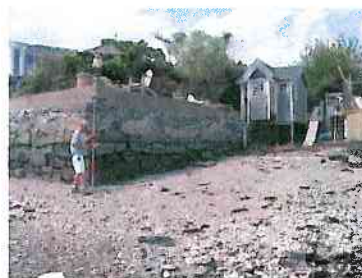
House and road directly behind stone masonry wall. House also has mass concrete foundation extending out from stone wall.

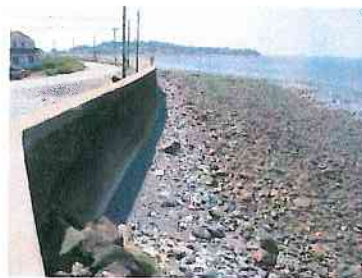
30 inch wide concrete seawall with slightly sloped outshore face. No revetment. Coastal rocky beach outshore. Some vertical and transverse cracks through entire structure width. Footing top is exposed and has some deterioration at joints

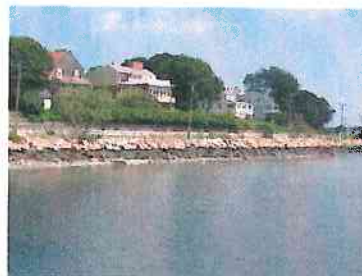
Dumped rip rap slope (1 to 2) in fair condition. Toe and top not defined well. Stone size is 100 to 2000 lbs. Many stones are loose or dislodged.

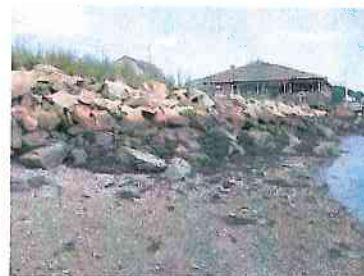
Yacht club and road behind revetement. Dumped rip rap slope (1 to 2) in fair conditions. Toe and top not defined well. Stone size is 100 to 2000 lbs. stone. Many stones loose or dislodged.

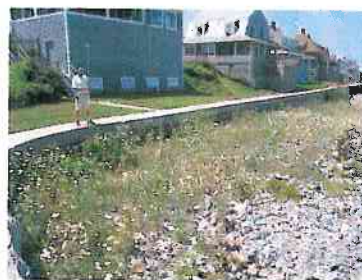
3 feet to 9 feet wide concrete seawall in excellent condition. Coastal (rocky) beach outshore.

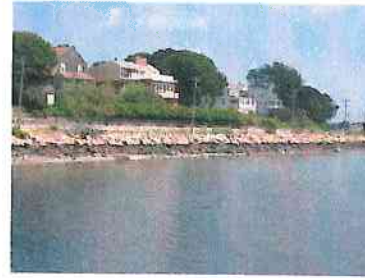
Dumped rip rap slope (1 to 2) with road directly inshore. 200 to 1000 lbs stone. Slope has loose and dislodged stones and is not toed into beach. Some fill loss at top of revetment.

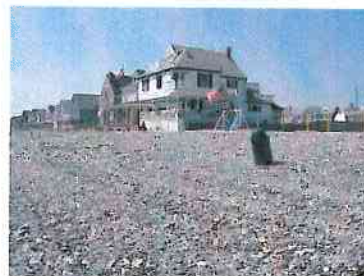
Concrete seawall (12 feet wide) with coastal beach up to 1 foot below top of wall. Top broken in isolated locations. Cracking of top.

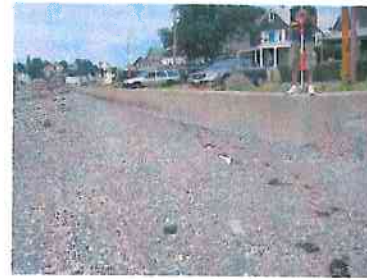
12 inch wide concrete seawall with gravel parking and road directly inshore. Dense housing across road from seawall some deterioration of top and outshore face. Minor cracking due to corrosion of hardware drilled into wall.

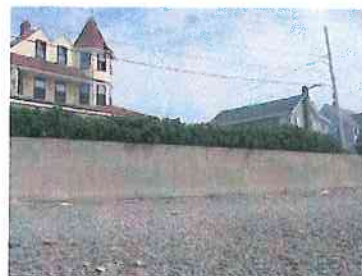
**Concrete seawall cast-in-place on top of cast-in-place slab. Large vertical and horizontal cracks.***Condition***C***Rating***Fair***Level of Action***Moderate***Description*

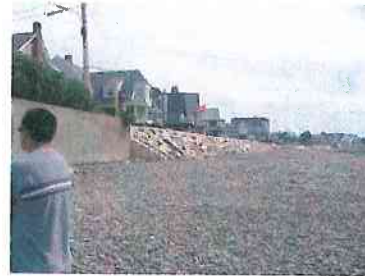
**New construction. 1 to 2 ton stone on placed rip rap slope at 2 to 1. Granite curb concreted at top of wall.***Condition***A***Rating***Excellent***Level of Action***None***Description*

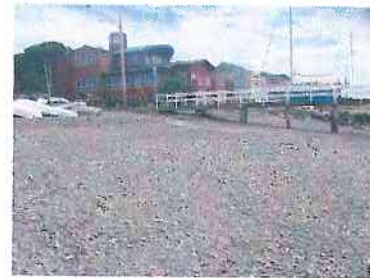
**Concrete boat ramp in fair condition. Partially buried by sand/pebbles.***Condition***C***Rating***Fair***Level of Action***Moderate***Description*

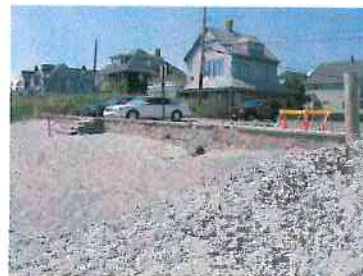
2 foot high by 2 feet 6 inch wide stone masonry wall at edge of road/access way to beach. Concrete cap (2 feet thick) broken on edges. 2 timber CCA piles at face to mark access ramp.

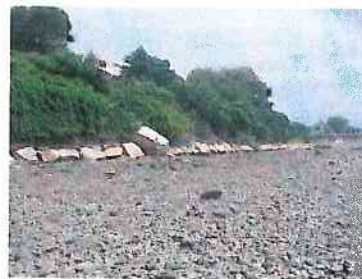
Placed revetment slope (45 degree) along steep earth bank. Slope is not toed into beach. 1 to 2 ton stones. Slope located in front of concrete foundation for multi-unit residential building. The stairs and slope at the Strawberry Hill area have failed.

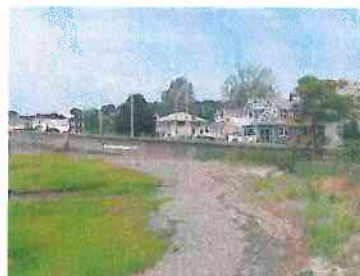
Concrete seawall (approximately 2 feet thick) with 4 foot wide cap and wave break face. 16 inch by 16 inch concrete buttress inshore at 10 feet on center and angled at 45 degree. Placed rip rap at base which is buried for majority of length. Deterioration at joints at wall base. Exposed reinforcing and spalling in places at toe.

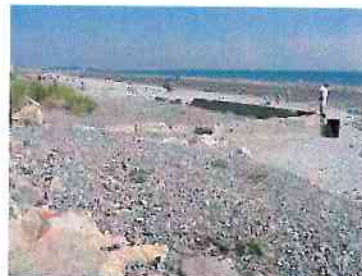
Concrete seawall (possibly building foundation) in poor condition and heavily deteriorated.

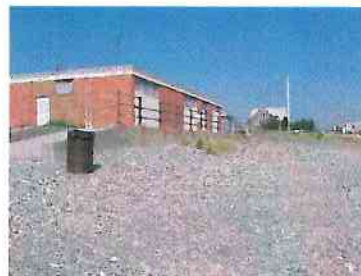
First 100 feet is bathouse on 18 inches to 24 inches concrete slab foundation. Remainder is 2 feet revetment (500 to 1000 lbs.) with jersey barrier on top.

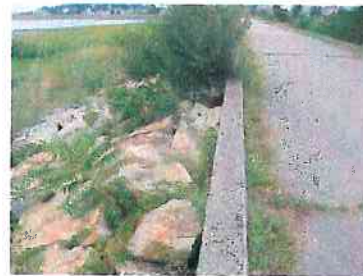
12 inch wide concrete seawall with placed rip rap slope (1 to 3) outshoue. Asphalt sidewalk inshore. Minor deterioration and cracking of concrete. 1000 to 4000 lb. stones. Slope toed into beach. Tide gate does not function.

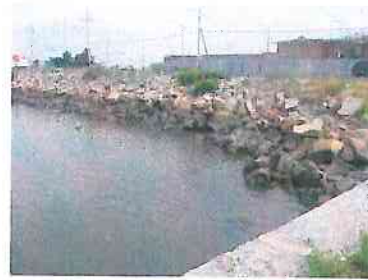
Dumped rip rap slope at 45 degree with road directly inshore. Not toed in at base. 100 to 200 lb. stone loosely placed with evidence of movement.

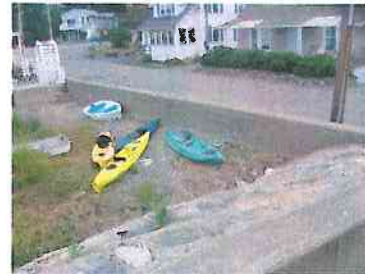
**18 inch wide cast in place concrete seawall with road directly inshore. Minor cracking and slight outshore lean.***Condition***B***Rating***Good***Level of Action***Minor***Description*

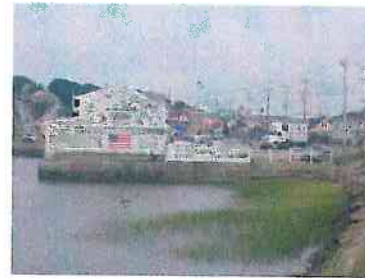
**Stone block seawall (mortared) with building above. Loss of grout from mean high water down.***Condition***B***Rating***Good***Level of Action***Minor***Description*

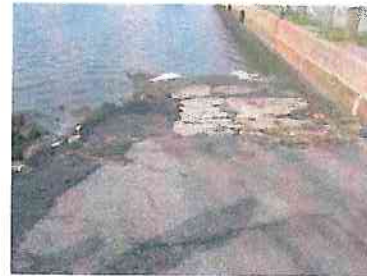
Concrete public boat ramp in poor condition. South Face heavily eroded with material loss. Patched multiple times.

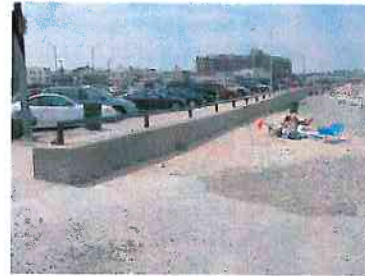
2 foot wide concrete seawall with coastal beach outshore. In satisfactory condition with steel railing on top (12 feet high). Parking lot directly behind then stops and apartment building. Weep draining at 25 feet on center at sidewalk elevation (2 feet below wall top).

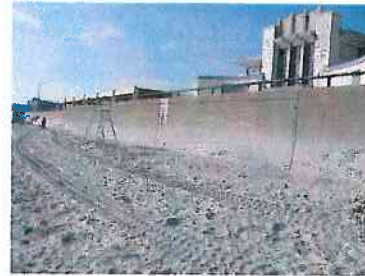
24 inch wide concrete seawall with slight taper in satisfactory condition. Minor deterioration of face and minor cracking.

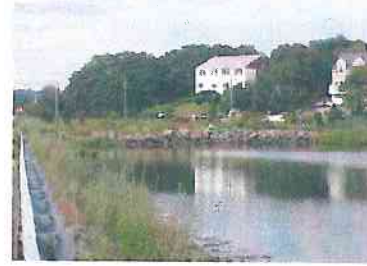
Revetment slope at 45 degree with 100 to 500 lb. stone. Some loose and jumbled stone. Slope appeared to toe into soft bed.

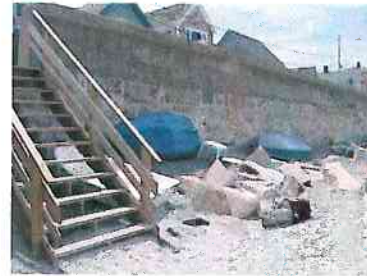
Wall base is mortared stone seawall in satisfactory condition. Height is 4 feet to 6 feet. Wall top concrete wall (4 feet high) with wave break top. Coastal beach (sand) outshore of wall. Wall top is 30 inches wide. One way road directly behind seawall. Inshore face of wall is 4 feet high above grade. Some grout loss and small voids at base.

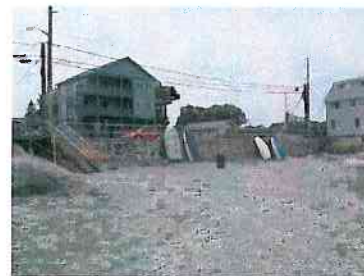
Stone masonry wall at edge of road in satisfactory condition. Railing in poor condition and not suitable for edge of road.
