**September 2021**

**Report No. 21-024**

# Improved Load Rating Procedures for Deteriorated Steel Beam Ends with Deteriorated Stiffeners

**University of Massachusetts Amherst**

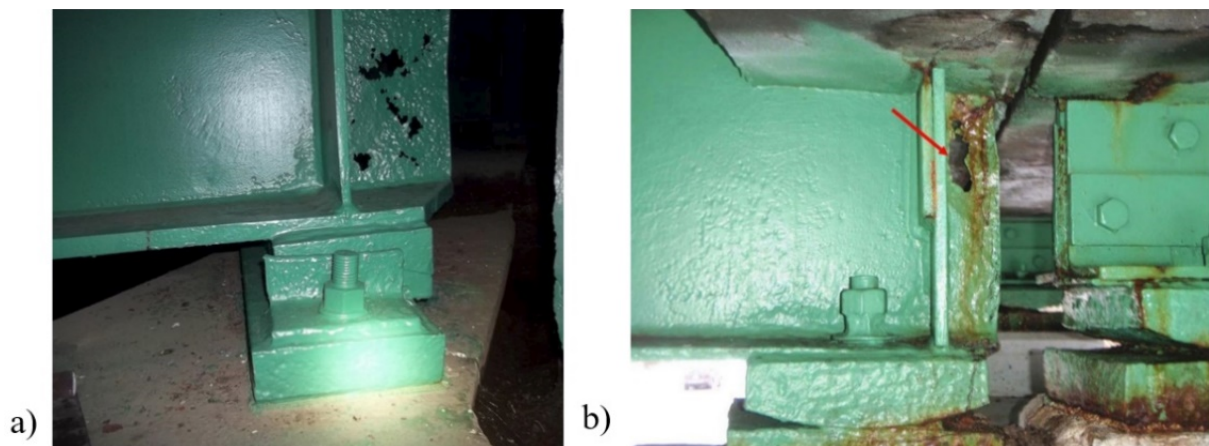
A preliminary look at the received data revealed a variability of the beam configuration at the support area, regarding the number of stiffeners at each web face and their location. In particular, one (Fig. 2.3) or two (Fig. 2.4) bearing stiffeners were found welded at each web face above the support.

Sources: Adopted from a) W46011-3YK-DOT-NBI (District 5, Town of Wrentham); b) W30026-3WB-DOT-NBI (District 5, Town of Westport).

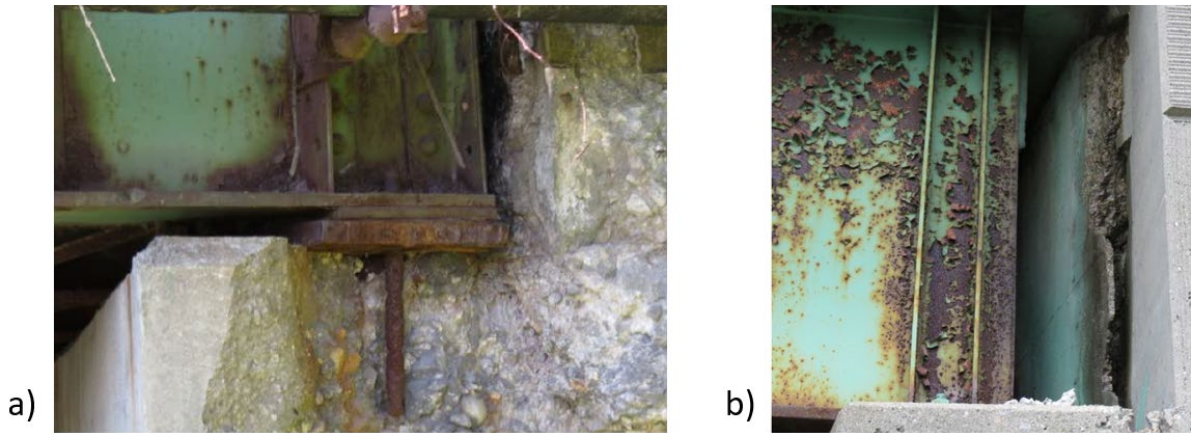
In case where two stiffeners were employed (Fig. 2.4), an additional source of variability emerged in terms of their location with respect to the bearing. Two techniques were detected: first, the distance between the adjacent stiffeners matched the bearing length (Fig. 2.4a); and second, the stiffeners lay within the bearing area (Fig. 2.4b). Finally, for beam ends with one bearing stiffener, there were reported cases where partial bearing stiffeners had been welded to the end diaphragm connection plate as a repairing technique to provide an alternative load path to corroded ends (Fig 2.3b).

Sources: Adopted from a) W44063-1LA-DOT-NBI (District 3, City of Worcester); b) B06022-2AR-DOT-NBI (District 3, Town of Bellingham).

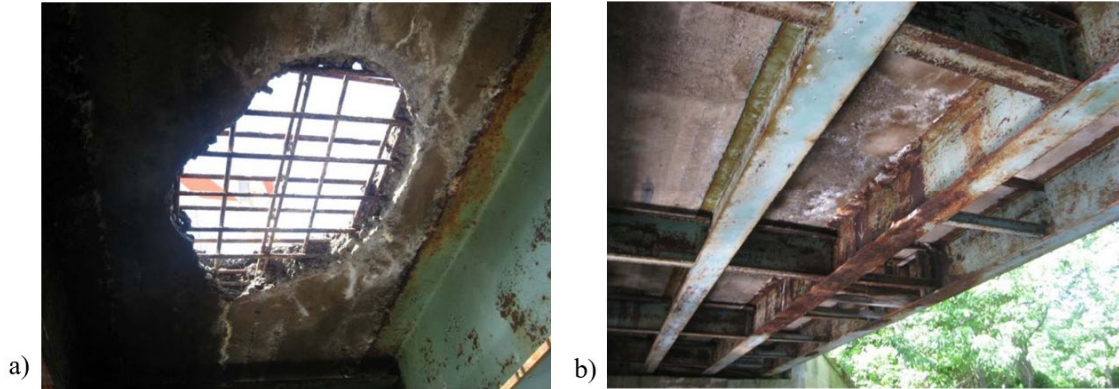
**Figure 3.1: a) Hole through the deck and b) map cracking with heavy efflorescence at O-03-009 bridge (adopted from O03009-0TW-MUN-NBI)**

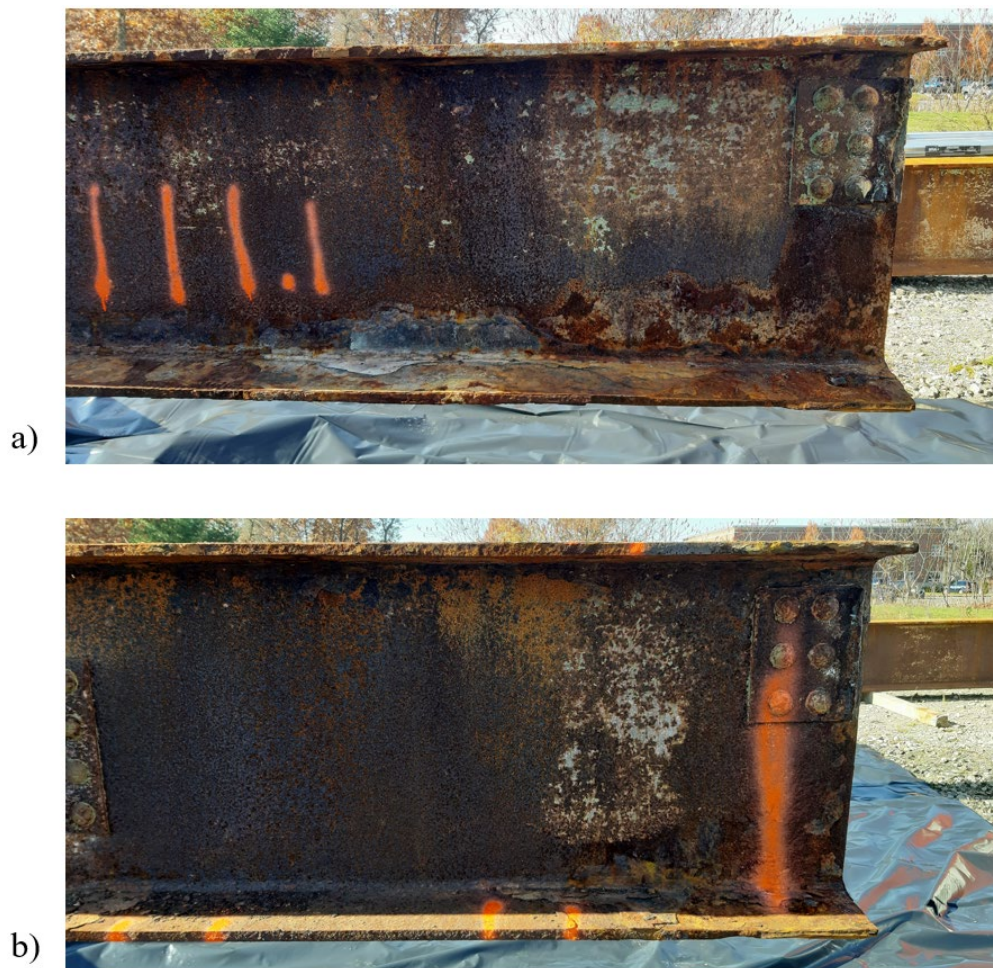
To avoid failure loads that could exceed the available load capacity of the testing rig, the researchers were oriented toward fully stiffening the girder that visual observation indicated as the most damaged one. Consequently, partial stiffeners were welded to the second specimen. Fig. 3.3 depicts the as-received condition of the girders for the fully (Fig. 3.3a) and the partially (Fig. 3.3b) stiffened specimens, hereafter referred to as Specimens A and B, respectively. In both cases, the riveted plates located above the support were removed before welding.

**Figure 3.3: As-received condition for Specimens A and B**

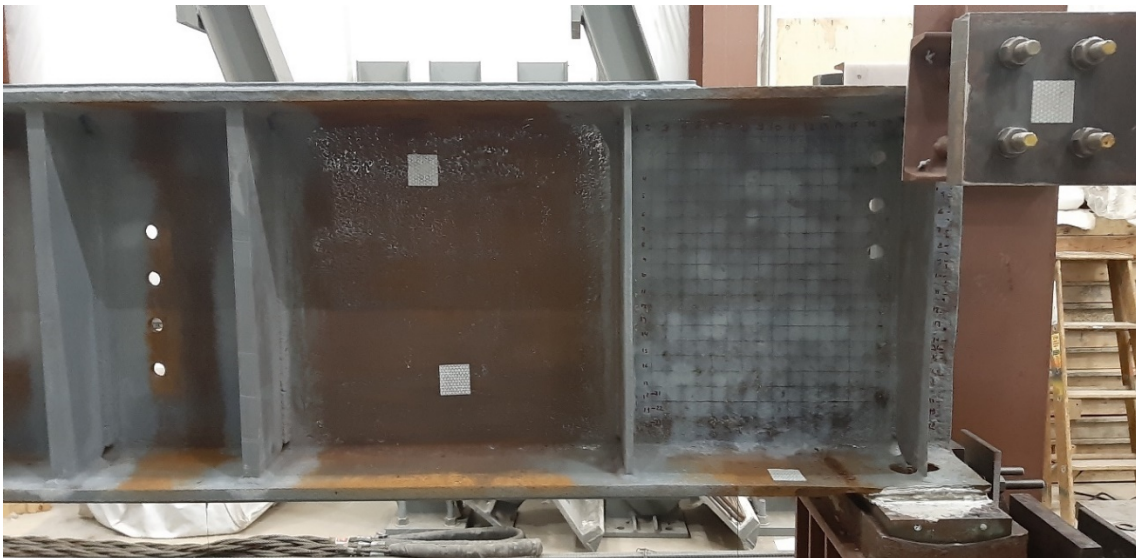
A photograph of the actual specimen is presented in Fig. 3.7. Observation of the same figure revealed perforations resulting from the removal of the riveted plates along the web. Additional perforations were found at the bottom flange, where anchor rods were passing through to restrict the girder in in-service conditions. Their existence prevented the bearing stiffeners from transferring load to the bottom flange along their whole width.

**Figure 3.7: Corroded end of Specimen A**

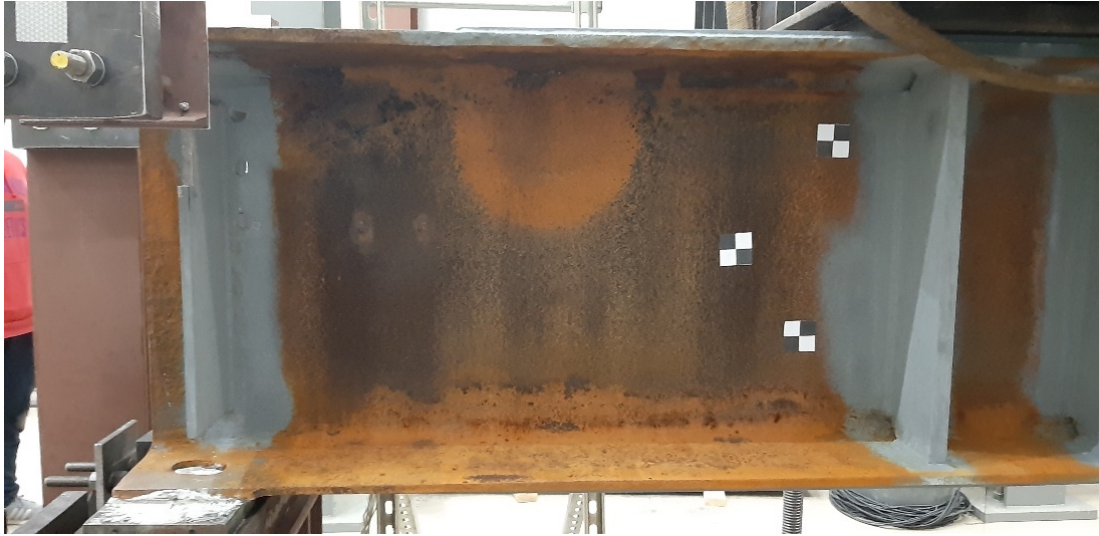
**Figure 3.12: Corroded end of Specimen B**
