Integrated Water Infrastructure Vulnerability Assessment and Climate Resiliency Plan TOWN OF WALPOLE, MASSACHUSETTS

OCTOBER 2020

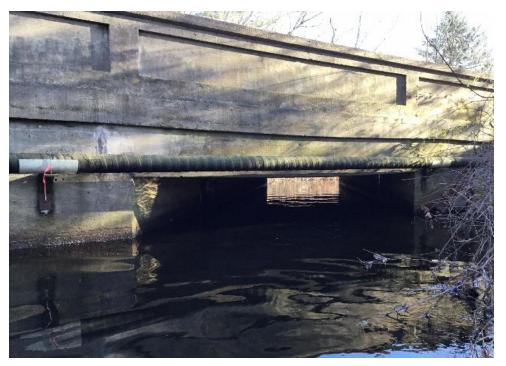
Figure 30. View of existing crossing outlet taken during field assessment on November 21, 2019.

Replace the existing undersized culvert with a structure appropriately sized to accommodate the stream channel bankfull width and increase hydraulic capacity.

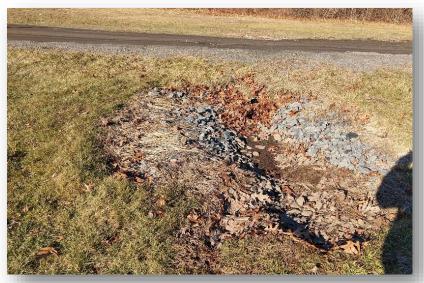
Image 1: Existing stormwater outfall (partially obscured by leaves).

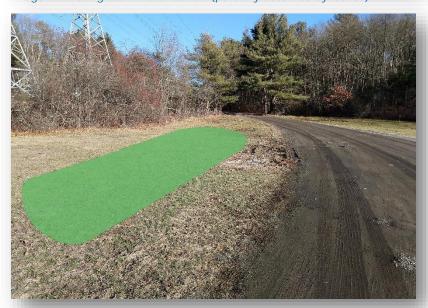
Image 2: Proposed infiltration basin area (JF_IB_1) is shown in open area to the left of gravel road.

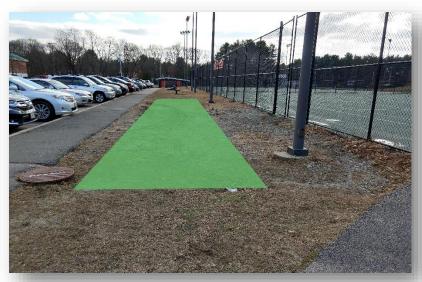
Image 1: Area of proposed infiltration swale (WHS_IB_1) along the length of the tennis courts.

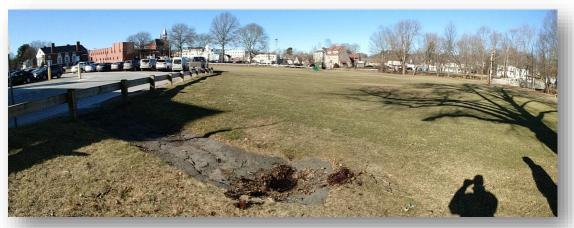
Image 1: Proposed location of bioretention basin north of Town Hall parking lot.

- Municipal parking lot redesign, angled parking spaces, infiltration swales in new parking islands.
- Install a bioretention basin or swale north of the Town Hall rear parking lot. Retrofit northernmost catch basins to sediment forebays. Re-lay pipe from southern catch basins to increase invert elevation, include sediment forebay at pipe outlet to increase treatment and extend lifespan of infiltration practice. Install overflow structure that ties into existing pipe and outfall to School Meadow Brook.
- Soils information at both locations is not available on the NRCS database, so systems would need to overflow into existing infrastructure. However, if the soils are found to be suitable during design, infiltration basins are the preferred alternative.

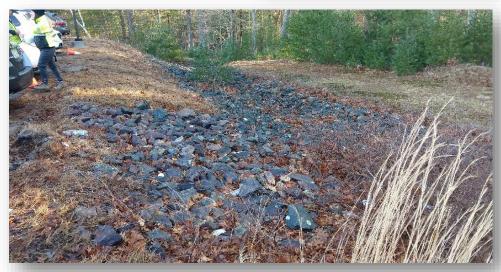
Image 2: Proposed location of infiltration swale and basin (ESS_IB_3)
