***South Shore Coastal Infrastructure Inventory
and Assessment Demonstration Project
Coastal Hazards Commission***

Town of Kingston

February 28, 2007

Structure Assessment Reports

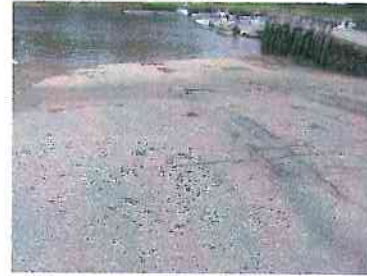
Bituminous concrete boat ramp beside town wharf. Moderate deterioration of pavement.

Structure observed to exhibit very minor problems, superficial in nature. Minor erosion to landform is present. Structure / landform adequate to provide protection from a major coastal storm with no damage. Actions taken to prevent / limit future deterioration and extend life of structure.

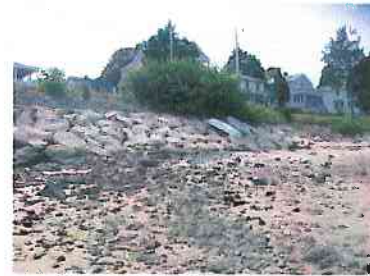
Erosion rip rap slope (1 vertical to 2 horizontal) with 1 to 2 ton stones. Toed into sandy beach offshore (just below mean low water). Erosion evident above top of wall (stones dumped along top). Road inshore of slope.

Structure observed to exhibit very minor problems, superficial in nature. Minor erosion to landform is present. Structure / landform adequate to provide protection from a major coastal storm with no damage. Actions taken to prevent / limit future deterioration and extend life of structure.

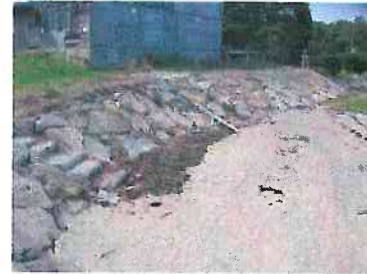
Placed rip rap slope (1 vertical to 2 horizontal) toed into sandy beach. 500 to 2000 lb. stone with chinking done well.

*Condition***B***Rating***Good***Level of Action***Minor***Description*

Structure observed to exhibit very minor problems, superficial in nature. Minor erosion to landform is present. Structure / landform adequate to provide protection from a major coastal storm with no damage. Actions taken to prevent / limit future deterioration and extend life of structure.

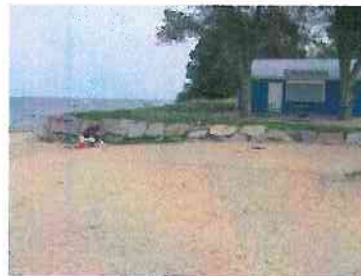
Stone block seawall (dry set) with beach outshore. Snack bar building and park inshore. Many small voids and much erosion inshore.

Structure is sound but may exhibit minor deterioration, section loss, cracking, spalling, undermining, and/or scour. Structure adequate to withstand major coastal storm with little to moderate damage. Actions taken to reinforce structure to provide full protection from major coastal storm and for extending life of structure. Moderate wind or wave damage to landform exists. Landform may not be sufficient to fully protect shoreline during a major coastal storm. Actions taken to provide addition material for full protection and extended life.

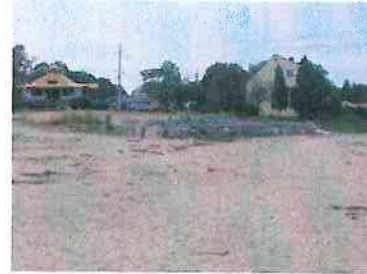
One 2 foot high course of stone blocks with 4 inch to 8 inch rocks dumped inshore of it. Erosion of material inshore.

Structure is sound but may exhibit minor deterioration, section loss, cracking, spalling, undermining, and/or scour. Structure adequate to withstand major coastal storm with little to moderate damage. Actions taken to reinforce structure to provide full protection from major coastal storm and for extending life of structure. Moderate wind or wave damage to landform exists. Landform may not be sufficient to fully protect shoreline during a major coastal storm. Actions taken to provide addition material for full protection and extended life.

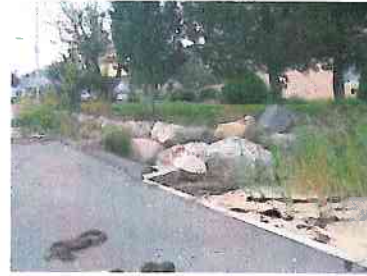
Placed rip rap slope along edge of boat ramp and residential property. 500 to 1500 lb. stone. Erosion at top of slope.

Structure is sound but may exhibit minor deterioration, section loss, cracking, spalling, undermining, and/or scour. Structure adequate to withstand major coastal storm with little to moderate damage. Actions taken to reinforce structure to provide full protection from major coastal storm and for extending life of structure. Moderate wind or wave damage to landform exists. Landform may not be sufficient to fully protect shoreline during a major coastal storm. Actions taken to provide addition material for full protection and extended life.

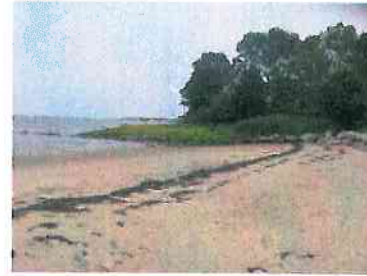
500 to 2000 lb. stone placed along edge of town beach. Several gaps in structure and dislodged stones.

Structure exhibits advanced levels of deterioration, section loss, cracking, spalling, undermining, and/or scour. Structure has strong risk of significant damage and possible failure during a major coastal storm. Structure should be monitored until repairs/reconstruction can be initiated. Actions taken to reconstruct structure to regain full capacity to resist a major coastal storm. Landform eroded, stability threatened. Landform not adequate to provide protection during major coastal storm. Actions taken to recreate landform to adequate limits for full protection from a major coastal storm.

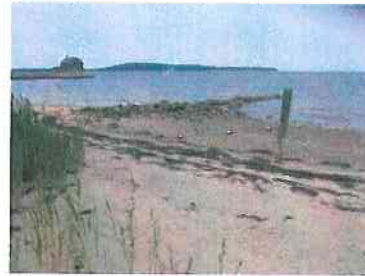
Dumped rip rap (100 to 1000 lb. stone) along edge of public beach. Movement and jumbling of stones.

*Condition***C***Rating***Fair***Level of Action***Moderate***Description*

Structure is sound but may exhibit minor deterioration, section loss, cracking, spalling, undermining, and/or scour. Structure adequate to withstand major coastal storm with little to moderate damage. Actions taken to reinforce structure to provide full protection from major coastal storm and for extending life of structure. Moderate wind or wave damage to landform exists. Landform may not be sufficient to fully protect shoreline during a major coastal storm. Actions taken to provide addition material for full protection and extended life.

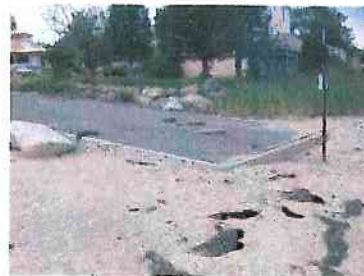
Bituminudious concrete emergency boat ramp with precast concrete curb around outshore end. Outshore end just above mean high water.

Structure observed to exhibit very minor problems, superficial in nature. Minor erosion to landform is present. Structure / landform adequate to provide protection from a major coastal storm with no damage. Actions taken to prevent / limit future deterioration and extend life of structure.
