**REPORT#:** 19MA015

**REPORT DATE:** 12/02/2021

## Laborer Crushed Between Two Large Stone Slabs at a Manufacturing Facility— Massachusetts

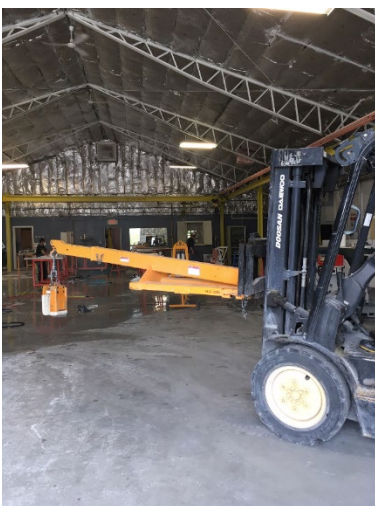
A propane-powered forklift was being used at the time of the incident (Figure 1). The company had a long-term rental agreement for the forklift, and the machine was in overall good condition. The forklift had four wheels, a three-stage mast with a maximum lift height of 15 feet and six inches, and a load capacity of 5,000 pounds. The forklift had a boom attached to its tines and a slab lifter attached to the end of the boom (Figure 1 and 2). Both the boom and the slab lifter were manufactured by the same company and were designed specifically for lifting slab material.

The telescoping boom attachment consisted of two rectangular steel tube sections. Specifications from the manufacturer indicated the boom weighed 286 pounds, had a maximum rated load capacity of 3,300 pounds when fully retracted, and a maximum load capacity of 1,320 pounds when fully extended. The telescoping range of the boom was from approximately 6.8 feet to 11.7 feet in three increments of 19 inches. The boom could only be extended manually and had a series of pins and clips to hold it in position. The boom attached to the forklift by sliding onto the forklift tines and was secured by two bolts and two restraint pins (Figure 1).

Figure 1 – The forklift inside the shop with the boom and slab lifter attached.

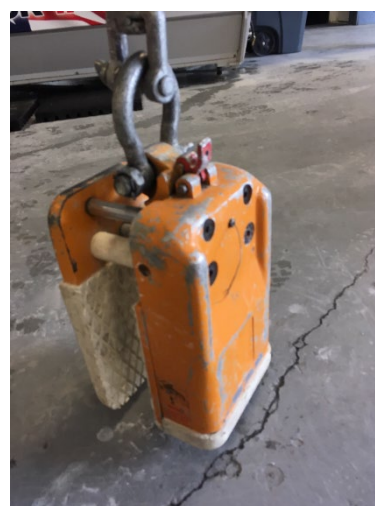
Figure 2 – The slab lifter.

The slab lifter was an accessory attachment for the boom that was used for gripping, lifting, and moving slab loads (Figure 1 and 2). The slab lifter had a spring-loaded latch incorporated into the design. The spring-loaded latch would automatically release the grip of the lifter from the slab once the slab had been fully lowered to the ground.

Once the slab was lowered onto the rack, the slab lifter grip automatically released. As the forklift operator was lifting the boom up to move the forklift way from the slab and rack, it appears that the slab lifter became hung up on the horizontal top beam of the rack. As a result, the forklift and boom were not able to move away from the rack. The stone slab was blocking the forklift operator's view of the rack, therefore the operator could not see what the issue was and what was causing the slab lifter and boom to be stuck. The victim walked over to the slab lifter to assess and fix the issue.

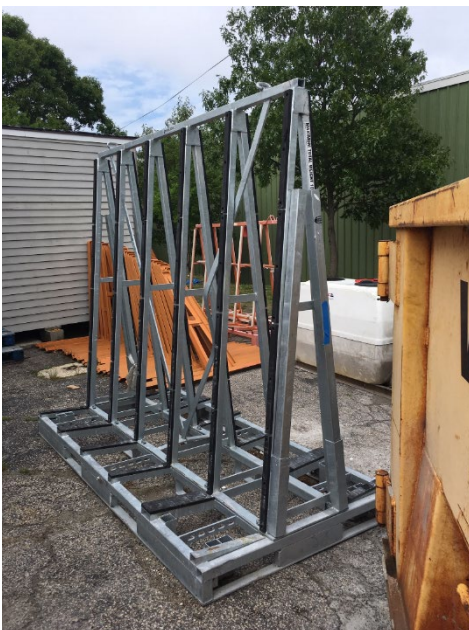
An A-frame rack was in use at the time of the incident and was designed to hold slabs in a range of sizes (Figure 3). The rack was equipped with removable caster wheels that were in place at the time of the incident. The caster wheels consisted of 8-inch diameter roller bearing wheels that were rated at 2,000 pounds each. Two of the four wheels were swivel casters with brakes and the other two wheels were rigid. The rack's rated capacity was 8,000 pounds, 4,000 pounds for each side of the rack with the installed wheels (it had a 10,000 pound capacity, 5,000 pounds per side, without the optional wheels installed). The rack was equipped with four hold-down ratchet straps to secure the slabs being stored on the rack. It was also equipped with four safety posts, two for each side, to prevent a slab from tipping off the rack and provide safe access of unstrapped loads that may shift unexpectedly. The rack was 96 inches long by 28 inches wide and 99 inches high (88 inches high without the optional caster wheels).

Figure 3 - A-frame rack involved in the incident without the caster wheels attached and the safety posts not installed.

The A-frame rack was positioned inside the shop area, next to another rack with stored stone slabs. These racks were located near the overhead door. At the time of the incident, the company owner and the customer were close by waiting to view the slab. The forklift operator drove the forklift with the marble slab attached to the slab lifter into the fabrication shop. The marble slab was positioned onto the A-frame rack. The victim was standing off to the side of the marble slab and rack. The rack's safety posts were not being used and they were located in the post storage locations on the rack, which are for when the rack is being transported.

***Recommendation #1: Employers should use slab racks designed with fixed safety posts and individual compartments for each slab.***

Discussion: This fatal incident underscores the need to use slab racks designed with fixed safety post and individual compartments for each stone slab. If a rack with fixed safety posts was being used, the hazard of the slab tipping uncontrollably while it was being placed in the rack would have been eliminated. By eliminating the potential uncontrolled tipping hazard the fatal injury that occurred would have been prevented.<sup>2</sup>

It appears that the safety posts were infrequently used at this company. If A-frame racks with removable safety posts have to be used, employers should make sure the safety posts are being used by securing them in place at all times. This will help ensure the stone slabs don't tip over uncontrollably when using the racks. In addition, slabs that are not being accessed and will remain on the A-frame rack should be tied down to ensure that these slabs will not move unexpectedly.

In this case, as soon as it was realized there was an issue while placing the marble slab on the A-frame rack, the forklift operator should have stopped the task and the situation should have been evaluated. At this point because the safety posts were not being used, the safety post should have been immediately installed by the worker on the ground. While installing the safety posts the worker must stay out of the fall shadow. If this was performed when the stone started to tip the safety posts would have stopped the slab and prevented the injury.

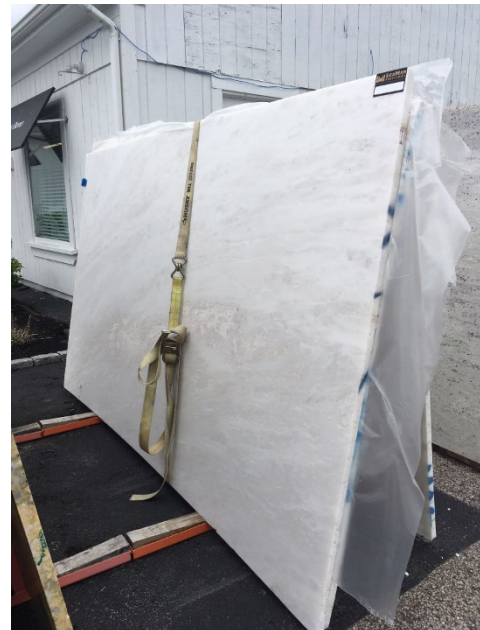
Figure 4 – The marble slab involved in the incident.

On the day of the incident, the victim arrived at approximately 7:30 a.m. to the company location. The victim would have been performing his normal work tasks the morning of the incident. Prior to the incident occurring, a customer arrived to view a stone slab and the positioning of a countertop template onto the slab. The stone slab that was involved in the incident was a marble slab measuring 114 inches long by 69 inches high by 1 1/8 inches thick. This marble slab weighed approximately 719 pounds (Figure 4).

While the victim was positioned near the center of the rack and marble slab, within the fall shadow of the slab, he was having trouble releasing the slab lifter from the slab. The forklift operator tried raising the boom a couple more times, but as the boom raised the slab lifter was still getting caught on the top of the rack, causing the slab lifter to push out towards the victim. This pushing motion of the slab lifter caused the slab to also be pushed out towards the victim. At this point, the marble slab tilted and became free from the slab lifter and tipped uncontrollably towards the victim. The slab pushed the victim into another stone slab on a rack behind him. The victim was standing and was crushed/caught between two large stone slabs. At this point, the company owner and the forklift operator realized what happened and, with another co-worker, pushed the marble slab off the victim and back onto the A-frame rack. A call was immediately placed for emergency medical services (EMS). EMS arrived within minutes to the incident location and the victim was transported to a local hospital where he was pronounced dead later that same day.

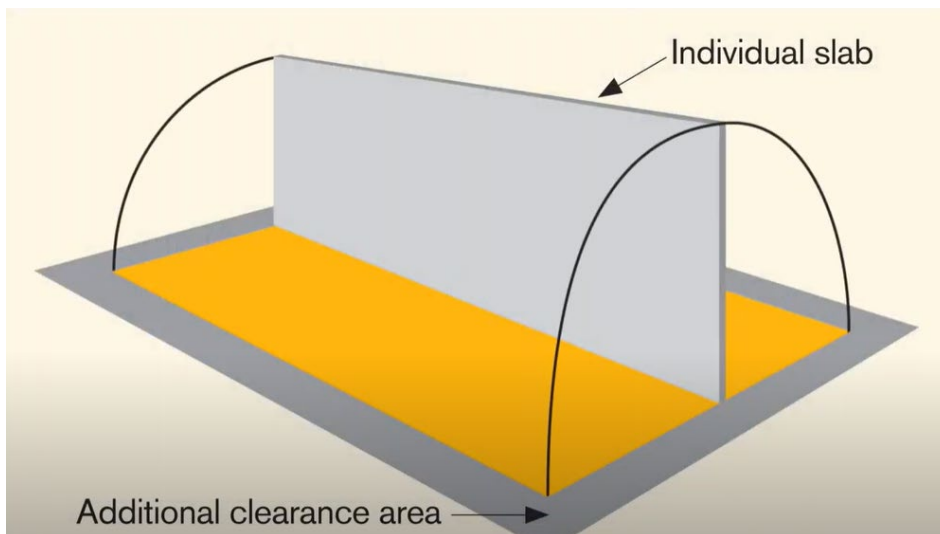
Discussion: The fall shadow of a stone slab is the potential path the slab will take as it tips and falls uncontrollably.<sup>3</sup> The fall shadow is located on both sides (Figure 5). The fall shadow will become larger when the slab is lifted. The higher the slab is lifted, the larger the fall shadow becomes. Ensuring employees are always positioned outside of the fall shadow will help prevent employees from being crushed or struck-by an uncontrolled stone slab.

Figure 5 – Example of the fall shadow. The yellow area is where the slab would land if it tipped over.

**Recommendation #2: Employers should ensure that employees are never located in the fall shadow of a stone slab while the slab is being accessed to be moved.**

To ensure employees are positioned outside of the fall shadow, employers must make sure employees are standing at the ends of the slab and not at the center of the slab, or anywhere along the flat sides of the slab. Employees should keep, at a minimum, an arms-length away from the ends of the slab.
