REPORT#: 18MA001

REPORT DATE: May 7, 2020

Landscape Construction Laborer Compressed between Compact Excavator and Steel Beam at Residential Site—Massachusetts

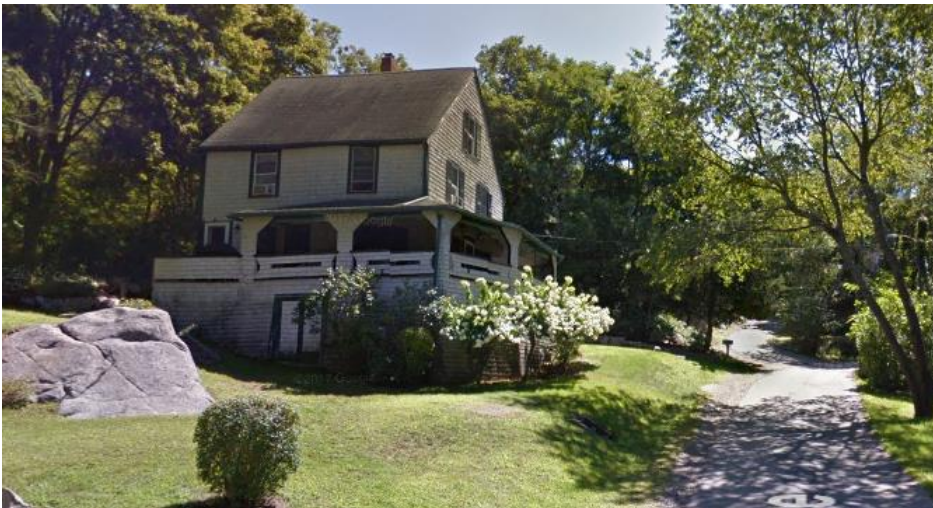
Figure 1 - View of home, facing uphill, before work began

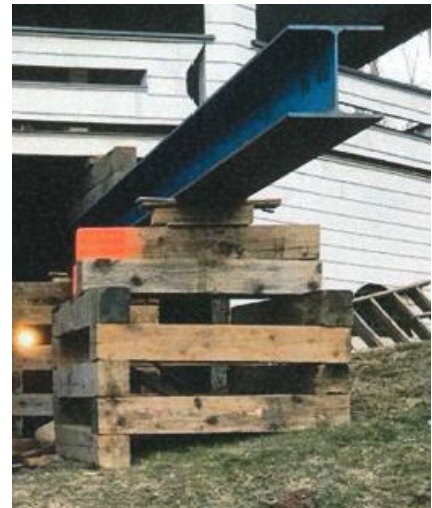
Figure 2- Steel support beam and cribbing

As described previously, the home was shored on steel beams that were supported on two cross beams and cribbing. It appears that after warming up the area and the equipment, the victim had positioned the excavator, partially underneath one of the beams and lowered the left and right stabilizers. The excavator was perpendicular to the overhead beam, but the beam was likely out of the forward view of the victim as he sat in the operator's seat.

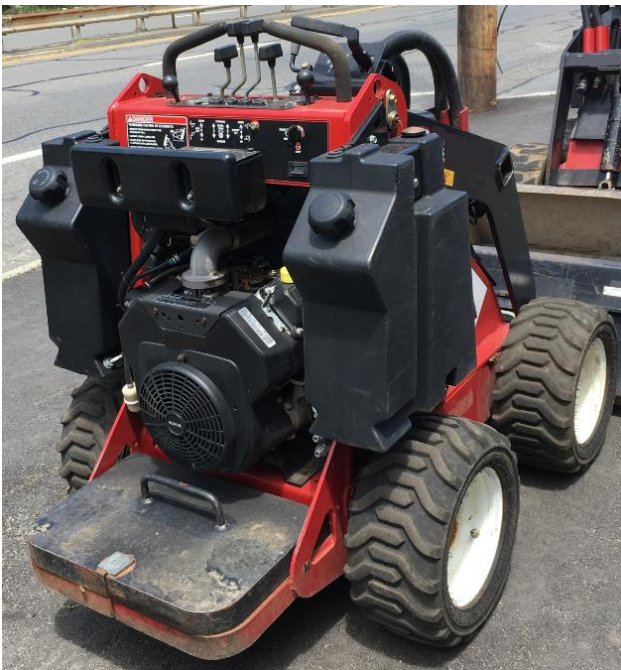
The excavator consisted of a compact utility loader base power unit with an excavator (backhoe) attachment. The base unit had a gasoline engine that powered four drive wheels and attachments through a hydraulic system that had a maximum pressure of 3,250 psi (Figure 3). At the rear of the base unit was an operator standing platform with controls for driving and operating various attachments. The unit had a maximum ground speed of 4.5 mph in forward or reverse.

Figure 3 - Base power unit

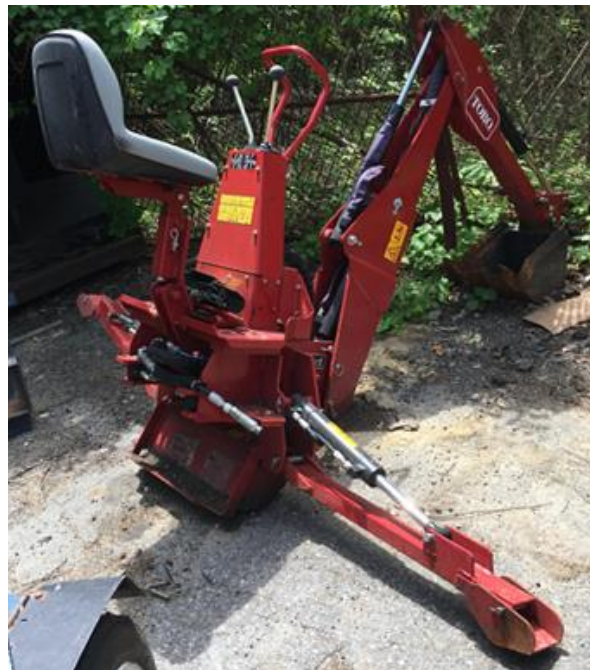
The backhoe attachment mounted on the front of the base unit and tapped into the hydraulic system. It had an operator's seat and a separate set of controls for operating the stabilizers and excavation boom, dipperstick, and bucket (Figure 4). When the backhoe attachment was installed, the unit was driven into position using the rear controls and then the user would set the engine speed, divert hydraulic flow to the accessory hoses, and install an interlocking cover over the drive controls. This would enable the second set of controls near the backhoe operator's seat. The backhoe attachment was designed without a protective cab for the operator.

Figure 4 - Excavator (backhoe) attachment involved in the incident

In this case, the manufacturer designed the loader's backhoe attachment without a protective cab, but had equipped the control area of the backhoe attachment with a bar guard. The bar guard provided some protection to the levers, from physical damage or incidental activation. In this situation, incidental activation or the inability to stop activation of the control levers led to the crushing of the operator. If a protective cab was part of the design of the backhoe attachment the victim might not have been compressed.

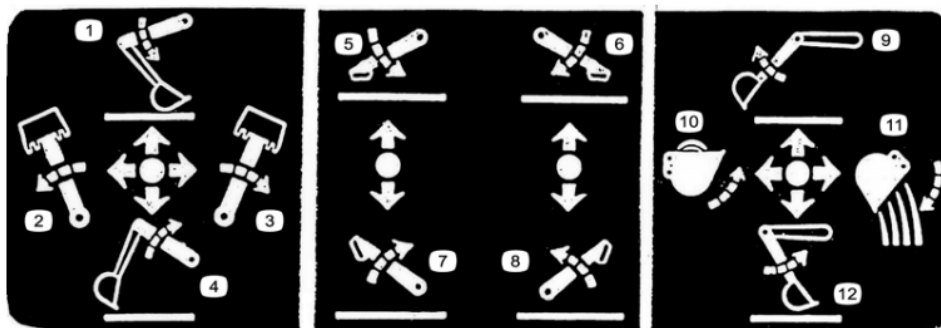
The excavator had four control levers mounted on a pillar in front of the operator's seat. Two smaller levers controlled the stabilizers and were activated by either pushing in a forward direction to deploy the stabilizer or pulling in a backward direction to stow the stabilizer. When the stabilizers were in use, the front wheels of the base unit would raise off the ground. Two larger levers controlled the three components of the backhoe attachment: the boom, dipperstick, and bucket. The left lever controlled the swing of the boom: by moving the lever to the left or right the boom would swing to the left or right. The left lever also controlled the extension of the boom. The boom was raised by pulling back on this lever, and was lowered by pushing on the lever. The right lever controlled the scooping motion of the bucket with a left/right push, and the extension and flexion of the dipperstick with a forward/backward push (Figure

Figure 5 - Decal image of control functions

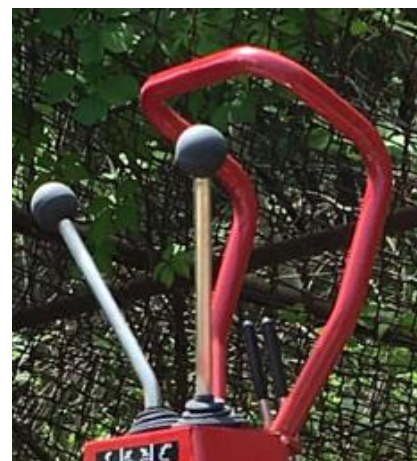
5). These control levers were partly protected by a guard made of steel tubing that wrapped in front of and over the two larger control levers (Figure 6).

Figure 6 - Excavator controls

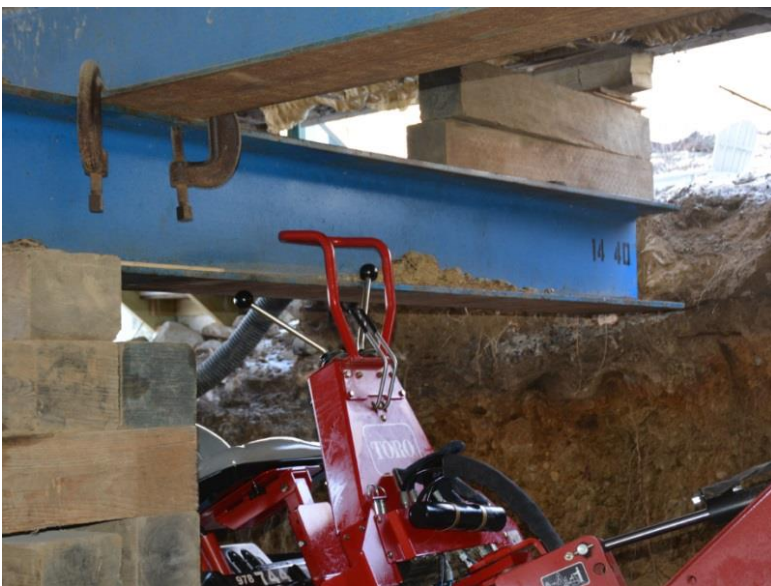
The victim was working alone at the time of the incident, but evidence indicates that the victim was operating the excavator when his body made contact with the overhead steel beam. This contact would have pushed him forward in the operator's seat such that he could not move out of the way of the controls and the guard and he became trapped. The boom and bucket were found in an extended position, which suggests the left main control lever was forced in the forward direction after coming in contact with the beam (Figure 7). Having the left main control lever continuously engaged would have caused the boom to extend or move in a downward direction, lifting the front of the unit and the stabilizers off the ground. This continuous pressure was compressing the victim's back and neck against the beam and the front of the victim against the top of the unit. Because the hydraulic system was still trying to move the boom, which could not move any further, the system started to leak hydraulic fluid onto the ground.

Figure 7 – The excavator's left control lever against the overhead beam

Discussion: The small size and maneuverability of the compact utility loader along with the multiple attachment options make it a versatile piece of equipment. It is the compact size and maneuverability that enables this equipment to fit into small spaces. But the absence of a protective cab and operating this piece of equipment with the backhoe attachment in proximity to an overhead obstruction are factors that contributed to this incident.

When deploying the outriggers or, even as in this case, when digging with the backhoe attachment the entire loader can raise, including raising the operator in the loader's seat. Employers should ensure that ride-on equipment that does not have overhead protection is not operated in areas with low ceiling clearance or other overhead obstructions. Additionally, the knowledge of this type of hazard could be made more prominent in the warning decals and training materials for the equipment (discussed further in Recommendation 5).
