INDOOR AIR QUALITY ASSESSMENT

**Lowell High School
1922 Building
14 French Street
Lowell, MA**

Prepared by:
Massachusetts Department of Public Health
Bureau of Environmental Health
Indoor Air Quality Program
August 2017

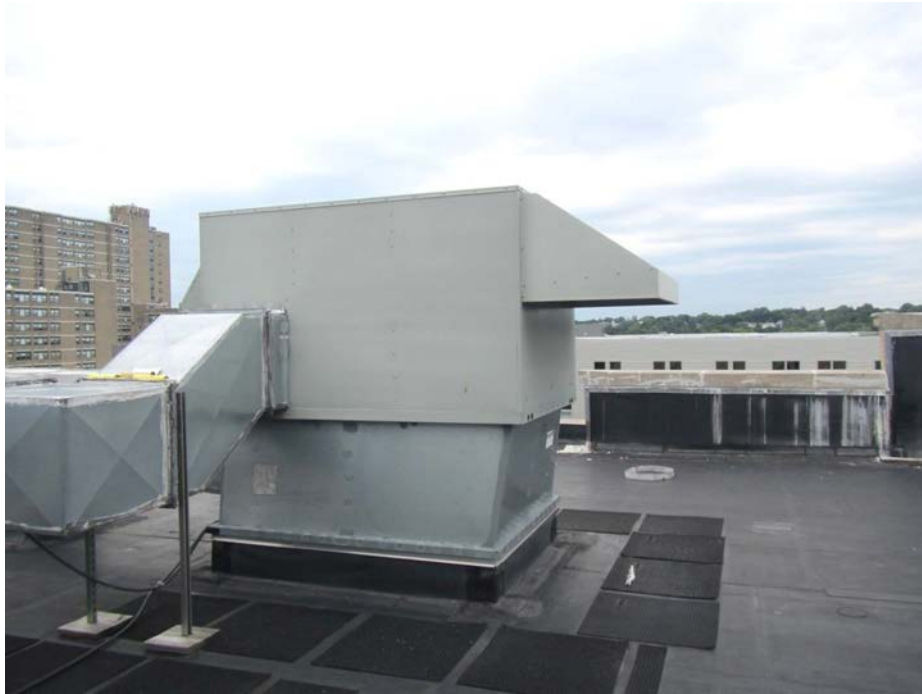
Picture 1

Fresh air is provided by multiple air-handling units (AHUs) located on the roof (Pictures 1 to 3). These units vary in size, age, and condition. In general, AHUs draw fresh air through an intake vent, where the air is filtered, then heated or cooled (i.e., conditioned). The conditioned fresh air is mixed with some air returned from rooms, then supplied to rooms through supply diffusers/grates throughout the building (Pictures 4 and 5). Return vents in rooms (Picture 6) bring stale air back to the AHU where a portion of this air is exhausted through louvers in the AHU. Some of the AHUs appeared to require maintenance and filter changes.

Air handling unit (AHU) on the roof

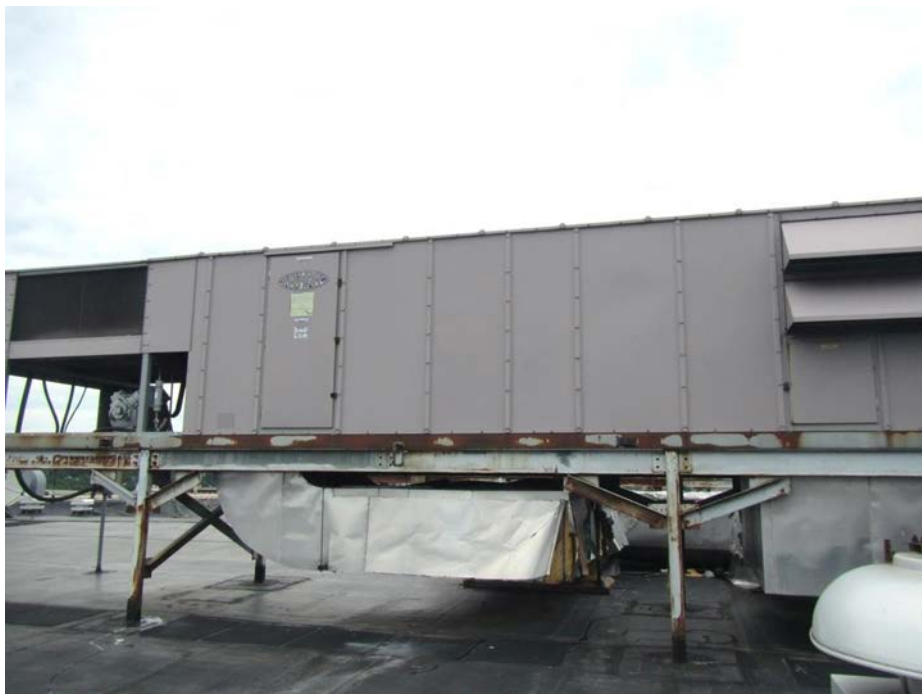
Picture 2

“Packaged” AHU on roof

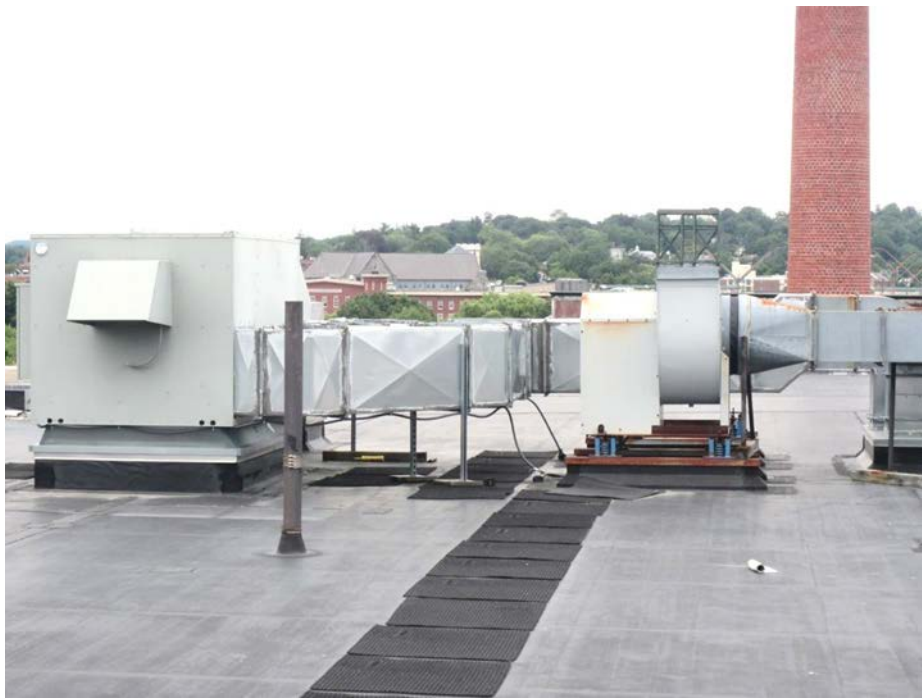
Picture 3

AHU on roof

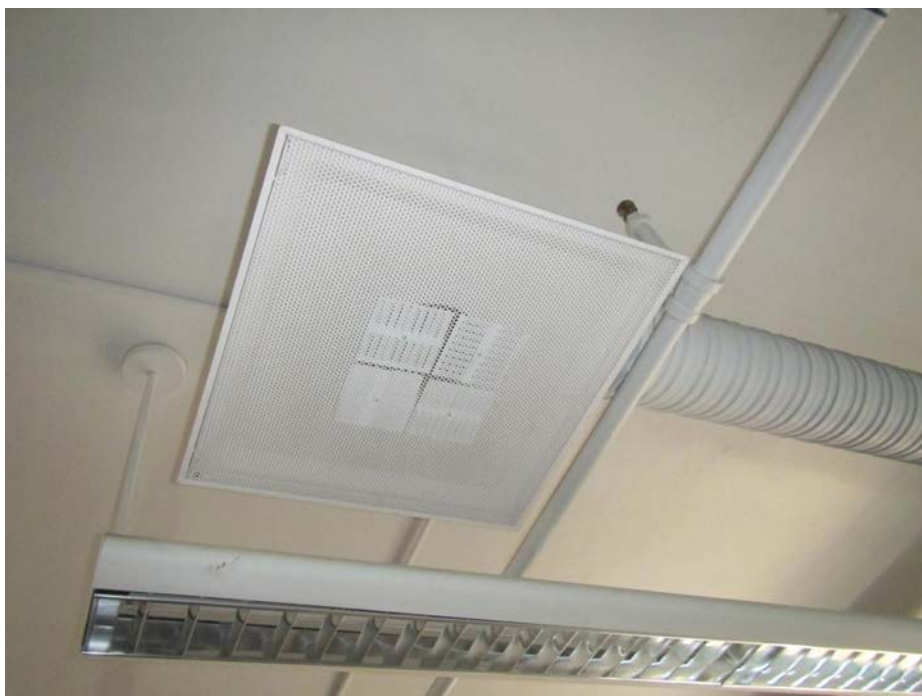
Picture 4

Classroom supply air vent

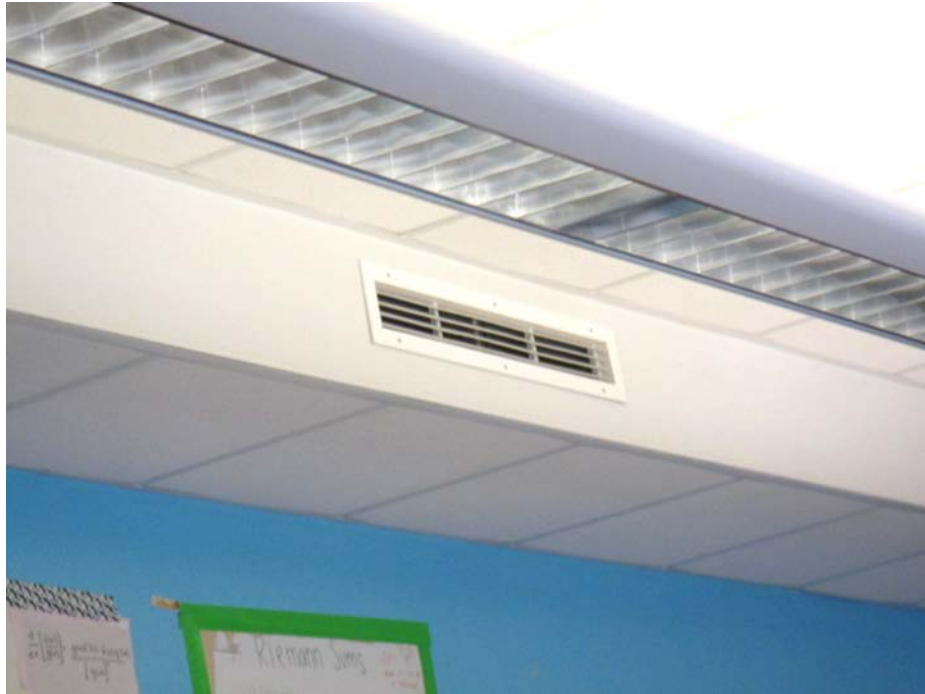
Picture 5

Classroom supply vent

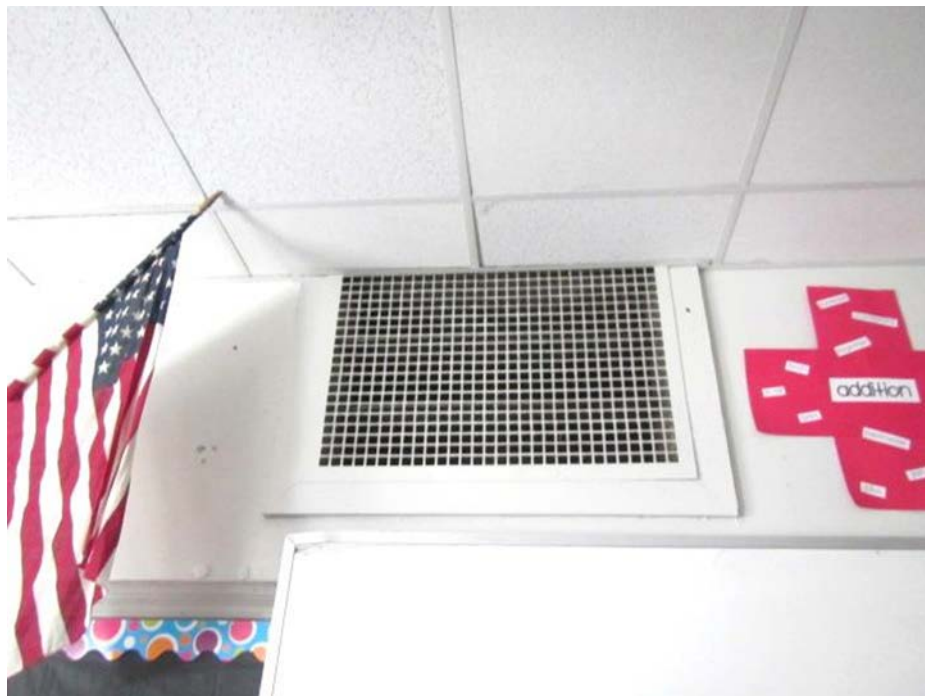
Picture 6

Exhaust/return vent in classroom

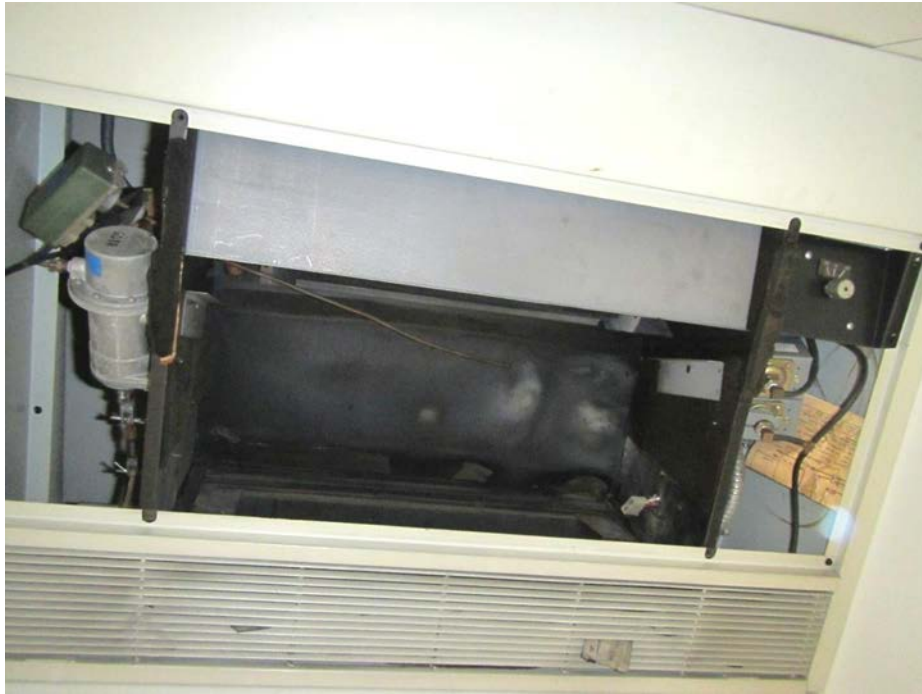
Picture 7

In the basement area, some classrooms were equipped with separate AHUs/fan coil units mounted in the ceiling. Some of these units were in disrepair (Picture 7).

Ceiling-mounted fan coil unit in disrepair

3. Consult with an HVAC contractor to thoroughly examine all HVAC system components to ensure proper function. Make any necessary repairs to ensure the system is working as designed.

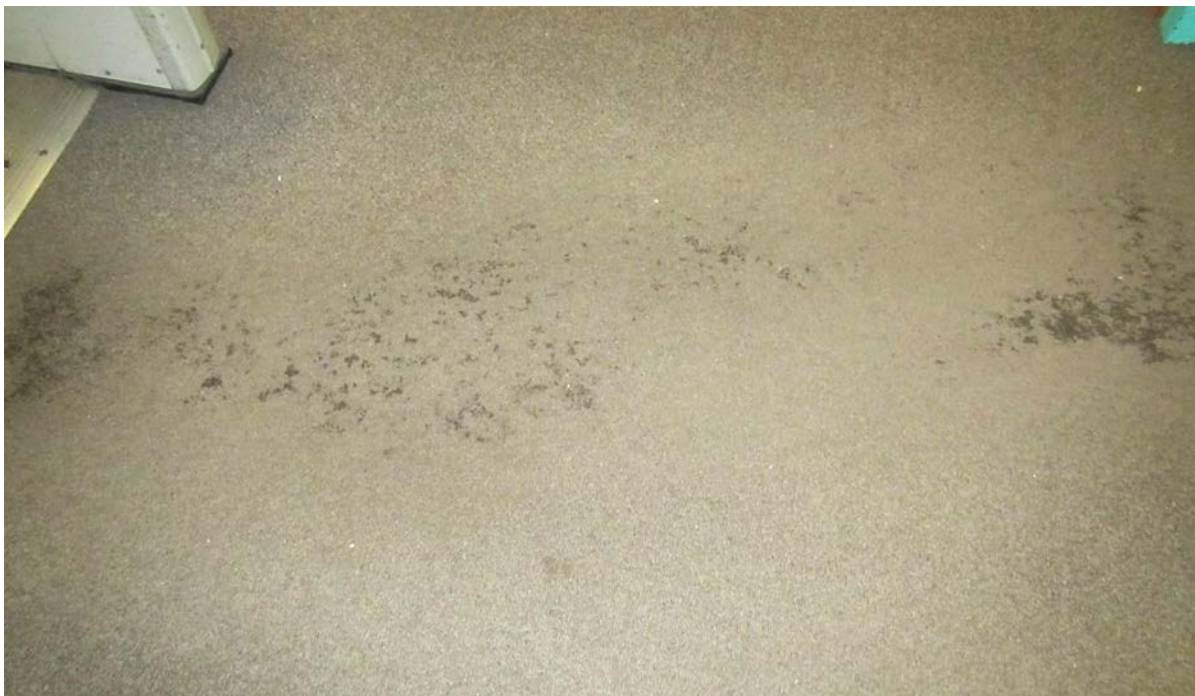
Picture 8

Stained, worn carpeting

1. Remove any water-damaged, musty, or worn carpeting. Alternative floor coverings should be explored for below grade areas as carpeting is not recommended.

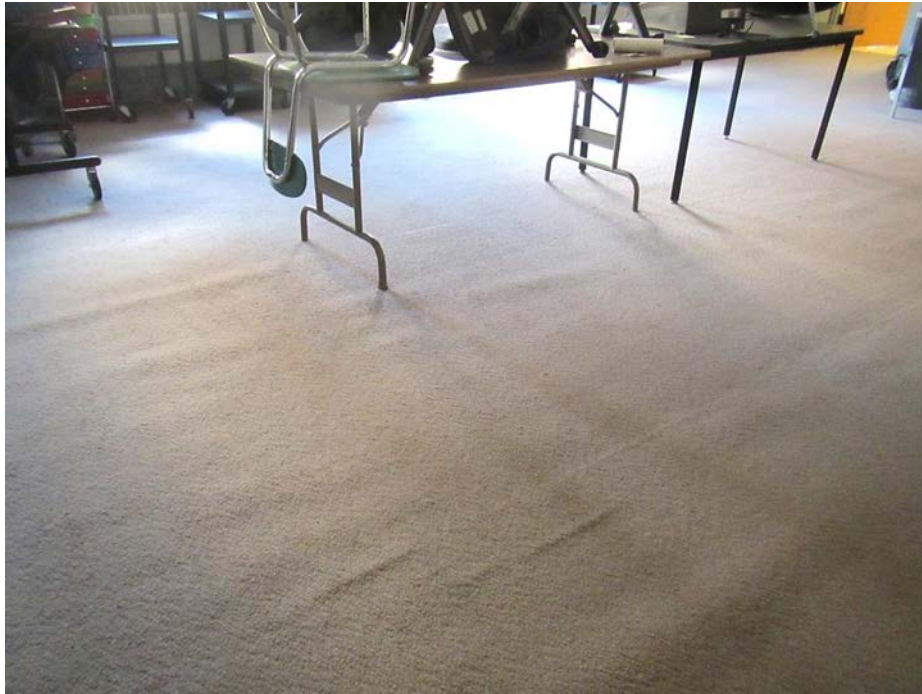
Picture 9

Worn, wrinkled carpeting

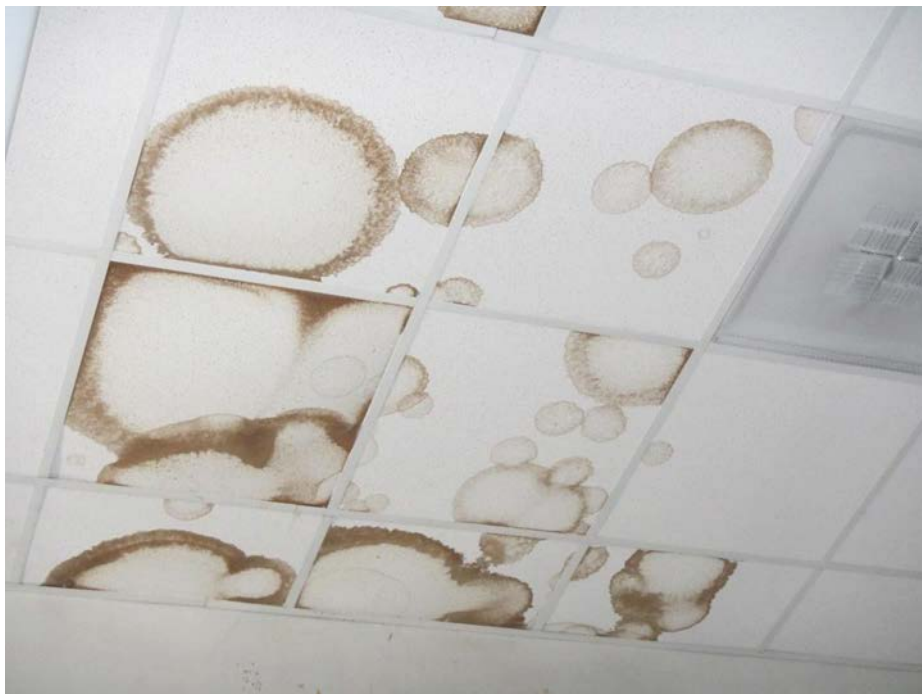
Picture 10

Water-damaged ceiling tiles and gypsum wallboard were observed in classrooms, offices, and hallways (Pictures 10 to 12; Table 1). Damage to these materials indicates leaks from the building envelope or plumbing system. In a few locations (e.g., basement room 24), the ceiling tiles and/or gypsum wallboard were found to be colonized with mold (Pictures 13 and 14, Table 1). Ceiling tiles and gypsum wallboard should be replaced after the leak is found and repaired. In general, ceiling tiles have an open space above them (the ceiling plenum) and tend to dry out quickly, reducing the chance that they will be colonized with mold.

Water-damaged ceiling tiles

Measures should be taken to ensure water-damaged materials are cleaned, replaced, and/or repaired in a manner consistent with the U.S. Environmental Protection Agency's guidelines (US EPA, 2008). The US EPA and the American Conference of Governmental Industrial Hygienists (ACGIH) recommend that porous materials (e.g., ceiling tiles, gypsum wallboard) be dried with fans and heating within 24 to 48 hours of becoming wet (US EPA, 2008; ACGIH, 1989). If not dried within this time frame they should be removed/discarded.

2. Replace any water-damaged/mold-colonized porous building materials (e.g., ceiling tiles, gypsum wallboard) in classrooms, hallways and stairwell areas. Ensure water-damaged materials are cleaned, replaced, and/or repaired in a manner consistent with the U.S. Environmental Protection Agency's guidelines (US EPA, 2008).

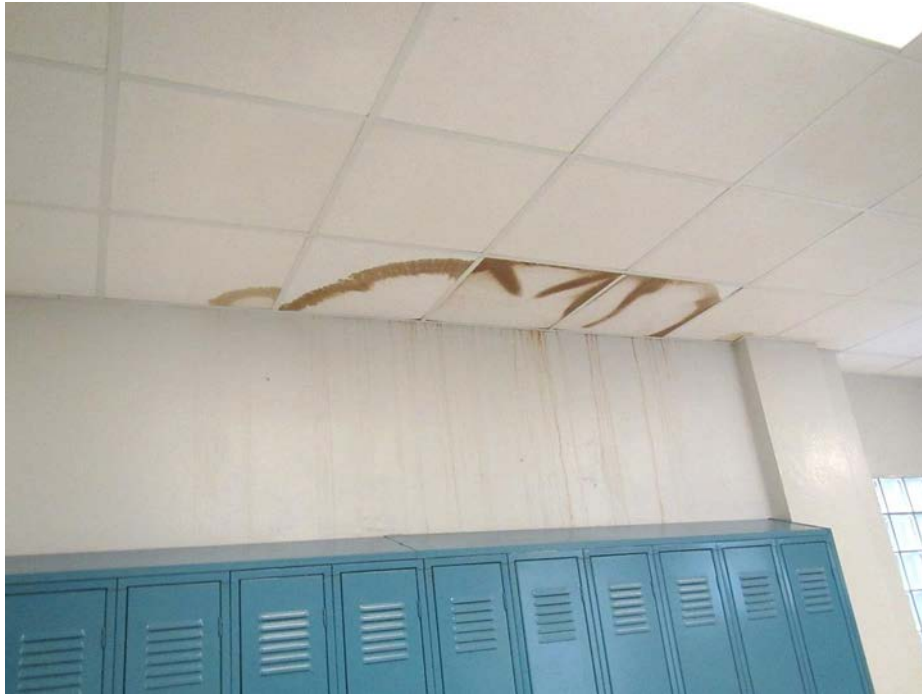
Picture 11

Water-damaged ceiling tiles

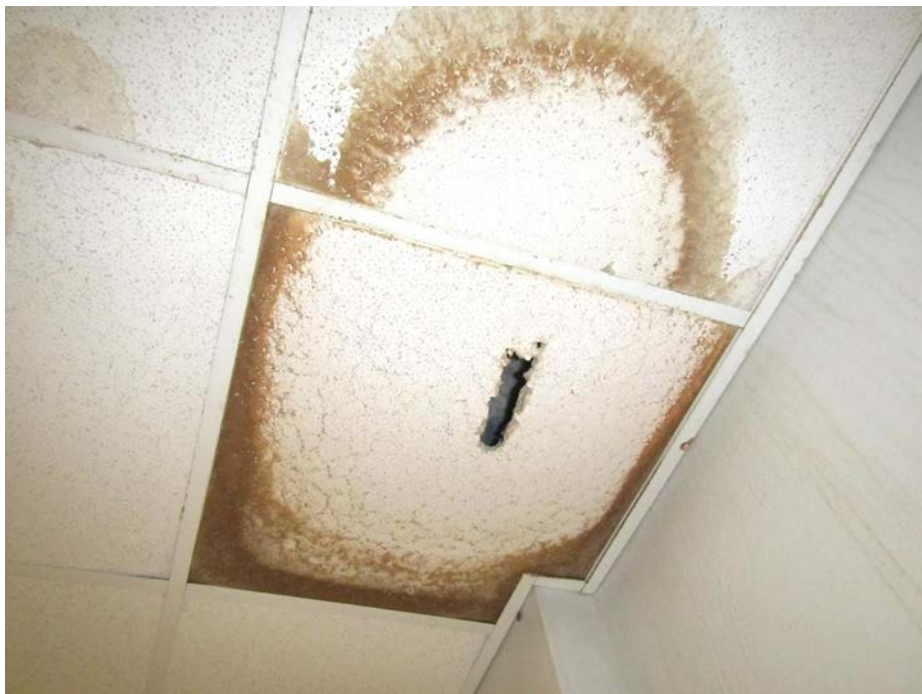
Picture 12

Water-damaged ceiling tiles

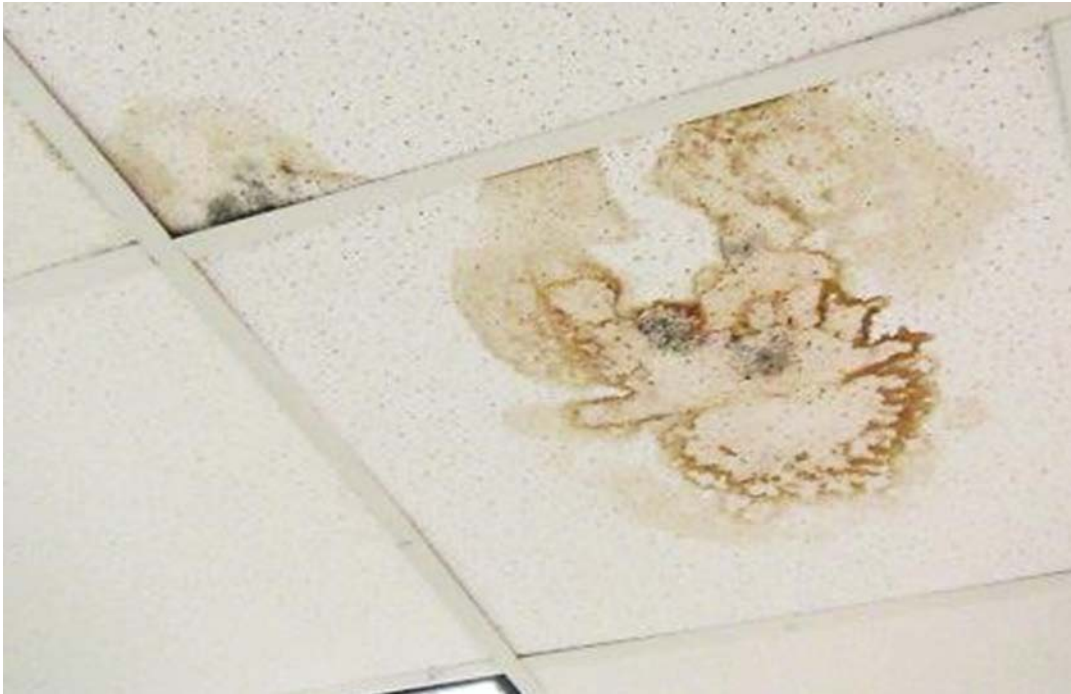
Picture 13

Water-damaged/mold-colonized ceiling tiles

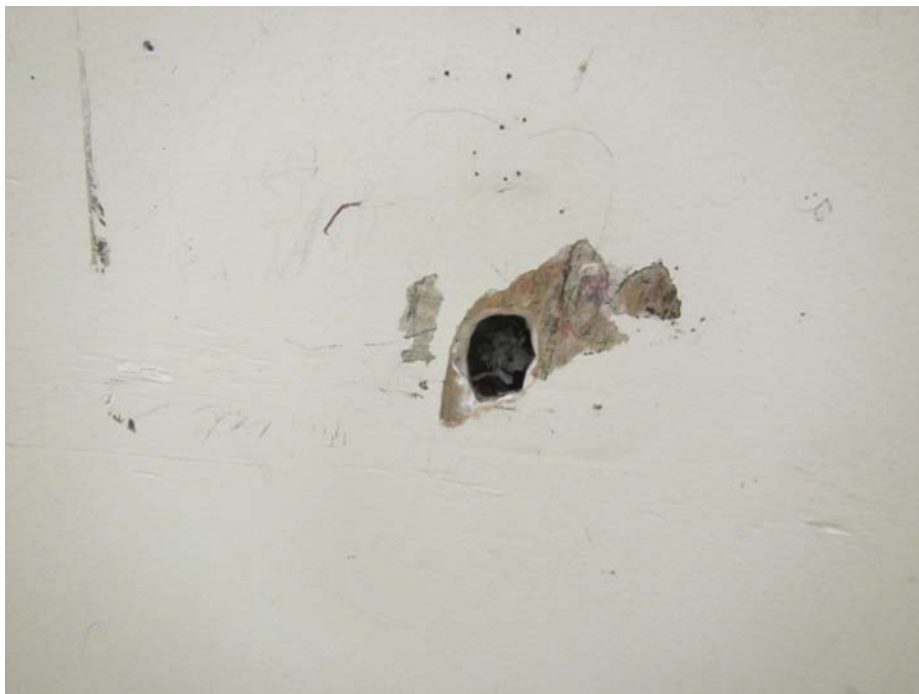
Picture 14

Water-damaged/mold-colonized gypsum wallboard

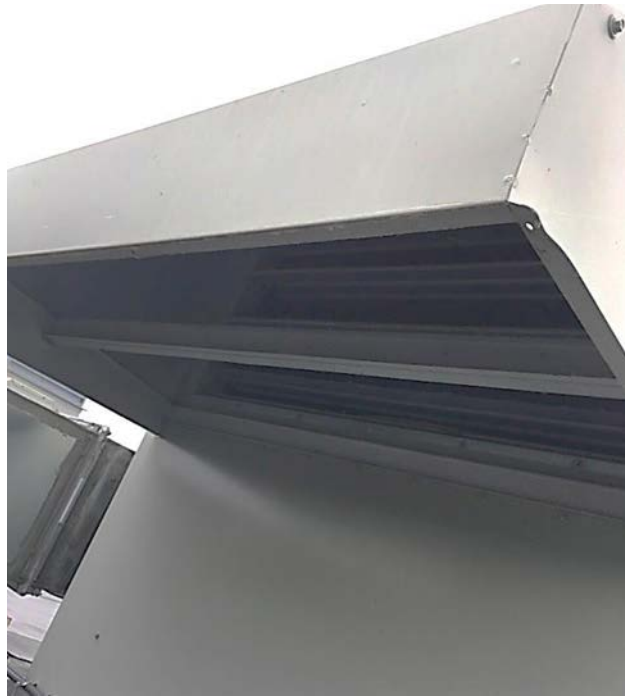
Picture 15

Of note are the AHUs located above the 1980's section of the building. Both AHUs lack bird screens over the fresh air intakes (Picture 15). Screens are necessary to prevent birds and other animals from nesting inside the HVAC equipment. No signs of bird roosting were noted inside the fresh air intakes at the time of this assessment. In addition, fans exist in ductwork connected to each AHU in this section. Each fan has a louver system that faces upwards (Picture 16), which would allow rainwater to readily enter the fan housing and connected ductwork.

Rooftop fresh air intake lacking bird screen/pre-filter

9. Inspect and repair/replace any fresh air intakes that have missing or damaged bird screens or pre-filters.
10. Consult with a building engineer to inspect the building envelope to address any areas of water intrusion (e.g., windows, brickwork/mortar, flashing). This would include the brickwork noted with efflorescence and the spalling parapet.

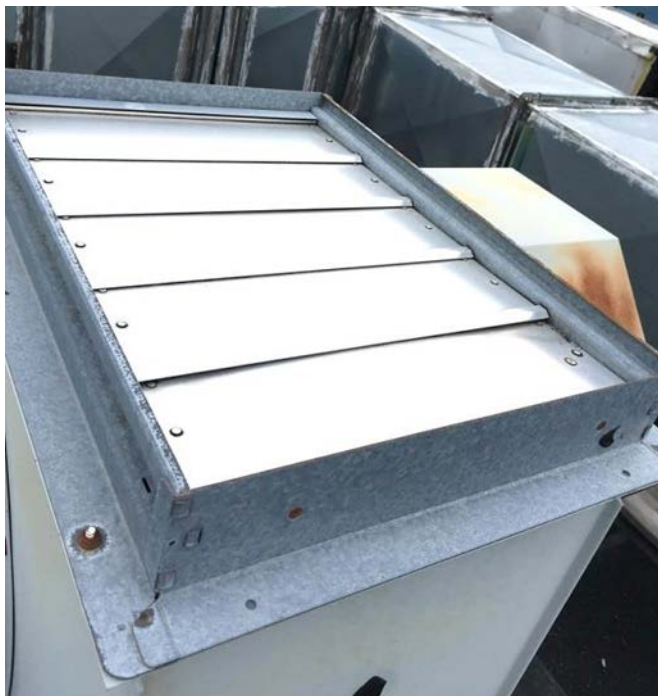
Picture 16

Usually a candy cane-shaped duct cap is installed over a louver system to prevent water accumulation.

Exhaust duct louvers lacking “candy cane” vent cap

7. Roof drains should be inspected regularly to remove any debris to avoid clogging/pooling.
8. Exterior HVAC ductwork should be inspected to find any missing or damaged insulation or unintended gaps which may allow moisture or pests to be introduced into the ductwork. Perform any necessary repairs. This would also include adding the “candy cane” vent covers to the exhaust louvers open to the elements.

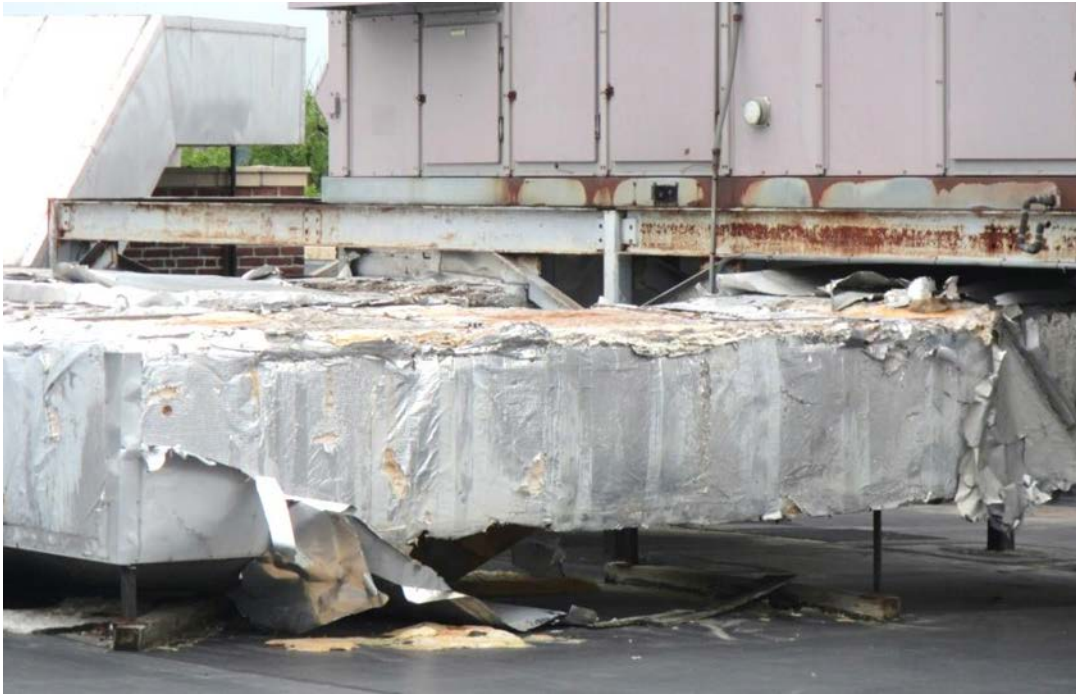
Picture 17

BEH/IAQ staff noted the ductwork insulation of an AHU to be badly deteriorated (Picture 17). This condition may allow water or condensation to enter the ductwork.

Deteriorating insulation reduce the capacity of the material to insulate.

Deteriorated exterior duct insulation

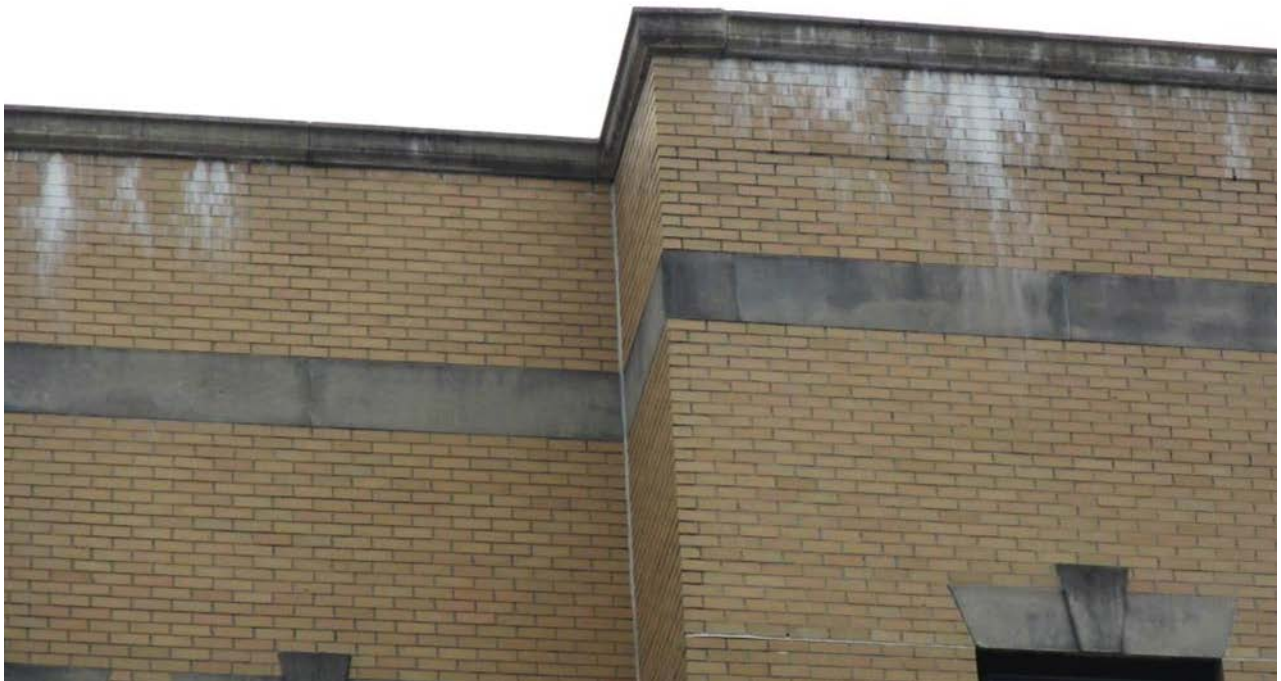
Picture 18

To prevent water damage, sources of water infiltration need to be minimized. The exterior walls of the 1980's building section exhibited a significant coating of white material along the edge of the roof (Picture 18). This material is efflorescence. Please note, efflorescence is not mold; it is a sign of water exposure in brick and mortar. As moisture penetrates and works its way through mortar, brick, or plaster, water-soluble compounds dissolve, creating a solution. As the solution moves to the surface of the material, the water evaporates, leaving behind white, powdery mineral deposits.

Efflorescence in brickwork near roof edge

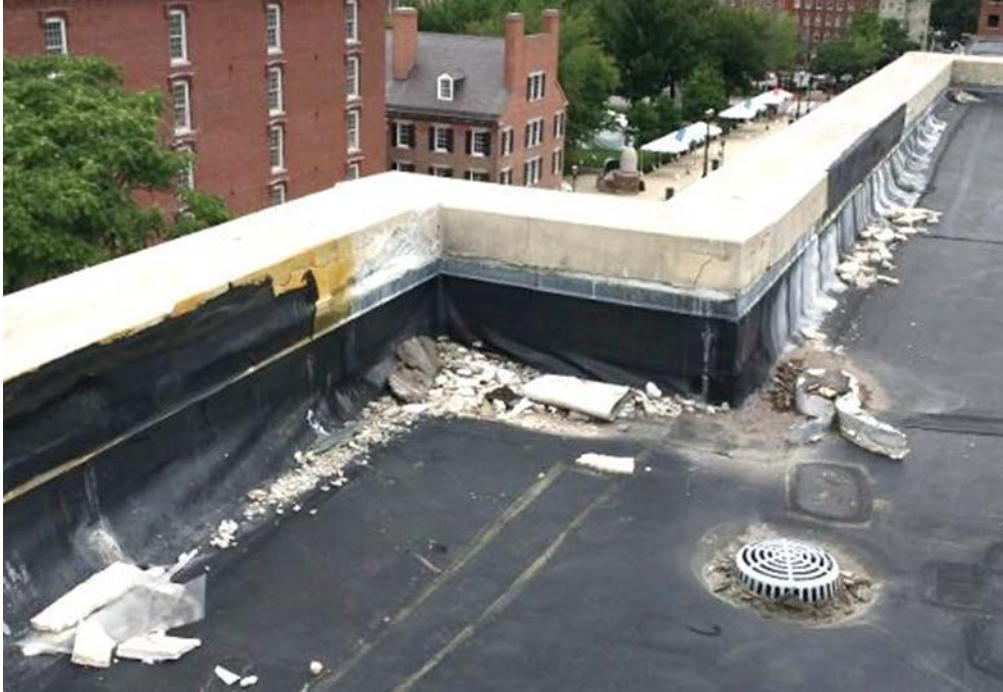
Picture 19

The roof in this area is flat with a raised parapet. The parapet itself was cracked and spalling with efflorescence above the roof membrane (Picture 19). Signs of chronic moisture issues (staining) were also visible along the front of the building below the parapet on the brick. These stains indicate damage is occurring to the parapet, roof, and façade of the building in this section.

Evidence of spalling parapet and efflorescence

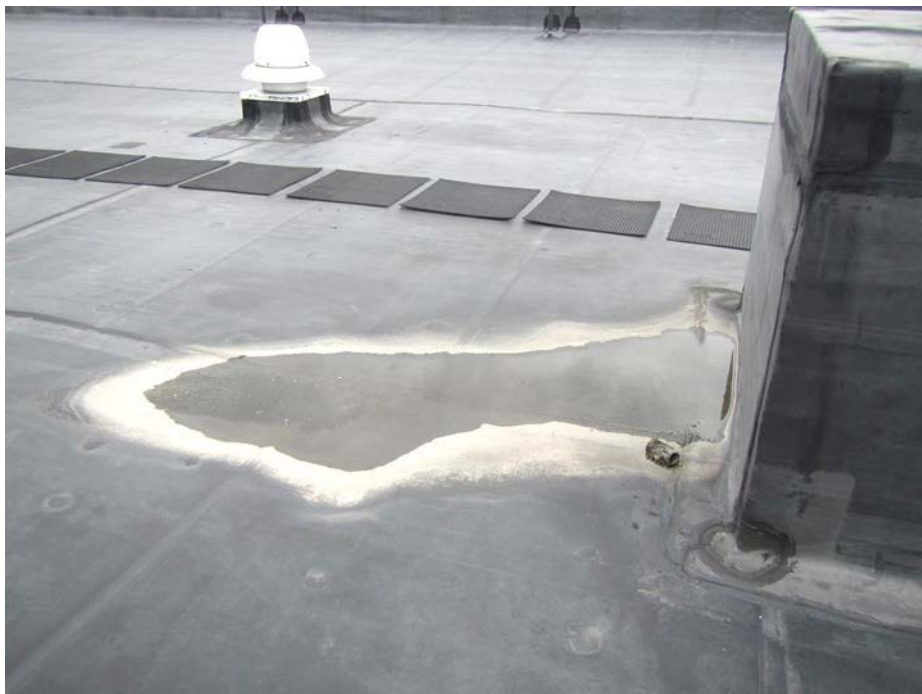
Picture 20

Note that the building has a complex shape with several levels of roof; roof seams were observed where exterior wall sections meet. Water from recent rains was observed pooling on some of the roof segments (Picture 20). This can lead to leakage inside the building once the roof membrane becomes damaged. Roof drains, roofing materials and flashing/connections between roof segments and walls should be examined regularly for pooling water and other indications of deterioration with repairs made as needed. Roof drains were clogged with debris in some areas (Picture 21). This condition will also increase the chance for pooling/leaks to occur. These drains should be cleaned regularly to allow for proper function.

Water pooling on roof

6. Consult with a roofing contractor to assess the roof membrane and underlayment/decking system. Repairs should be made to stop leaks and chronic water damage to building materials. The roofing system should then be monitored regularly for water pooling, leaks, and other deteriorating conditions.

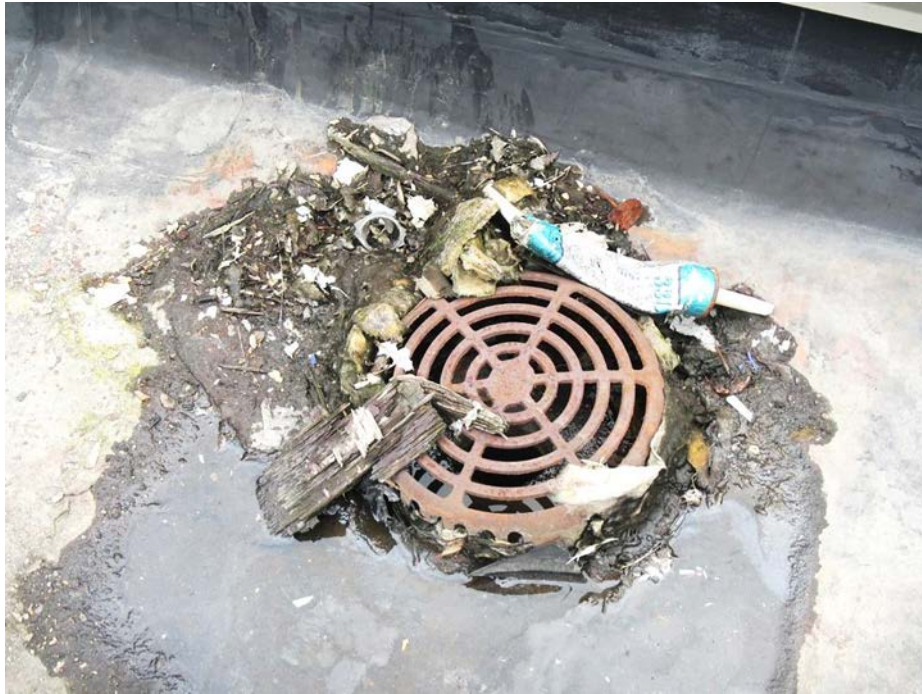
Picture 21

Debris around roof drain

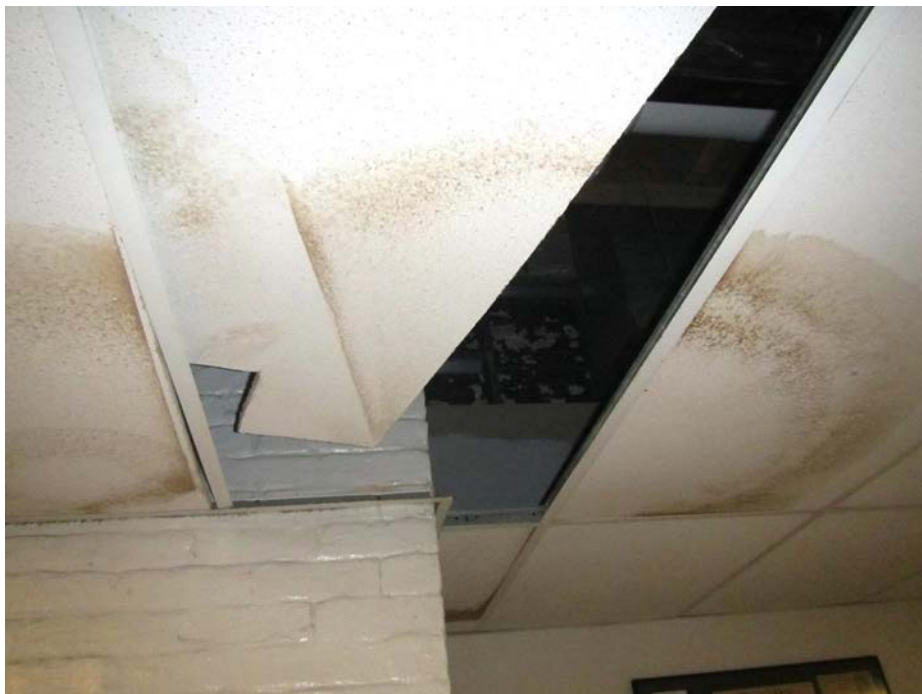
Picture 22

BEH/IAQ staff noted many areas with missing/ajar ceiling tiles (Picture 22). These ceiling tiles should be replaced to avoid serving as pathways to unconditioned areas.

Missing ceiling tiles

12. Replace any missing or ajar ceiling tiles to avoid pathways to unconditioned areas.
13. Consider adopting a balancing schedule of every 5 years for all mechanical ventilation systems, as recommended by ventilation industrial standards (SMACNA, 1994).

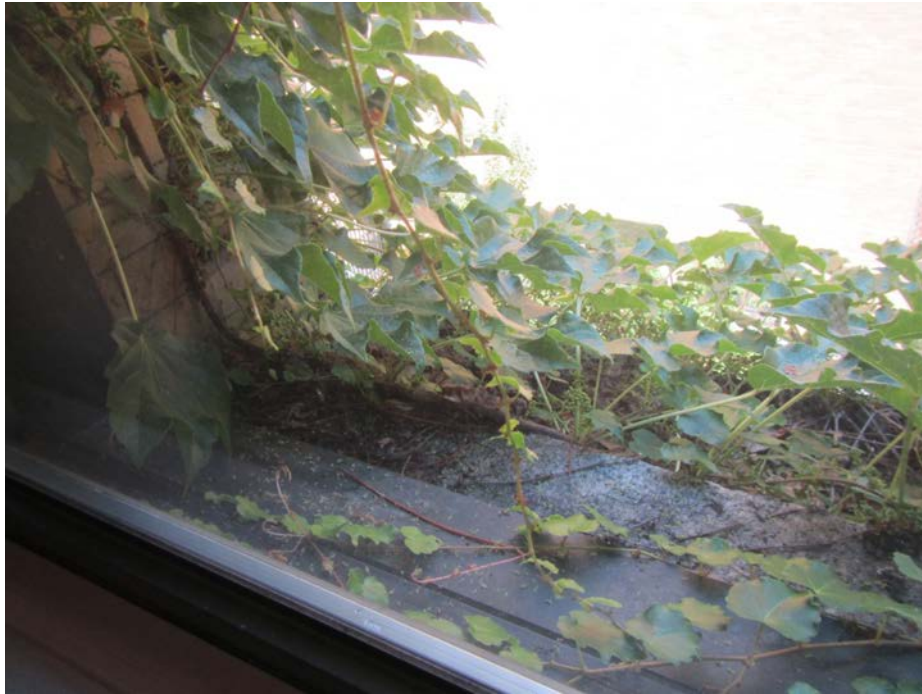
Picture 23

In some areas, including the interior courtyard, vegetation was observed close to/against the building exterior (Picture 23). This can allow moisture to build up in building materials leading to damage and moisture infiltration. Root growth can damage the foundation. Vegetation can also be a source of allergens such as pollen and mold, which can enter the building through open windows.

Vegetation against exterior of building

21. Trim back trees/vegetation within 5' of the building. Remove any vegetation (e.g., ivy) that is growing on the building to avoid damage to exterior from associated moisture.

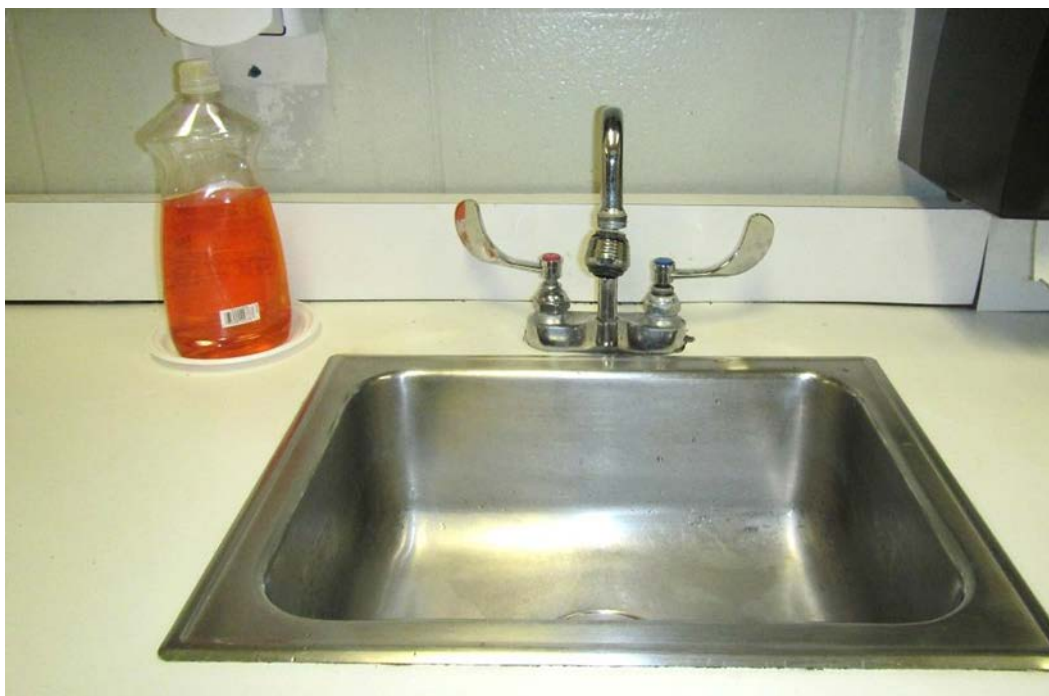
Picture 24

Sinks were observed in a number of classrooms. In a few areas, the backsplashes were unsealed (Picture 24). Some bathroom sinks were dripping and could not be shut off. Leaking plumbing can be a source of moisture to classroom materials and the indoor environment, particularly when outdoor humidity is high. Some sinks examined also had porous items (books, paper) stored inside the sink cabinet, which is a moist environment.

Backsplash behind sink lacking caulking

14. Ensure any plumbing leaks are repaired to avoid chronic water damage in the building.
15. Repair sinks and sink backsplashes in classrooms.
16. Regularly add water to any fixtures/drains that are out of order or are rarely used to avoid dry drain traps. Make necessary repairs or if fixtures are deemed unnecessary they should be properly abandoned and capped.

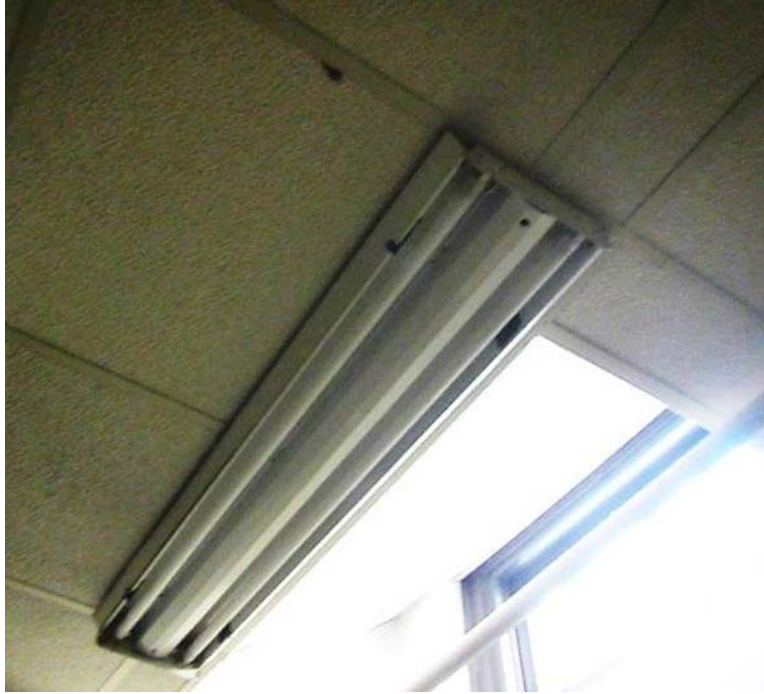
Picture 25

Missing/ajar light covers were seen in a few areas (Picture 25; Table 1). Fixtures should be equipped with access covers installed with bulbs fully secured in their sockets. Breakage of glass can cause injuries and may release mercury and/or other hazardous compounds. Other fluorescent lights had dust and debris inside them which should be cleaned.

Missing light cover

25. Replace/repair fluorescent light covers; ensure fluorescent lights are fully secured to prevent breakage and clean debris out of covers.
26. Encourage faculty to report classroom/building related issues via a tracking program.
