INDOOR AIR QUALITY ASSESSMENT

**Lowell High School
“1980 Building”
50 Father Morissette Blvd
Lowell, MA**

Prepared by:
Massachusetts Department of Public Health
Bureau of Environmental Health
Indoor Air Quality Program
August 2017

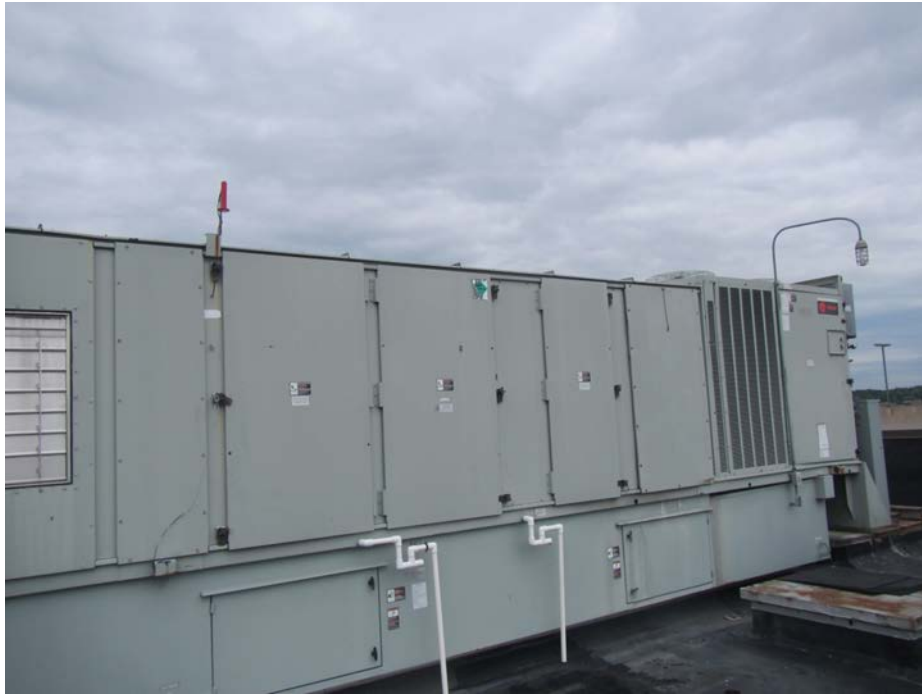
Picture 1

Fresh air is provided by multiple air-handling units (AHUs) located on the roof. The AHUs are mostly “packaged” units that provide both heat and air conditioning (AC) (Pictures 1 and 2). Fresh air intakes draw in fresh air through an intake vent where it is filtered, then heated

Large “packaged” AHU on the roof

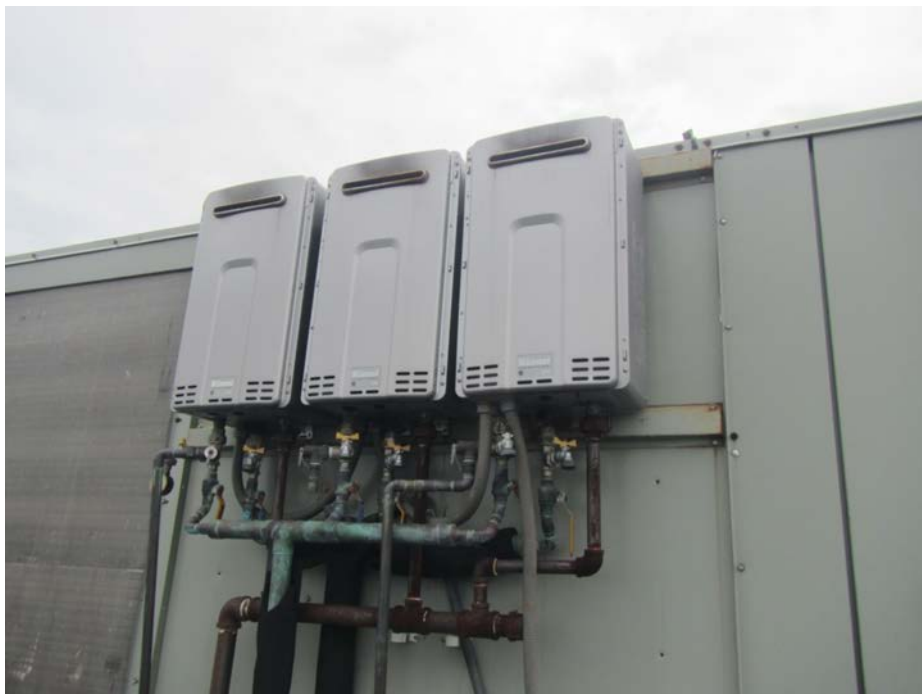
Picture 2

Direct gas-fired heating units on roof top AHU

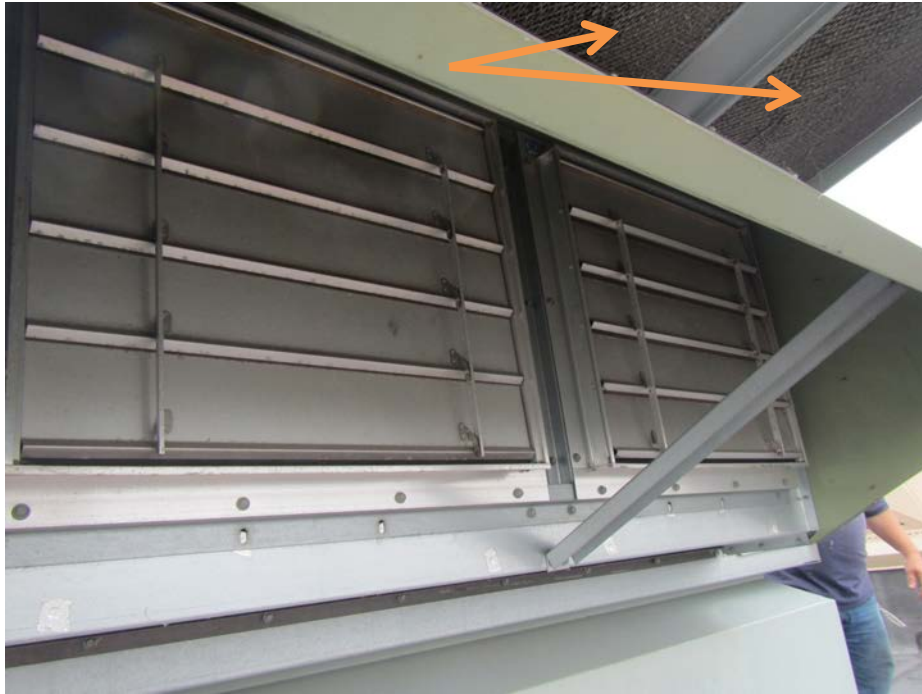
Picture 3

or cooled (Picture 3). The conditioned fresh air is mixed with some air returned from classrooms, then supplied to rooms through supply diffusers/grates throughout the building (Picture 4). Return vents (Picture 5) bring stale air back to the AHU where a portion of this air is exhausted through louvres in the AHU. The HVAC systems should be regularly maintained and operate continuously during occupied hours.

Fresh air intake vent (arrows) and closed exhaust louvres (below)

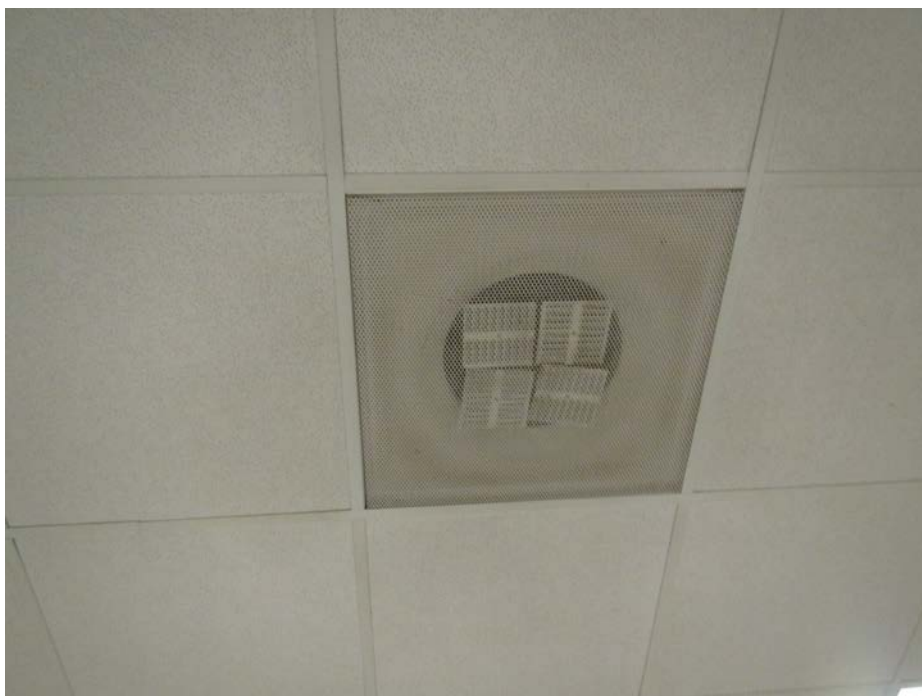
Picture 4

Ceiling-mounted supply vent

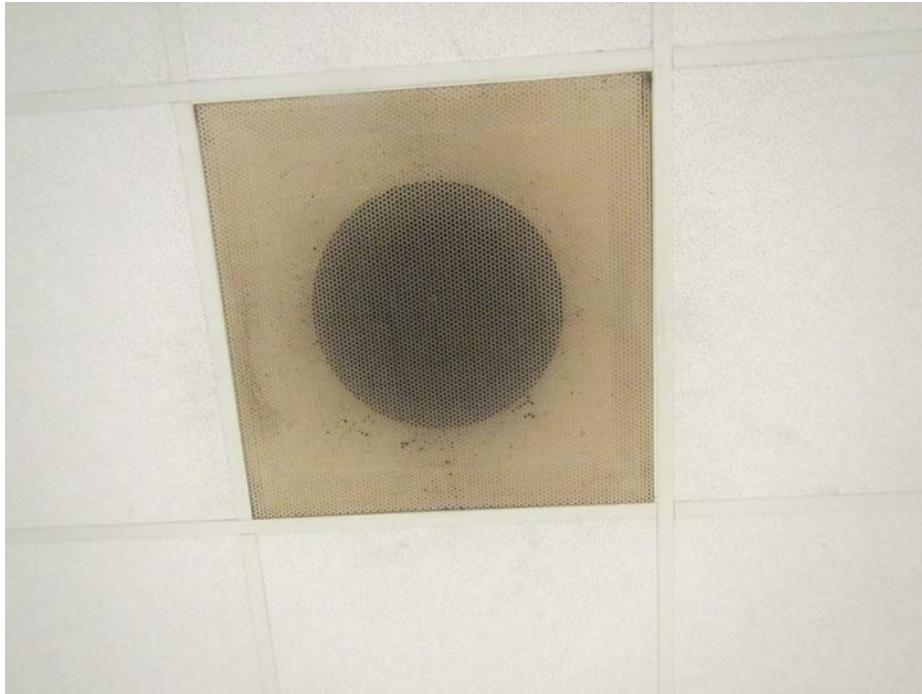
Picture 5

Ceiling-mounted exhaust vent

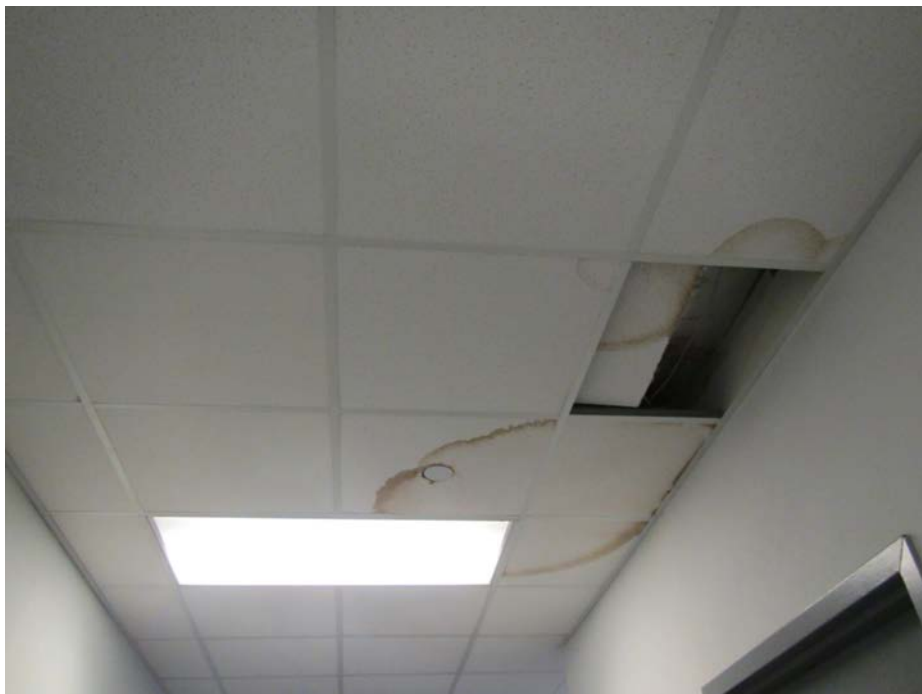
Picture 6

Water-damaged ceiling tiles and plaster walls were observed in many classrooms, offices, and hallways (Pictures 6 through 8; Table 1), indicating leaks from the building envelope or plumbing system. Ceiling tiles should be replaced after the leak is found and repaired. In general, ceiling tiles have an open space above them (the ceiling plenum) and tend to dry out quickly, reducing the chance for mold colonization. Ceiling plaster does not contain organic material; therefore, it will not support microbial growth even when frequently moistened. In some cases, dust or paint on the surface of plaster can become mold colonized. If this occurs, plaster can often be cleaned to remove the mold.

Considering the number of water-damaged ceiling tiles observed, the roofing system should be assessed to find and repair these leaks. Roof drains, roofing materials, and flashing/connections between roof segments and walls should be examined regularly for pooling water and other indications of deterioration with repairs made as needed.

Water-damaged and missing ceiling tiles

2. Consult with a roofing contractor to assess the roofing system. Repairs should be made to stop leaks and chronic water damage to building materials. The roofing system should then be monitored regularly for water pooling, leaks, and other deteriorating conditions.

12. Replace water-damaged and mold-colonized ceiling tiles after leaks have been addressed. Clean/remediate any moldy wall material consistent with the U.S. Environmental Protection Agency's guidelines (US EPA, 2008).

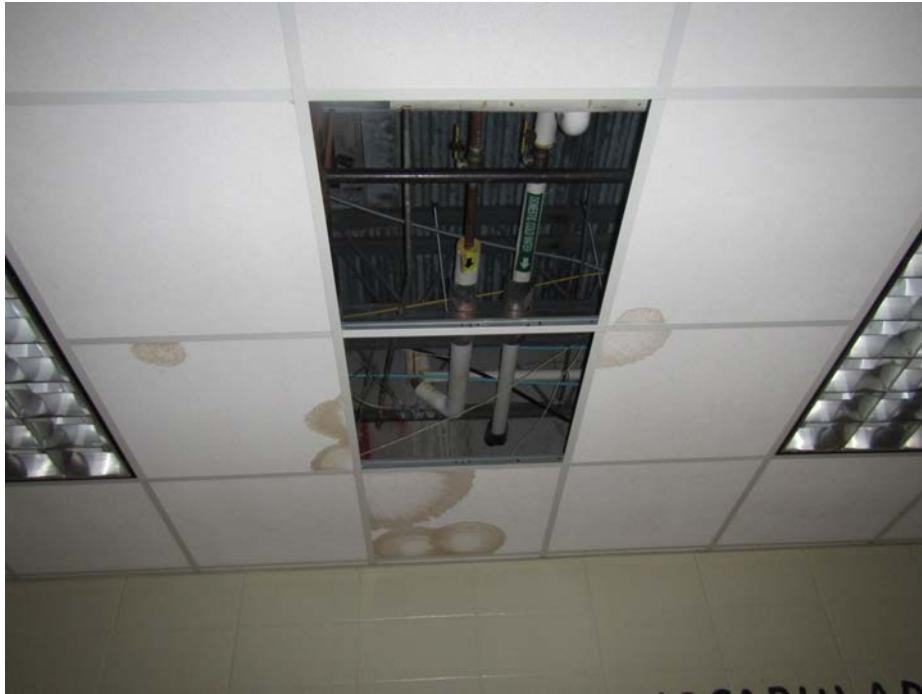
Picture 7

Water-damaged and missing ceiling tiles

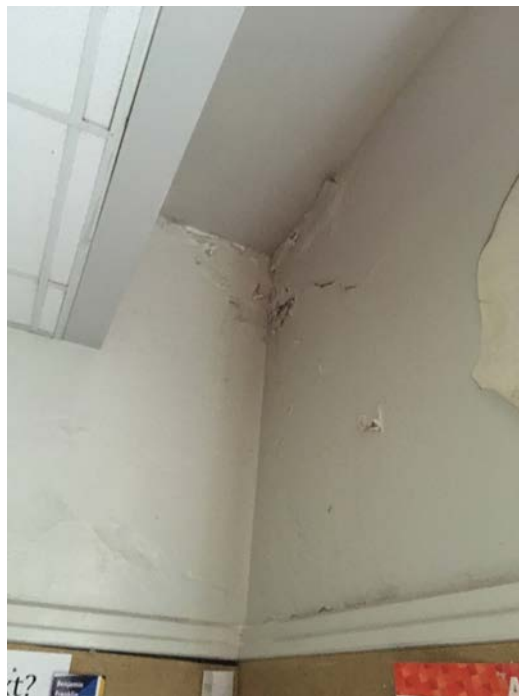
Picture 8

Water-damaged ceiling plaster

1. Replace any water-damaged or mold-colonized porous building materials (e.g., ceiling tiles, gypsum wallboard, carpeting) in classrooms, hallways, and stairwell areas. Ensure water-damaged materials are cleaned, replaced, and/or repaired in a manner consistent with the U.S. Environmental Protection Agency’s guidelines (US EPA, 2008).

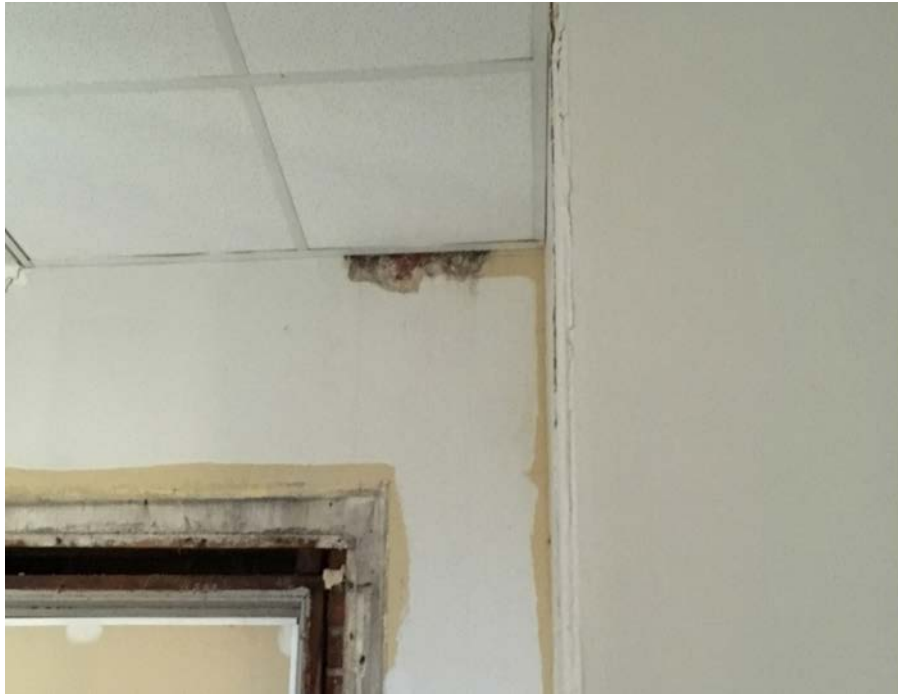
Picture 9

In a few locations, gypsum wallboard was found to be colonized with mold (Picture 9; Table 1). Mold growth can be a source of allergies and irritation. Measures should be taken to ensure water-damaged materials are cleaned, replaced, and/or repaired in a manner consistent with the U.S. Environmental Protection Agency's guidelines (US EPA, 2008). The US EPA and the American Conference of Governmental Industrial Hygienists (ACGIH) recommend that porous materials (e.g., ceiling tiles, gypsum wallboard) be dried with fans and heating within 24

Mold staining on wall

to 48 hours of becoming wet (US EPA, 2008; ACGIH, 1989). If not dried within this time frame, these materials should be removed/discarded.

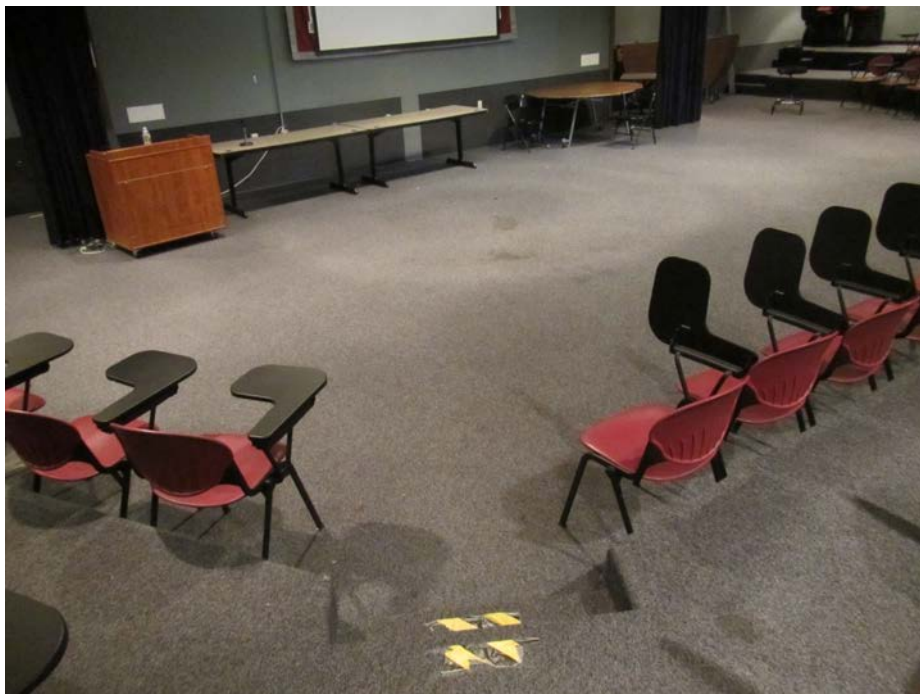
Picture 10

Wall-to-wall carpeting was observed in some classrooms and offices. Wall-to-wall carpeting is not recommended in school classrooms in general, due to the difficulty in maintaining it in good condition, including wear, dirt, and spills. Roof leaks leading to stained ceiling tiles can also be a source of water to moisten carpeting. Carpeting moistened for more than a short period of time will be subject to microbial growth. Some carpeting was visibly stained (Picture 10). The service life of carpeting in schools is approximately 10-11 years (IICRC, 2002). Aging carpet can produce fibers that can be irritating to the respiratory system. In addition, tears or lifting carpet can create tripping hazards. Carpeting should be cleaned annually or semi-annually in soiled high traffic areas as per the recommendations of the Institute of Inspection, Cleaning, and Restoration Certification (IICRC, 2012).

Stained carpeting

15. Regularly clean supply/return vents and fans to avoid aerosolizing accumulated particulate matter.
16. Clean carpeting and area rugs annually or more often in high-traffic locations in accordance with IICRC recommendations (IICRC, 2012) and discard those that are worn out or too soiled to be cleaned.

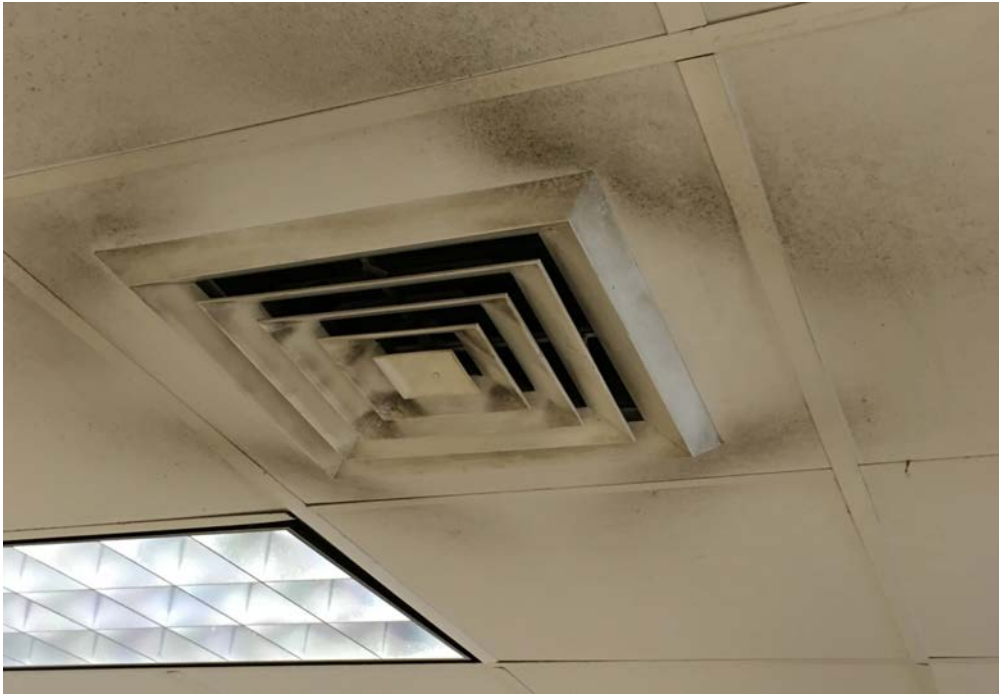
Picture 11

Many classrooms had personal fans. Some of these had dusty blades. Many supply and exhaust vents were also observed to be dusty (Pictures 11 and 12; Table 1). Dust on ventilation and fan equipment can be aerosolized when the units are activated.

Dusty supply vent

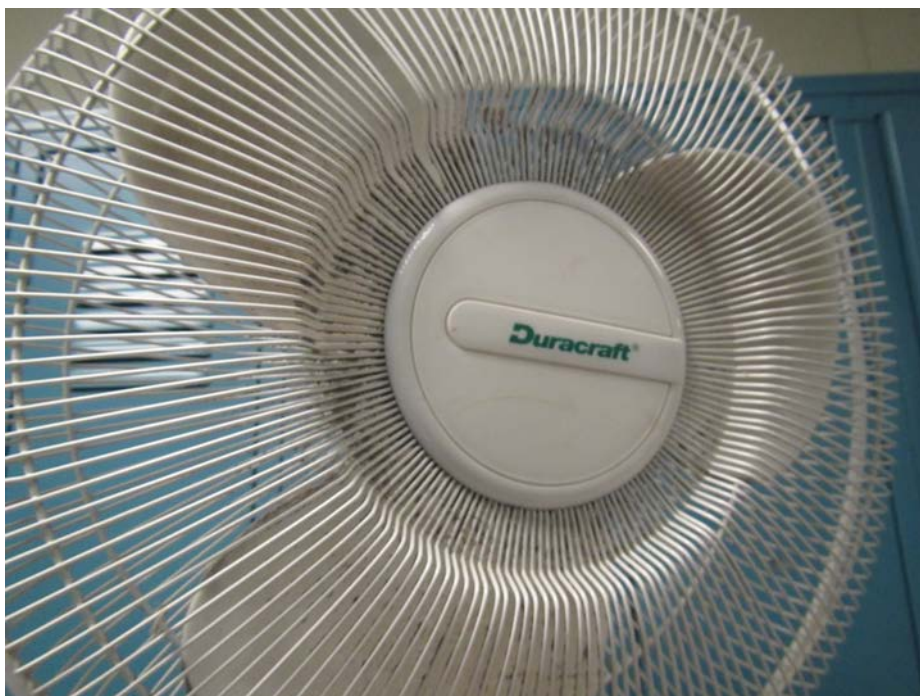
Picture 12

Dusty personal fan

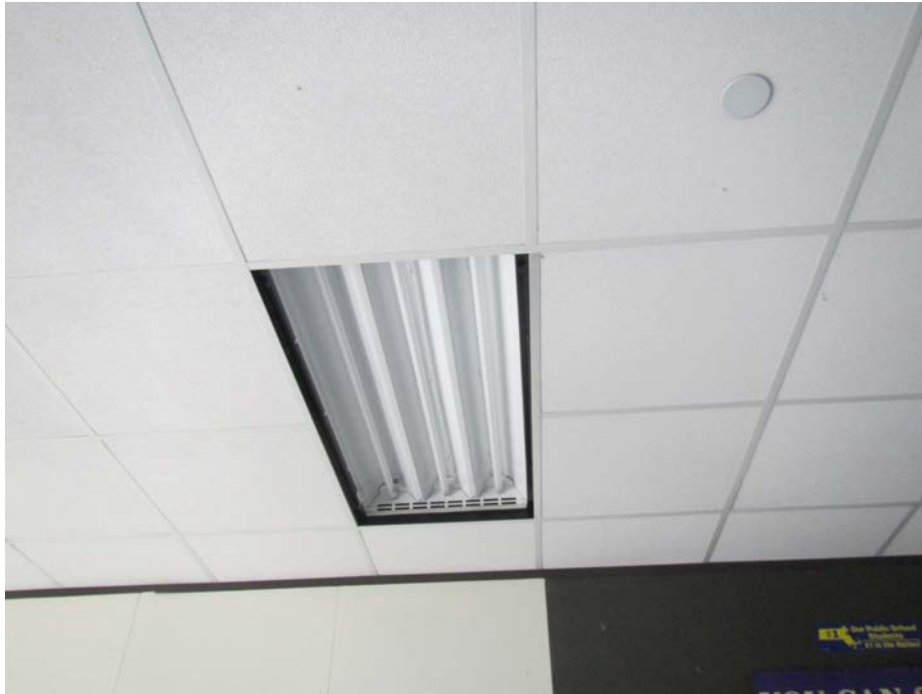
Picture 13

Missing/ajar light covers were seen in a few areas (Picture 13; Table 1). Fixtures should be equipped with access covers installed with bulbs fully secured in their sockets. Breakage of glass can cause injuries and may release mercury and/or other hazardous compounds.

Missing fluorescent light cover

17. Replace/repair fluorescent light covers; ensure fluorescent lights are fully secured to prevent breakage and clean debris out of covers.
18. Encourage faculty to report classroom/building related issues via a tracking program.

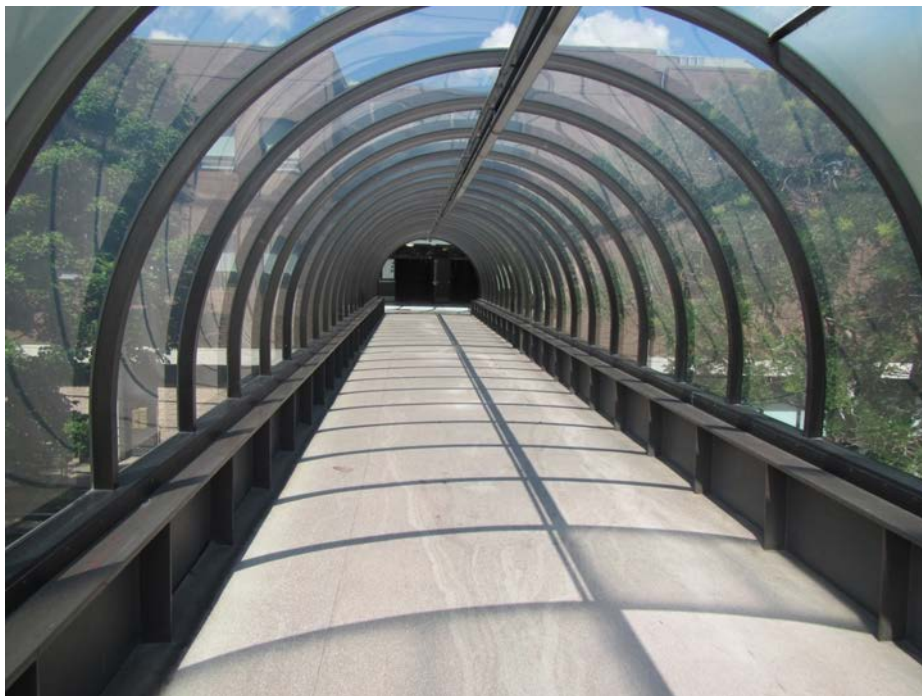
Picture 14

This building has two enclosed walkways that connect to the “1920’s” building from the second floor (Picture 14). A plastic-like odor was detected by IAQ staff when entering a walkway. It is likely that exposure of the soft vinyl flooring/adhesive to direct sunlight is causing the flooring to release these odors. When entering the walkway later in the day during overcast skies, there was no odor detected. It is the experience of the IAQ staff that odors are typically detected long before reaching established guidelines for volatile organic compounds (VOCs). However, VOC testing will be conducted to confirm this during the next scheduled visit to the school.

Enclosed walkway connecting 1980 building to 1920's building
