Main Street, Hampden Flooding Assessment Report

Prepared for Town of Hampden, Massachusetts

Prepared by Howard Stein Hudson

June 2021

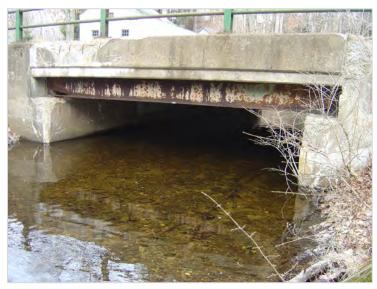
South Fascia - East Brook Culvert / Bridge No. H-04-008

The bridge is a simple span steel stringer bridge with a reinforced concrete deck and is supported by concrete gravity abutments. The bridge has a span length of 17'-8" with an out-to-out width of 44'-0" and a curb-to-curb width of 40'-0". The bridge carries two 12'-0" travel lanes (one each direction) with 4' shoulders, 4'-wide grass strips and no sidewalks. The bridge has been on an ongoing 12-month MassDOT inspection cycle since the superstructure was given a condition assessment equal to 4 or "Poor Condition" due to the fascia stringers having areas of 100% section loss. The deck has a condition assessment of 5 or "Fair

Condition" and the substructure has a condition assessment of 6 or "Satisfactory Condition." Copies of the latest Bridge Inspection Reports and bridge plans for Bridge No. H-04-008, Main Street over East Brook, are provided in **Appendix D**.

A preliminary hydraulic analysis was performed for this structure and it appears that 25-year design storm exceeds the capacity of the structure and the stream flows flood the roadway. As flooding has been an issue in the past, it would be recommended to replace this structure with a longer span structure to provide more hydraulic capacity and reduce the risks of flooding at this location. As this structure has a span length greater than 10 feet but less than 20 feet, it meets the requirements of MassDOT's Small Bridge Program. The Small Bridge Program provides funding for bridge projects

with a maximum total annual benefit of up to \$500,000, where the municipality is responsible for costs exceeding that limit. This structure also qualifies for the DER Culvert Replacement Municipal Assistance Grant, if design follows DER's specific methodology. Lastly, the Town can also use the Massachusetts Chapter 90 program to assist in funding a replacement bridge.

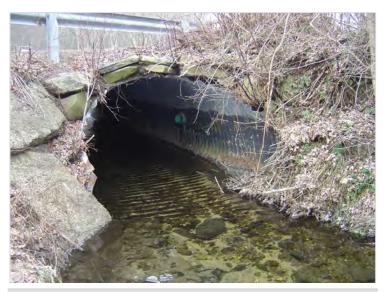
North End (Inlet) - Big Brook at Main Street Culvert

The culvert is a Corrugated Metal Pipe (CMP) Arch with a span of 8'-8" and a rise of 5'-11" with random stone headwalls. The culvert carries two 12'-0" travel lanes (one each direction) with 2' shoulders, no sidewalks, and has w-beam guardrail. This culvert is not on MassDOT's bridge or culvert inventory list and is not being inspected since it is a municipally owned structure with a span less than 10 feet. HSH performed a visual inspection of this structure on December 16, 2020 and found the structure to be in relatively good condition with no major deficiencies to note.

The conceptual StreamStats hydraulic analysis (see Appendix B) for this structure also appears to indicate that the 25-year design storm overtops the roadway. As flooding has been an issue in the past, when it comes time for the replacement of this structure, it is also recommended to replace this structure with a longer span structure to provide more hydraulic capacity and reduce the risks of flooding at this location.

This structure would also qualify for the DER Culvert Replacement Municipal Assistance Grant, if design follows DER's specific methodology and is identified by the Massachusetts Wildlife Climate Action Tool as a top 5% for culvert replacement. However, the condition of the existing structure does not currently warrant replacement. Lastly, the Town can also use the Massachusetts Chapter 90 program to assist in funding a replacement culvert.

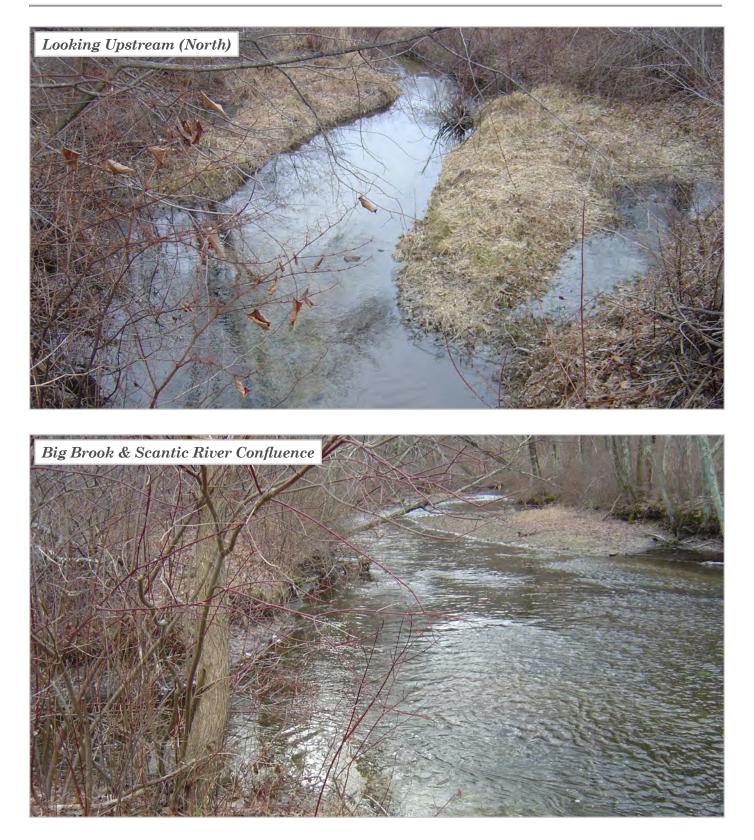
Big Brook Culvert Photos

Notes: Wingwalls are generally exhibiting delamination and spalling. Bank-to-bank measures 18'-8" at the inlet (North) and 24'-7" at the

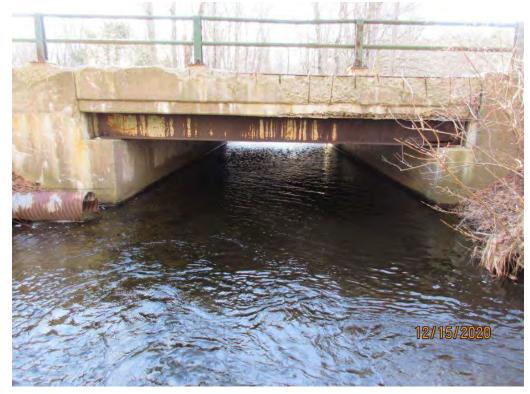
Photo 1: Deck Underside has longitudinal hairline cracks.

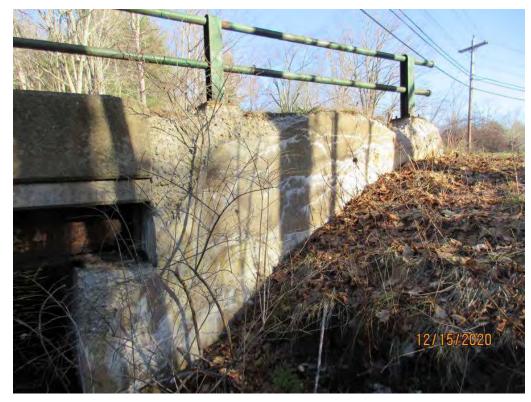
Photo 9: East Abutment has hairline cracks
