# MassDEP Field Assessment and Support Team

**After Incident Report**

**NE-11-6727**

**Malden High School Mercury Spill Incident**

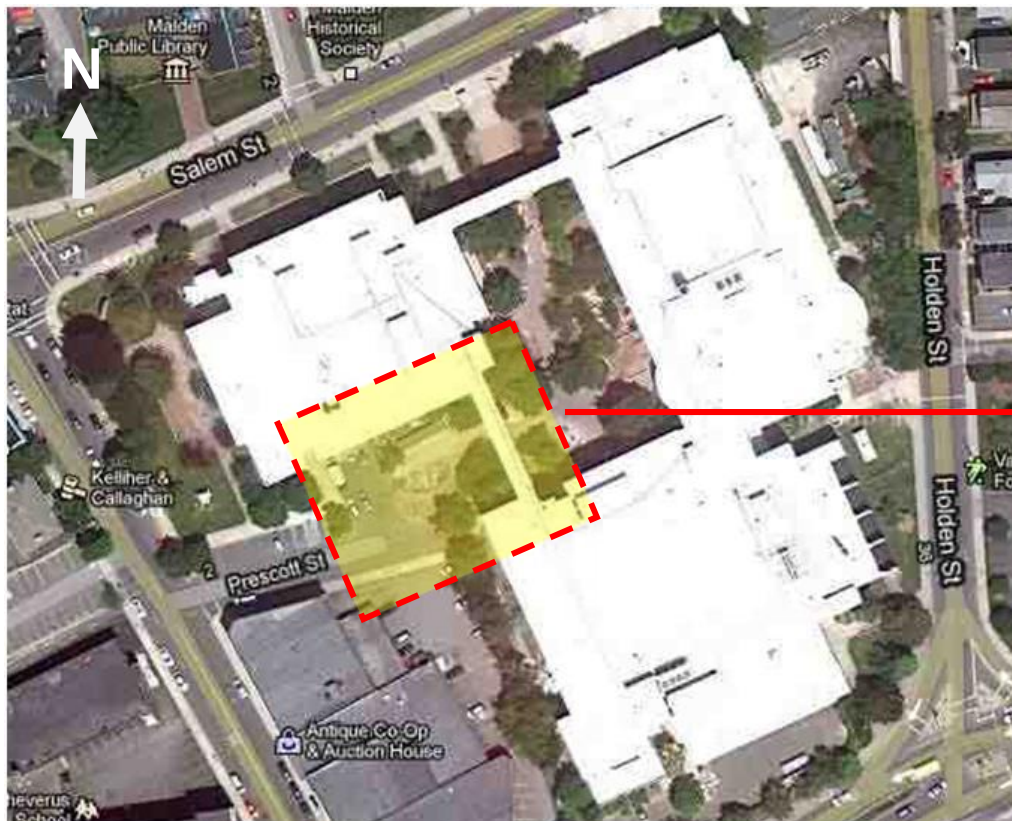
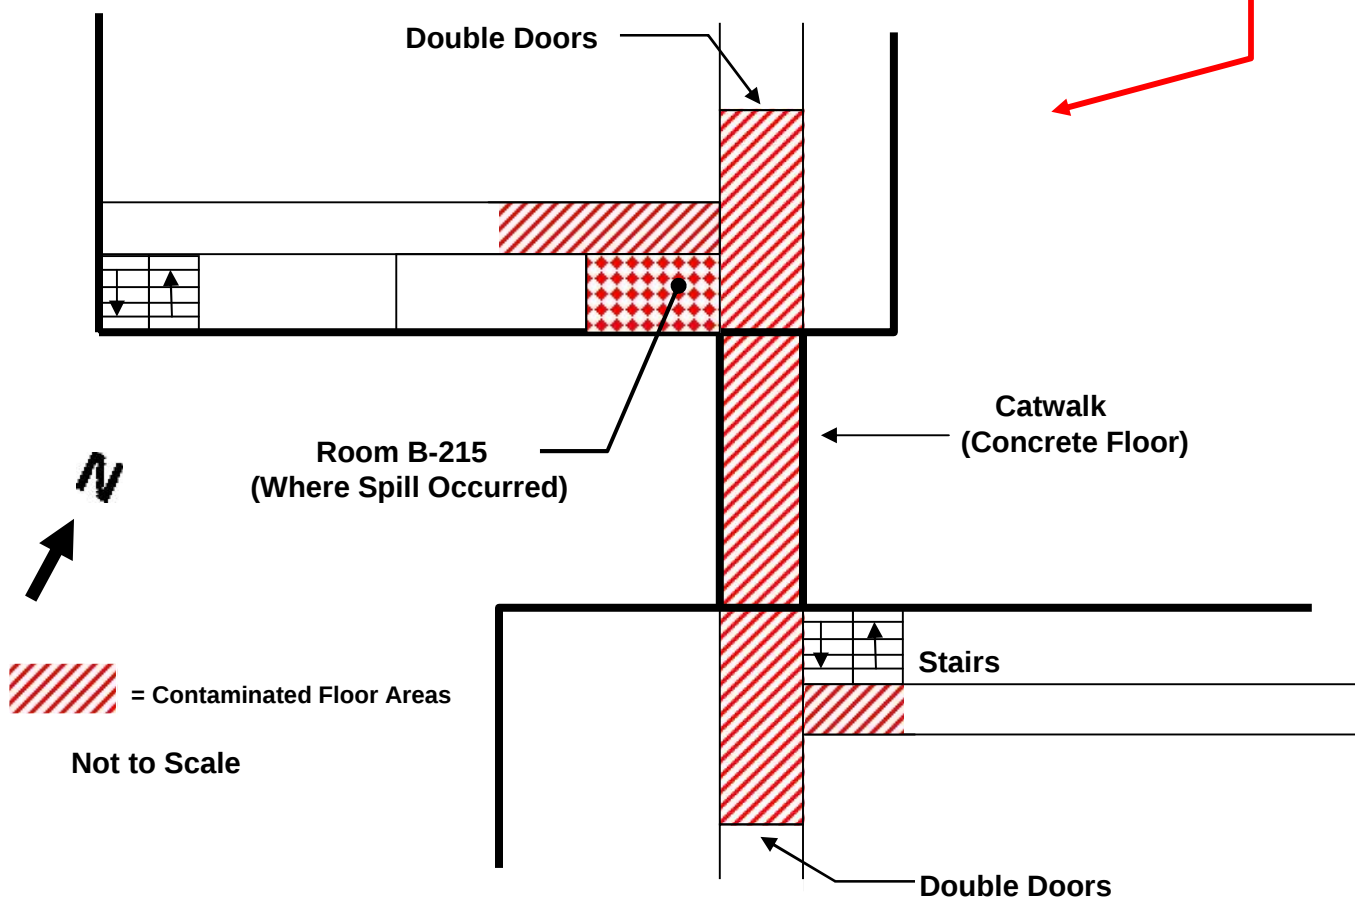
Figure 1 – Spill and Cleanup Location (2<sup>nd</sup> Floor)

On the basis of this effort, the most significantly contaminated area (outside Room B-215) was the concrete floor in the catwalk that runs perpendicular to and south of Room 215. Lesser amounts were found in the building south of the catwalk, continuing to a stairway to the east of the catwalk/hallway. The boundaries of areas of concern are highlighted in Figure 1.

Staff from MassDEP explained the situation to the ENPRO supervisor, and delineated the areas of contamination. A suggestion was made to apply a mercury immobilization agent in the impacted hallway areas, and to use a Mercury Vacuum in Room B-215, to remove visible droplets, followed by the immobilization agent.

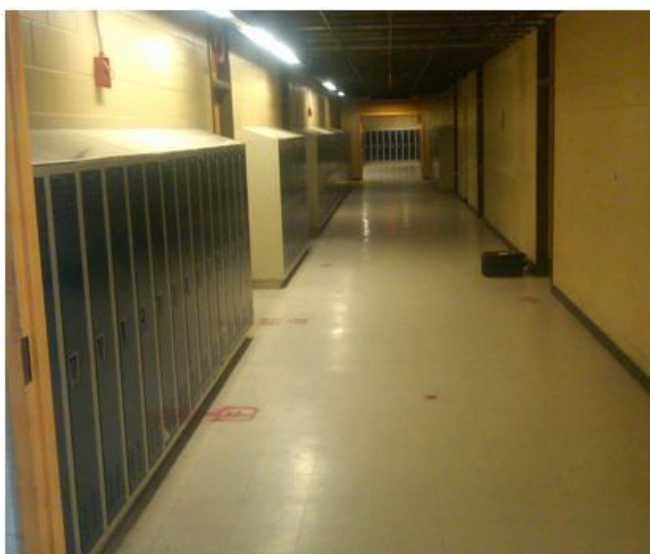
**Hallway outside Room B-215, looking west**

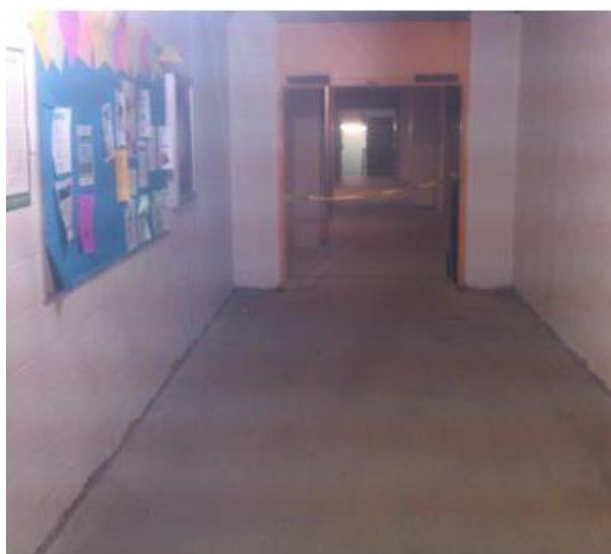
**Hallway perpendicular/easterly of Room B-215 hallway, looking north**

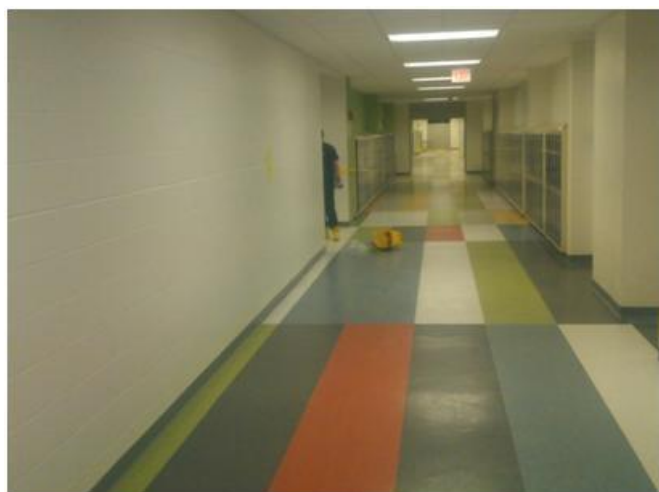
**Hallway south of catwalk, looking south**

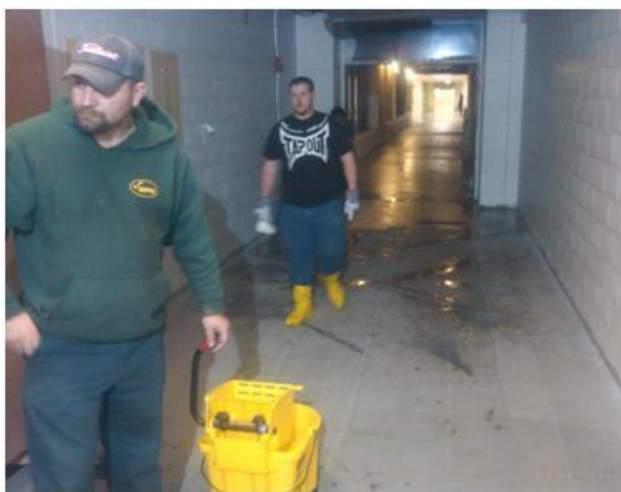
**ENPRO personnel applying HgX<sup>®</sup> to hallway just north of catwalk**

ENPRO chose to use the commercial product *HgX*<sup>®</sup> as the immobilization agent. This product, a solid powder, is dissolved in water and applied to impacted areas with mops and brushes. It contains proprietary sulfur compounds that chemically react with elemental mercury to form a non-volatile mercuric sulfide salt. After a drying period, the film residue is washed off/removed with water and mops.
